## Restoring and structurally reinforcing historic monuments by glass

Proceedings of the 6th International Conference on Structural Engineering, Mechanics and Computation

**ABSTRACT:** In this paper a pioneering, transparent restoration methodology is presented, introducing structural glass elements to substitute missing components of damaged monuments and simultaneously reinforce the original structure. To prove the feasibility of the concept, a damaged medieval tower in Toolse, Estonia is selected as a case study: Soil movements and over-consolidated clay layers result to a widening vertical crack, approximately one meter wide. Alternative designs, with float and cast glass components respectively, are proposed for restoring the crack and improving the wall's stability. The considerable differences in strength and stiffness between the original wall and the glass addition require connections that establish a coherent system. Specimens bonded with selected adhesives are tested in shear and evaluated. Finally, full-scale prototypes of a characteristic part of the wall are produced and tested in three point bending to compare the overall cooperation and compatibility of each desig

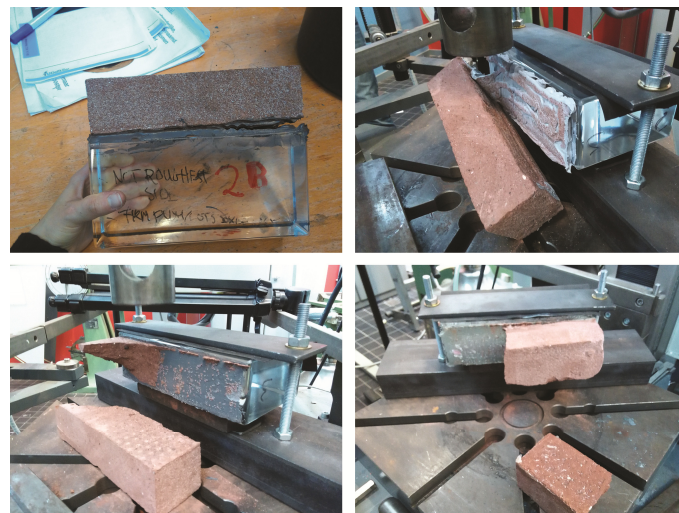
Figure 3 shows the typical failure mode of each type of adhesive. The specimens bonded with *Araldite 2013* and *MD-MS polymer* failed by damage of the brick component. Even though these two adhesives present the highest shear stress upon failure, their failure mode is unfavourable for the restoration purposes; when the adhesive is stronger than the masonry it results in damage of the historic wall in the

The specimens bonded with *Tec7 Brown* and *Sabatack 780* failed by either cohesion of the adhesive or adhesion to glass after considerable deformation. These types of failure are the most favourable: by showing a gradual, visible deformation both adhesives provide by a ductile behaviour a warning mechanism before failure. Furthermore, the connection behaves as the weakest link, preventing the brittle failure of both glass and masonry. Moreover, the semi-rigid nature and considerable application thickness of these two adhesives can accommodate movements, and thus prevent the introduction of stresses due to the different thermal expansion coefficient of the two materials or due to settlement of the structure. For the same reasons, they can cover deviations in the rough surface of the historic wall, ensuring a uniform connection method.

Figure 3. Failure mode in shear of the different types of adhesives. Top Left: *Tec7 Brown*. Top Right: *Sabatack 780*. Bottom Left: *Araldite 2013*. Bottom Right: *MD-MS Polymer*.

*Tec7 Brown* was selected as the most suitable adhesive for constructing the full-scale prototypes since it exhibits a ductile connection and has approximately double the strength compared to *Sabatack 780*. In terms of reversibility, its semi-rigid nature allows for a relatively easy mechanical removal without damaging the monument. Moreover, this adhesive presents a good long-term performance as it is UV-, water-, saltwater- and moisture- resistant and shrinkage free.

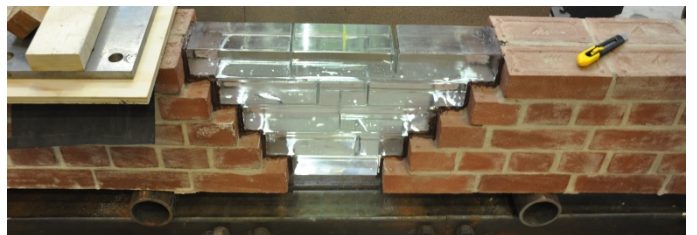
The construction of this design revealed some practical difficulties of filling the missing part with cast glass elements: Deviations in the height of each masonry layer can be easily accounted for when using float glass. However, in the case of cast glass elements dimensional deviations can only be compensated for by the thickness of the adhesive layer. The range of different size components has to be restricted due to high manufacturing cost. In this case, to follow the pattern of the masonry, float glass panes were inserted between the cast elements (see figure 7).

Increasing the test load, an initial crack occurred in the mortar at the bottom zone of the beam, close to one of the supports. It was observed that prior to testing the mortar at that location was very dry and brittle. The crack propagated as far as the glass addition, separating a small segment of the wall from the rest of the masonry. Still, the adhesive connection in collaboration with the glass insert sustained the separated segment until the complete failure of the beam due to increased deformation at a load of approximately 45 kN. Until failure, there was no considerable deformation observed within the adhesive connection.

Figure 7. Top: Specimen 3 before failure. Bottom: Specimen 3 after failure.

- In the case of specimens 1 and 3, cracks initiated at the mortar or the masonry due to support reactions before a visible deformation of the adhesive. Still, the adhesive connection was strong enough to hold the specimen together and elastic enough to absorb the deformations created in the masonry. Only after a considerable load increase and visible deformation did the adhesive connection fail, leading to the complete detachment of the damaged part of the masonry. In reality, such cracks may occur to the masonry and it is important that the adhesive can hold the pieces to-
