**Rail Condition Monitoring using Axle Box Acceleration Measurements  
Defect detection in the Netherlands and Romania**

**Published in**  
Proceedings of the 2018 World Transport Convention

# **Rail Condition Monitoring using Axle Box Acceleration Measurements: defect detection in the Netherlands and Romania**

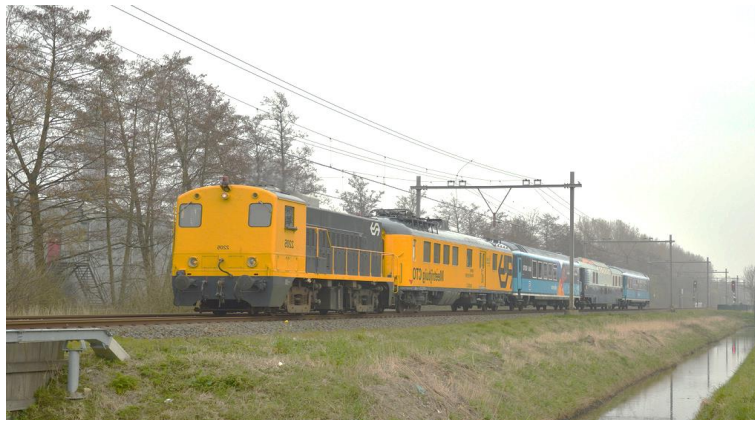
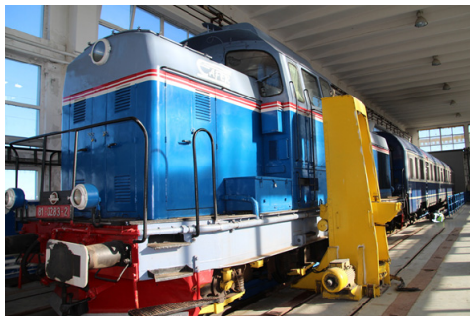
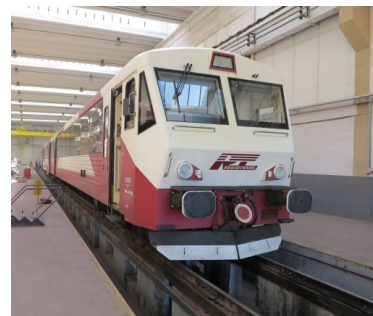
Figure 1: ABA sensors installed on trains in (a) The Netherlands, (b) the test ring Faurei in Romania, and (c) the line Bartolomeu-Zărnești, Romania.

ABA data is collected from accelerometers mounted at the axle boxes. For positioning, a GPS receiver and either a tacho or speed-sensor are used. The monitoring of the entire Dutch railway provides a data volume of several terabytes (Núñez et al., 2014). Multiple accelerometers are usually considered to reduce noise to increase the detection hit rate of small defects. Once installed, the measurement has a low cost in the sense that it is not needed to book expensive specialized measurement trains for the daily monitoring of defects. Accelerometers are also becoming cheaper in the market. The information acquired from the measurement provide an accurate indication of the effective severity of the defect. In Figure 1, the trains used for measurements in The Netherlands, Faurei Test Ring and are presented.

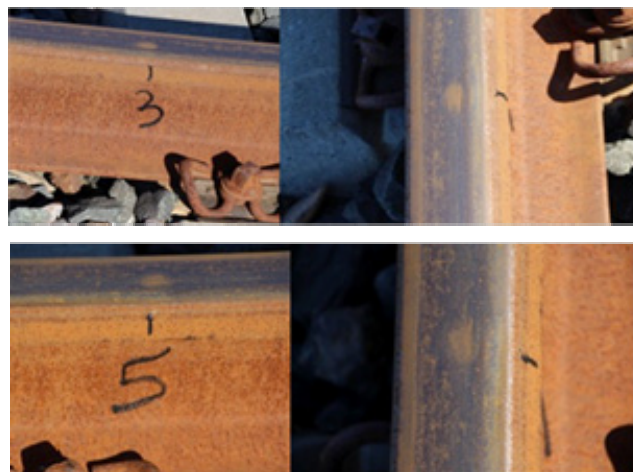
Figure 6: Examples of some of the defects detected.

Făurei railway testing centre belongs to the Romanian Railway Authority (AFER). Different dynamic measurements are performed in this ring. The trains in this test ring can run with speeds up to 220km/h. Thus, the track quality condition of the test ring should be kept with high standards, to ensure safety specially during the high-speed operations. ABA measurements were conducted in this ring with various speeds. Defects and condition of insulated joints and switches and crossings were measured. In Figure 5, a map of the test ring and a map with the location of defects (D), insulated joints (IJ), switches and crossings (S&C), welds (W) with low quality are presented. All those detected locations were inspected, and some few examples are shown in Figure 6.
