## Full Length Article

## Preliminary results of a fiber optic scour sensor (FOSS) for bridges

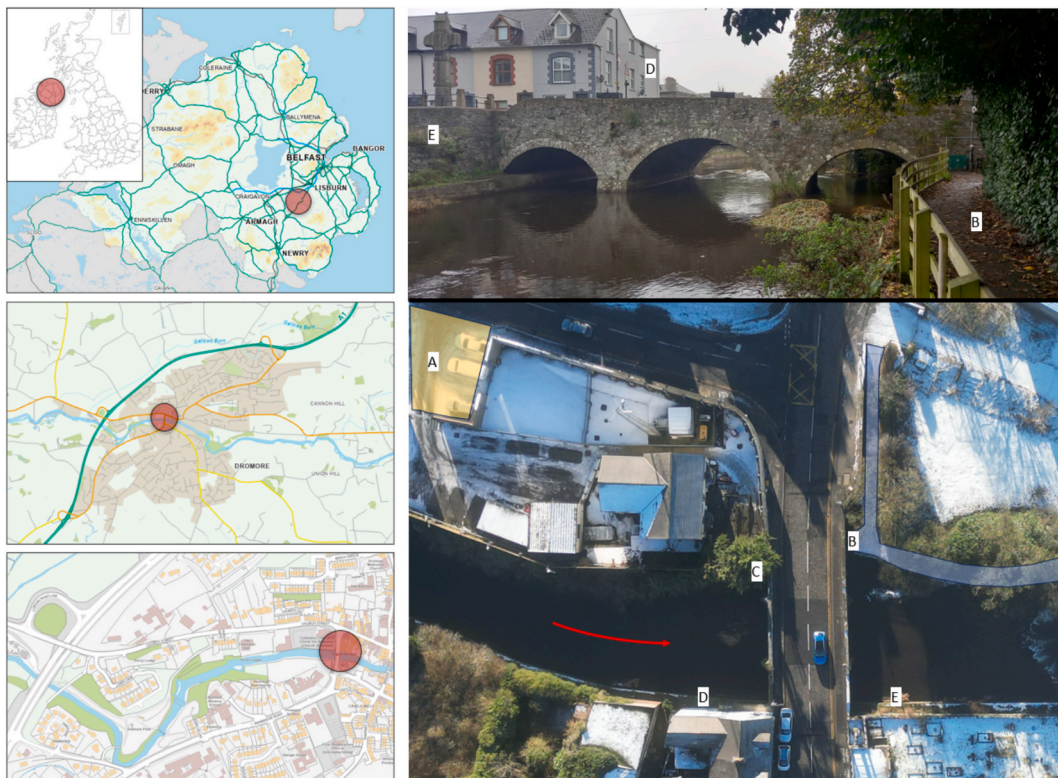
Fig. 3. Regent Bridge showing proximity of the car parking (A), illuminated surfaced pedestrian footway (B), property boundary's (C, D & E).

There are no water level riverbanks within this area of the river which further limits pedestrian access. A property access balcony located at point ‘D’ in Fig. 3 at road level provides a vantage point for viewing the upstream face of the bridge without entering the river.

A stainless-steel waterproof enclosure was located approximately 3 m above the river edge, set back from a masonry river training wall and mounted to a reinforced concrete wall adjacent to the upstream spandrel (Fig. 3c and rectangular yellow marker labelled 'Data Logger' in Fig. 4a). Power was supplied from the green cabinet (as seen in Fig. 3 and rectangular green marker labelled 'Power' in Fig. 4a).

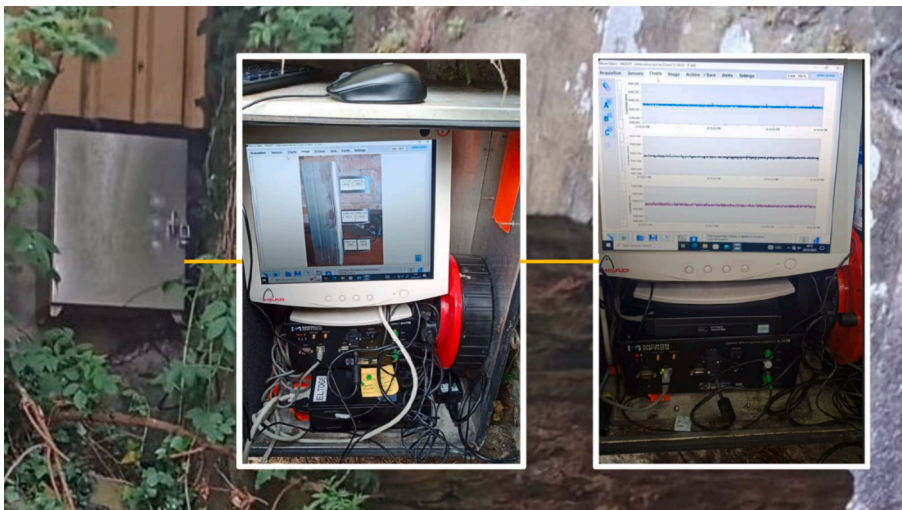
Fig. 5. Steel cabinet showing data acquisition equipment layout.

Fig. 5 shows the layout of the equipment within the stainless-steel cabinet, as well as the flat traces of the three buried fins.

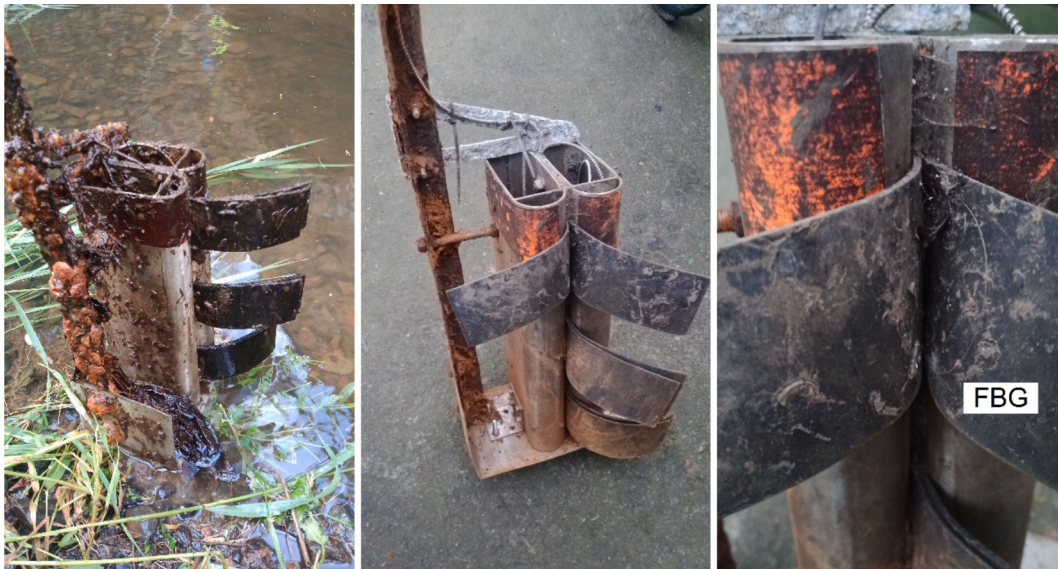
Fig. 13. Images showing the recovered VFS including the delaminated fins and exposed FBG. Top fin deliberately splayed open to show FBG.

4. **Fin Delamination:** Glue used between rubber fin layers failed resulting in the fins delaminating and exposing the FBG to sand and grit resulting in the failure of the sensor. Future deployments necessitate the improvement of these fins to either use harder wearing glue or investigate methods of embedding the FBG within a single layer of rubber molded around it.
