# Ageing and Lifetime of Medium Voltage ROV Umbilical Cables

Master Thesis

Delft University of Technology

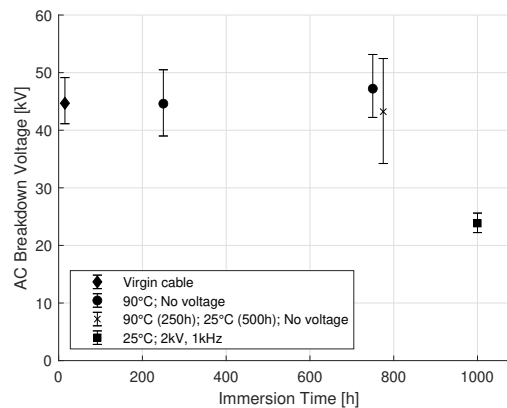
Figure 2.3: Breakdown voltage vs immersion time (reproduced from Bulinski et al. [27]).

From experiments conducted by Bulinski et al., immersion without voltage application on unaged cables does not affect the AC breakdown voltage [27]. Even temperature changes during the immersion have no effect, as shown in Figure 2.3. Hence, the moisture curing of silane cross-linking does not compromise the short-term AC breakdown strength. Thus, the cross-linking process with warm water does not affect the quality of XLPE.

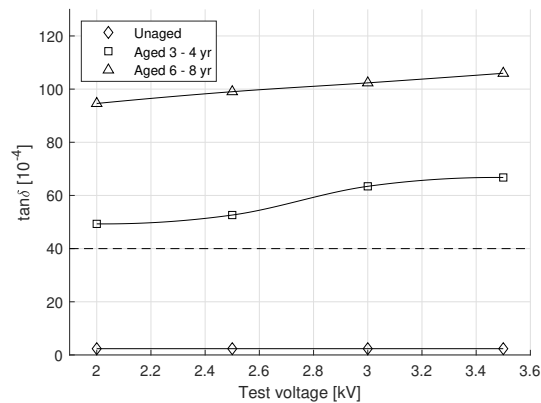
Figure 2.6: Influence of wet ageing on  $\tan \delta$  vs voltage (reproduced from Ponniran et al. [34]).

Figure 2.6 shows the change in  $\tan \delta$  with the voltage for unaged and aged samples. According to IEC standard 60502 [35], the  $\tan \delta$  must be  $<40 \times 10^{-4}$  at  $U_0$  and the maximum normal operating temperature. Before testing, the aged samples were kept in an open environment for moisture absorption. It is shown that the environmental conditions, mechanical and electrical stress and temperature also significantly influence the  $\tan \delta$  values.

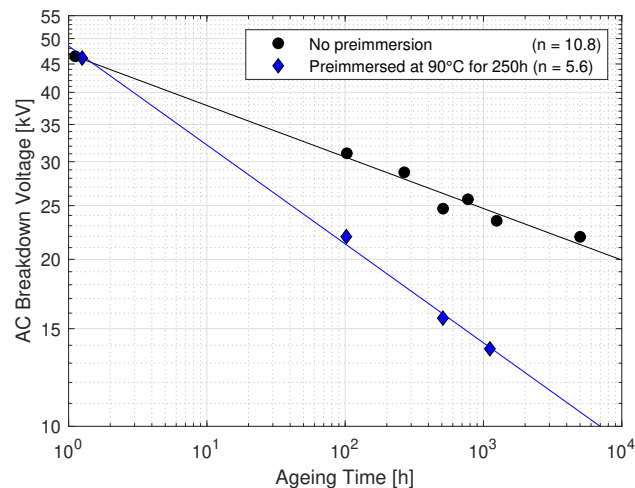
Figure 2.8: Effect of ageing and preconditioning on AC breakdown voltage (adapted from Bulinski et al. [27]).

Figure 2.8 presents the voltage lifetime curves for several conditions (unaged and pre-immersed as described above). The power law exponent  $n$  could be derived using this data, which is a critical parameter in determining cable lifetime. The value is  $n = 10.8$  for the cable unsaturated by water, representing the dry conditions. In contrast, the cable saturated with water shows  $n = 5.6$ . This also seems to be in the range used by Mellinger et al. [38], where  $n = 6$  was used for wet-aged cables to calculate the lifetime. Saturation with water will result in a significant reduction in lifetime.

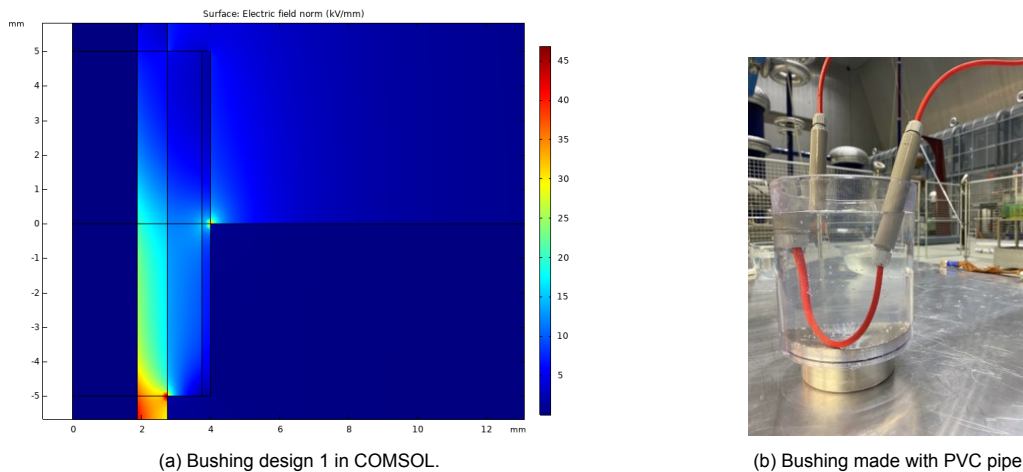
Figure 4.4: Triple point when cable under water.

**Bushing 1 – PVC Pipe** For the first bushing, a PVC pipe was filled with grease to increase the overall diameter of the construction, thereby decreasing the stress at the triple point. The pipe was terminated using watertight caps. However, during experiments, it was noticed that the cable broke only at the tip of the watertight caps under water. Further simulations showed that the field is also enhanced at the tip inside the water, as shown in Figure 4.4a. Thus the design needed to be modified.

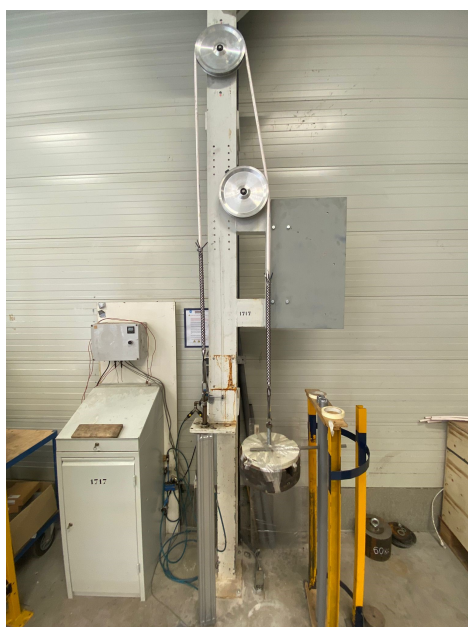
(a) CBoS setup for cable triples with jacket.

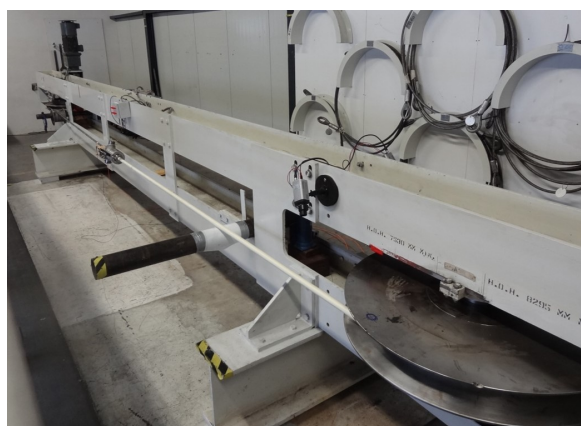
Figure 6.1: Loaded CBoS Setup

(b) CBoS Machine used for Ageing Cables with Armour

Tests were performed on an ROV cable made of HDPE with steel armour, which underwent 20,000 cycles on the test machine as shown in Figure 6.1. The stroke length of the test was 2 m, which is also shown in the distance profile, along with the velocity profile seen in Figure 6.2. The other parameters for CBoS are shown in Table 6.1.

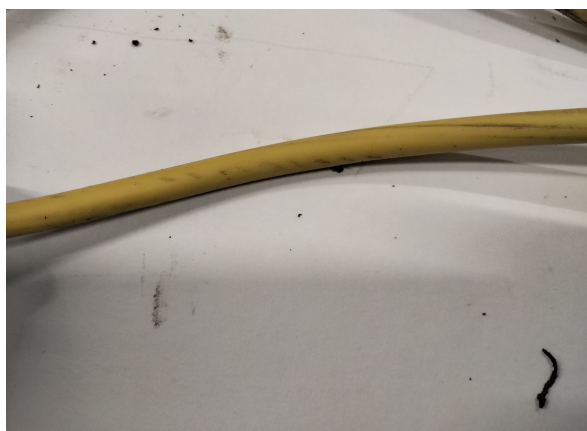
(a) Single conductor from a failed cable on field

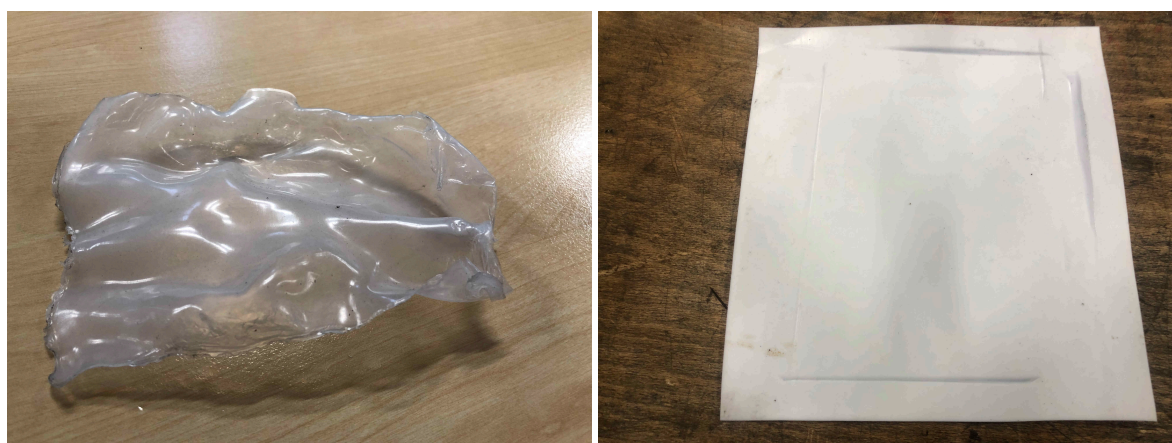
(a) Deformation due to sudden cooling of XLPE

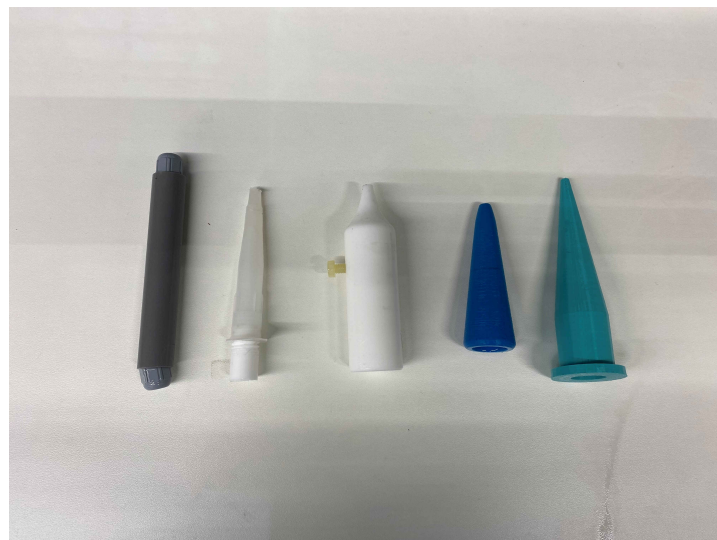
Figure B.3: Bushing trials made of different materials done starting from the left (a) PVC pipe with water-tight cap, (b) modified glue cap, (c) Teflon cone, (d) PET cone, and (e) TPU cone.
