CHAPTER 26

EROSION AND ACCRETION ALONG CLATSOP SPIT

Harold A. Kidby, Chief, Rivers and Harbors Section
John G. Oliver, Hydraulic Engineer, Tidal Hydraulics Subsection
U. S. Army Engineer District, Portland
Corps of Engineers
Portland, Oregon

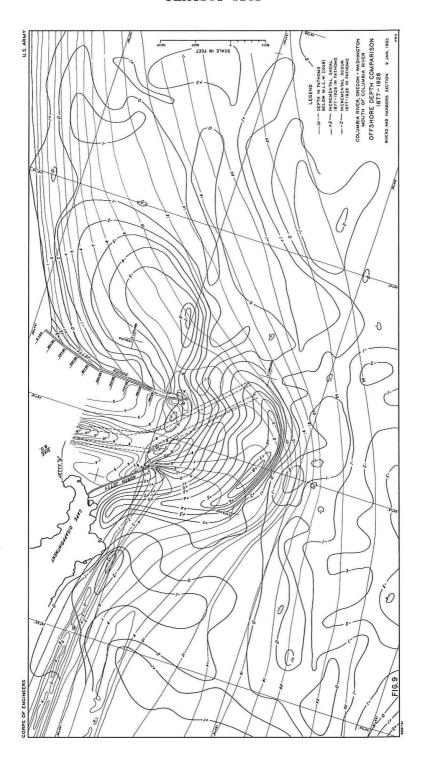
Depth comparisons for the area at the mouth of Columbia River are shown on figures 9, 10, and 11 for the periods 1877-1926, 1926-1958, and

1958-1962, respectively. It should be noted that the incremental scour unit on figures 9 and 10 is in fathoms whereas it is in feet in figure 11. The earliest period included the time of initial jetty construction and shows a general scouring of the underwater area south of the south jetty for about 7 miles. Scouring occurred at depths as great as 200 feet. The maximum amount of scour was about 42 feet and is shown on figure 9 about 2 miles south of the head of the south jetty. It is apparent that the big change occurred during and immediately after the 6.62-mile-long jetty construction period from 1885 to 1913. The scour that occurred offshore of Clatsop Beach for the 1926-58 period amounted to 12 feet or less and was generally less than 6 feet. For the 1958-62 period (figure 11) the area offshore of Clatsop Beach is practically stable.
