Inspection and Assessment of Corrosion in Pretensioned Concrete Bridge Girders Exposed to Coastal Climate

To investigate the applicability and accuracy of the above measurement methods for corrosion detection in pretensioned bridge girders, we carried out a study based on experimental data collected during field investigations of Dalselv Bridge, a 33-year-old girder bridge exposed to the Norwegian coastal climate.

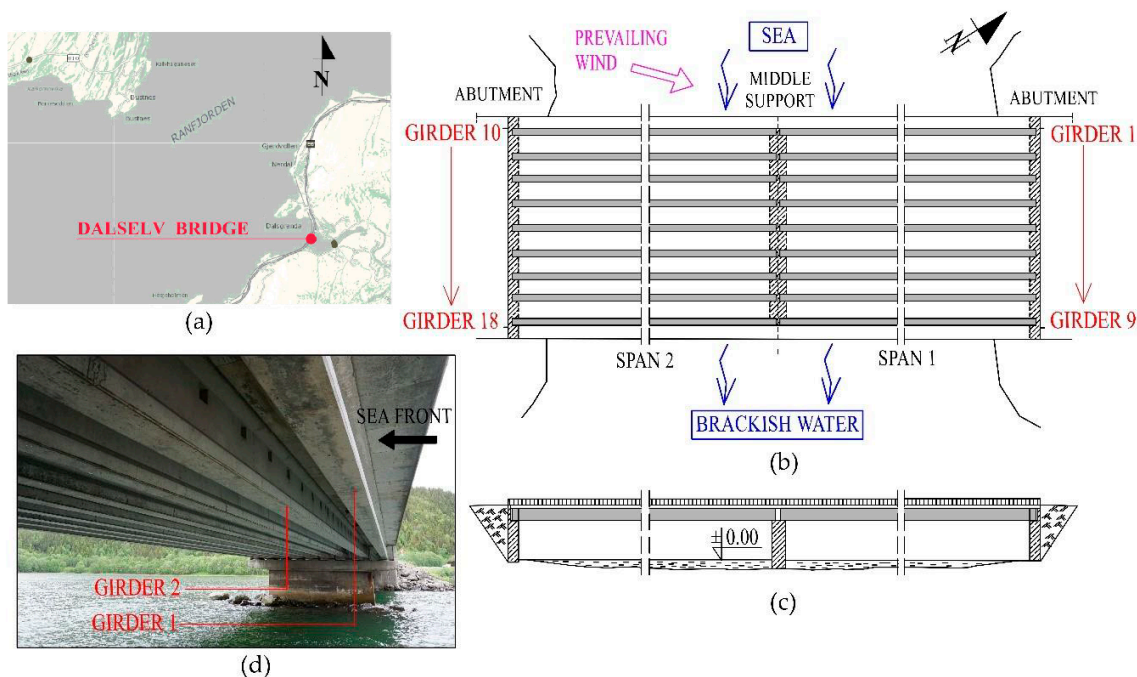
Dalselv Bridge is a 40 m long, two-span bridge consisting of nine simply-supported standardized I-shaped precast pretensioned (NIB) girders in each span; see Figure 1. The bridge was built in 1985 in the inner coastal climate (fjord area) of the northern part of Norway. The superstructure is close to sea level (approximately 2.3–2.9 m measured at high and low tide), which implies high chloride loads on the bridge superstructure. According to data from the Norwegian Meteorological Institute collected in the years 2011–2019, the prevailing winds come from the sea side, from the south-west; see Figure 1a. The average temperature and relative humidity are 4.6°C and 77%, respectively.

Figure 1. Dalselv Bridge: (a) bridge location; (b) bottom view; (c) side view; (d) photo taken underneath the bridge, facing south.

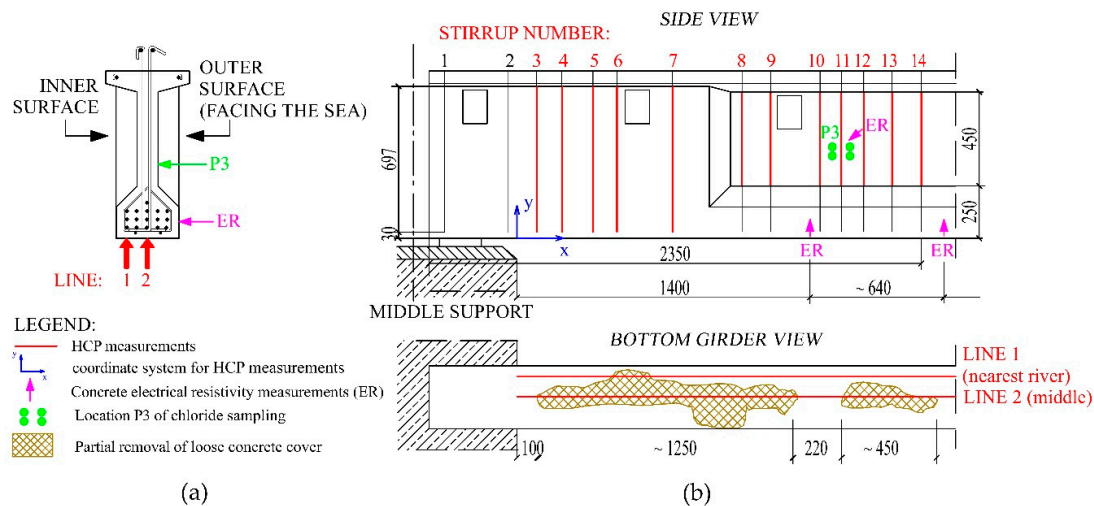
Figure 2. Location of half-cell potential (HCP) and electrical resistivity (ER) measurements in Girder 2: (a) measurements in the girder's bottom flange; (b) measurements (mm) in the web above the stirrups, and removal of loose parts of concrete cover.

To locate areas with high corrosion probability in Girder 2, HCP mapping was performed along the whole span length of the bottom surface of the girder, see Figure 2a. The measurements followed two lines to detect possible variations in corrosion probability between the strands. Moreover, to assess the condition of the vertical reinforcement in the shear zone near the middle support, the HCP was measured above the stirrups (numbered 3–14 in Figure 2b) on the inner and outer vertical surfaces of the girder.

The potentials measured above the stirrups near the middle support (numbered 3–14 in Figure 2b) are shown in Figure 9. The highest HCP values were measured in the upper corner of the girder end cross section, referred to here as the thick web. The potential distribution follows the moisture pattern observed in inner NIB girders close to the middle support (see Figure 4) and confirms the influence of moisture on HCP measurements.

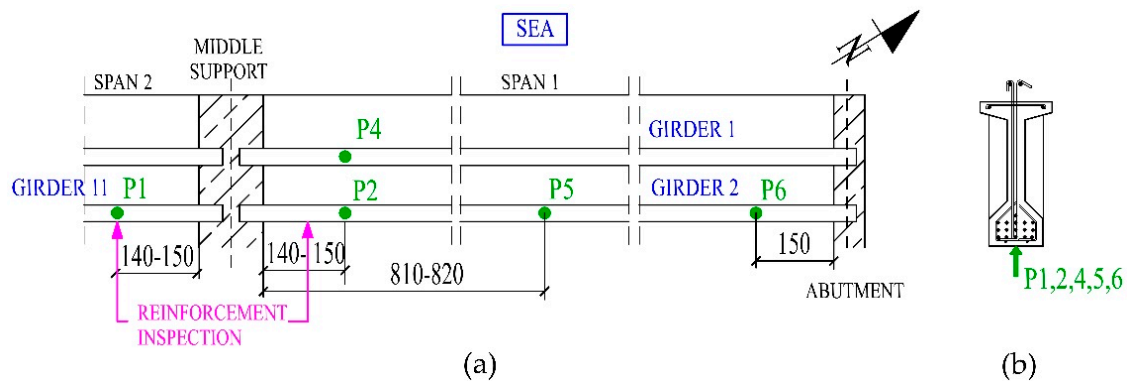
Chloride concentrations in Girder 2 were measured at four locations, three of which were in the girder's bottom flange: P2 close to the middle support, P6 close to the abutment, and P5 in the middle of the span; see Figure 3. The fourth sampling point, P3, was located in the girder web; see Figure 2b. Additional chloride measurements were taken from the bottom flange of Girder 1 (P4) and Girder 11 (P1) at the same distance from the middle support as P2; see Figure 3a.

Figure 3. Locations P1, P2, P4, P5, and P6 for chloride sampling (distances in cm): (a) girder layout; (b) girder cross section.

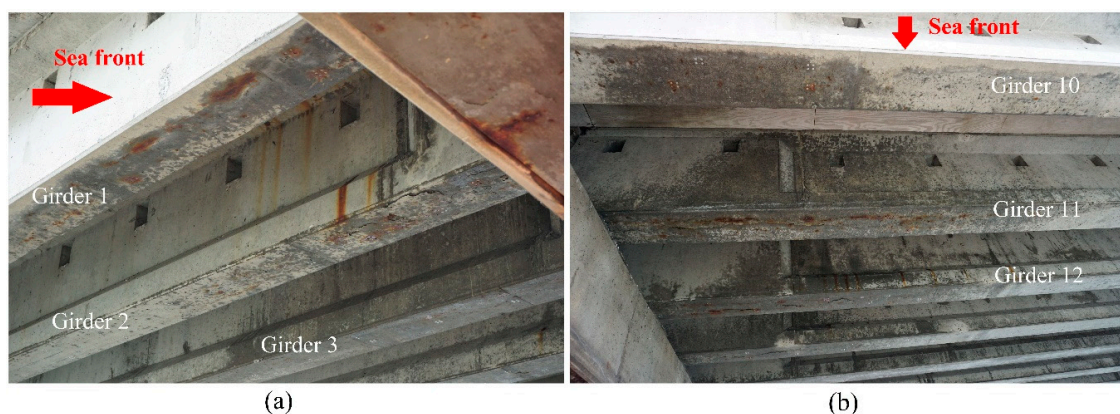
Corrosion was found in the pretensioned NIB girders of Dalselv Bridge, in and near the support zones. The most severe corrosion damage was found close to the middle support, in the second and third girders facing the sea (Girders 2, 11, 12), and in the bottom flanges of the outermost girders facing the sea (Girders 1, 10); see Figure 4. Less severe corrosion cracking was detected in the bottom flanges of girders close to the abutments. Girders 1 and 2 also had severe cracking with visibly corroding strands in the top flange next to the middle support.

Figure 4. Corrosion-induced damage and humid areas in NIB girders: (a) in the first bridge span (1st to 3rd girders facing the sea) next to the middle support; (b) in the second bridge span (1st to 3rd girders facing the sea) next to the middle support.

At a certain distance from the middle support, the bottom surface of the first four NIB girders facing the sea had a significantly darker color. Moreover, the inner girders (Girders 2, 3, 11, 12, 13) had a darker color in the web next to the middle support; see Figure 4. We think this color change was due to a greater moisture load in these areas. The bottom flanges of the girders next to the abutments were also humid, although to a lesser extent than near the middle support.

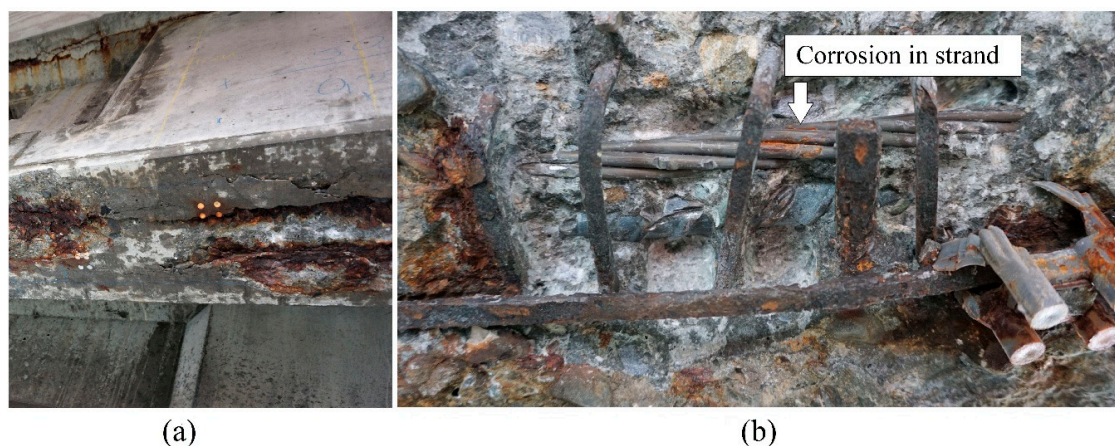
The removal of the concrete cover in the bottom flange of Girder 2 revealed severe corrosion of mounting bars; see Figure 5a. Similar damage was found in the exposed mounting bars in Girder 11. Inspection of chloride sampling location P1 (in Girder 11) also revealed corrosion in stirrups and one strand; see Figure 5b. In the $\phi 6$ stirrups, the severest corrosion had accumulated in and near their bends, with a loss of diameter measured at about 50%. The horizontal part of the $\phi 12$ stirrup shows fairly moderate corrosion.

Figure 5. Reinforcement corrosion: (a) next to chloride sampling location P2 in Girder 2; (b) next to chloride sampling location P1 in Girder 11.

Surprisingly, only small corrosion spots were found on the strand itself (see Figure 5), which suggests that corrosion started recently or that the corrosion rate is low. It should be noted that only a short length of strand was exposed and more corrosion spots could probably be found outside this area.

In this study, exposing the reinforcement in location P1 (Figure 5b) confirmed the indicated 100% corrosion probability of the strands. However, for chloride concentrations of 0.344% by weight of concrete (1.81% by weight of cement) only small pitting was detected, whereas heavier corrosion would have been expected based on corrosion bridge studies [62]; see Figure 16. Moreover, for the high chloride content at the level of both strands and stirrups in location P1 (Table 3), stirrups exhibit more severe and uniform corrosion; see Figure 5b. This means that relying on chloride concentrations alone may give unreliable information about not only the probability, but also the severity of corrosion in NIB girder strands.

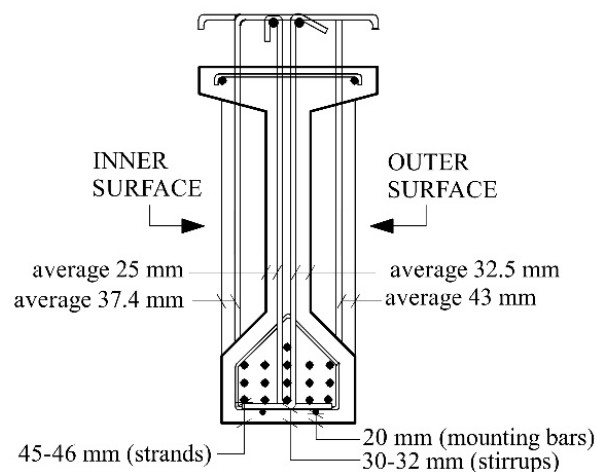
Measurement of the concrete cover up to the stirrups in Girder 2 revealed 5.5–7.5 mm more cover on the outer than the inner surface of the web, see Figure 6. This means that the mold must have moved before casting. During inspection, we also detected two visible mounting bars supporting stirrups in the girder's bottom flange, with plastic reinforcement chairs supporting the bars.

Figure 6. Concrete cover thickness measured in Girder 2.

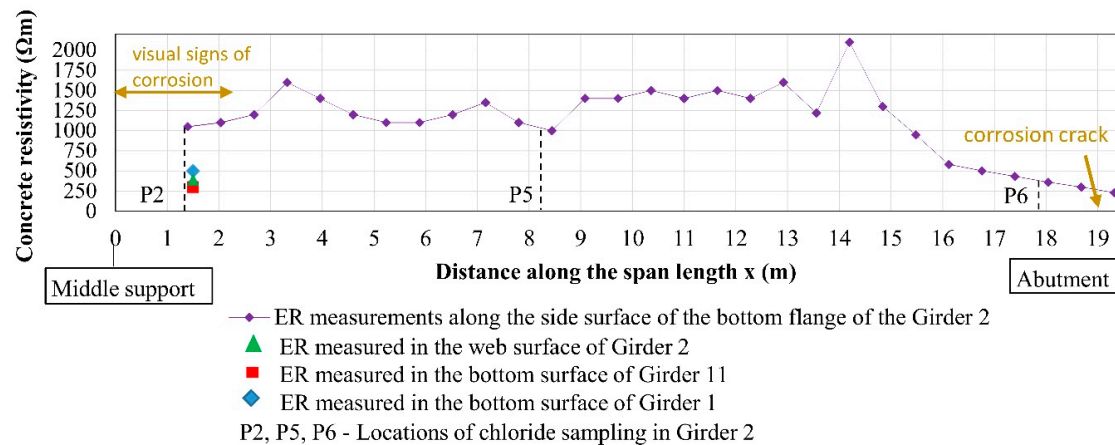
The ER readings scatter significantly along the girder span from 230 Ωm to more than 1000 Ωm ; see Figure 7. Overall, the ER measurements were rather high, which can indicate a good concrete quality (low w/c) with low concrete porosity.

Figure 7. Concrete resistivity measured along the side surface of the bottom flange of Girder 2, in the web of Girder 2, and in the bottom surface of Girders 1 and 11 (about 1.5 m from the middle support).

For most of the span, the ER was greater than 1000 Ωm , which suggests dry concrete [23]. The ER readings decreased in the last approximately 4.5 meters to the abutment, which suggests a gradual change in moisture conditions; see Figure 7. Although wet areas observed during visual inspection suggested ER would also decrease near the middle support, high ER readings were recorded (more than 1000 Ωm). For comparison, the ER measurements in wet areas of Girders 1 and 11 close to the middle support were considerably lower (500 and 320 Ωm , respectively) than those in Girder 2; see Figure 7. In addition, the ER of 380 Ωm measured in the web of Girder 2 indicates high moisture next to the middle support. The high ER in the bottom flange of Girder 2 near the middle support may be due to delamination of the concrete cover caused by corrosion, the signs of which were visible over a distance of about 2.1 m from the middle support; see Figure 4a. Wind conditions and the location of the measurements on the side of the girder flange could also have had an impact.

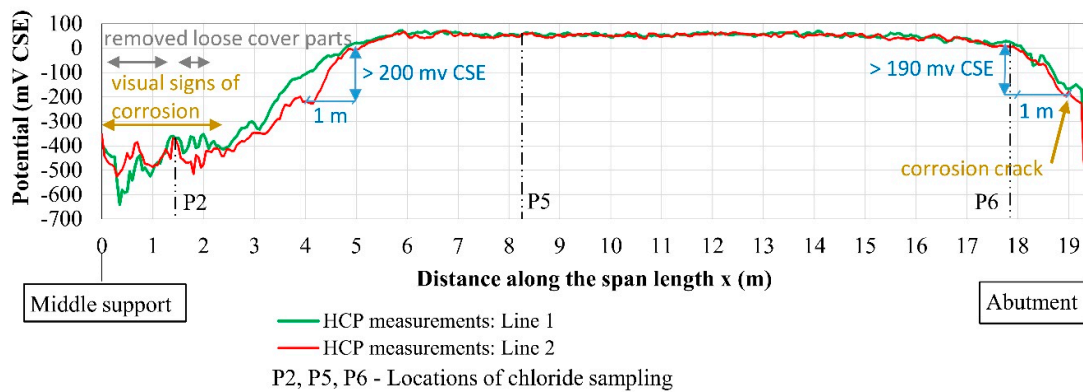
The HCP mapping along the bottom flange of Girder 2 is shown in Figure 8. Lines 1 and 2 both showed positive and stable HCP values (0 to 72 mV CSE) in the middle part of the span between 5 and 18 m from the middle support. Near the girder supports, HCP measurements decreased to their most negative values. The potential gradients near both supports were greater than 190 mV CSE/m, while no potential drops occurred in the middle of the span; see Figure 8. This indicates a higher probability of corrosion in reinforcement near the supports and a low probability of corrosion in the main part of the span.

Figure 8. Distribution of half-cell potentials along the bottom surface of Girder 2.

The local scatter in HCP readings from 0.1 to 1.3 m and from 1.6 to 2.1 m from the middle support is probably due to partially removed loose concrete cover; see Figure 8. Outside the area of removed cover, the HCP readings in Line 2 are slightly lower than in Line 1; see Figure 8. Otherwise, the potential gradients in both lines show the same trend. In this case, therefore, it was not possible to detect variation in corrosion probability between closely spaced (about 50 mm) and electrically connected strands. This can be explained by either active corrosion in both strands or polarization of neighboring strands by a locally active corrosion area. The area polarized depends, amongst other things, on the ER. As the ER decreases, the area polarized increases.

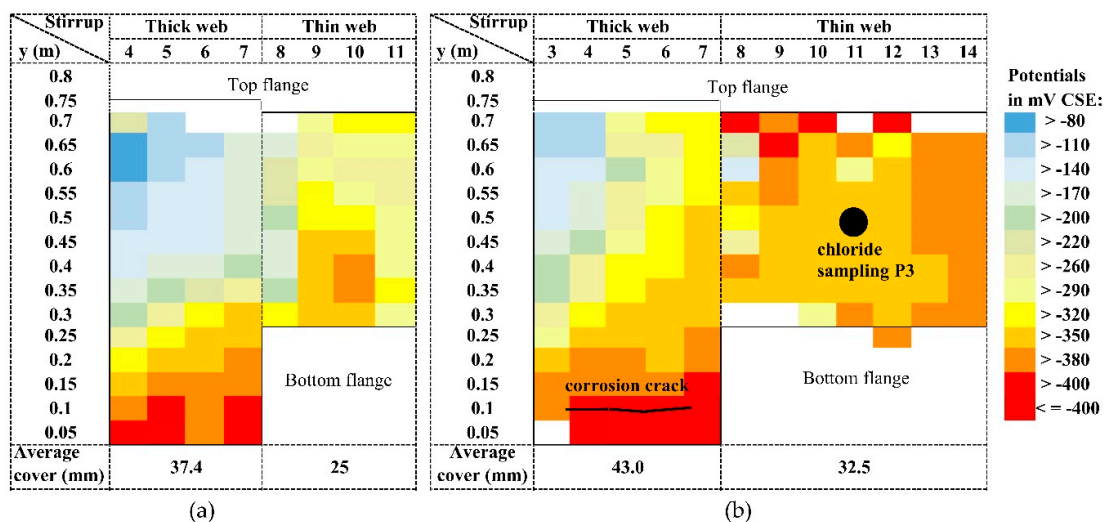
Figure 9. HCP measured above the stirrups in Girder 2: (a) inner surface; (b) outer surface (facing the sea) cf. Figures 2 and 6.

The most negative potentials (less than -380 mV) were found for parts of the stirrups at the bottom of the thick web. These locations correspond to the areas with visible corrosion damage shown in Figure 4a. The HCP readings above the stirrups show more negative values for the outer web surface (facing the sea) than for the inner surface. Despite its thicker cover (by 5.5–7.5 mm), the outer surface facing the sea is more likely to corrode than the inner surface.

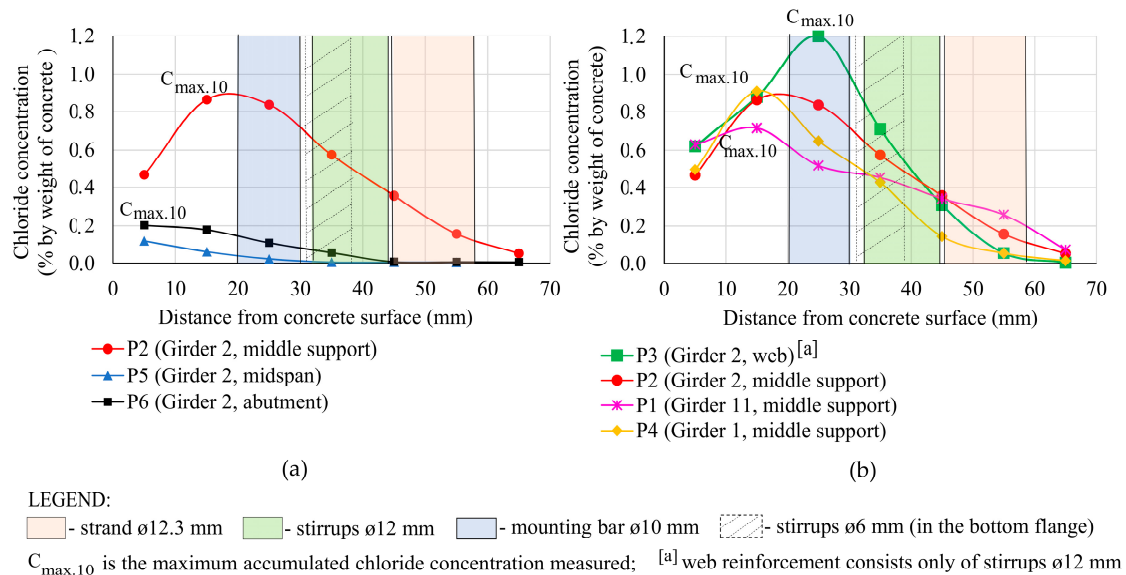
The chloride profiles obtained for all of the sampling locations are presented in Figure 10. The chloride sampling locations on the bottom flanges of Girders 1, 2, and 11 (P1, P2, P4, P5, and P6) are given in Figure 3, and the chloride sampling in the web of Girder 2 near the middle support (P3) is given in Figure 2.

Figure 10. Chloride profiles obtained in Girders 1, 2, and 11: (a) along the bottom flange in Girder 2; (b) near the middle support in Girders 1, 2 and 11.

As shown in Figure 10a for the bottom flange of Girder 2, the highest chloride content at the level of the reinforcement was found near the middle support (P2). The chloride content in unsaturated concrete is strongly affected by the accumulation of surface chlorides [55]. The maximum accumulated chloride concentration, based on measurements at 10 mm concrete depth intervals (denoted $C_{max.10}$), was more than seven times higher near the middle support and almost two times higher near the abutment than in the midspan. This resulted in deeper chloride penetrations in the support zones of Girder 2.

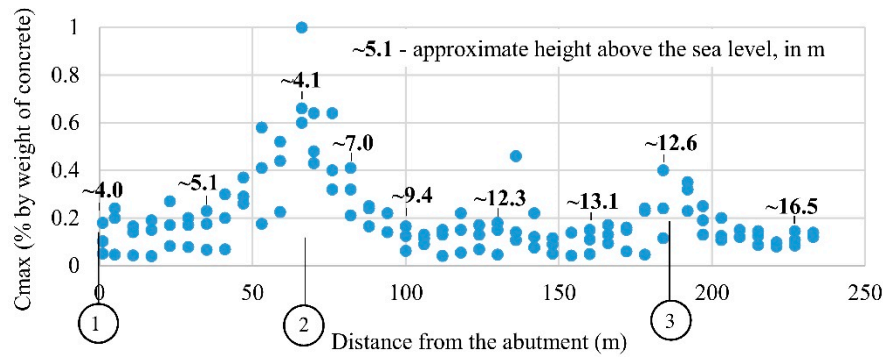
Higher maximum accumulated chloride concentrations close to supports were also observed in the box-girder Gimsøystraumen Bridge in Norway after 11 years of exposure to coastal climate [59]. Figure 11 shows that the $C_{\max,10}$ next to the abutment (axis 1) was lower than that around the middle support (axis 2). The moisture content measured also varied along the box girder, with the highest values next to supports and lowest in the midspans [59], which confirms the findings in this study.

Figure 11. Chloride concentrations C_{\max} in Gimsøystraumen Bridge measured in a 10 mm thick concrete layer after 11 years of exposure to Norwegian coastal climate [59].

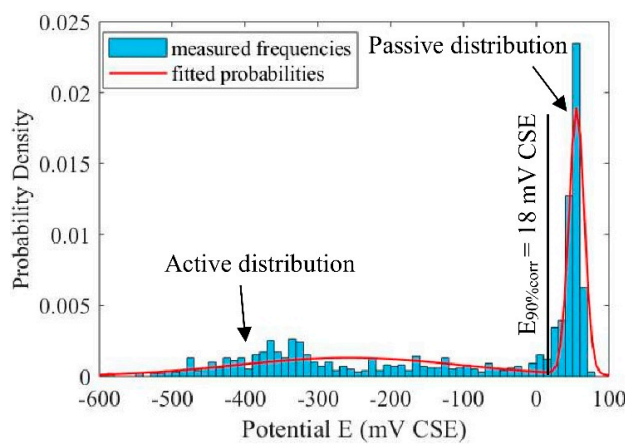
First, we assumed that Girder 2 is a homogenous structure with comparable exposure to chlorides and moisture. All 987 measured potentials were therefore considered in the statistical analysis. Results of regression analysis are presented in Figure 12.

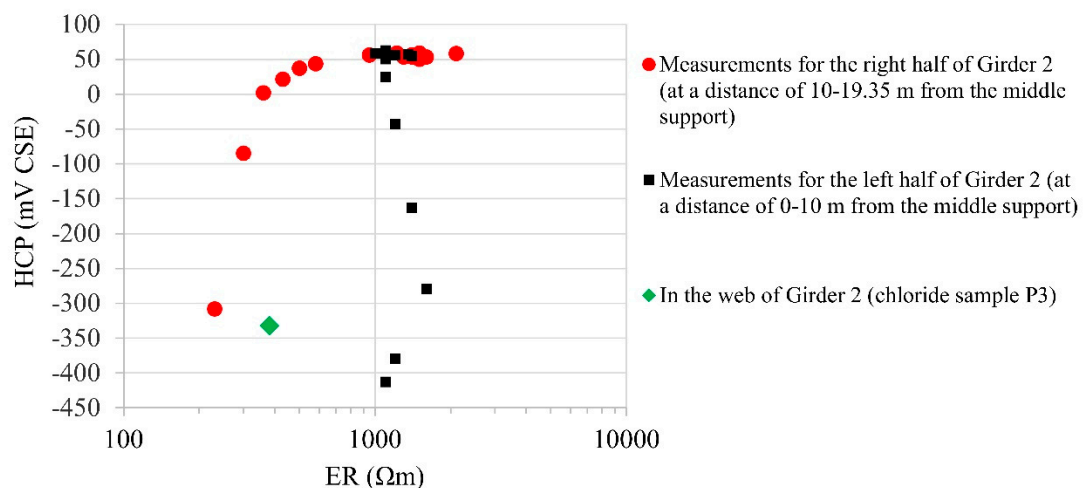
As shown in Figure 13, we found a strong correlation between HCP and ER measurements for the right half of Girder 2. The potential decreases when the ER is below approximately 580–950 Ωm . These values are close to the ER thresholds of 500 and 1000 Ωm , above which the corrosion probability is low and negligible, respectively [23]. However, they are higher than the ER of 350–530 Ωm found by Pailles [46], which may be because NIB girders require a higher quality concrete than bridge decks. For the left half of Girder 2, no clear relationship was found between HCP and ER, see Figure 13. Despite a high ER, decreasing HC potentials with decreasing distance to the middle support showed the same trend as in the right half near the abutment; see Figure 8. We therefore concluded that HCP measurements were more reliable for corrosion assessment than ER results, which should always be verified with visual inspection.

Figure 13. Relationships between HCP and ER measurements.

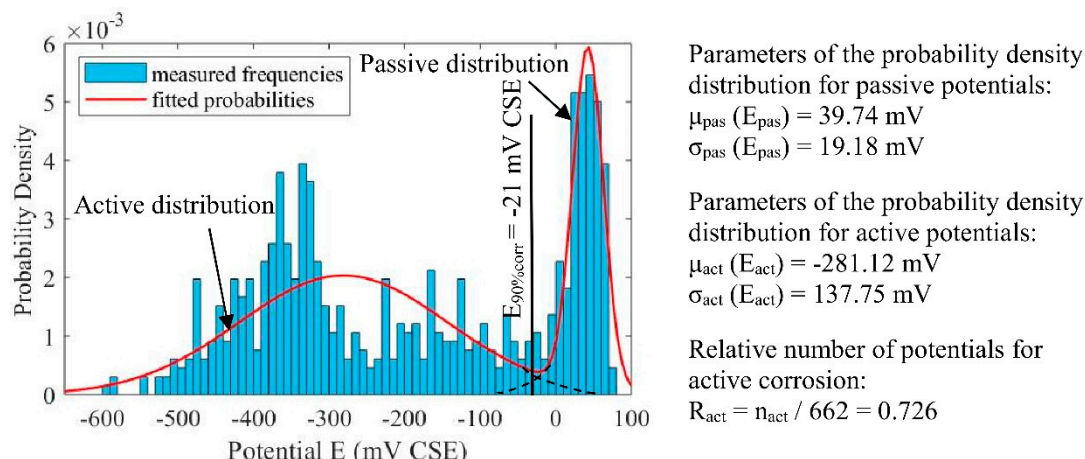
The exact ER threshold that separates zones with dry (non-corrosive) and humid (favorable for corrosion) environmental conditions could not be clearly specified for Girder 2. However, assuming the ER threshold lower than 980 Ωm , the region with elevated moisture was found to extend a distance of 3.8 m from the abutment; see Figure 7. Because low HCP measurements were found for a distance of about 6–6.5 m from the middle support (see Figure 8), the region near the middle support was initially estimated to extend 6.5 m. The results of regression analysis performed on the 642 potentials collected from these areas are shown in Figure 14. The calculated potential threshold for probability of corrosion greater than 90% was equal to −21 mV CSE.

Figure 14. Frequency density distribution of measured and fitted potentials assuming similar moisture conditions near supports. Parameters of the potential distributions.

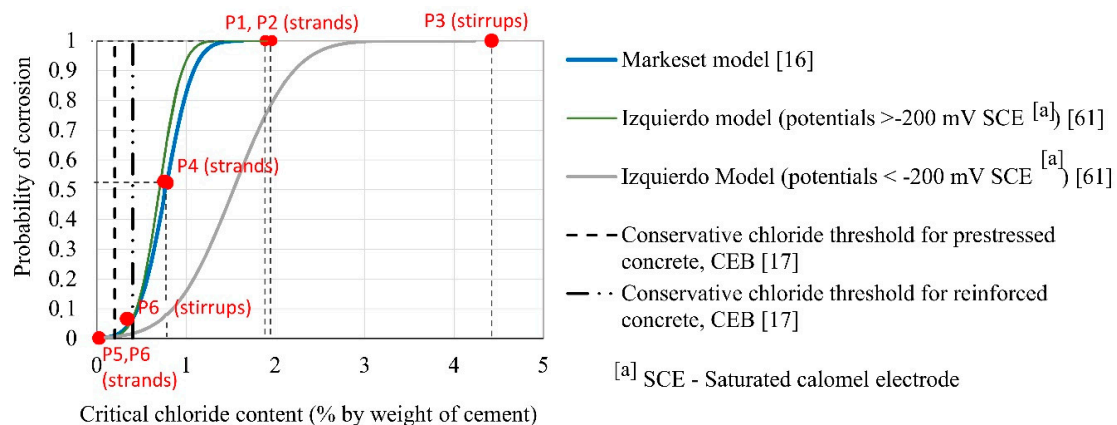
Using this model, we found that the corrosion probability was close to 100% for strands and stirrups close to middle support in the inner girders (P1–P3), whereas strands in the midspan (P5) and abutment vicinity (P6) had a negligible corrosion probability of less than 1%; see Figure 15.

Figure 15. Probability of reinforcement corrosion calculated based on the Marqueset statistical model.

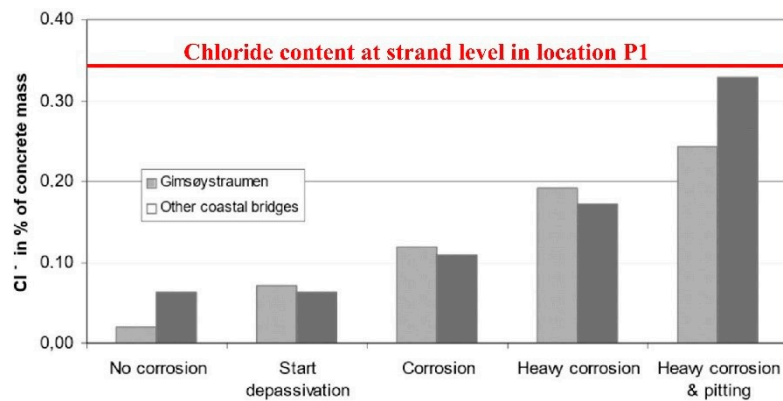
Figure 16. Relationships between corrosion severity and chloride content from more than 300 registrations on various coastal bridges in Norway [62]. Red line—chlorides at the strand level in location P1.

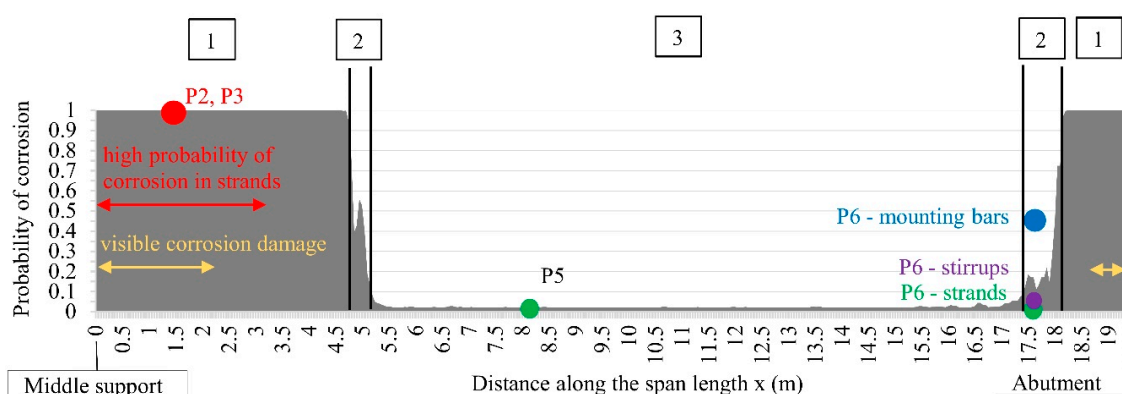
To analyze the correlation between NDT and DT results, the corrosion probabilities calculated for HCP based on statistical distributions in Figure 14 were compared with the probabilities calculated for chloride concentrations based on the Markeset model. The results are shown in Figure 17.

Figure 17. Comparison of calculated corrosion probability along Girder 2: grey area—corrosion probability based on HCP collected from support zones; dots—corrosion probability based on chloride concentrations; nos. 1, 2, 3—zones with high (>90%), uncertain, and low (<10%) corrosion probability, respectively.

The corrosion probabilities obtained from both kinds of test on Girder 2 are consistent for all reinforcements in locations P2, P3, and P5, which increases the reliability of assessment in the zones with the highest and lowest corrosion probabilities. Moreover, the zones with a corrosion probability greater

Nevertheless, a negligible corrosion probability was detected in location P5, where chloride content at the level of mounting bars was 0.04% by weight of concrete (0.20% by weight of cement). This means that the CEB [17] chloride threshold for prestressed structures was too conservative for the NIB girder in this study. In location P1, corrosion spots were found in the strands with a chloride content of 0.344% by weight of concrete, so corrosion in strands with a higher chloride level in location P2 is also to be expected; see Figure 18. Removal of cover in locations with severe damage allowed us to estimate the chloride threshold for initiation of strand corrosion. This was approximated at between 0.14 and 0.34% by weight of concrete; see Figure 18. Since strands probably corrode with potentials lower than the -370 mV CSE found in location P2, the area with a high probability of strand corrosion extends about 3.2 m from the middle support; see Figure 17.

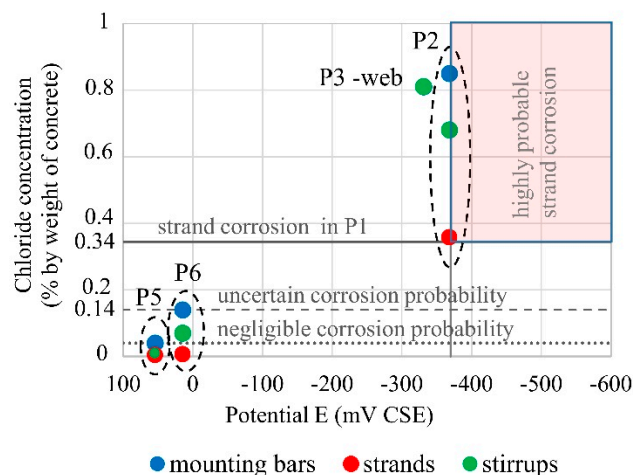
Figure 18. HCP and chloride concentrations for sampling locations in Girder 2. The chloride concentration at the level of the corroding strand in location P1 (in Girder 11) is included for comparison.

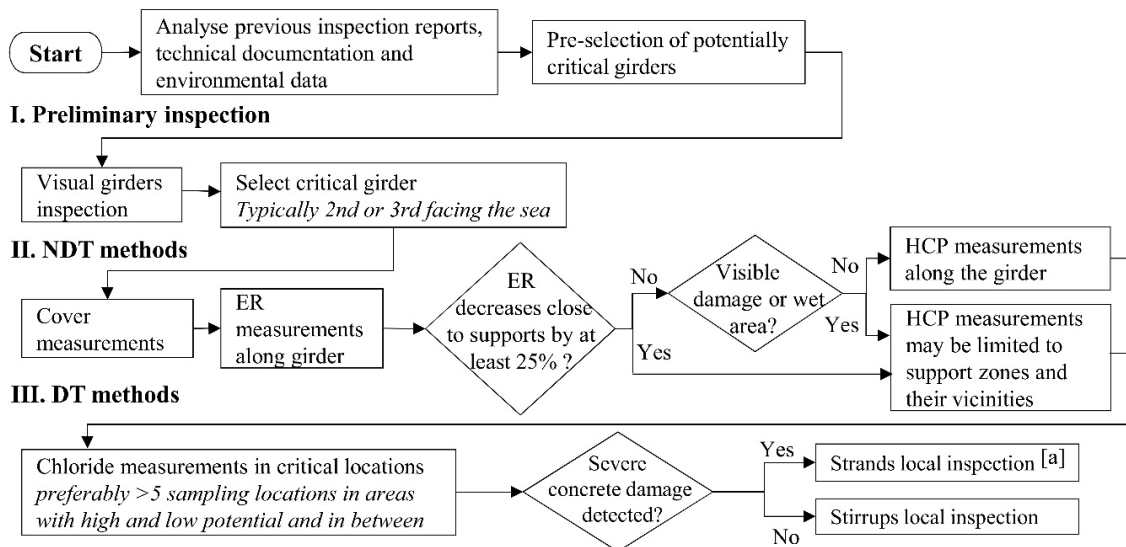
[a] Strand local inspection has to be carried out with extreme caution, so as not to mechanically damage the strands. The inspection area has to be limited to minimum (max. 50 mm), preferably selected where concrete cover is already loose.

Figure 19. Procedure for detailed inspection of pretensioned bridge girders in a marine environment.

Data collection is described in Figure 19.

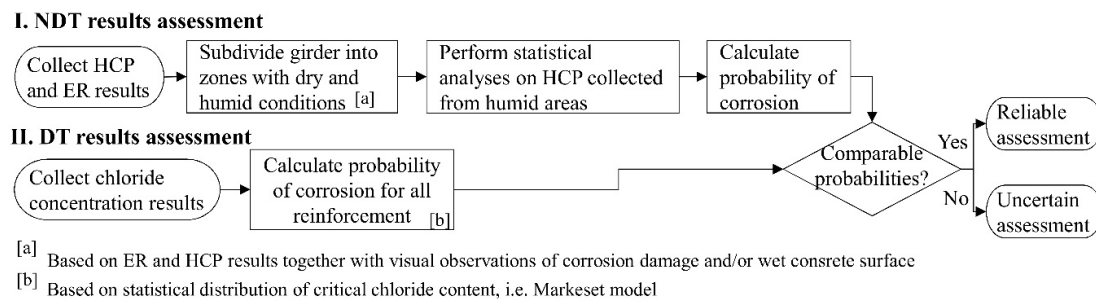
The assessment of the data collected is described in Figure 20. The statistical analysis of HCP should be performed following the procedure developed by Gulikers and Elsener [42] on data collected from areas where an increase in moisture is detected, e.g., support zones and their vicinities. Corrosion probabilities from measured chloride concentrations should be evaluated based on the statistical model for critical chloride distribution for similar structures and environmental conditions as proposed by Markeset [16]. The estimated corrosion probabilities from both chloride concentrations and HCP collected from areas with similar moisture conditions are then compared. Corrosion probability assessment can be considered reliable when both methods point to the same conclusions and coincide with the visual damage where present. The results can also be supported with reinforcement inspection results.

Figure 20. Procedure for assessment of pretensioned bridge girders in a marine environment.
