Effect of NaCl on the hydric and hygric dilation behaviour of lime-cement mortar

Lubelli, B.; Van Hees, R. P.J.; Huinink, H. P.

Heron

Lubelli, B., Van Hees, R. P. J., & Huinink, H. P. (2006). Effect of NaCl on the hydric and hygric dilation behaviour of lime-cement mortar. *Heron*, 51(1), 33-48.

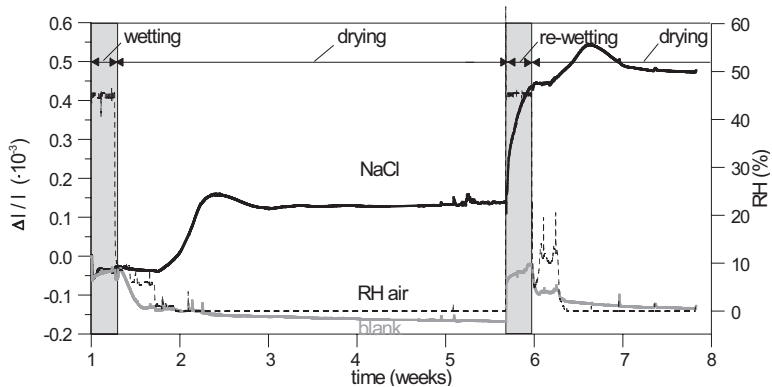
Figure 2: Dilation of blank and NaCl contaminated specimens during wetting at $\text{RH}=50\%$ (gray areas) and drying at $0\%\text{RH}$ (white area) cycles

Data on the temperature and RH of the air, as well as the dimensional changes of the specimens at its surface, were collected continuously. Figure 2 shows the results of the experiment. During wetting, both the salt contaminated and the reference specimens have a similar behaviour, consisting of initial shrinkage (due to the wetting of the lower part of the sample) followed by dilation (corresponding to the migration of water to the surface of the sample). During drying,

the blank specimen shrinks, while the salted specimen, after a period of about 4 days in which it does not show any change in size, starts dilating. It can be reasonably supposed that dilation occurs when, due to evaporation of water, the salt starts crystallizing. The maximum dilation is about $0.13\mu\text{m}/\text{mm}$ and is reached in 5 days. During the re-wetting both specimens dilate, but the dilation is larger in the salt contaminated than in the blank specimen. During drying the blank specimen shrinks while the salted specimen dilates further.

This experiment shows that the presence of sodium chloride strongly influences the hygric behaviour of this material. The salt contaminated specimen undergoes an irreversible dilation; on the contrary, the displacements of the blank specimen, apart from being smaller, are reversible.

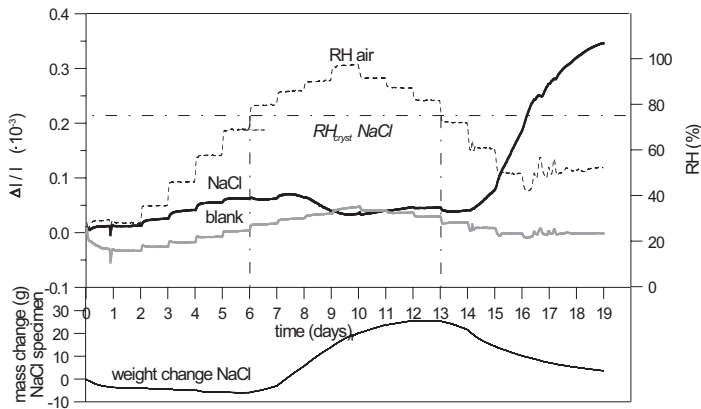
Figure 5: Dilation of blank and NaCl contaminated specimens (upper graph) and weight change of NaCl contaminated specimen (lower graph) during a single RH cycle (max RH 95%)

Three parts can be distinguished in the curves:

1. Increasing RH (30-75%RH)

In this range of RH the behaviour of the blank and of the NaCl contaminated specimens is similar: both dilate when the RH increases. The dilation is due to water vapor adsorption [Hiller, 1964].

2. Increasing and decreasing the RH while RH > 75% of NaCl (75-96-75%RH).

After crossing the 75%, the behaviour of the NaCl contaminated specimen starts to deviate from the specimen without salt: as soon as liquid water is present in the plaster (as shown by the weight change) and the salt starts dissolving, shrinkage is measured. The shrinkage of the salt contaminated specimen can be explained by the release of the tensions developed during the previous crystallization of the salt.

3. Decreasing the RH (75%-45%RH)

When the RH drops below the 75%, the salt contaminated specimen starts drying (as shown by the weight loss) and dilates considerably. The curve becomes steeper with decreasing RH. At the end of the test, after 4 days of drying, the dilation measured is about $0.35\mu\text{m}/\text{mm}$. The not contaminated specimen shrinks, as expected, when the RH is lowered; at the end of the cycle it comes back to the original size.

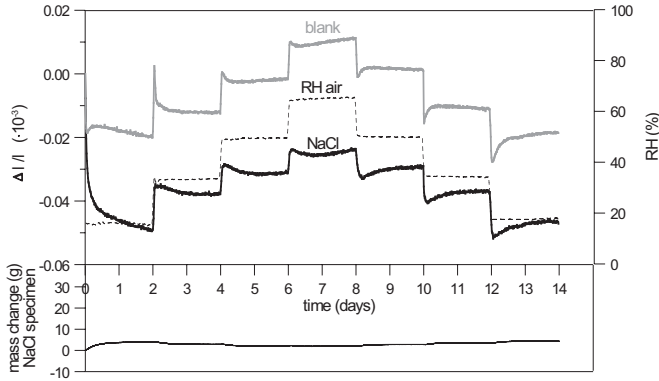
Figure 6: Dilation of blank and NaCl contaminated specimens (upper graph) and weight change of NaCl contaminated specimen (lower graph) during a RH cycle below 75%RH

A further prove that the behaviour of a salt contaminated specimen is modified only if the equilibrium RH of the salt is crossed is given by another experiment in which the RH was varied but kept below 75% (Figure 6): in this case no irreversible displacement took place.

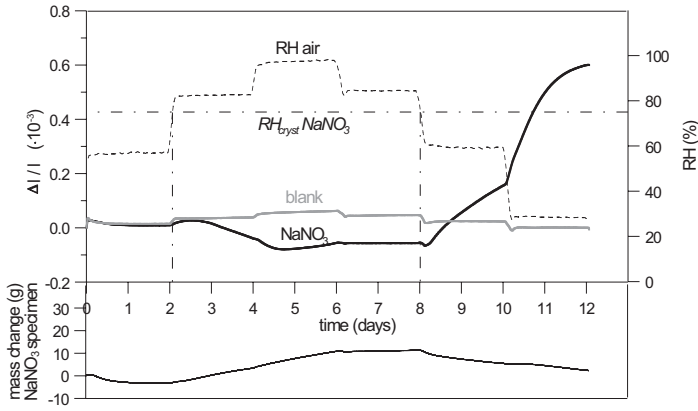
Figure 7: Dilation of blank and NaNO₃ contaminated specimens (upper graph) and change in weight of the NaNO₃ contaminated specimen (lower graph) during a RH cycle

The specimens were prepared in the same way as for NaCl . The same amount of solution was introduced in the mortar. The concentration of the solution was defined in such a way as to reach in all cases a salt content of 2%*m/m* of the weight of the dry specimen. As shown in Figures 7 and 8, in both cases shrinkage is observed when the RH exceeds the values where water starts to condensate and the salts dissolve in the water (at 20°C this happens at 85 and 75% for KCl and NaNO_3 , respectively [Arnold, 1990]). When the RH decreases below these values the specimens start drying, the salts crystallize and dilation occurs. Therefore it can be concluded that this behaviour is not typical for NaCl but is a more general phenomenon.

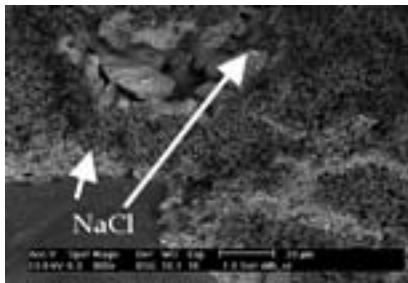
Figure 12: ESEM photomicrographs showing NaCl (lighter areas) crystallizing as a layer over the pore walls of the binder

In the ESEM picture of the lime-cement mortar contaminated with NaCl, the salt is visible in larger pores, creating a layer over the pore walls (Figure 12). It looks as if a strong interaction exists between the material and the salt crystals. This is in accordance with the observations reported in other studies [Benavente et al, 2004]. Under the salt layer, most of the distinguishable pores appear to be empty (Figure 13).

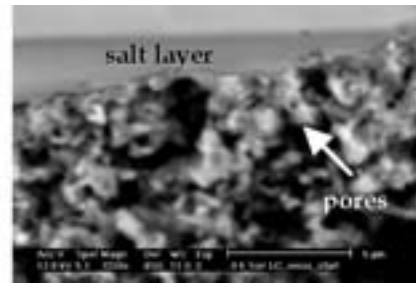
Figure 13: ESEM photomicrograph showing that, under the salt layer (white area), the pores of the material are not filled with salt
