Indoor climate in the Rietveld Schröder house

Lubelli, Barbara; van Hees, Rob

5 / INDOOR CLIMATE IN THE RIETVELD SCHRÖDER HOUSE

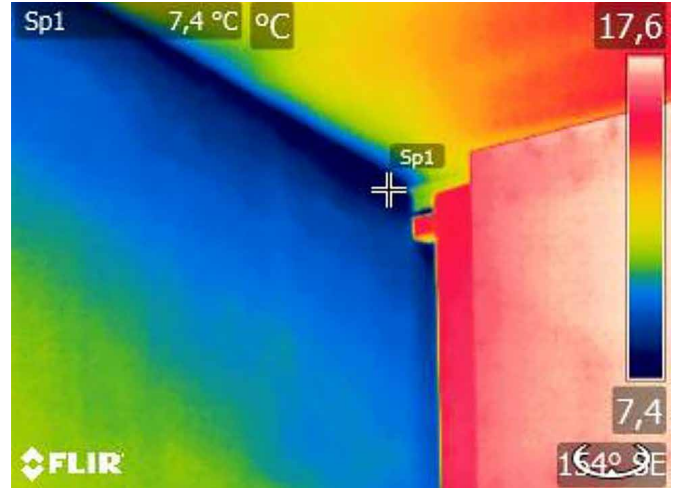
FIG. 5.3 Surface temperature in a corner of the construction, top: IR image, bottom: normal image; the insert shows the plan of the 1st floor with the location (in red) of the inspected area

Thermographic images made it possible to identify thermal bridges in corners and at connections between walls and ceiling in the external envelope of the building [FIG. 5.3].

No immediate risk of biological growth or surface condensation was detected in the present situation. However, as several severe thermal bridges are present in the construction, the risk of mould growth on the construction might arise should interventions like sealing of windows be undertaken without simultaneously introducing RH control.

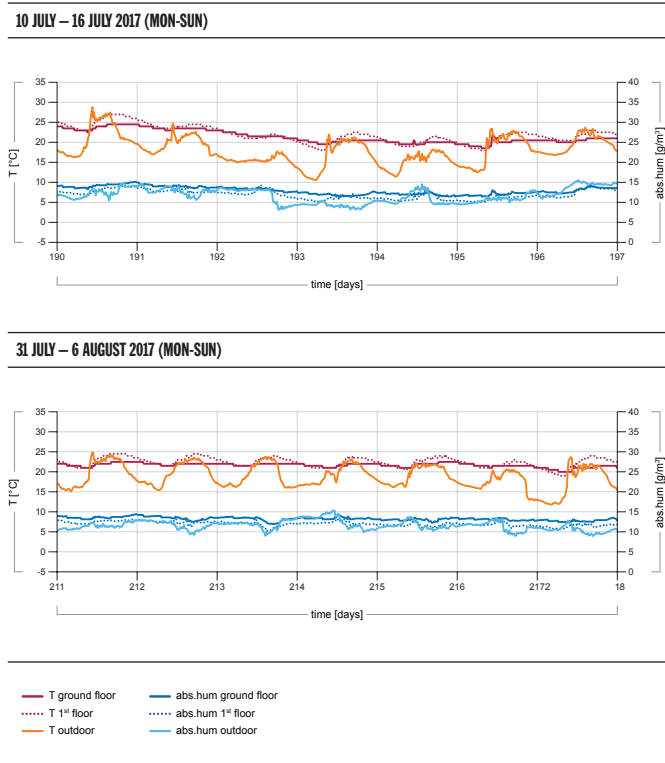
FIG. 5.5 Indoor and outdoor temperature and absolute humidity on the ground and 1st floor during two weeks in the summer period

This conclusion is confirmed when the indoor climate is correlated with the outdoor climate: the strong influence of the outdoor climate on the indoor climate is evident in the summer months, when the heating system is not in use; this is clearer on the first floor [FIG. 5.5], mainly due to the presence of large window surfaces and stronger (natural) ventilation.

In order to reduce RH in the summer, air dehumidification should be considered. Ventilation will not be sufficient, as the absolute outdoor humidity during summer is high.

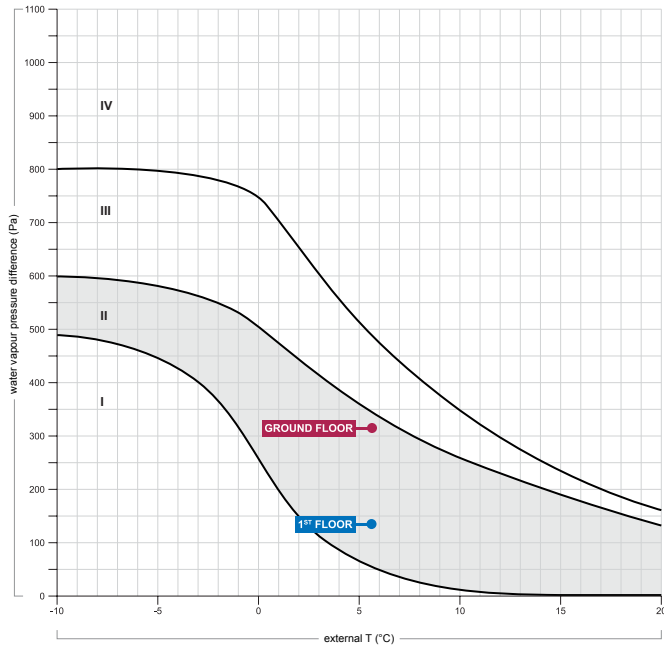
FIG. 5.7 The indoor climate class on the ground and first floors of the building (the period between 20/01/17 and 20/03/2017 was considered)

First of all, in order to assess the risk of surface condensation and/or mould growth, the indoor climate is compared to the classes of indoor climate as defined in Van Hees (1986);⁷ the ground floor is more humid than the first floor, but both fall within climate class II, which means that the indoor climate is sufficiently dry [FIG. 5.7]. Therefore, in principle (under the current regime) no moisture problems in the sense of surface condensation or mould growth on the building construction are to be expected.

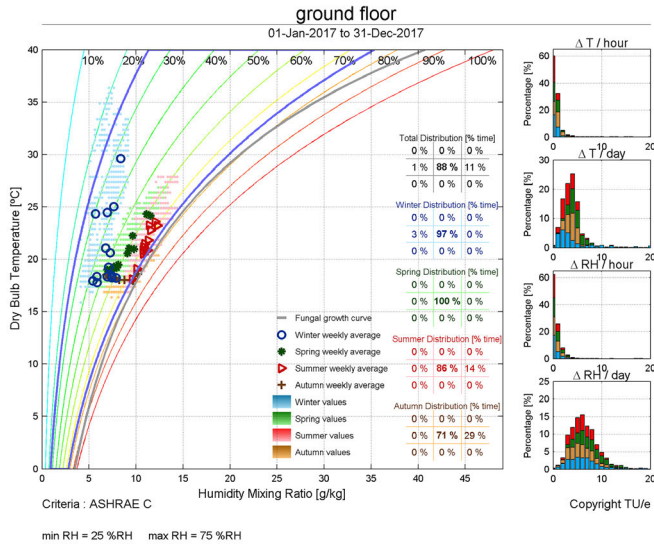
FIG. 5.8 Temperature and RH data recorded on the ground floor of the building in 2017 compared to the specifications for class C; graphical elaboration performed using the web tool available at <http://www.monumenten.bwk.tue.nl/>

Based on these results it is possible to conclude that the indoor climate is safe as far as the wooden furniture is concerned; neither biological growth (germination and growth of spores) nor mechanical damage are to be expected. However, the lifetime multiplier (LM), is relatively low, especially for the ground floor, which means that the service life is lower than it would be in ideal conditions (stable 20 °C and 50% RH).

Based on the results of the monitoring, it is suggested that the indoor temperature and RH level be monitored, and an alarm system used so as to be able to intervene promptly in case of malfunctioning of the heating system.

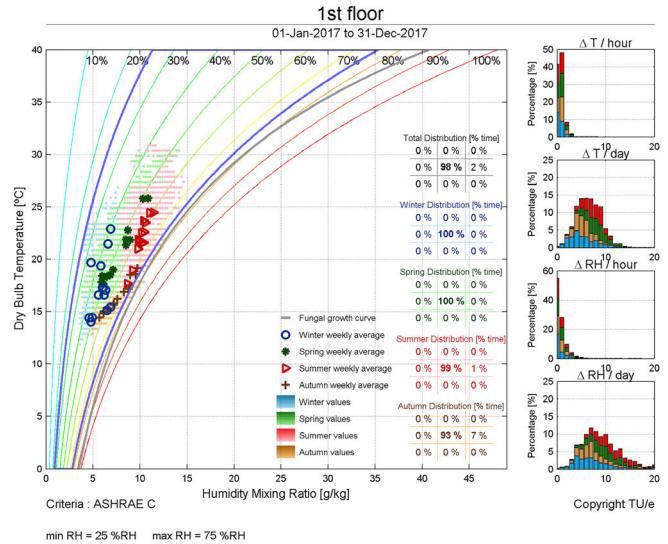
FIG. 5.9 Temperature and RH data recorded on the first floor of the building in 2017 compared to the specifications for class C; graphical elaboration performed using the web tool available at <http://www.monumenten.bwk.tue.nl/>

During the heating season, periods with higher than desirable temperatures and lower than desirable RH values were recorded, mainly due to a malfunction of the heating system. During the summer season, very high RH values were recorded.

The indoor climate of the building falls largely within the ASHRAE class of control C, which can be considered the class of control possible for this building (uninsulated masonry, single-glazed windows, heating without RH control). The risk to the furniture of mechanical damage and biological growth is low.
