The Destruction and Reconstruction of Aleppo's Citadel

A Historical Analysis

Architectural History Thesis

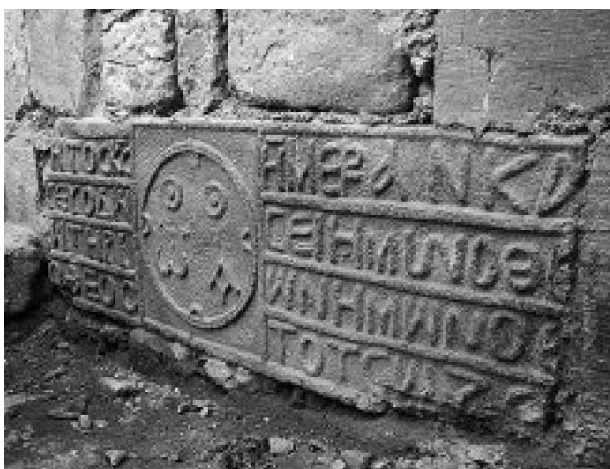
Figure 6: An engraved Byzantine stone block, reused in the masonry of the citadel entrance. From *Medieval Citadels Between East and West* (p.105), by Bianca, 2010.

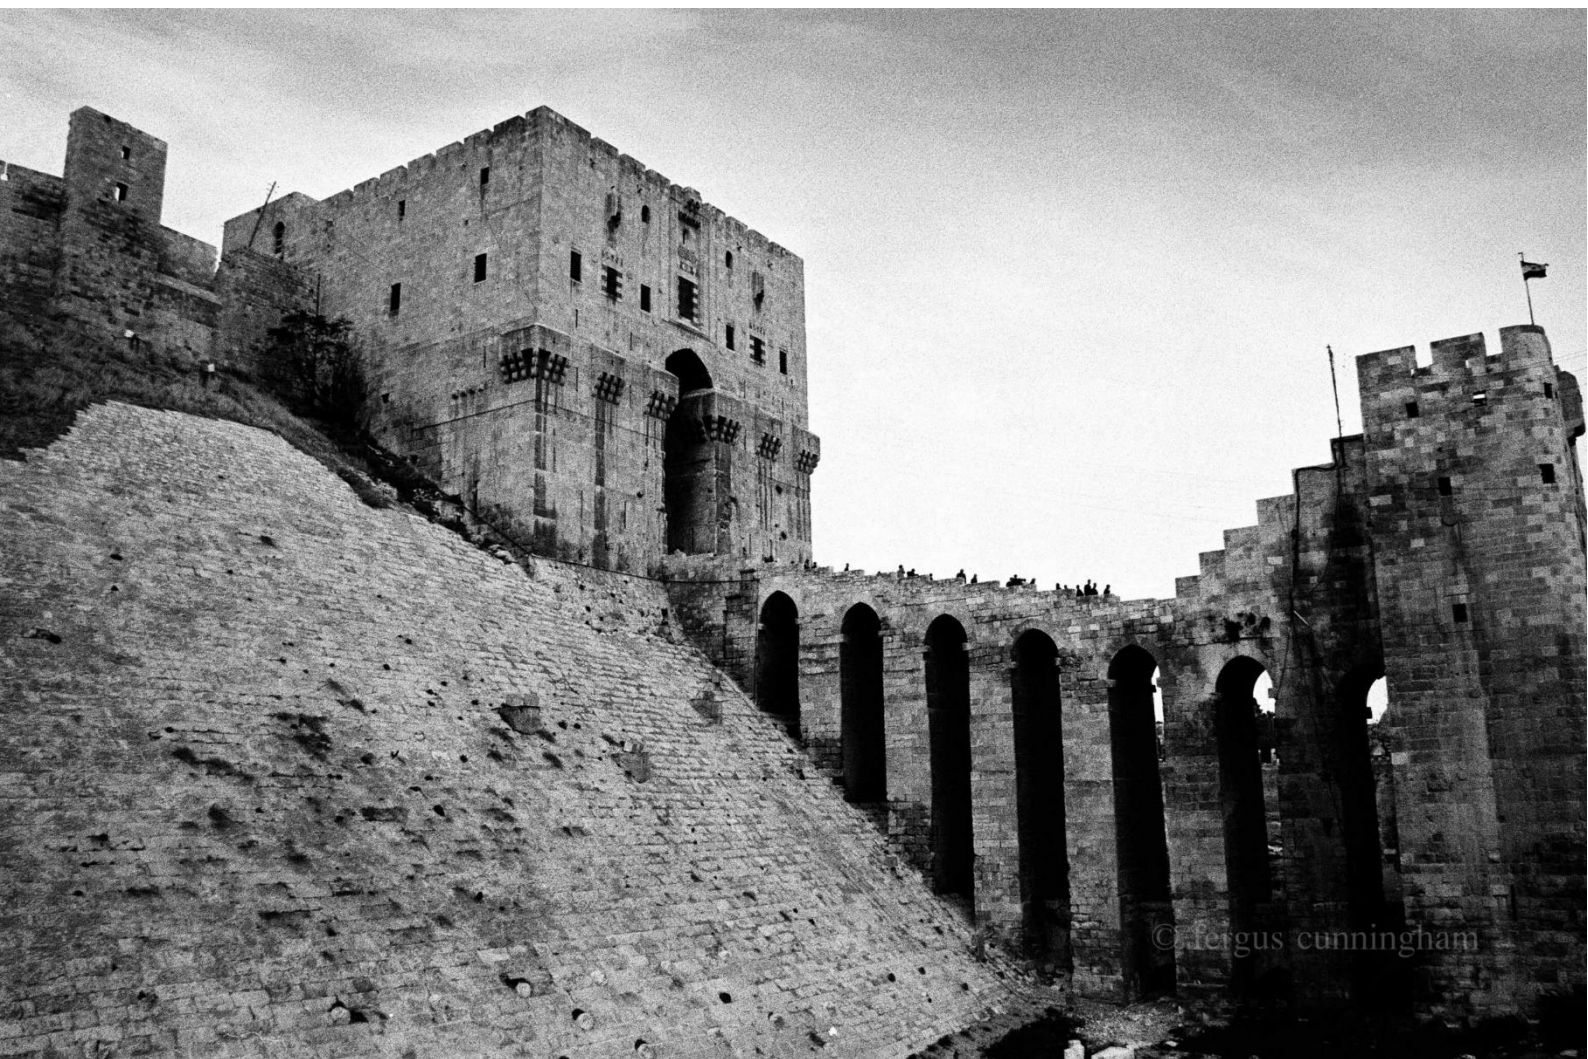
Figure 8: Citadel entrance viaduct. By Cunningham, 2005.

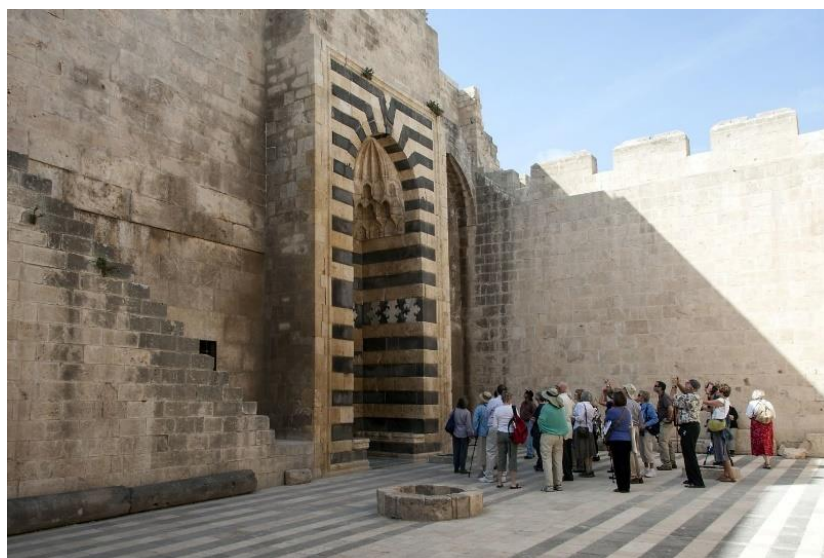
Figure 9: Mamluk Palace, view of entrance portal to Throne Hall. From *Archnet*, by Waugh, 2010.

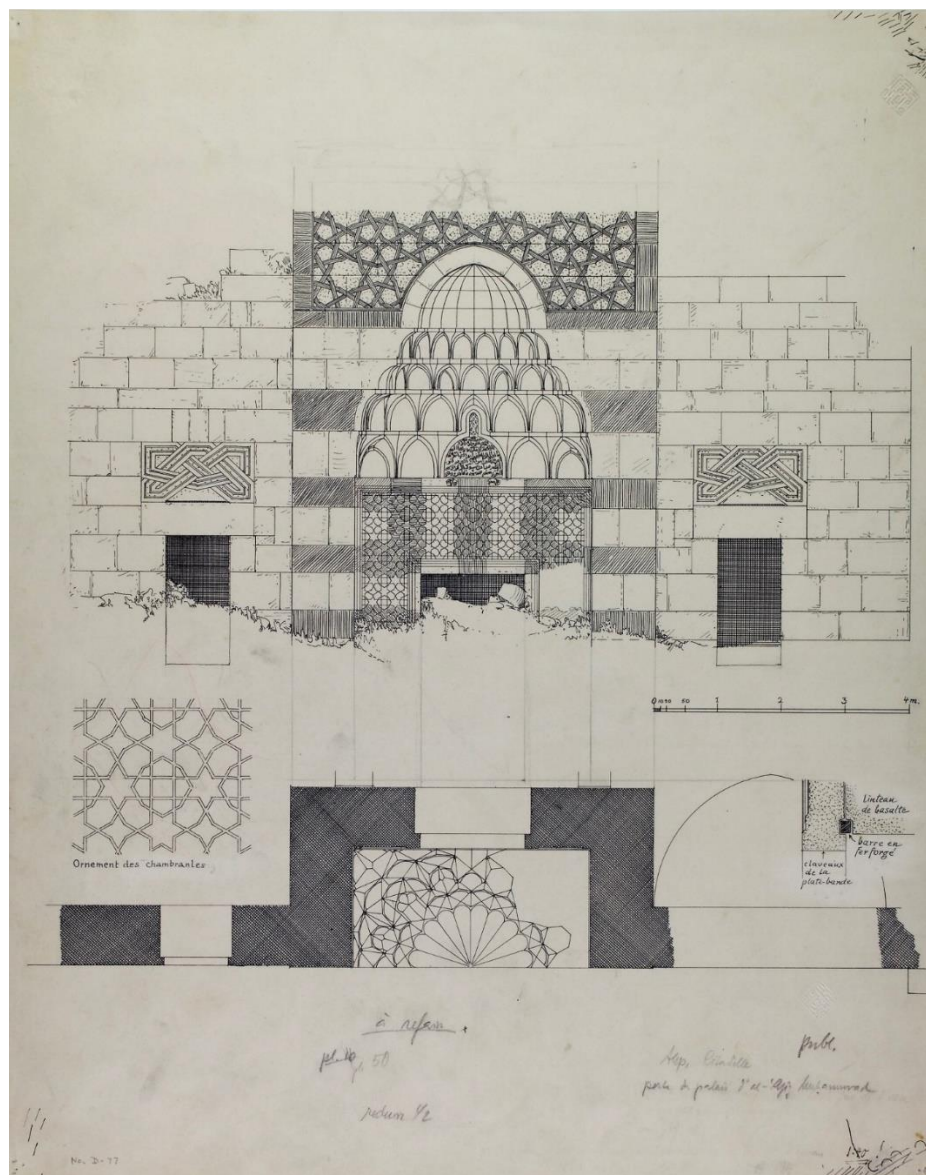
Figure 16: Ayyubid Palace of al-Malik al-Zahir Ghazi, Entrance Portal: Plan and Elevation. From *Smithsonian Institution*, by Herzfeld, 1908-1914

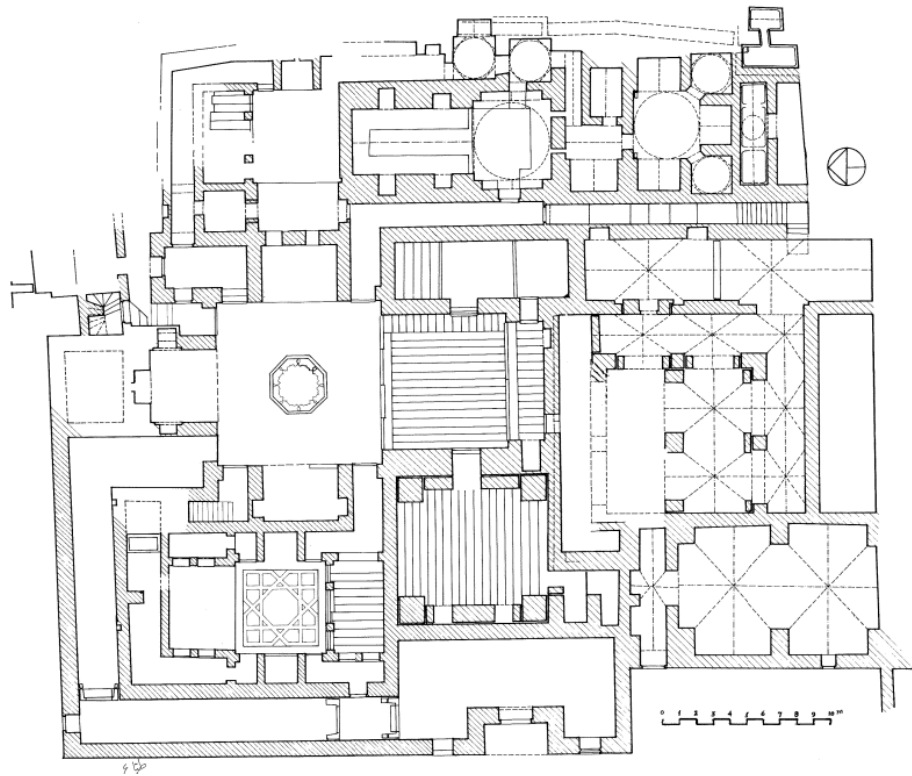
Figure 17: Ayyubid Palace Plan 1190-1230. From *Circle of Power* (p.97) by Tabbaa, 1993

As the Ayyubids took it over from the Zengids, they still had defending to do. Sultan Ghazi had to strengthen the walls, and he then covered the sections of the slopes near the entrance area with stone slabs, increased the moat depth, filled it with water, spanned it by a bridge-viaduct, had a big water reservoir made, built grain silos and a deep well, built the Palace of Glory in the Ayyubid court with multiple palaces, gardens and bath (Gonnella, 2008). See below the entrance to Ghazi's Palace, drawn by Ernst Herzfeld between 1908-1914 with its typical Ayyubid architecture of striped limestone. The Palace of Glory got at first destroyed by a fire that happened at Ghazi's wedding night in 1212 but got rebuilt right after. This destruction and reconstruction part shows how the Citadel not always got destroyed because of defensive and military reasons. Like said in the previous chapter, this shows how the Citadel added a new luxurious function to itself, see figure 17 for the plan of the Ayyubid Palace.

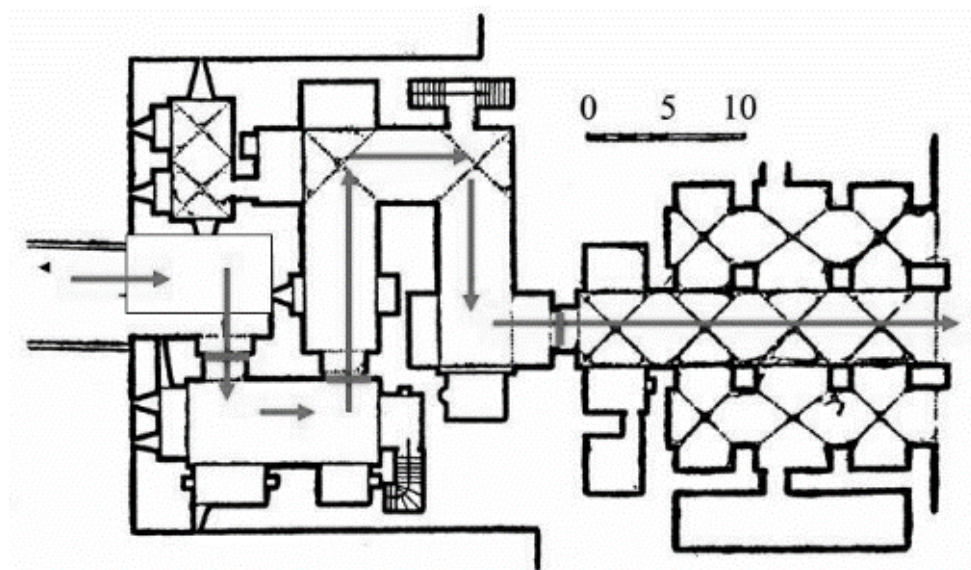
Figure 18: Plan of entrance to Citadel during the reign of Zaher al Ghazi. From *Historical Monuments of Aleppo* by Hadjar, 2000

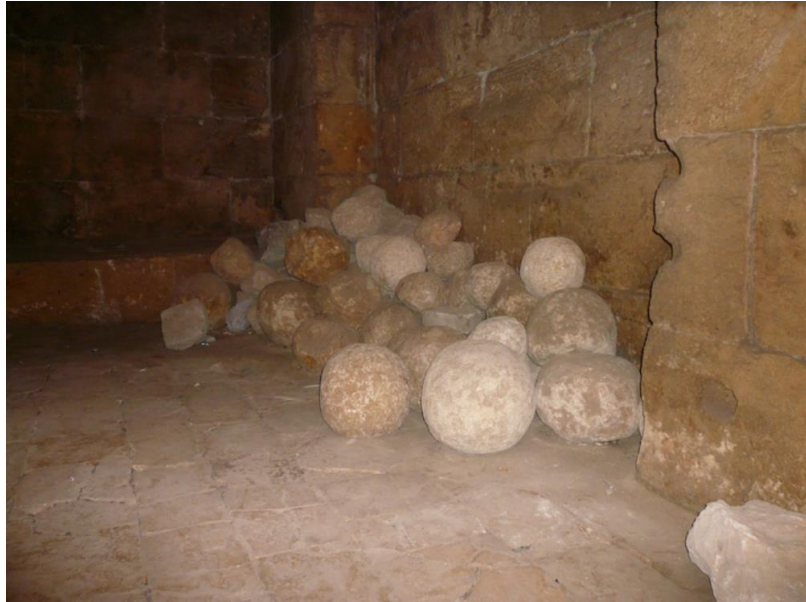
Figure 21: Ammunition for bliden stored in the upper gate area. From *Gerda Henkel Stiftung*, by Braune, 2010

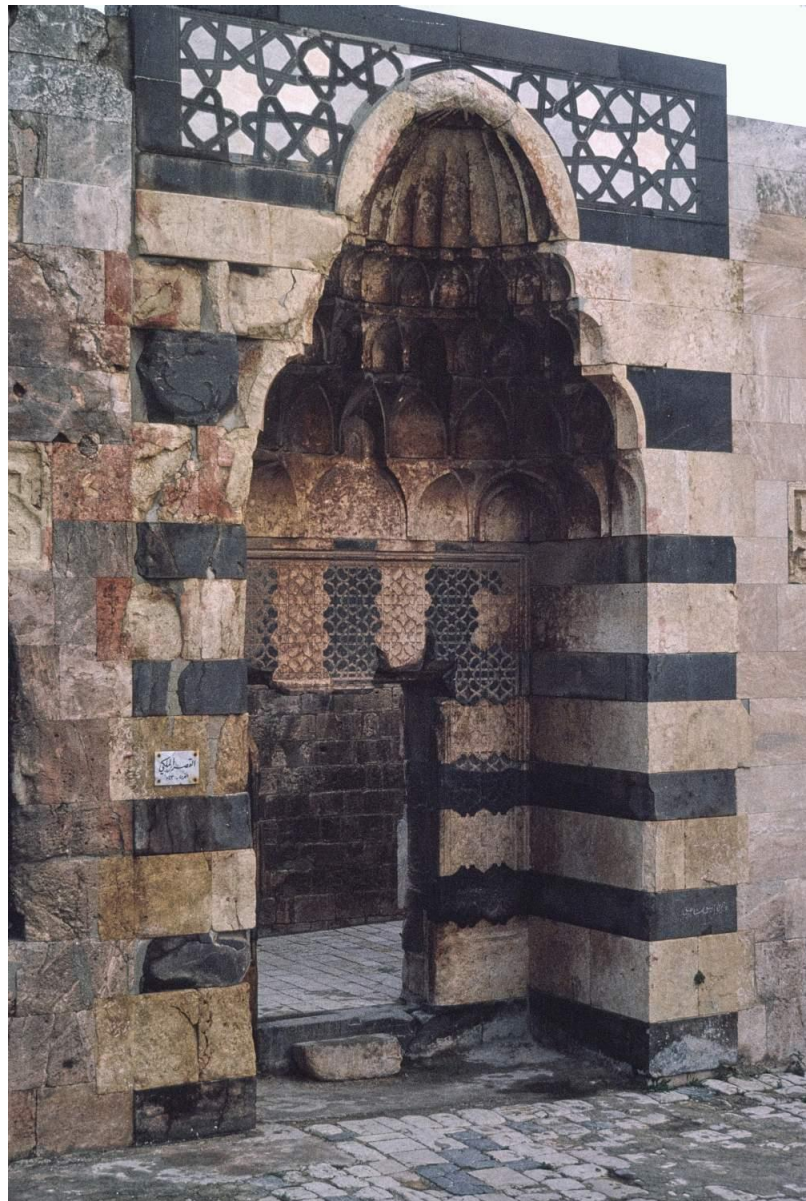
Figure 22: Palace of malek al-Zahir Ghazi, entrance portal. From *Archnet*, by Tabbaa, 1990

Below is an axonometric view of the Ayyubid Palace. Evidence of the wedding night destruction from 800 years ago can actually still be seen till today. There are traces of the fire in the Ayyubid courtyard and on the entrance portal, see figure 22. According to Gonnella (2008), Ghazi's arsenal also got destroyed by the fire but was restored by Ghazi's son. The big mosque in the Citadel also got destroyed by the fire but completely rebuilt by Ghazi according to the inscription on the tympanum of the entrance gate. The Ayyubid Cistern, which is an underground hall, is partly carved out of the limestone stone on which the Citadel is built and has signs of destruction but it is not known which events caused what exactly. The stone cladding on the slope was also applied by Ghazi and for military reasons as it made enemy intrusions harder but it also prevented walls from eroding and it offered protection from new medieval war machines (trebuchet) that could strike up to 300 meters with 90 kilos to catapult.

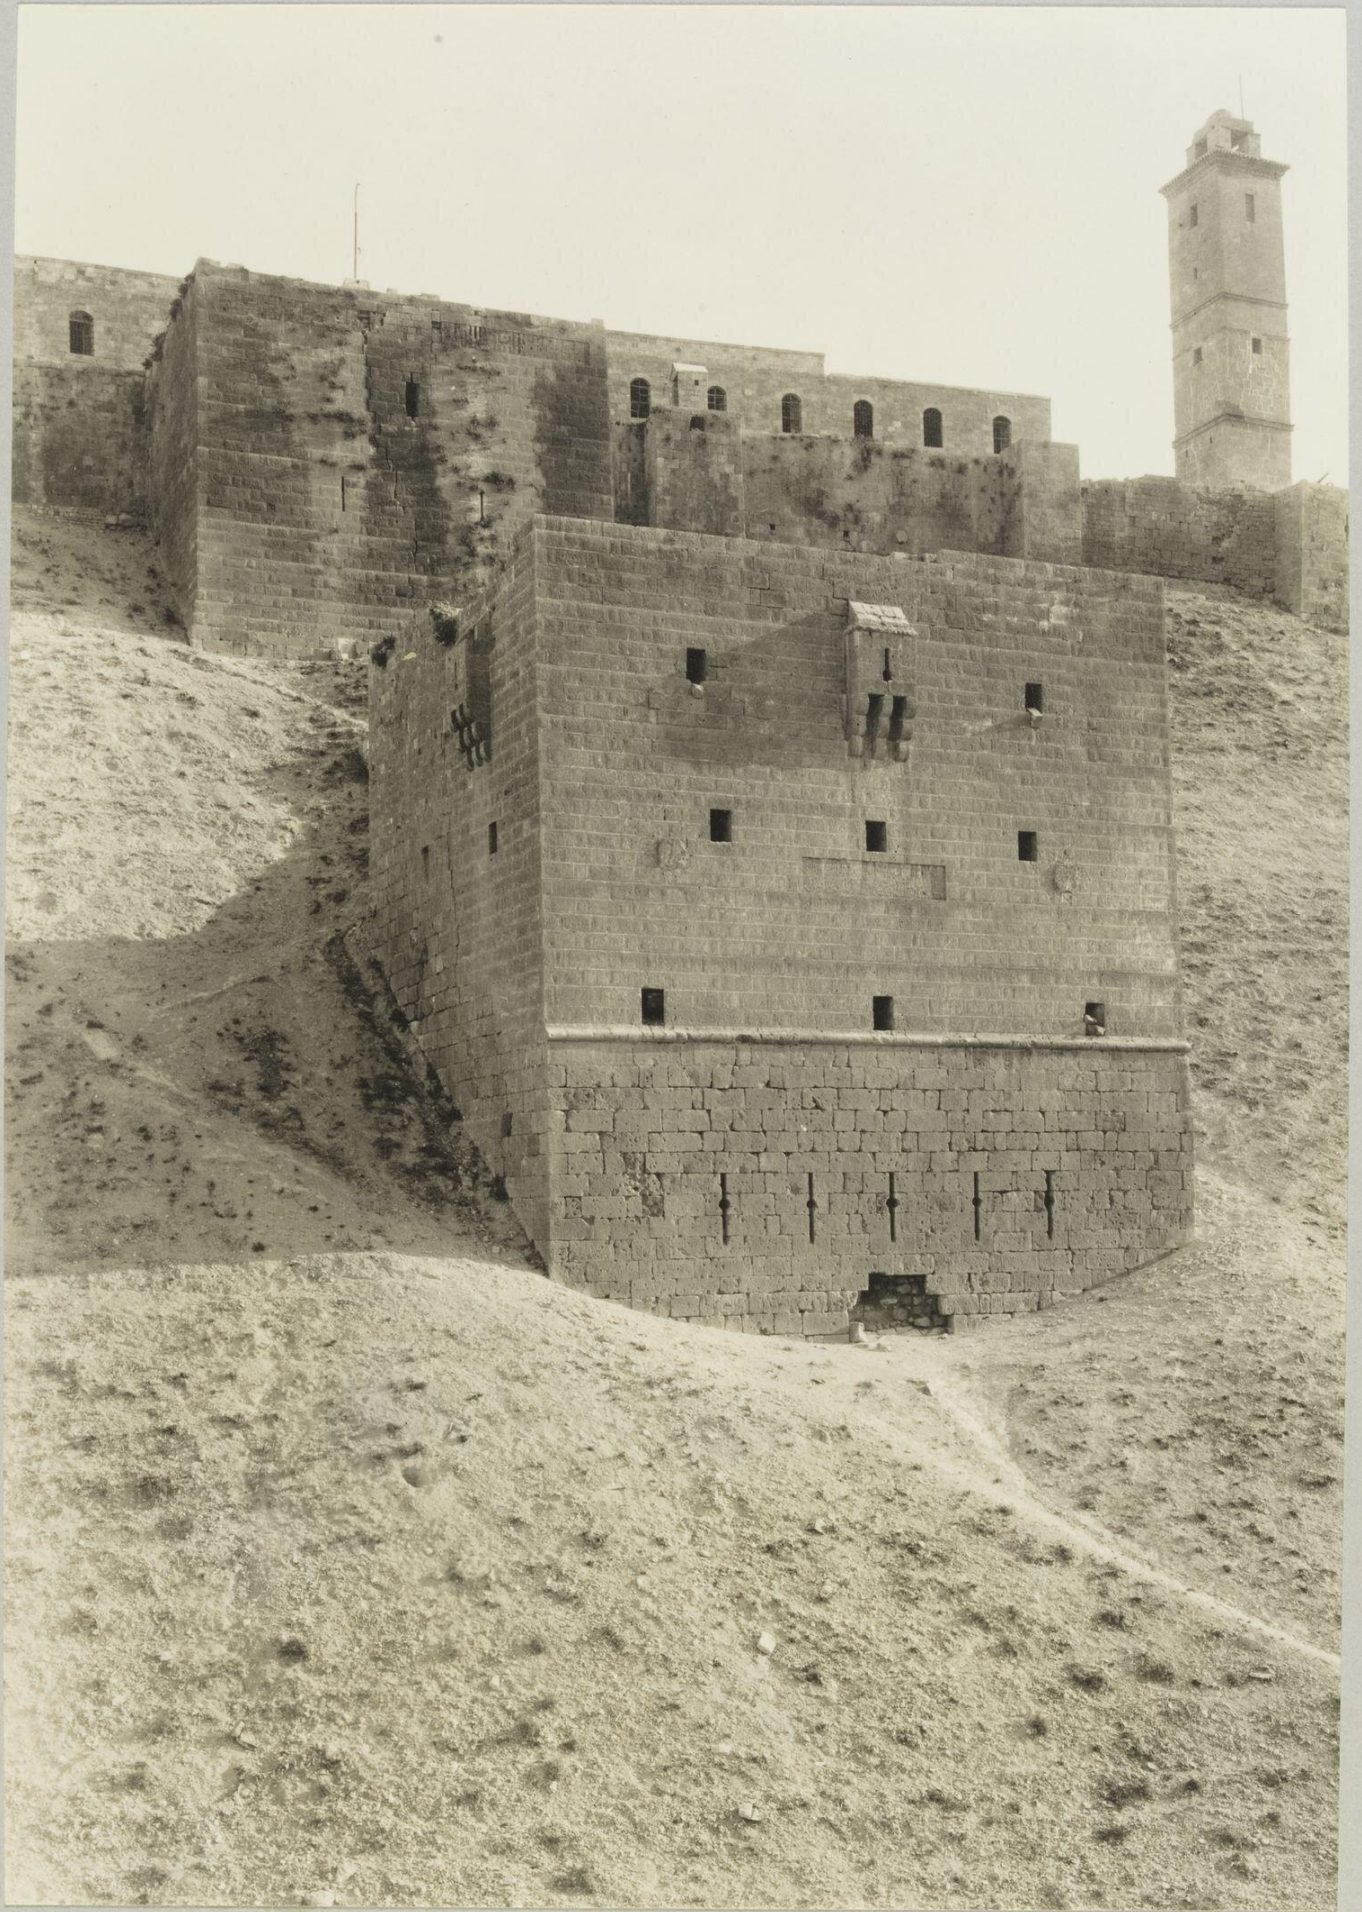
2343-1921.
advanced works on north glacis.

Figure 23: North advance tower of the Citadel. From *Victoria and Albert Museum*, by Creswell, 1919-1921

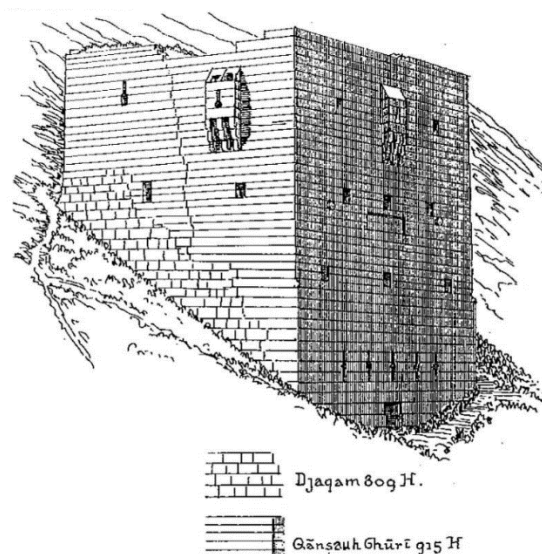
Figure 24: Engineering elevation of the North advance tower. From *Aleppo Citadel: A study of the history of the citadel and its antiquities* (p.286), by Shaat, 1996

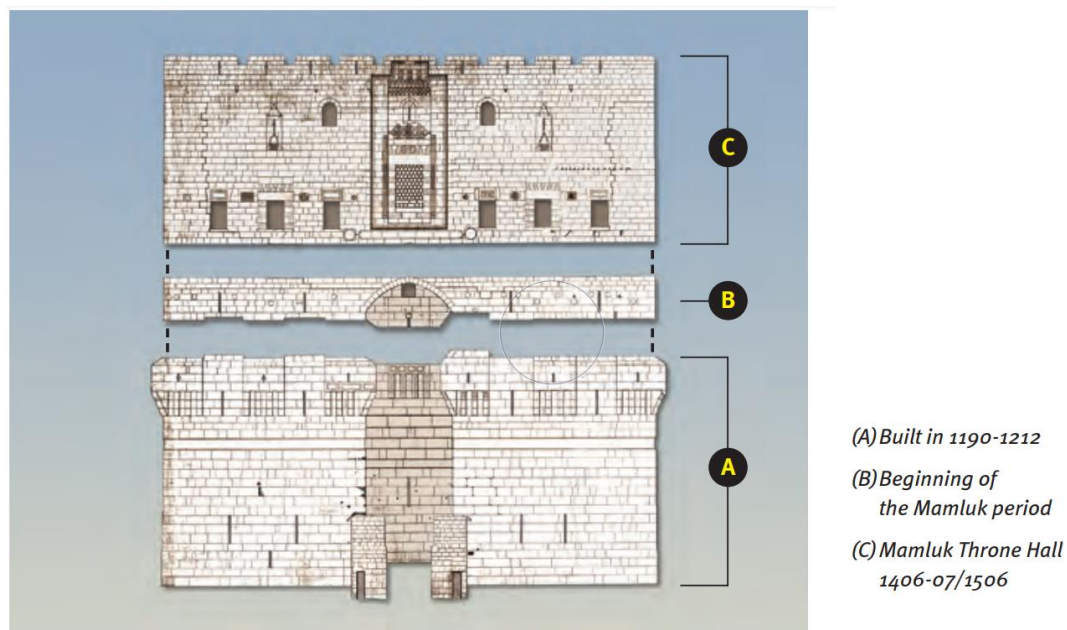
Below, the alterations of the Mamluks to the entrance block are shown. The architectural transformations in this façade can be seen. The first thing to note is the huge stone blocks the Ayyubids used, while the Mamluks used smaller stones. These, as can also be noticed, allowed for designs and decorations of the windows of the Mamluk façade part. The Ayyubid part shows strength and force which is typical for its military architecture, while the Mamluk part shows a spark of wealth with architectural detail. In general, decoration in the Citadel was nothing new. Rich ornamentation and detail can already be seen in the Ayyubid Palace (figure 16). But there is a visible transformation; from Islamic design elements such as the decorative motifs and geometric patterns to an adaption of such design elements and addition of Mamluk design innovations such as the use of intersecting vaults in the big mosque or ornamental and multi colored stones.

Figure 25: Entrance block alterations from Ayyubid to Mamluk period. From *The Citadel of Aleppo: Description, History, Site Plan and Visitor Tour* (2nd Ed., p.21), by Gonnella, 2008

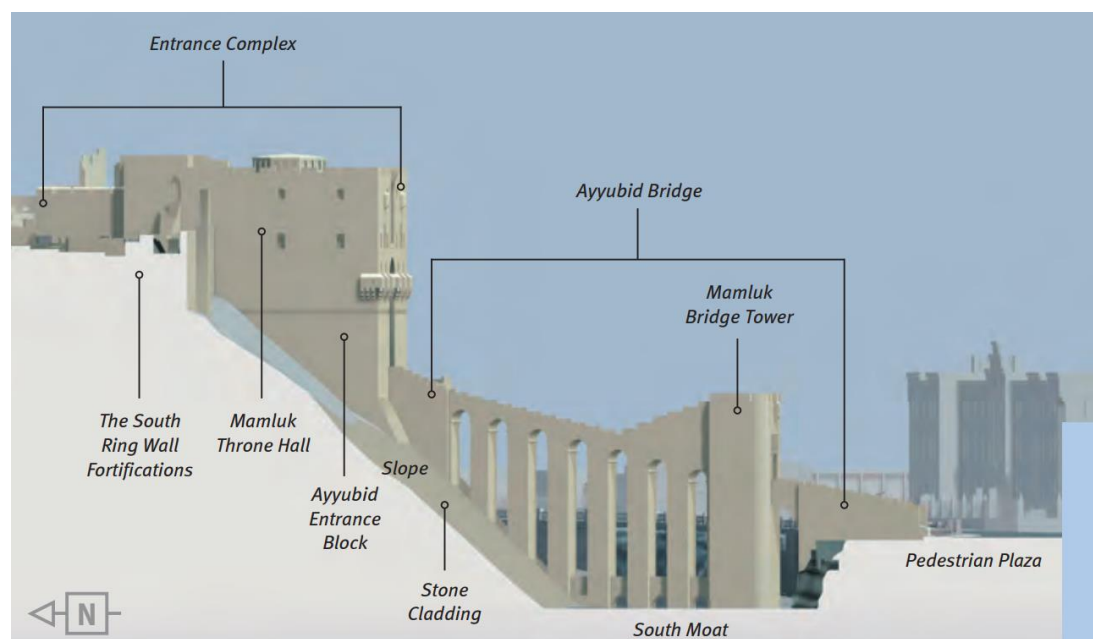
Figure 26: Entrance section. From *The Citadel of Aleppo: Description, History, Site Plan and Visitor Tour* (2nd Ed., p.31), by Gonnella, 2008

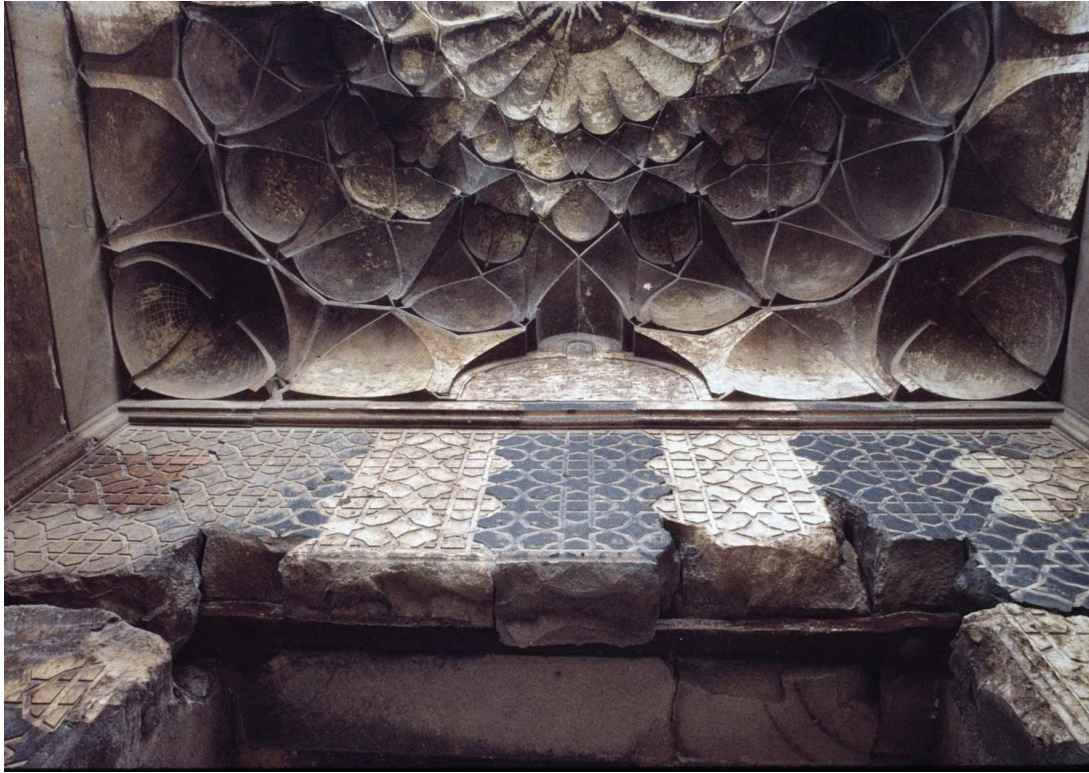
Figure 27: Ayyubid Palace entrance portal: view of muqarnas hood from below with the typical Ayyubid masonry work of striped limestone decorated with geometric patterns. From *Archnet*, by Tabbaa, 1990

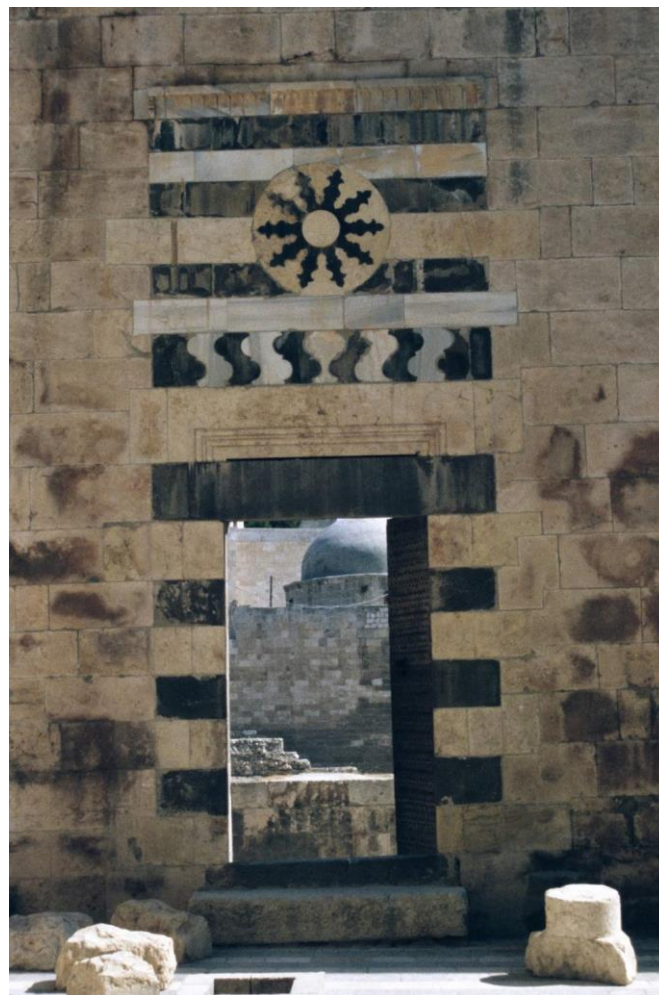
Figure 28: Mamluk Palace forecourt, view of ornamental and multi colored doorway in northern wall. From *Archnet*, by Tabbaa, 2000

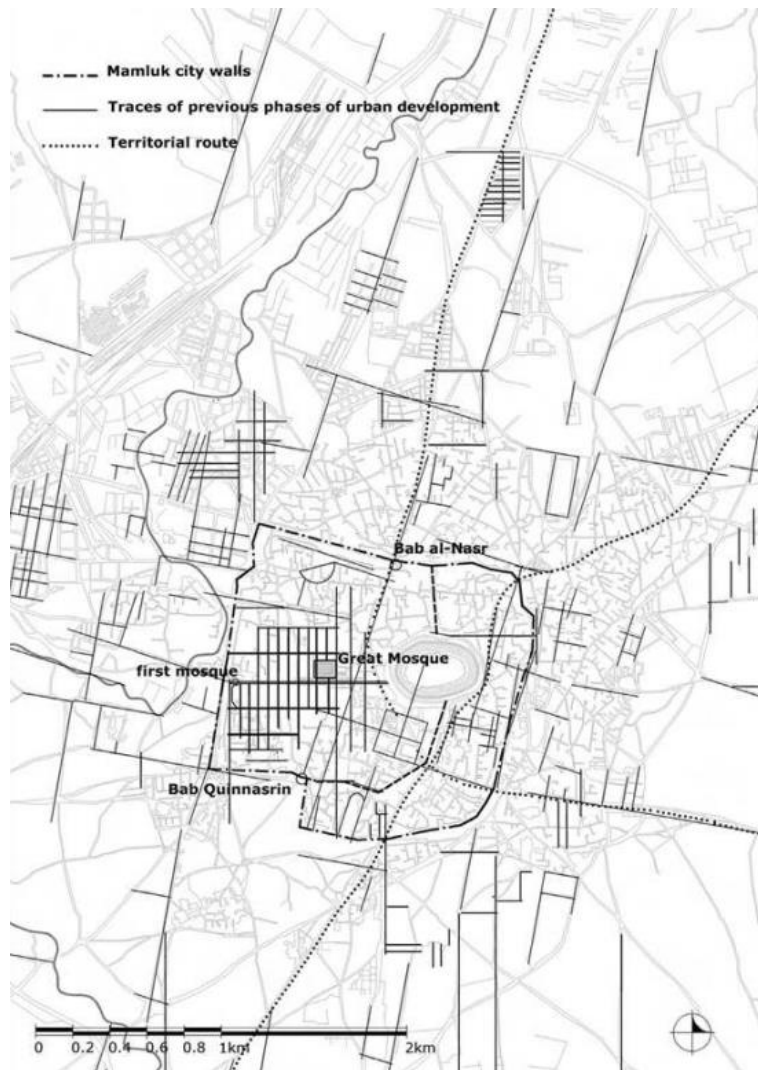
Figure 30: Relation between the traces of pre-Islamic Aleppo and the layout of the Ayyubid and Mamluk urban walls. From *Chapter Five: The forma urbis of Aleppo during the Middle Ages* (p.131) by Neglia, 2010

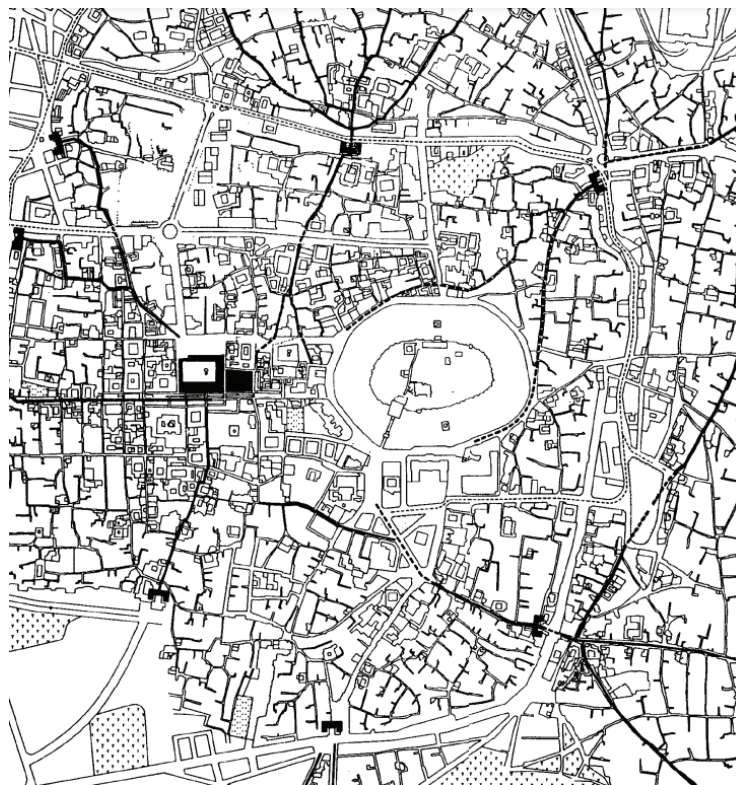
Figure 31: Main streets and the gates of the city during the Ottoman times. From *Aleppo : a design proposal for a deconstructed city* (p.31) by Martinez and Sozuner, 2018

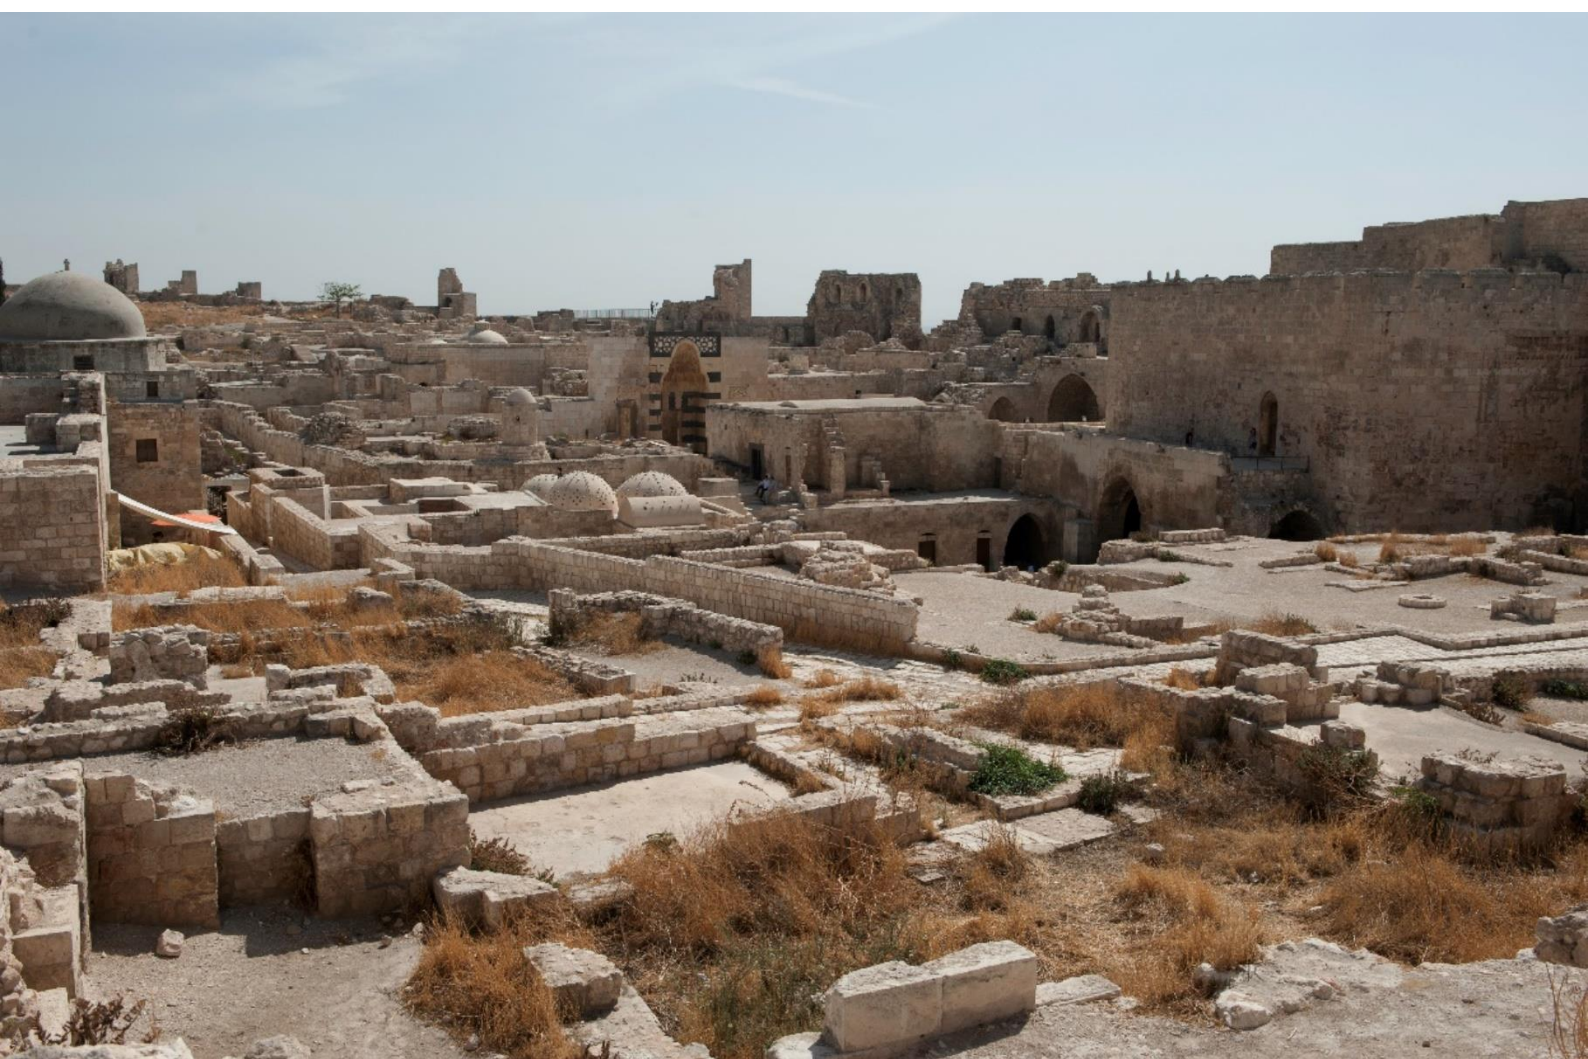
Figure 32: Aleppo Citadel, Ottoman dwellings. From *Wikimedia Commons*, by Osseman, 2010

The Ottoman quarter was uncovered only 20 years ago by excavations in the Citadel (Jodidio, 2011). These revealed different types of courtyard houses of various sizes which have been well built, with tiled and, in some houses, multicolored floors (Gonnella, 2007).

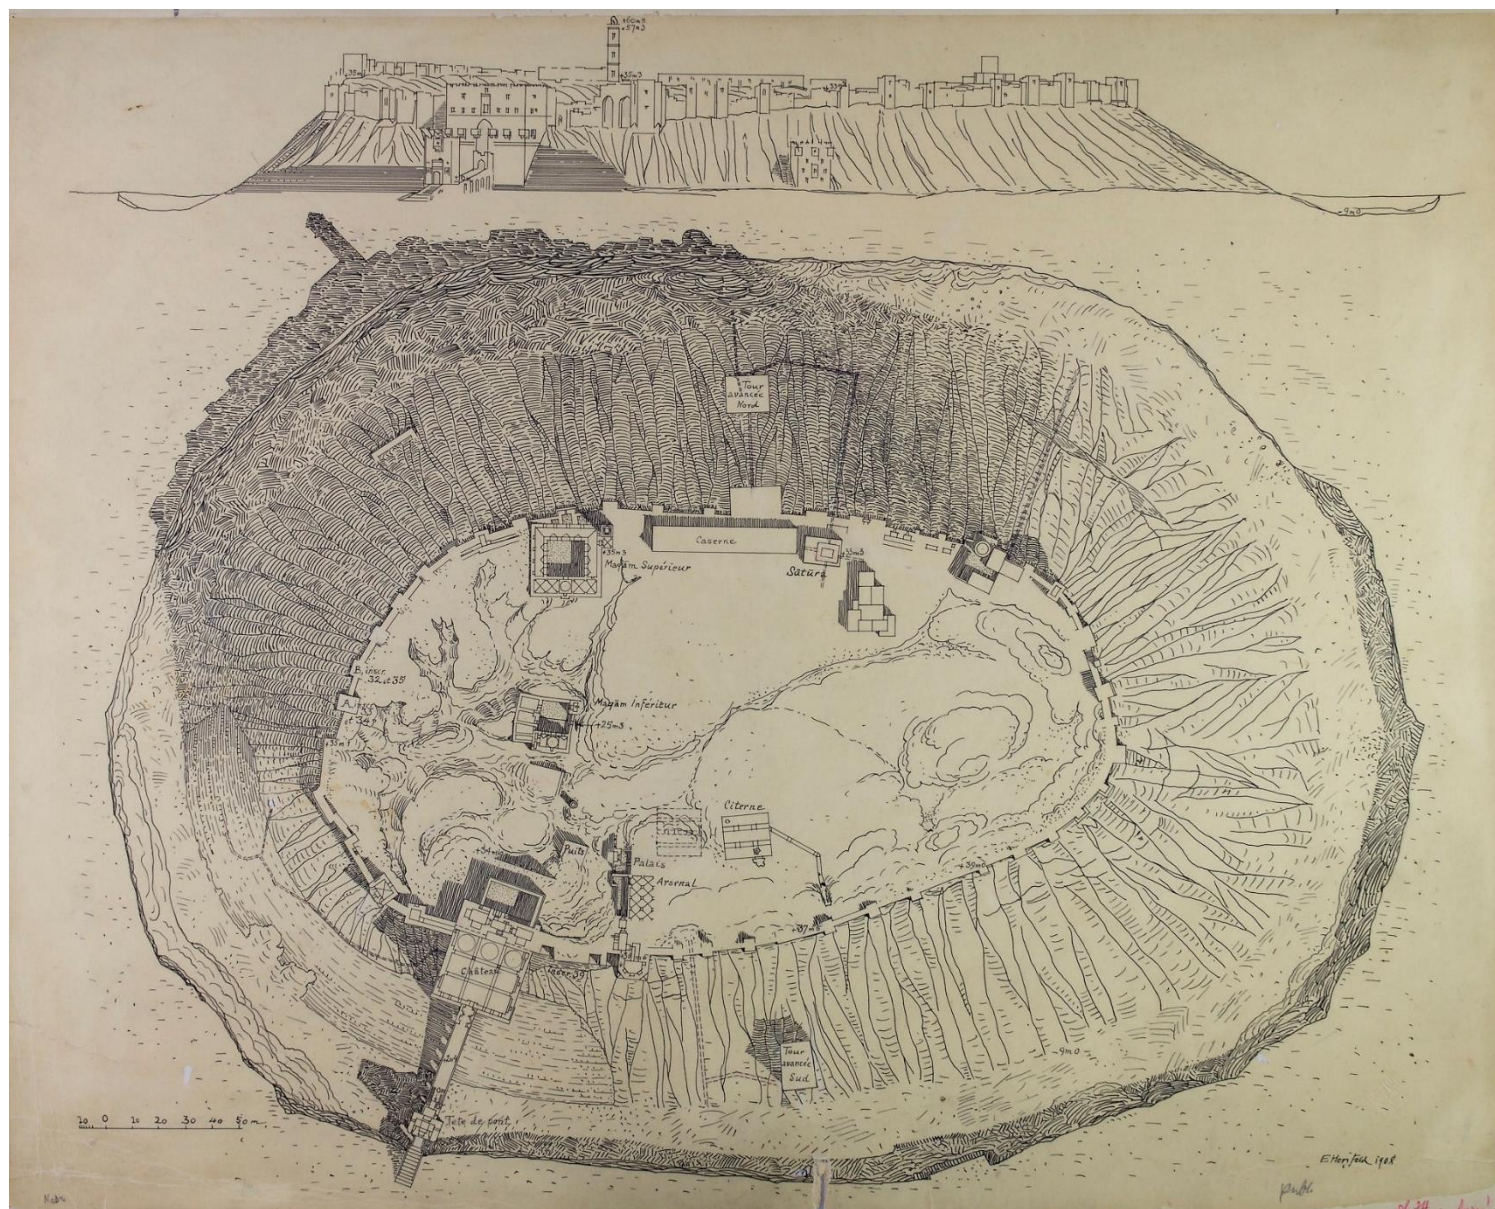
Figure 33: Plan of Citadel. From *Smithsonian Institution*, by Herzfeld, 1908-1914

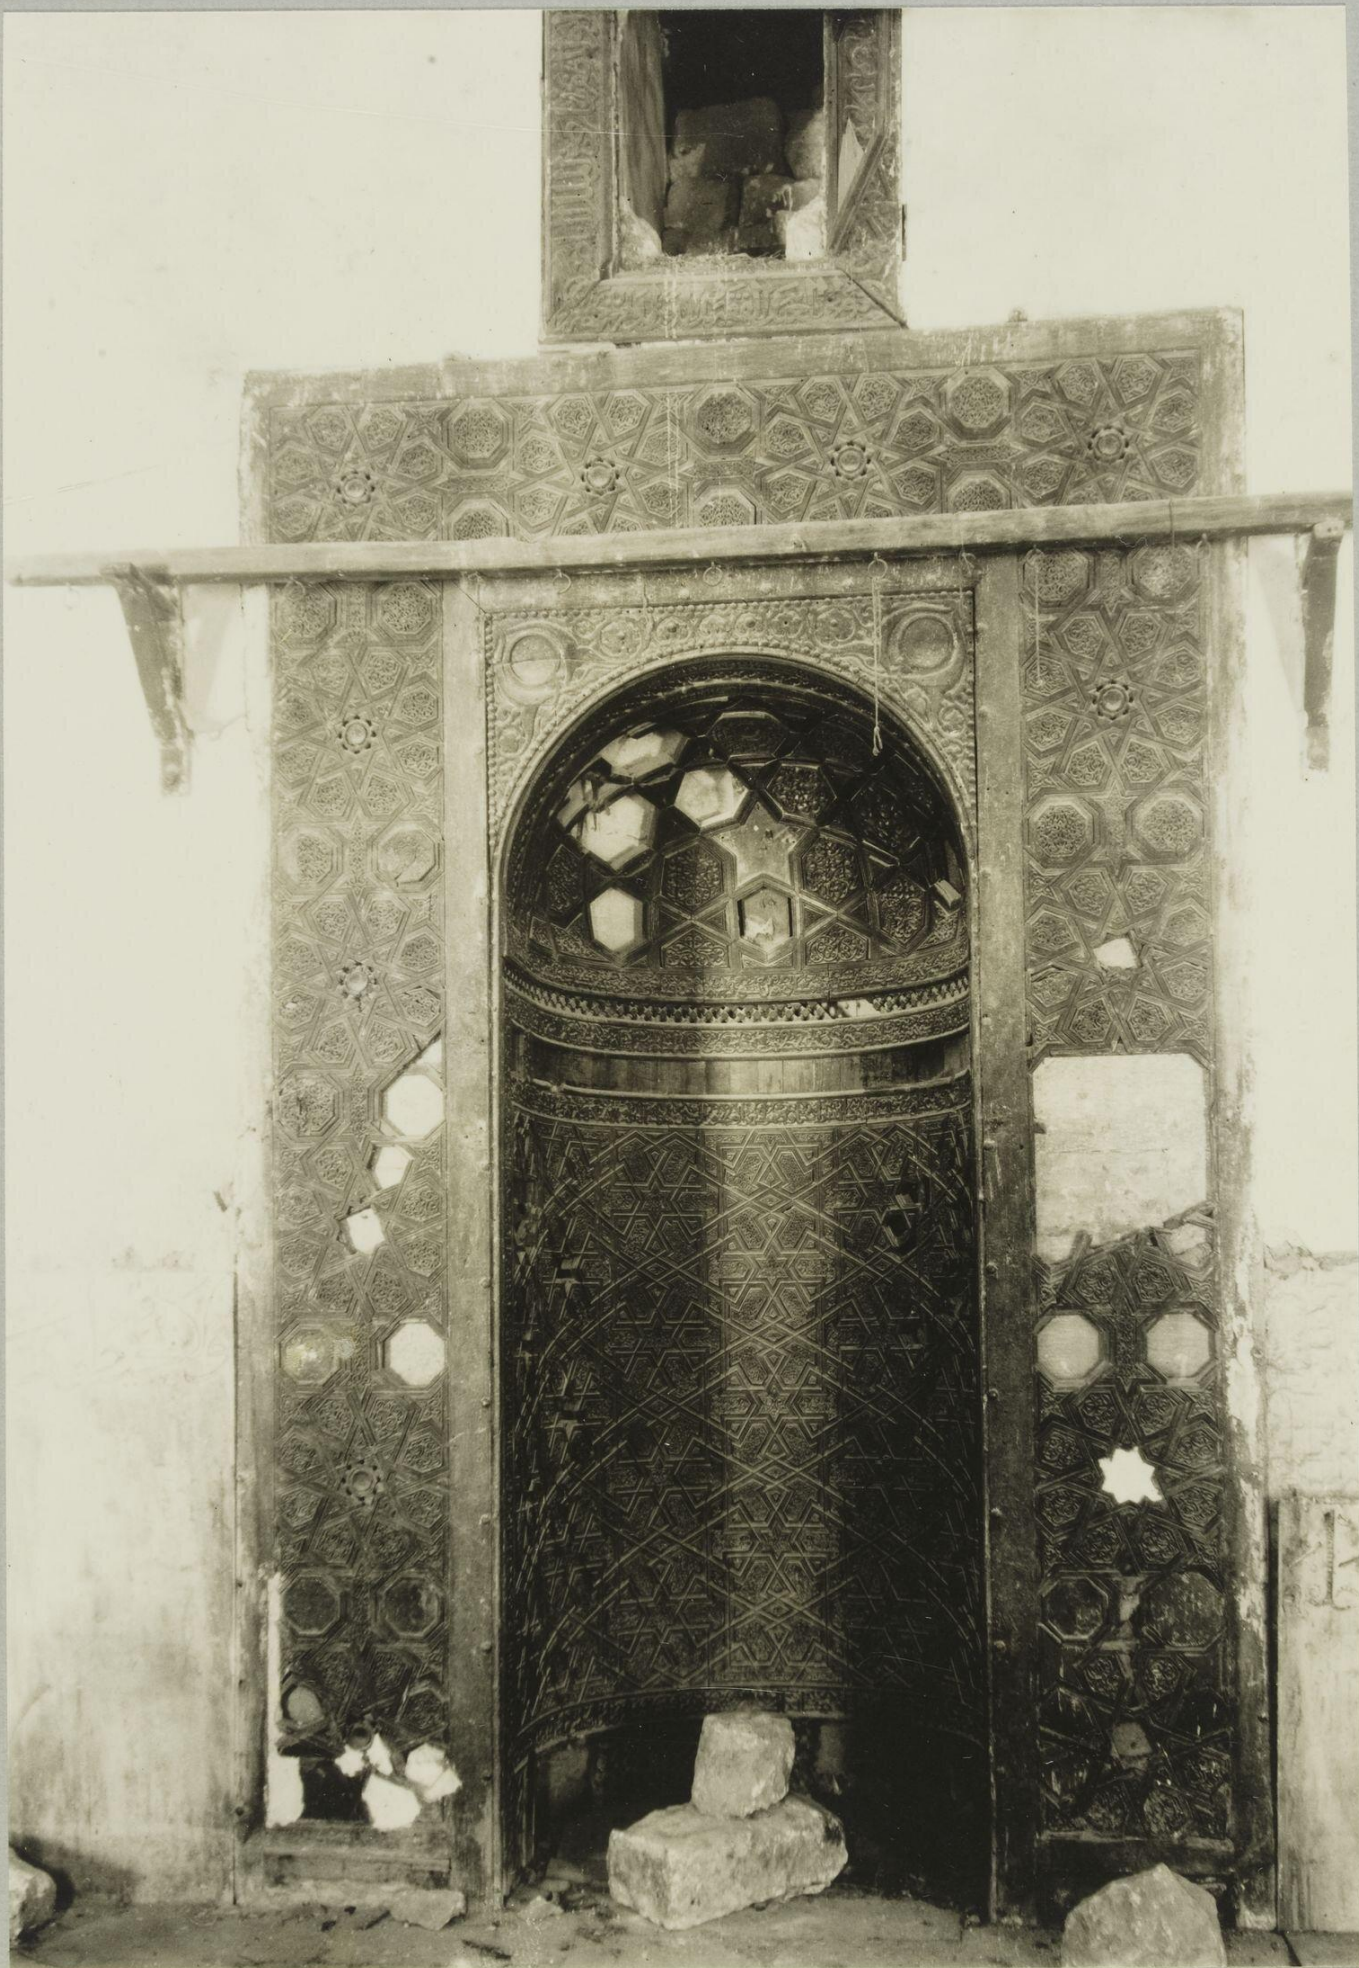
2454-1921.

Figure 36: The lost carved wooden mihrab in Maqam Ibrahim at the Citadel of Aleppo. From *Victoria and Albert Museum*, by Creswell, 1919-1921

Mihrâb.

A significant mark during the French Mandate is the disappearance of a part in the Citadel. In chapter 2 was mentioned how Nur ad-Din had built a wooden prayer niche in the mosque of Abraham. This niche disappeared during the French Mandate without a trace (Gonnella, 2007) and whether it was stolen or that something else happened to it, is not known. The lost prayer niche can be seen on the next page in a photograph by Creswell before the Citadel officially got under French Mandate.

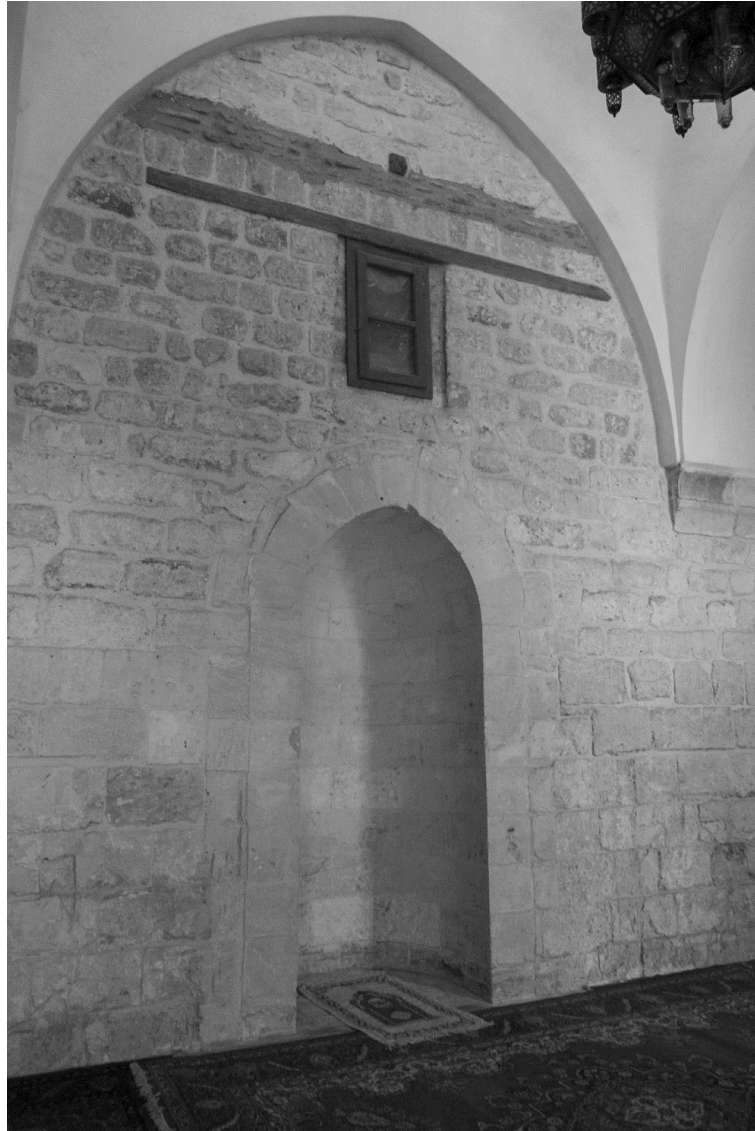
Figure 37: Maqam Ibrahim, view of mihrab. From *Archnet*, by Waugh, 2010.

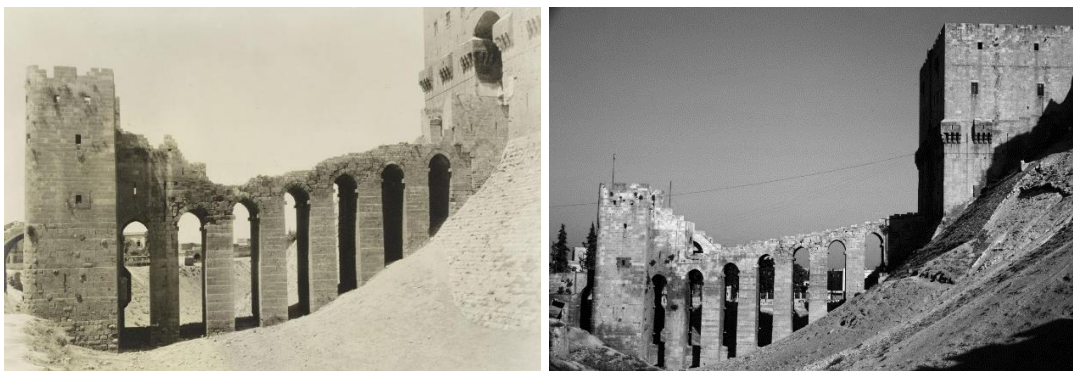
Figures 40 and 41: On the left: Entrance gate and bridge in Citadel. From *Victoria and Albert Museum*, by Creswell, 1919-1921. On the right: View of entrance block from east. From *Archnet*, by Tabbaa, 1990

The Syrian Directorate-General of Antiquities and Museums (DGAM) in the 1970s further strengthened sections of the ring wall, excavated and reconstructed the Palace Hammam, Hammam Nur ad-Din and the big mosque, and in the last years of the 20th century started restoration on the courtyards of the Ayyubid Palace and excavation of the ancient temple (Gonnella, 2008). According to Gonnella, the DGAM also excavated the Souk in the late 1990s, and also the Mamluk Tower got restored. The ring wall is iconic in this cycle of destruction and reconstruction. As stated before in the thesis, this part of the Citadel keeps getting rebuilt throughout the history of the Citadel. Below on the left is a photograph of the entrance gate and bridge with visible destruction on top of the bridge and on the right is a photograph of the bridge after its reconstruction. In figures 40 and 41 a view of the entrance gate and bridge from the upper entrance block can be compared again with before and after reconstruction.
