The Destruction and Reconstruction of Aleppo's Citadel

A Historical Analysis

Architectural History Thesis

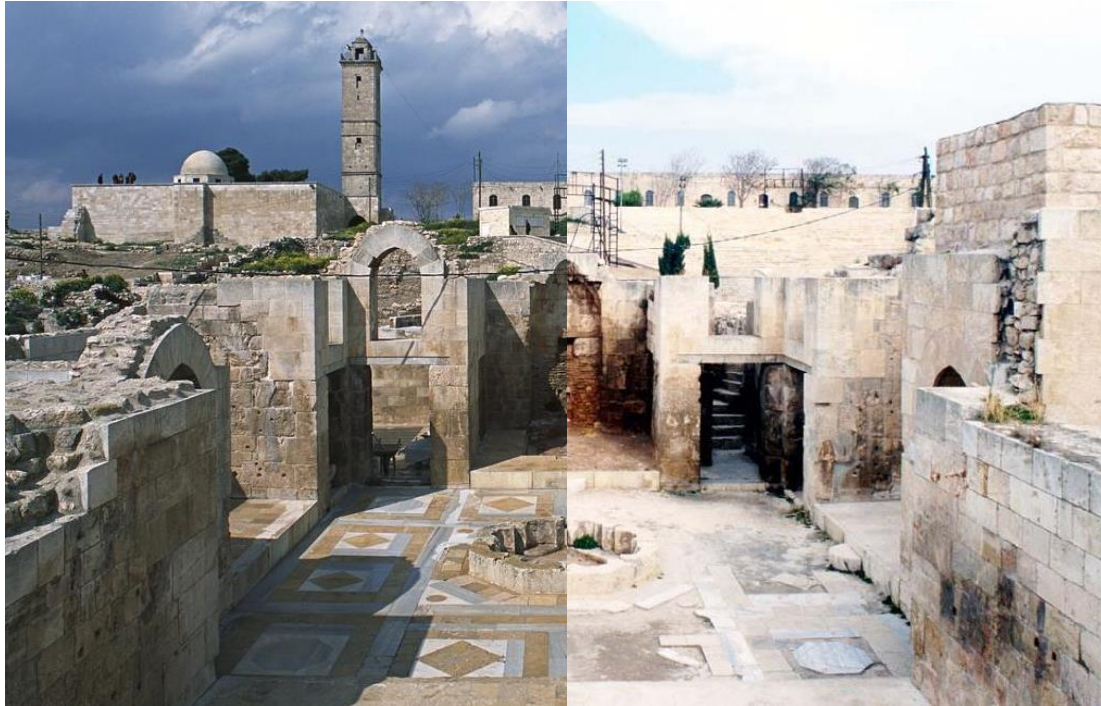
Figure 44: Rephotograph of the Ayyubid Palace, before and after reconstruction. From *The Aga Khan historic cities programme* (p.256), by AKTC, 2003 (left), 2001 (right)

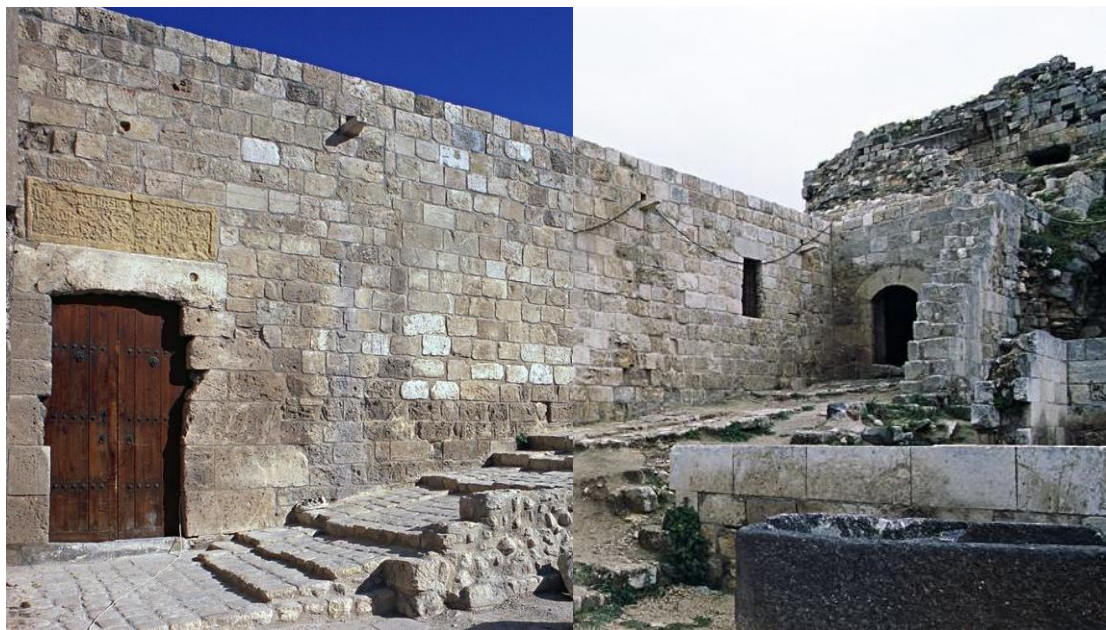
Figure 45: Rephotograph of the entrance Ayyubid arsenal, before and after reconstruction. From *The Aga Khan historic cities programme* (p.256), by AKTC, 2005 (left), 2003 (right)

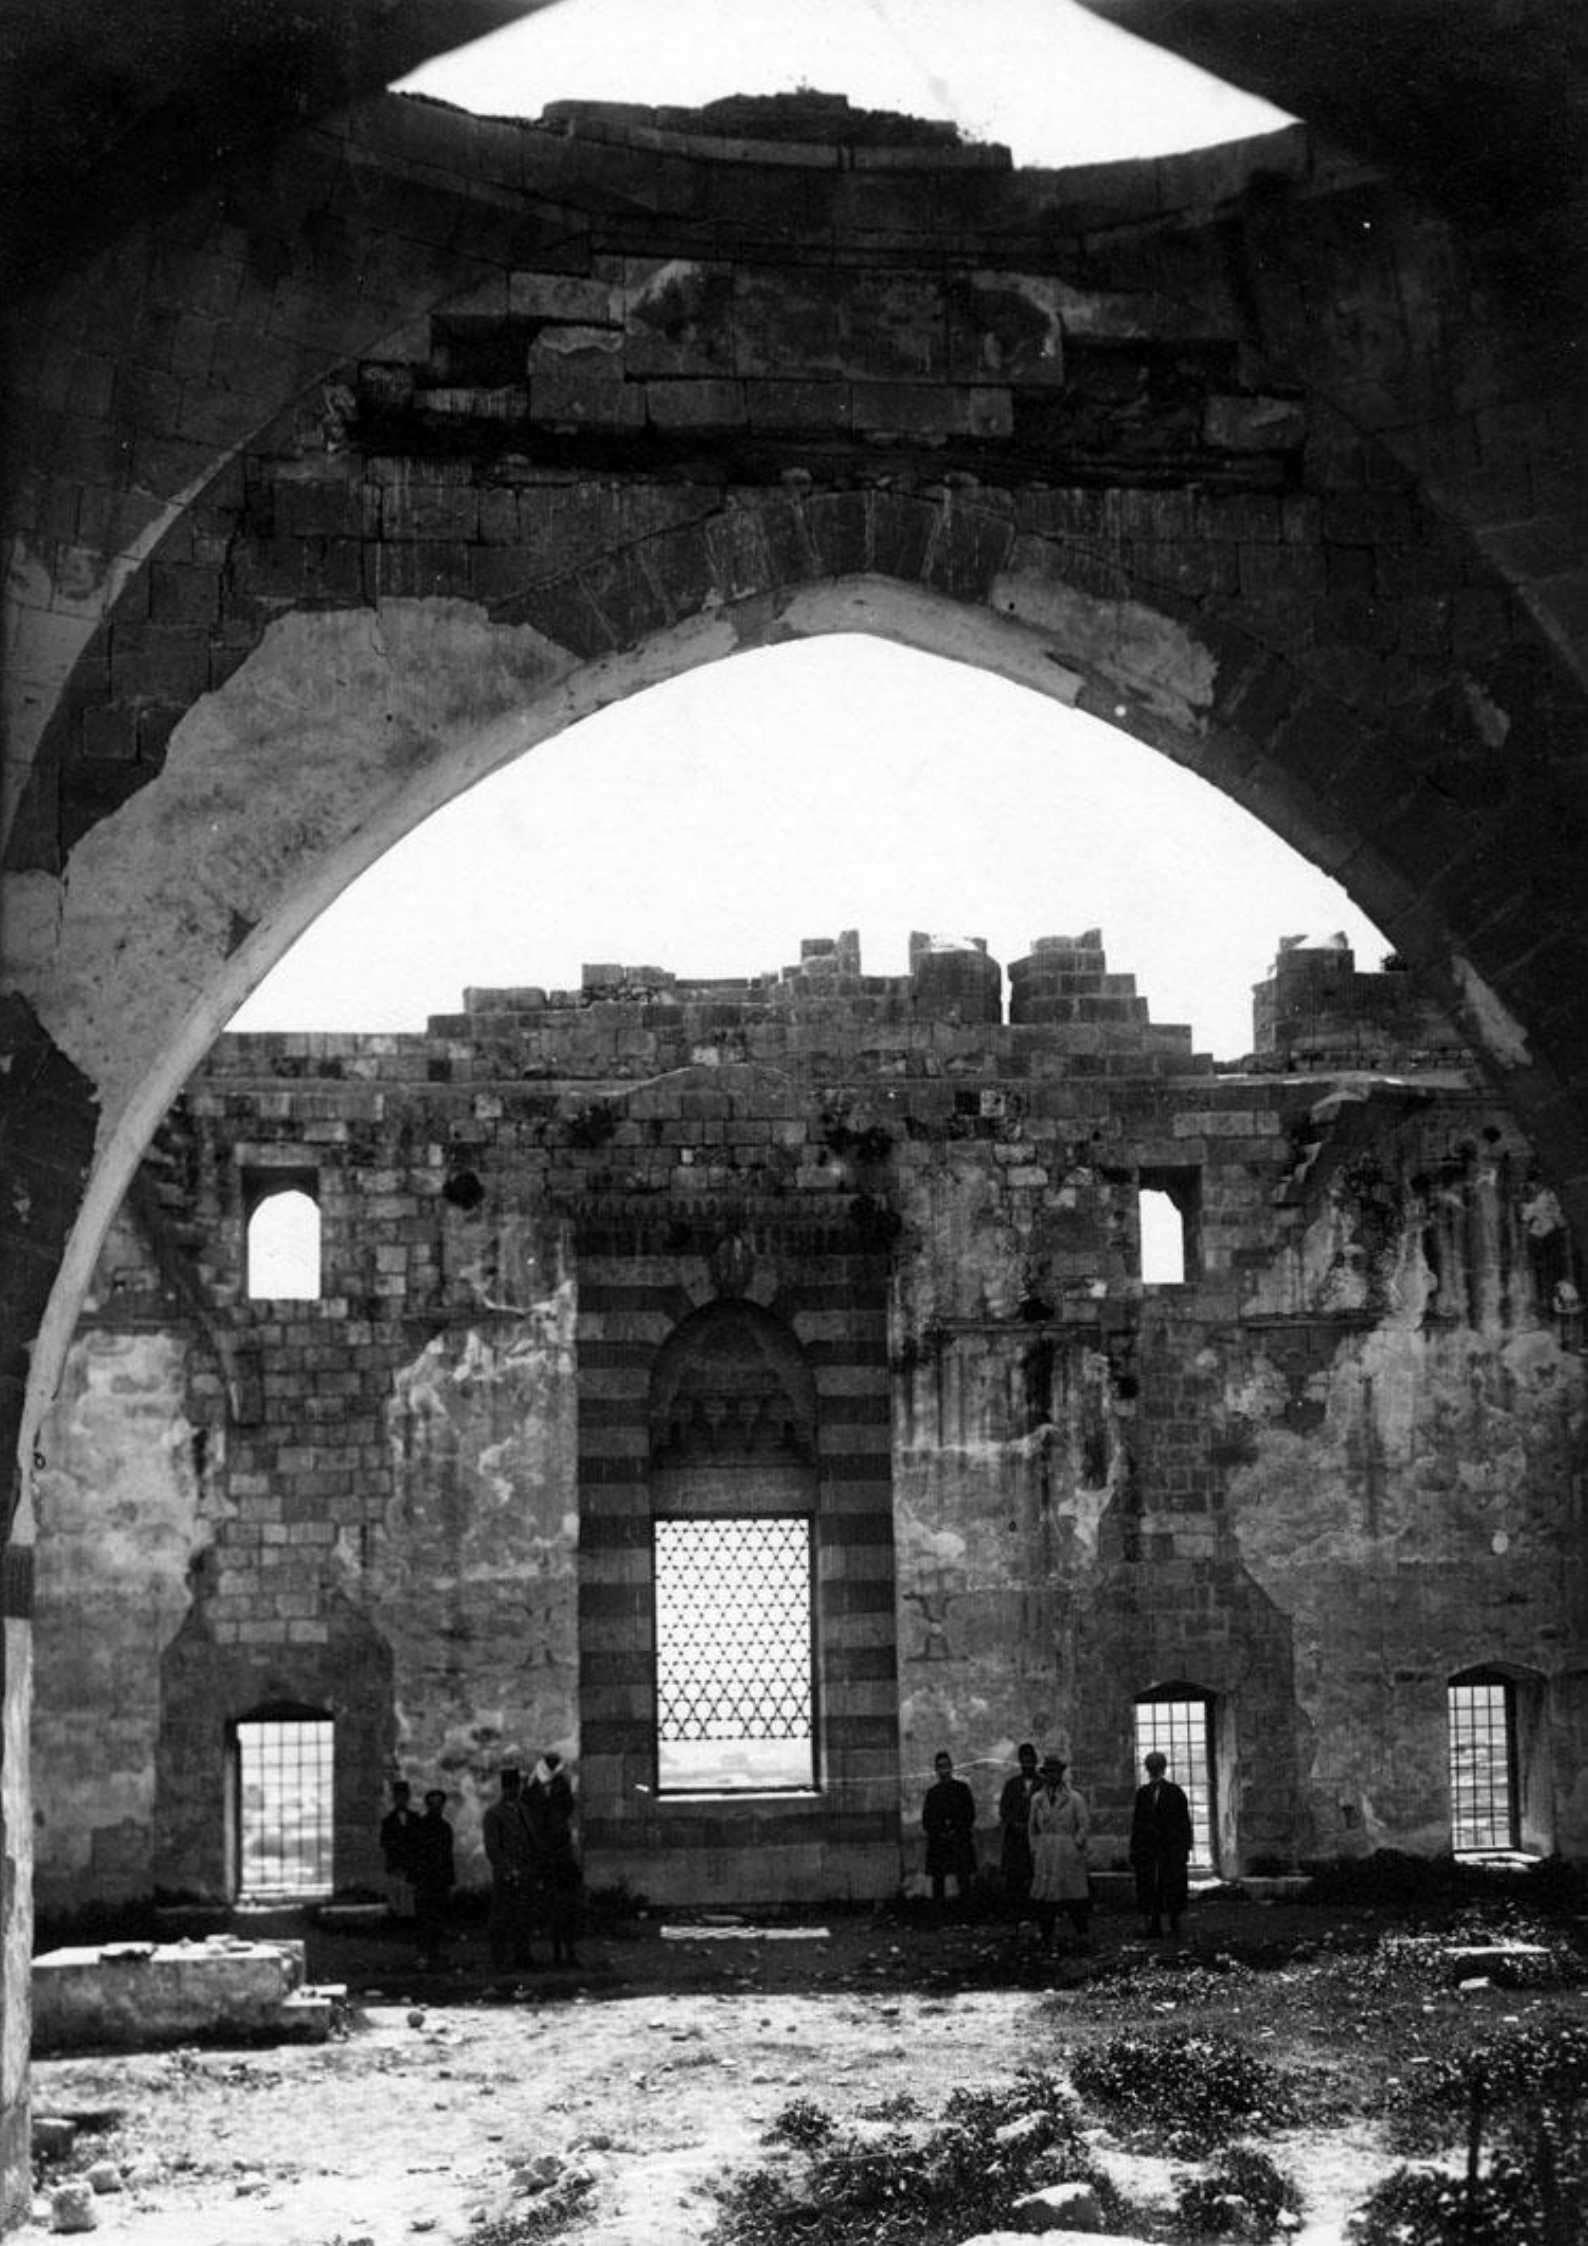
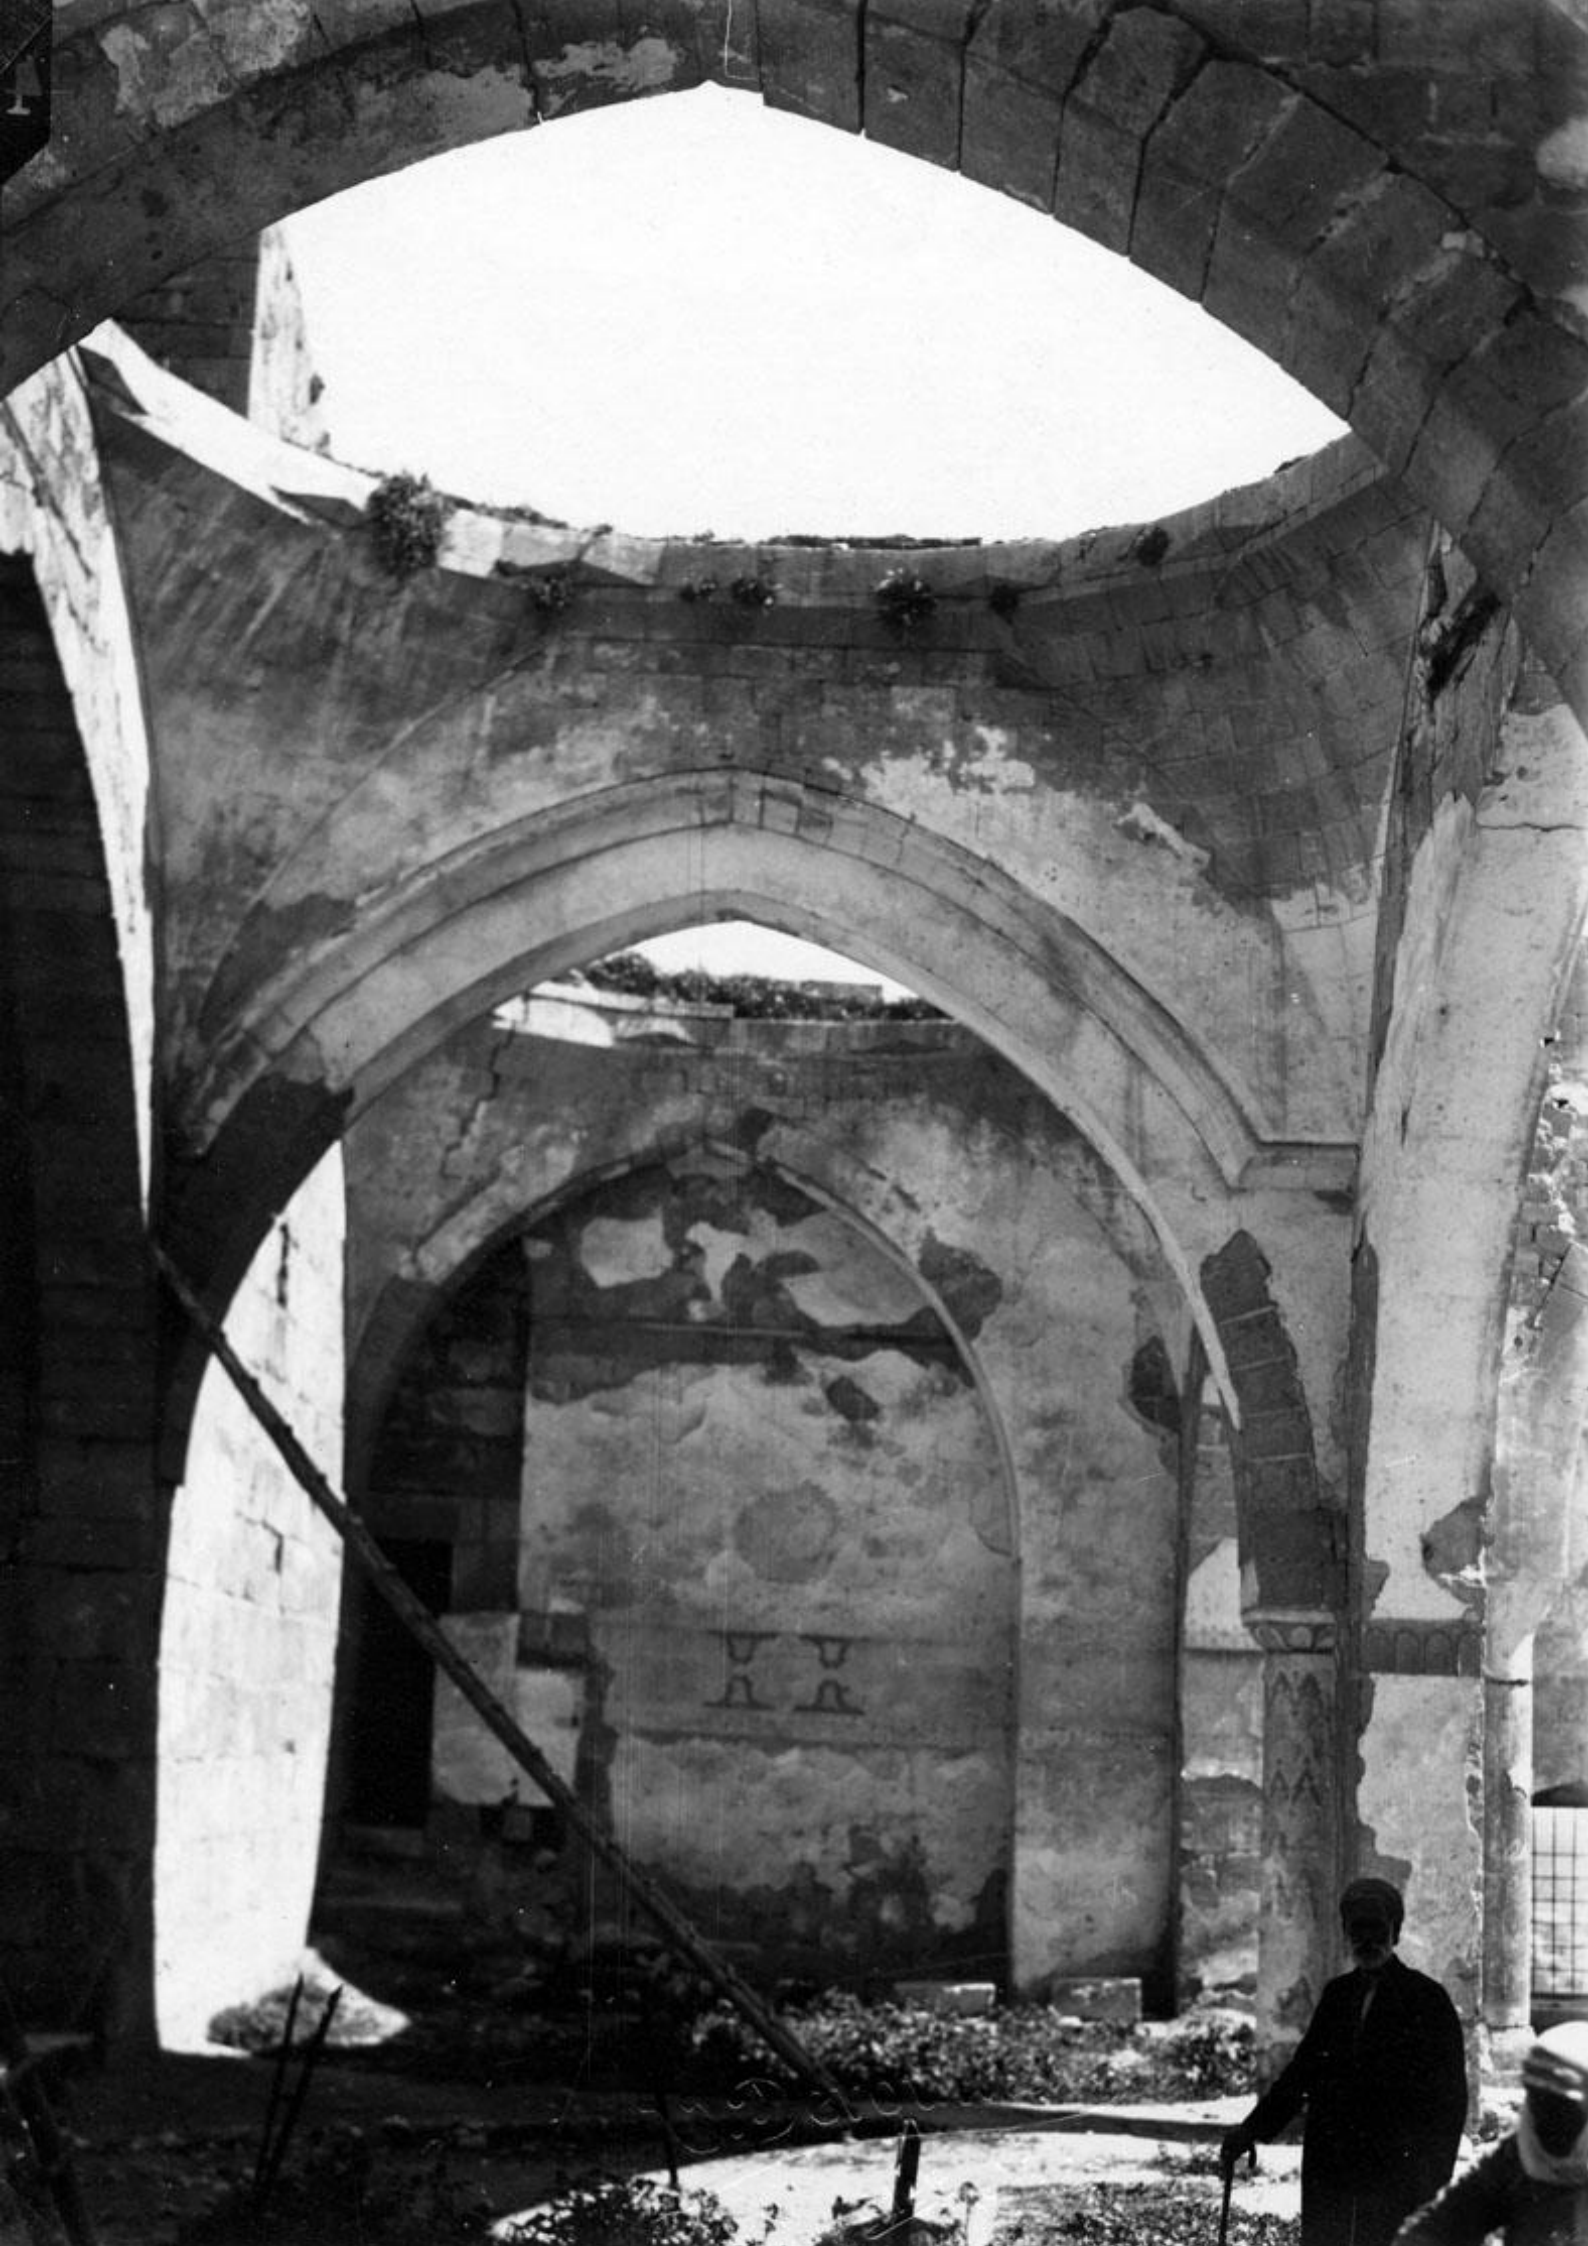
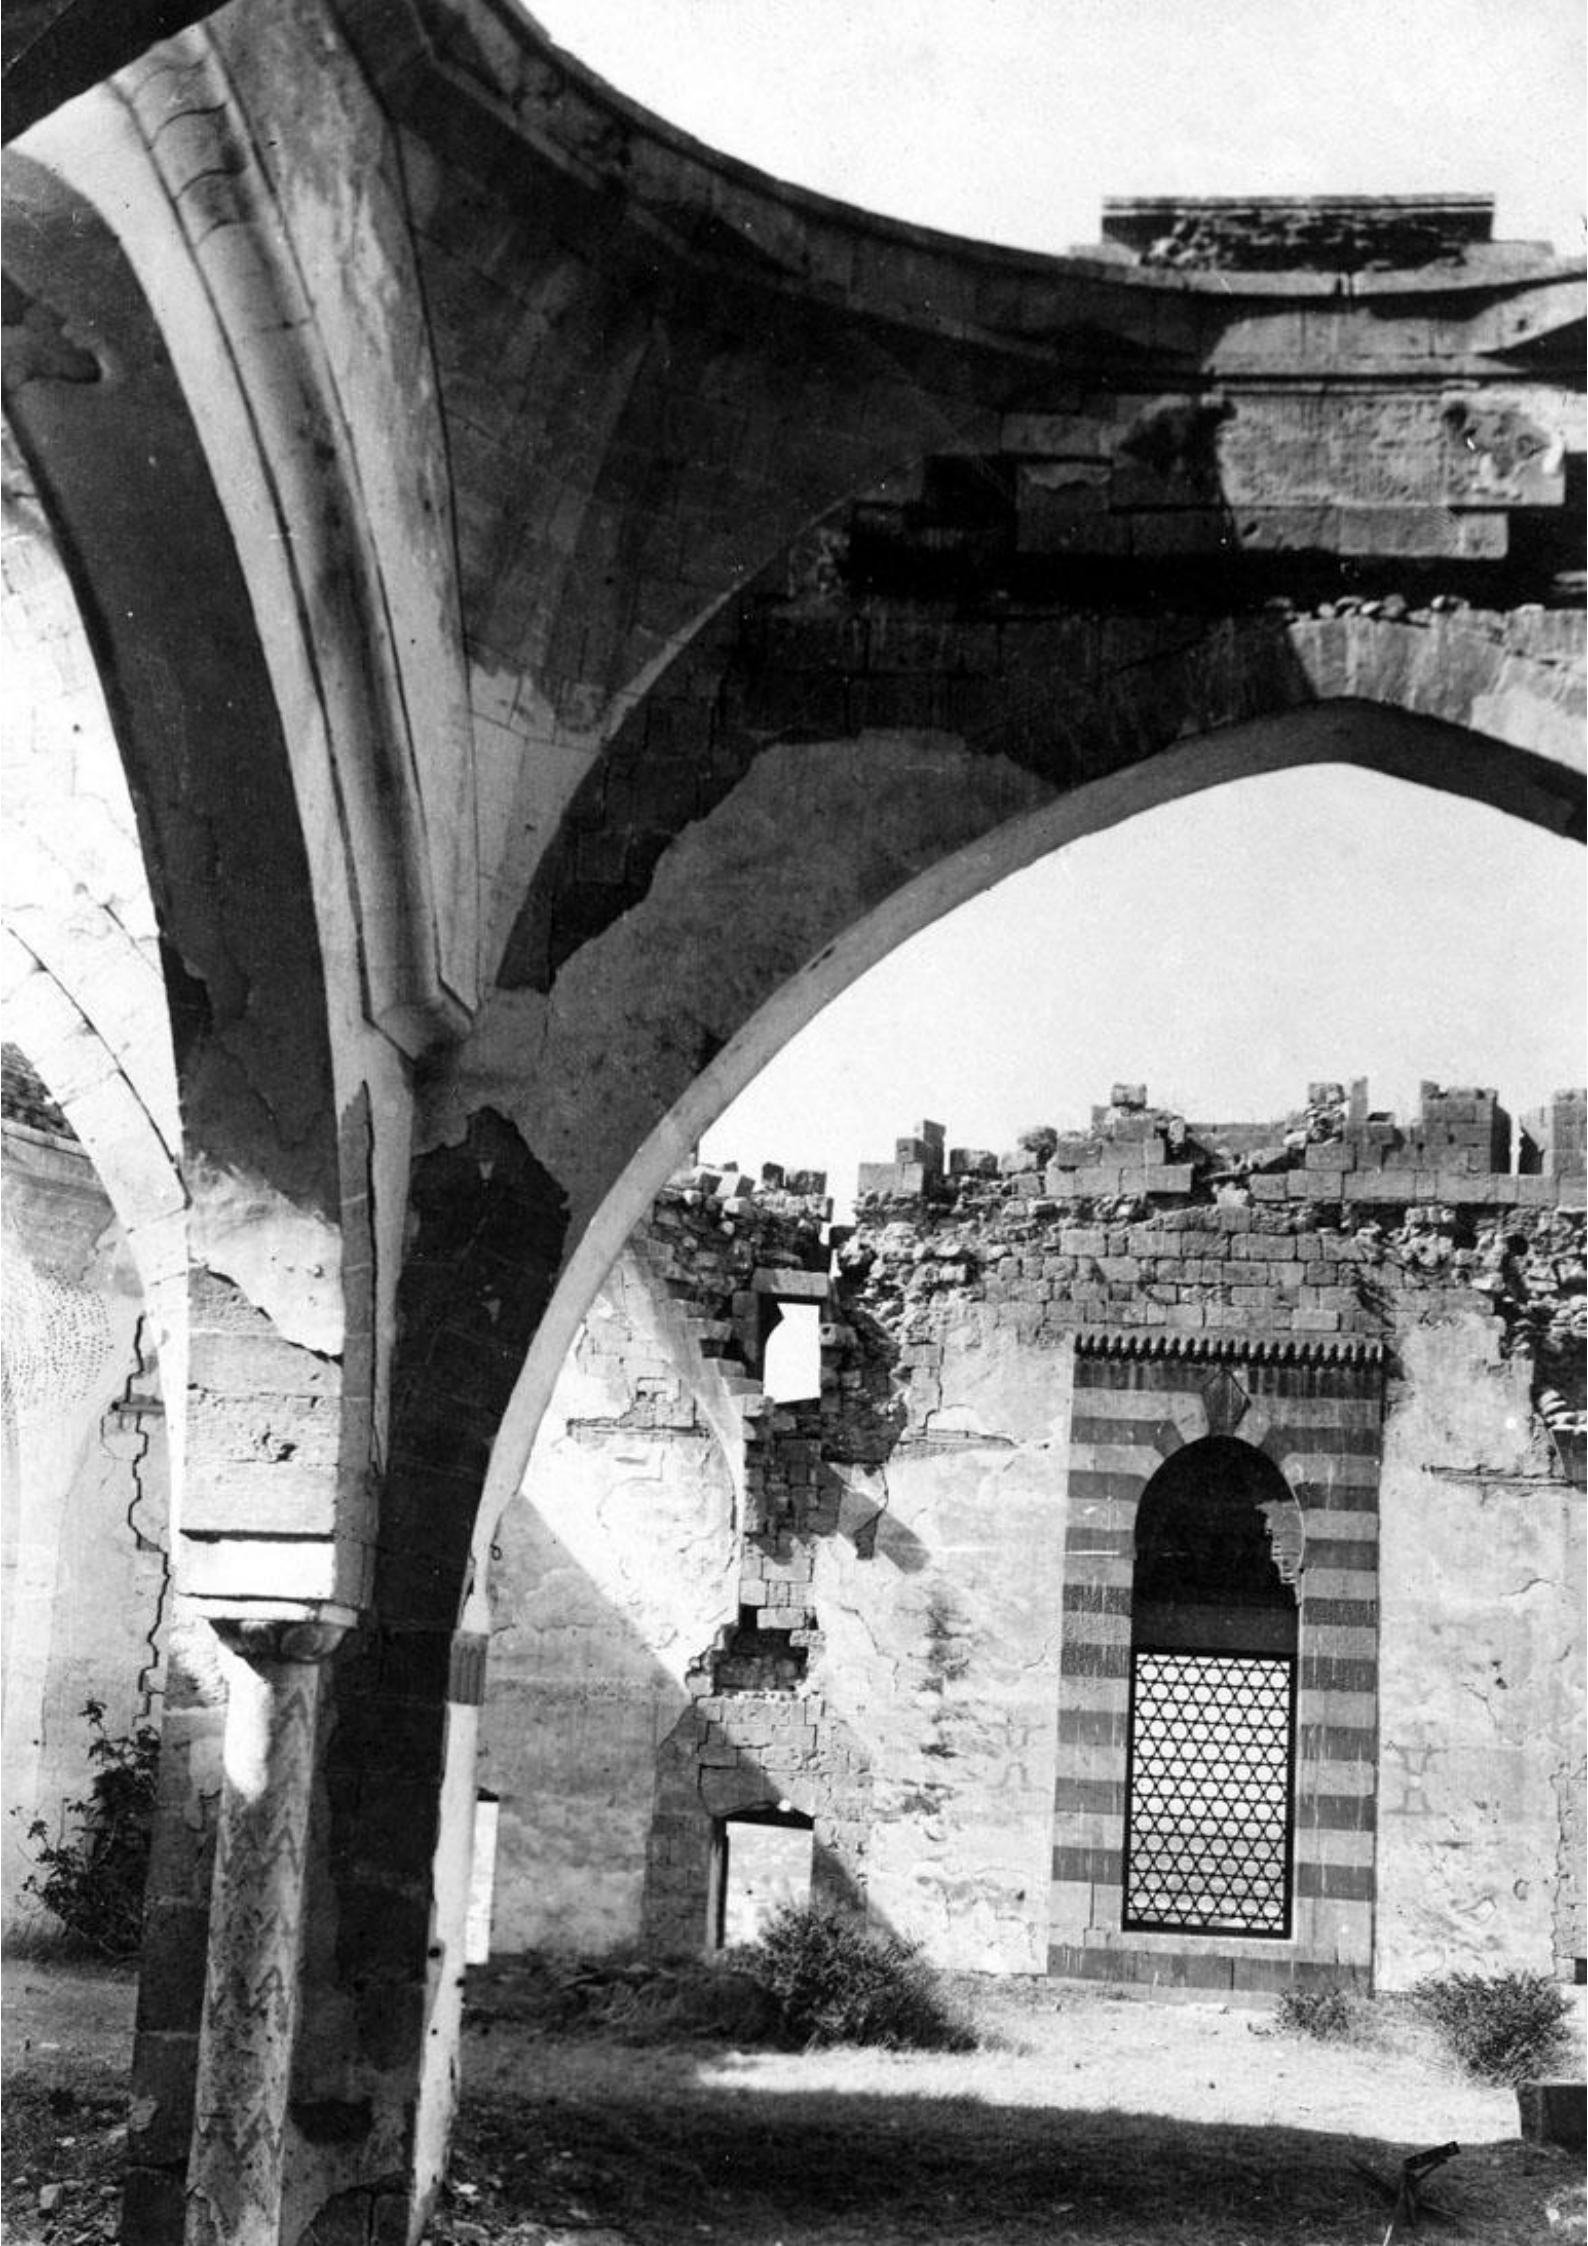
Figures 47, 48 and 49: Mamluk Palace, Throne Hall before reconstruction. From *Archnet* by Écochard, n.b.

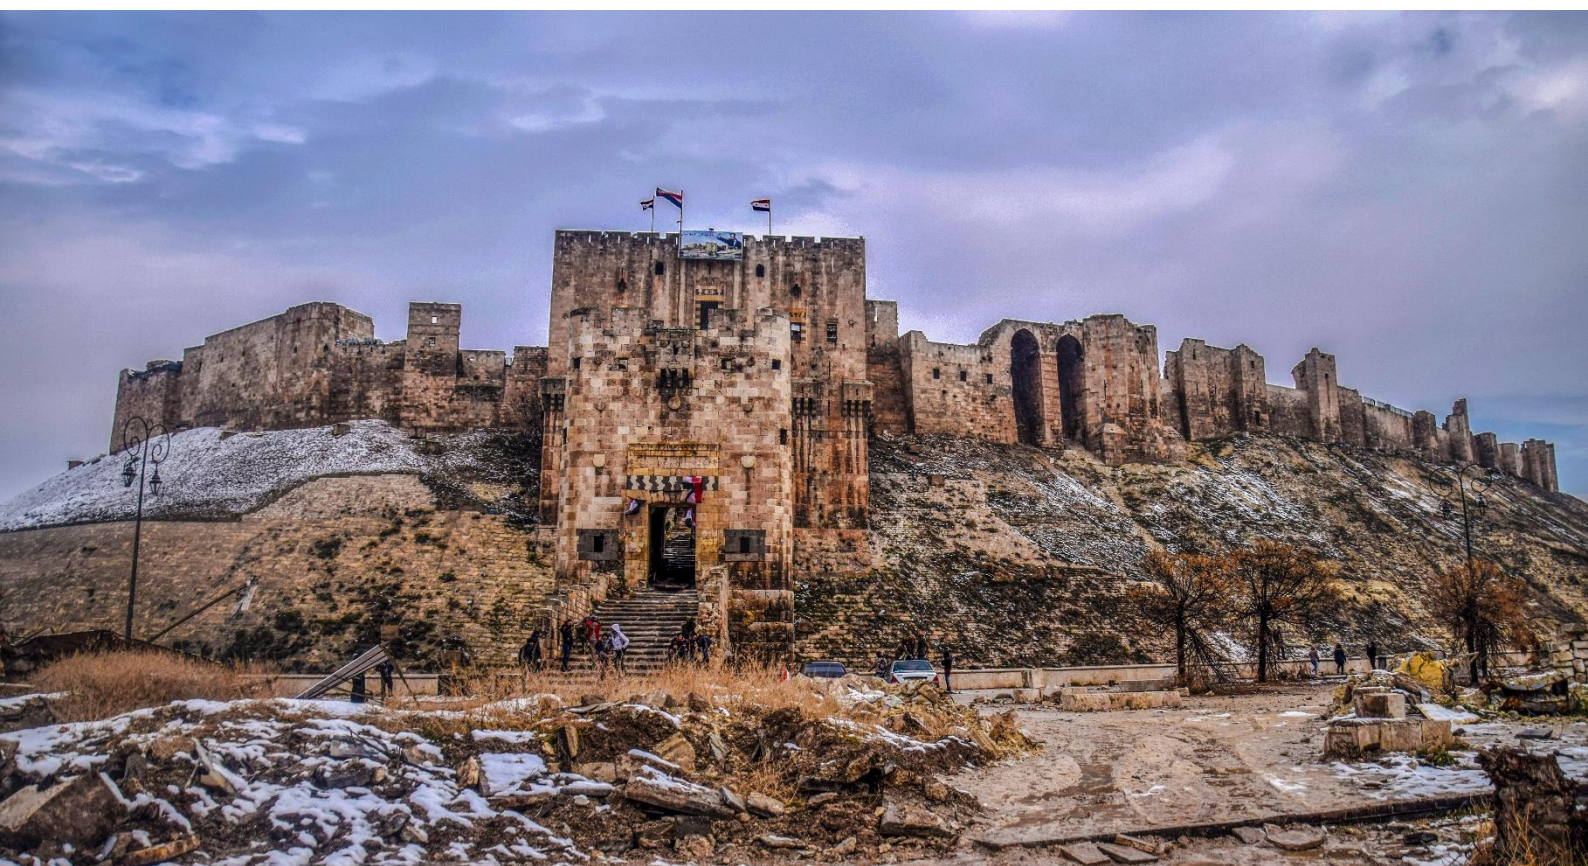
Figure 50: The historic Citadel of Aleppo, several days after the liberation of Aleppo, on a snowy day. From *Wikipedia Commons*, by Maghames, 2016.

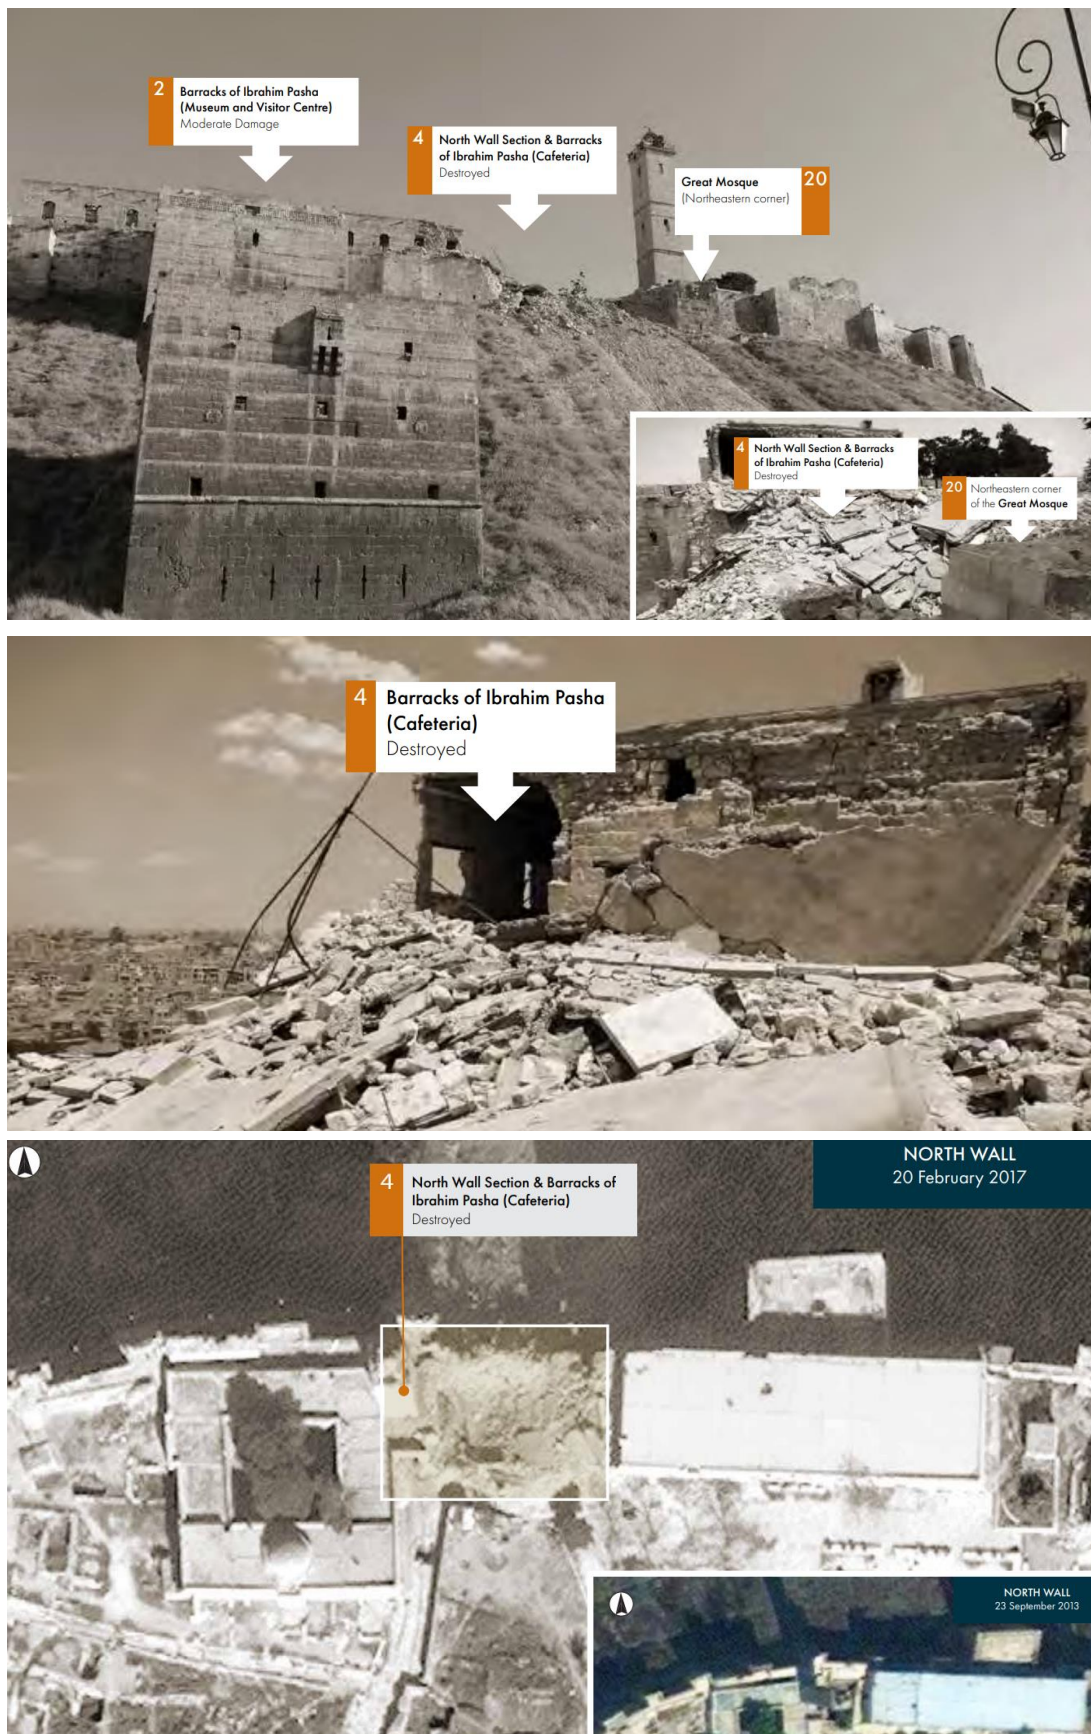
The north wall section and the section of the barracks of Ibrahim Pasha that houses the cafeteria got destroyed. According to UNESCO (2018), the theatre got damaged just slightly at the stage area, and the roof that was constructed in 2005 to protect the excavation of the temple of the storm god collapsed by May 2014. In the figure below a 3D map of the damage assessment is shown, from the same UNESCO analysis and on the next page views and 2D maps of the areas are shown. Later in this section more photographs will be looked at and the reconstruction process will also be discussed as this is a very recent event and the Citadel has not completely been reconstructed yet, even though it is now open to the public. A significant note of destruction in this area is how once again the ring wall, like mentioned earlier in the cycle of destruction and reconstruction of the Citadel, could not escape the damage. On the next page is shown how also the big mosque, a religious building, suffered moderate damage.

Figures 53, 54, 55 and 56: Image previous page: 3D representation of the Citadel with damage points. Top Image: View of the Barracks of Ibrahim Pasha and the North Wall Section. Middle: Barracks of Ibrahim Pasha (Cafeteria section). Bottom: North Wall before and after image. From *Five years of conflict: The state of cultural heritage in the Ancient City of Aleppo* (p.38, 39, 42 and 43) by UNESCO, 2018

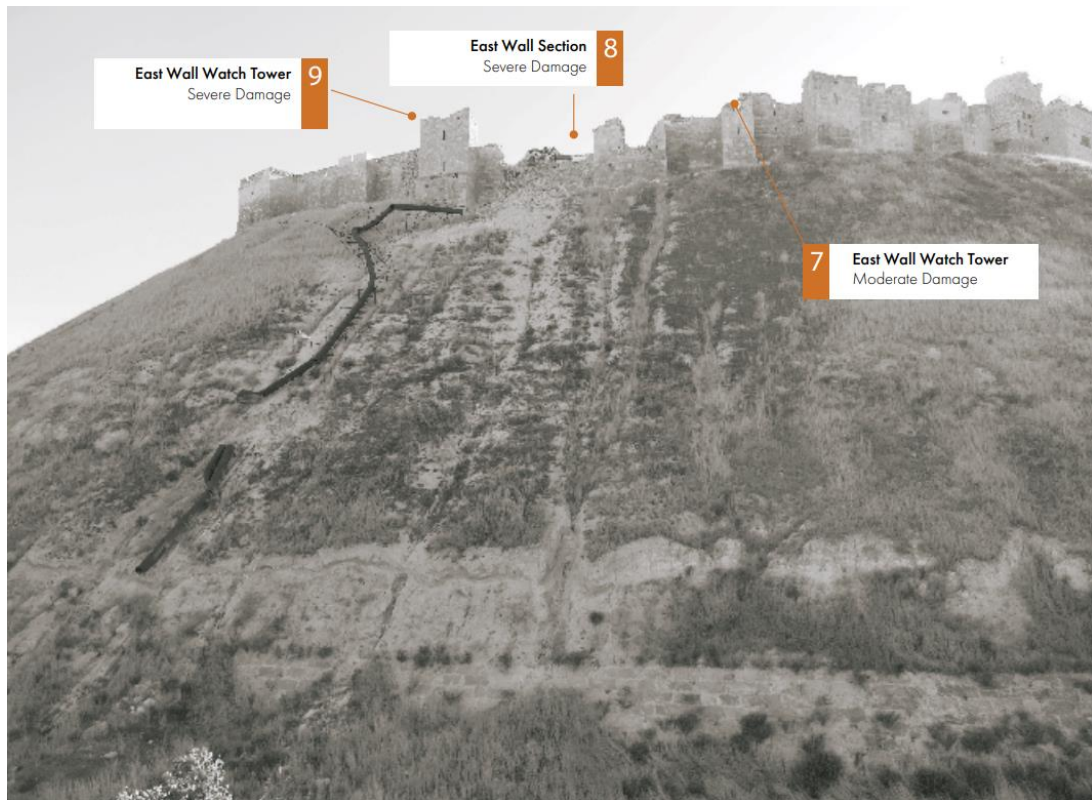
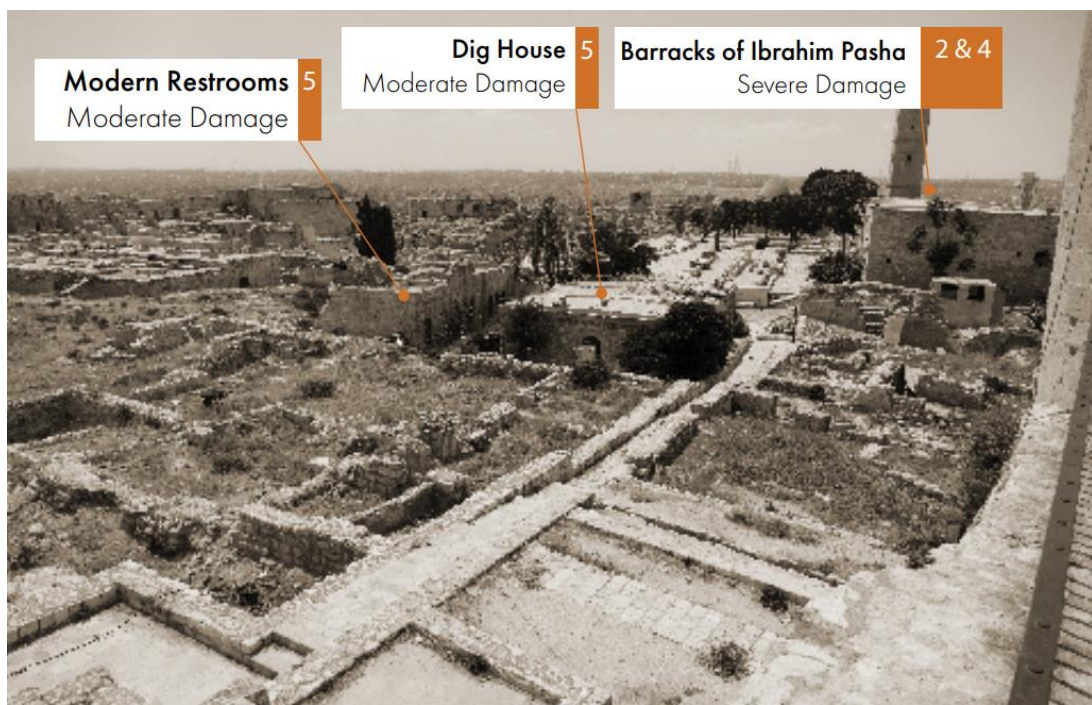
In 2015 a tunnel explosion caused the collapse of part of the ring wall (SANA, 2015). A section of the east wall got severely damaged along with the towers next to it, see figures below. According to UNESCO, a section of ground over the unexcavated area behind the wall has also been severely damaged, it is heavily disturbed and the walls are no longer visible. Mentioned is also that disturbed area covers round 1000 square meters and that there are multiple possible small holes scattered throughout the entire area.

The restrooms in the Citadel have also partially collapsed in the southeast corner and there are holes in the roof (UNESCO, 2018). The opposite building, a dig house for an excavation team in the Citadel, see figure on next page, has also been moderately damaged with holes in the roof and a possible collapse at one end.

Figures 57, 58 and 59: Image previous page: 3D representation of the Citadel with damage points on the east wall area. Top Image: View from outside the Citadel onto the East Wall. Bottom: View from the North Wall looking onto the dig house and the restrooms. From *Five years of conflict: The state of cultural heritage in the Ancient City of Aleppo* (p.44, 45 and 46) by UNESCO, 2018

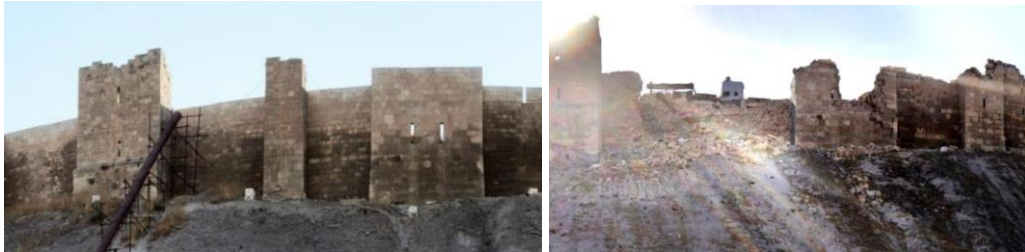
Figure 65a and 65b: Ring wall, before (a) and after destruction (b). From *ALEPPO BEFORE AND AFTER THE WAR 2010 – 2018*, (p. 451) by Fangi, 2019

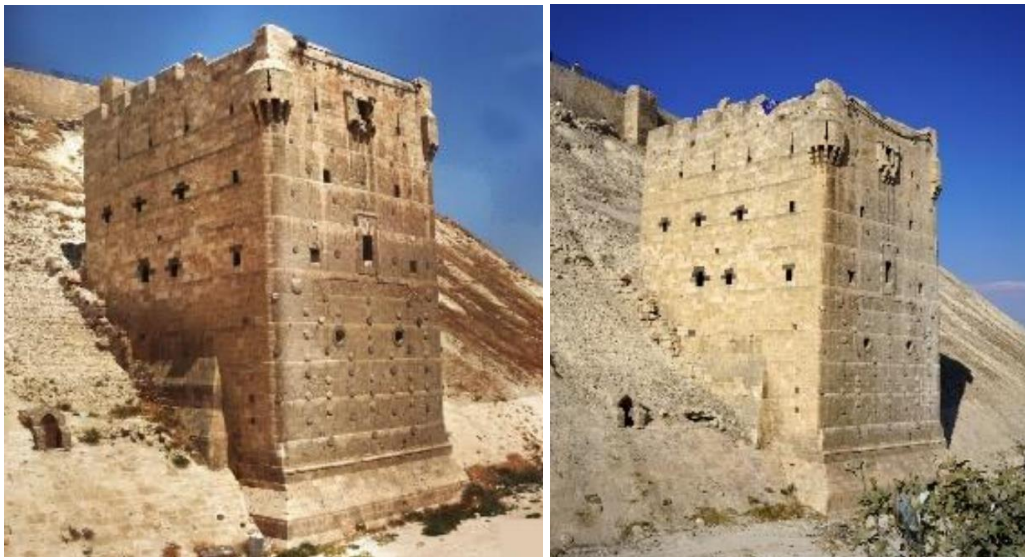
Figures 66a and 66b: Southern tower, before (a) and after destruction (b). From *ALEPPO BEFORE AND AFTER THE WAR 2010 – 2018*, (p. 452) by Fangi, 2019

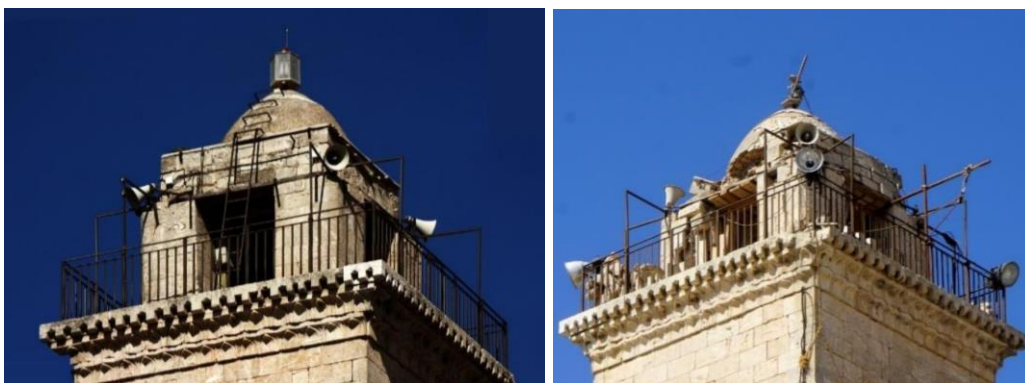
Figures 67a and 67b: Minaret of the big mosque, before (a) and after destruction (b). From *ALEPPO BEFORE AND AFTER THE WAR 2010 – 2018*, (p. 452) by Fangi, 2019

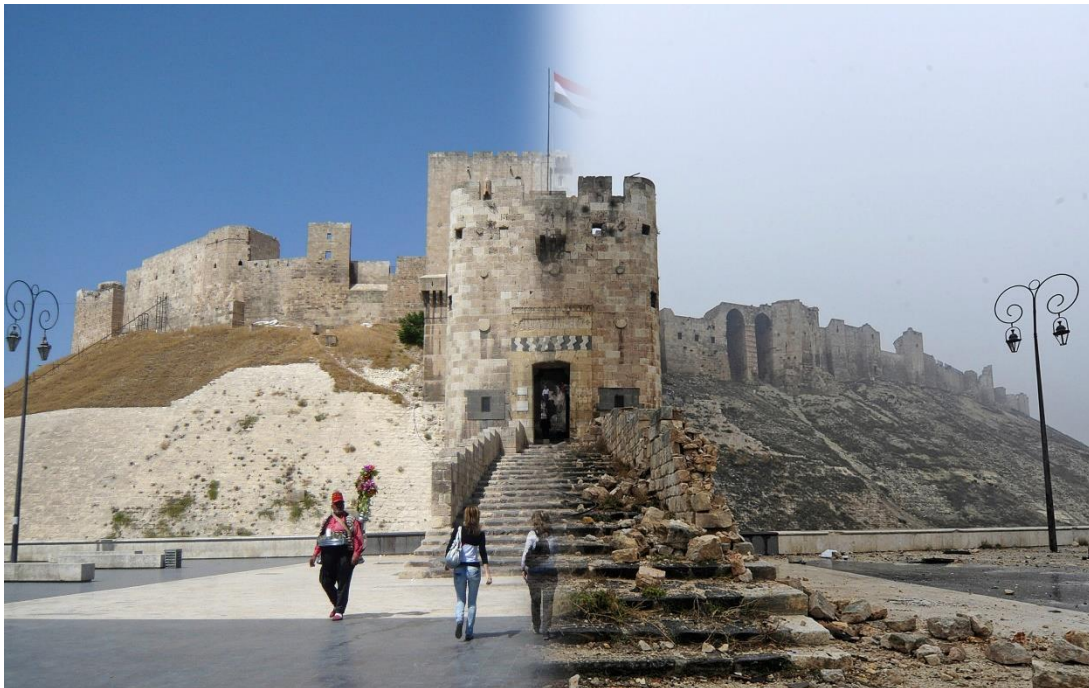
Figure 68: Rephotograph of the entrance of the Citadel, before and after the war. From *Reuters* by Auger (left), 2010 and Sanadiki (right), 2016

In this next part, shortly, photographs showing the impact of this historic event will be examined. Starting with the entrance complex, in the figures below the destruction caused by the war is visible. The two images can be compared. The first thing to be noticed is all the holes in the complex, which is the evidence of use of the various weapons. The second thing to be noticed is how all the windows are destroyed along with the stones surrounding the windows, which again shows how the soldiers inside were targeted as they were behind the windows. Furthermore heavy damage can be noticed at the second from left machicolation. There is also some damage to the top of the complex and to the inscription band. Considering the historical context of the destruction, it is, for example, not likely that the machicolation got destroyed on purpose, as these parts of the Citadel were more of use in the medieval ages in which stones or other things, such as boiling water, quicklime or boiling cooking oil, could be dropped on attackers. In the modern era different kinds of weapons are used so the destruction of the machicolation is historically ironic but not of much gain to the attacker in this era.

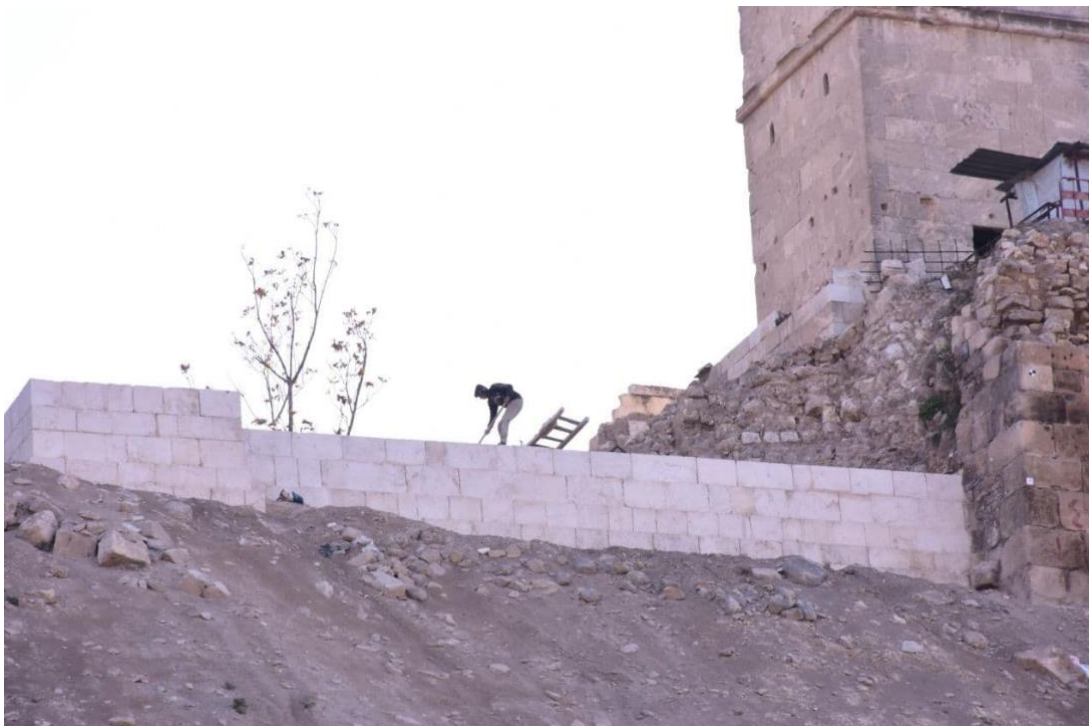
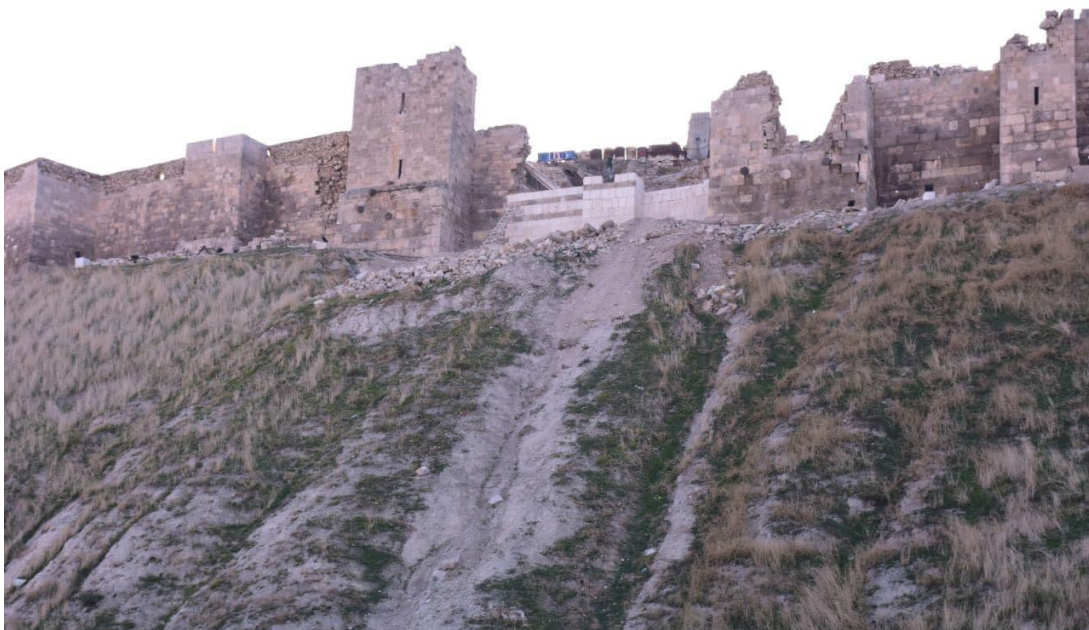
Figures 69 and 70: Restoration of the north wall. From *Al-Jamahir*, by Basmaji, 2020

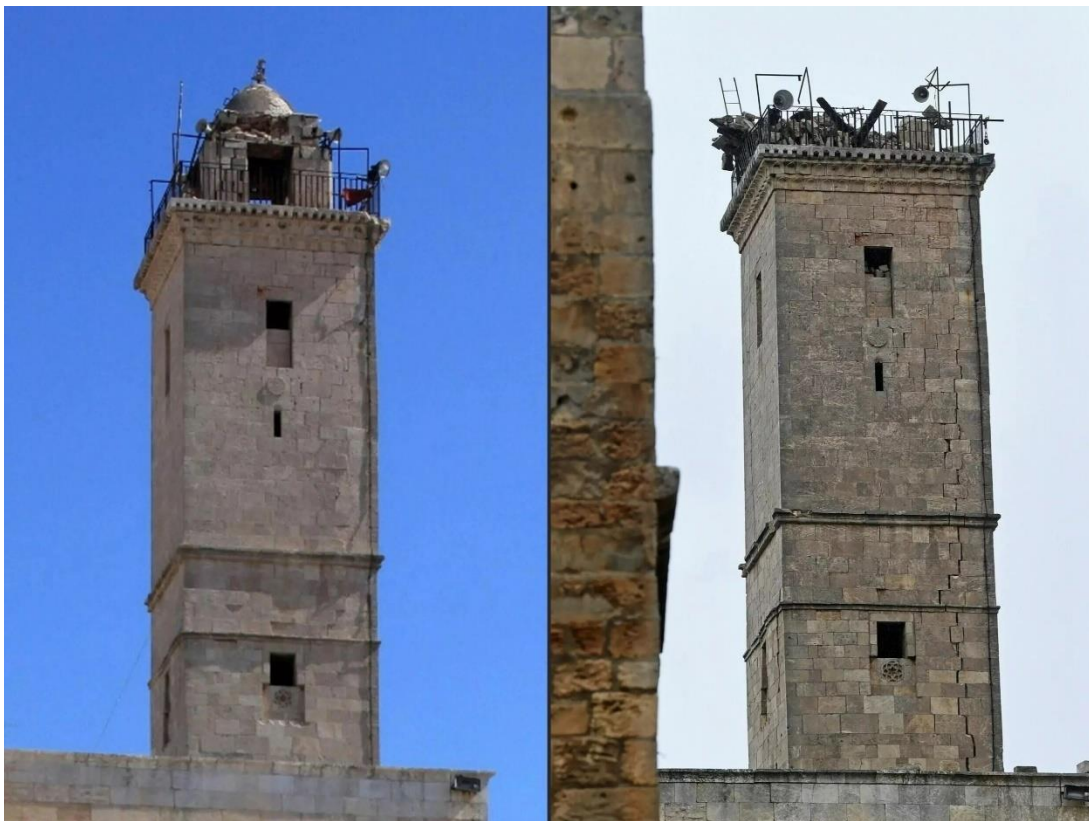
Figure 71: The minaret of the mosque before and after the earthquake. From *France24*, by AFP, 2023
