The Destruction and Reconstruction of Aleppo's Citadel

A Historical Analysis

Architectural History Thesis

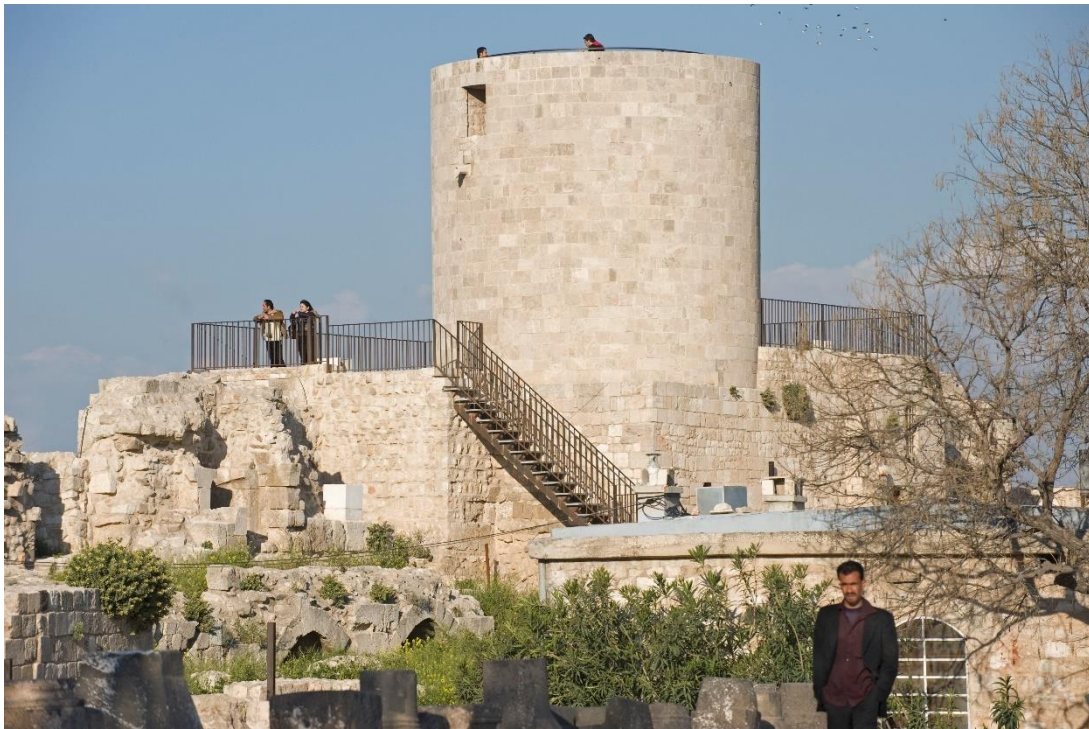
Figure 72: Ottoman mill before the earthquake. From *Wikipedia Commons*, by Osseman, 2009

Another part mentioned is the Ottoman Mill. In the figures below is shown how this looked like before and after the earthquake. A big part has collapsed; the walls that covered the staircase collapsed and the indoor staircase is visible. The rubble from the collapsed building covers the whole ground. It also seems that fences and the outside staircase have collapsed too. This is probably not because of the earthquake directly, but could be because of all the heavy blocks falling, as steel structures are earthquake resistant. This does not work here as the steel is connected to the natural stone of which the structure is not earthquake resistant. Notice how the inside staircase is still intact.

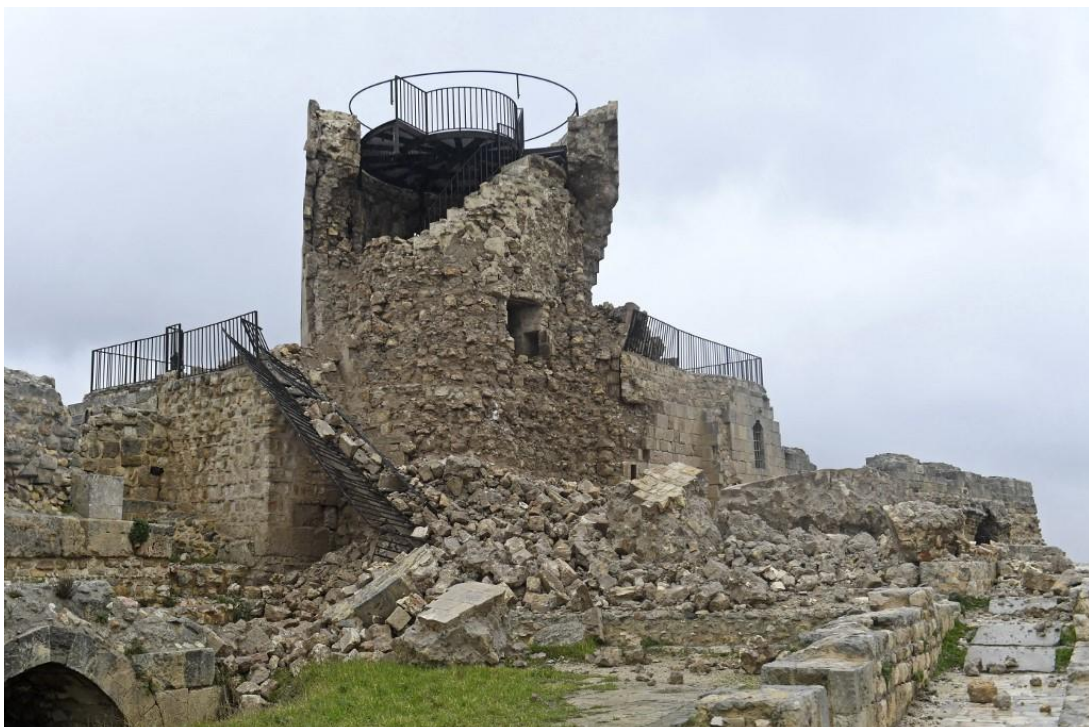
Figure 73: Ottoman mill after the earthquake. From *Ancient Origins*, by Syria's DGAM, 2023

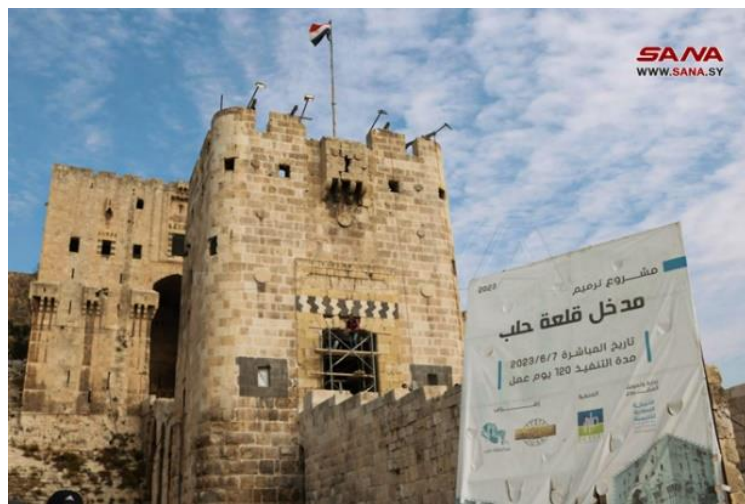
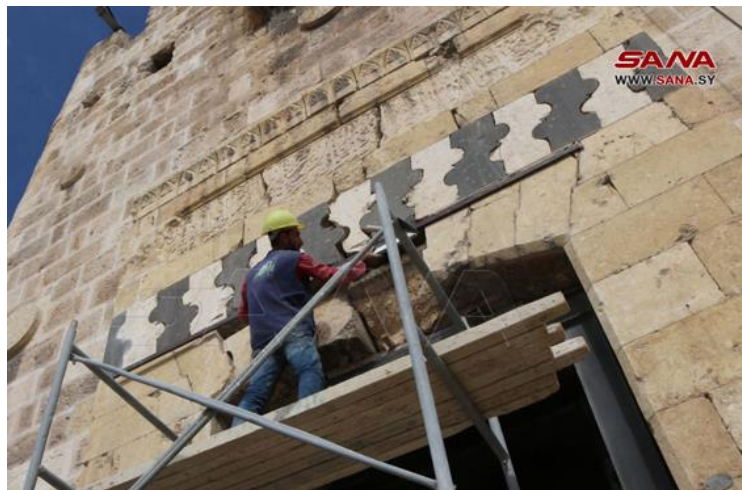
Figure 74 and 75: Restoration of the bridge tower. From SANA, by SANA, 2023

On February 17, 2024, Ministry of Culture stated that Aleppo Citadel has reopened its doors after the completion of the first and second phase of the restoration of the bridge tower (Qreima, 2024). The ministry also said in that same statement that maintenance and reconstruction work for the rest of the parts inside the Citadel will begin soon.
