AR3AH105 Vacant Heritage Studio  
P5 Presentation - 05/07/2021

# Revitalize V&D Haarlem into a new Hub

Rinus Bernabela  
4597850

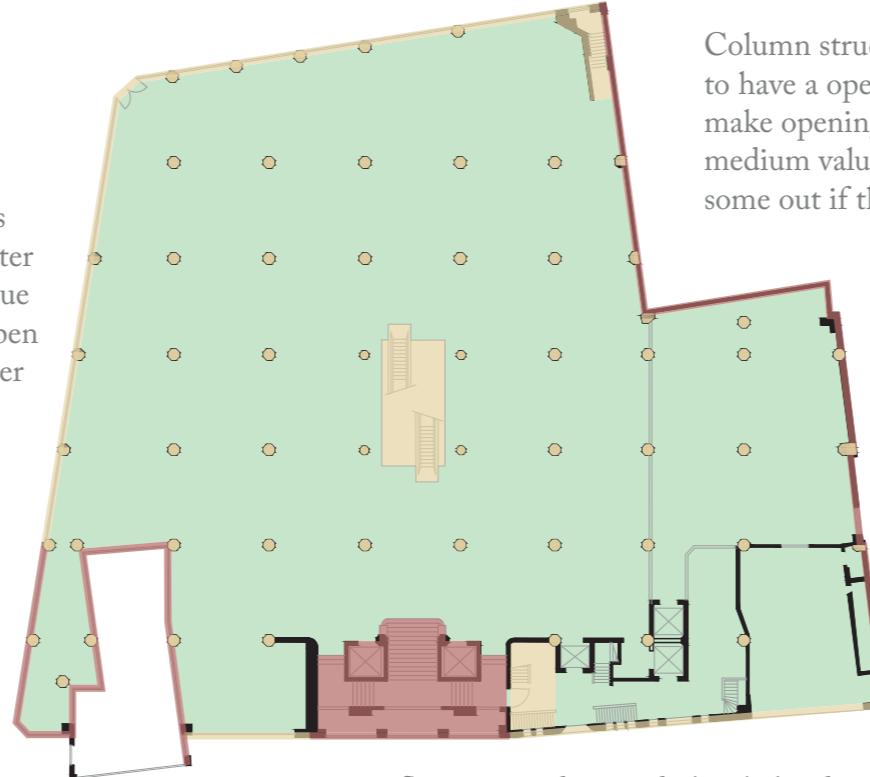
Escalators are typological elements of the retail function, but were a later addition in the 60s, so medium value its not original and it blocks the open feeling and visual contact with other floors.

Column structure allows the building to have an open plan and allows to make openings in the floor-slabs. So medium valueable, possible to take some out if the design requires it.

Staircase and stained glass behind are of high architectural value, have been heavily blocked and hidden over time so the escalators have the role. High value due to originality and art value.

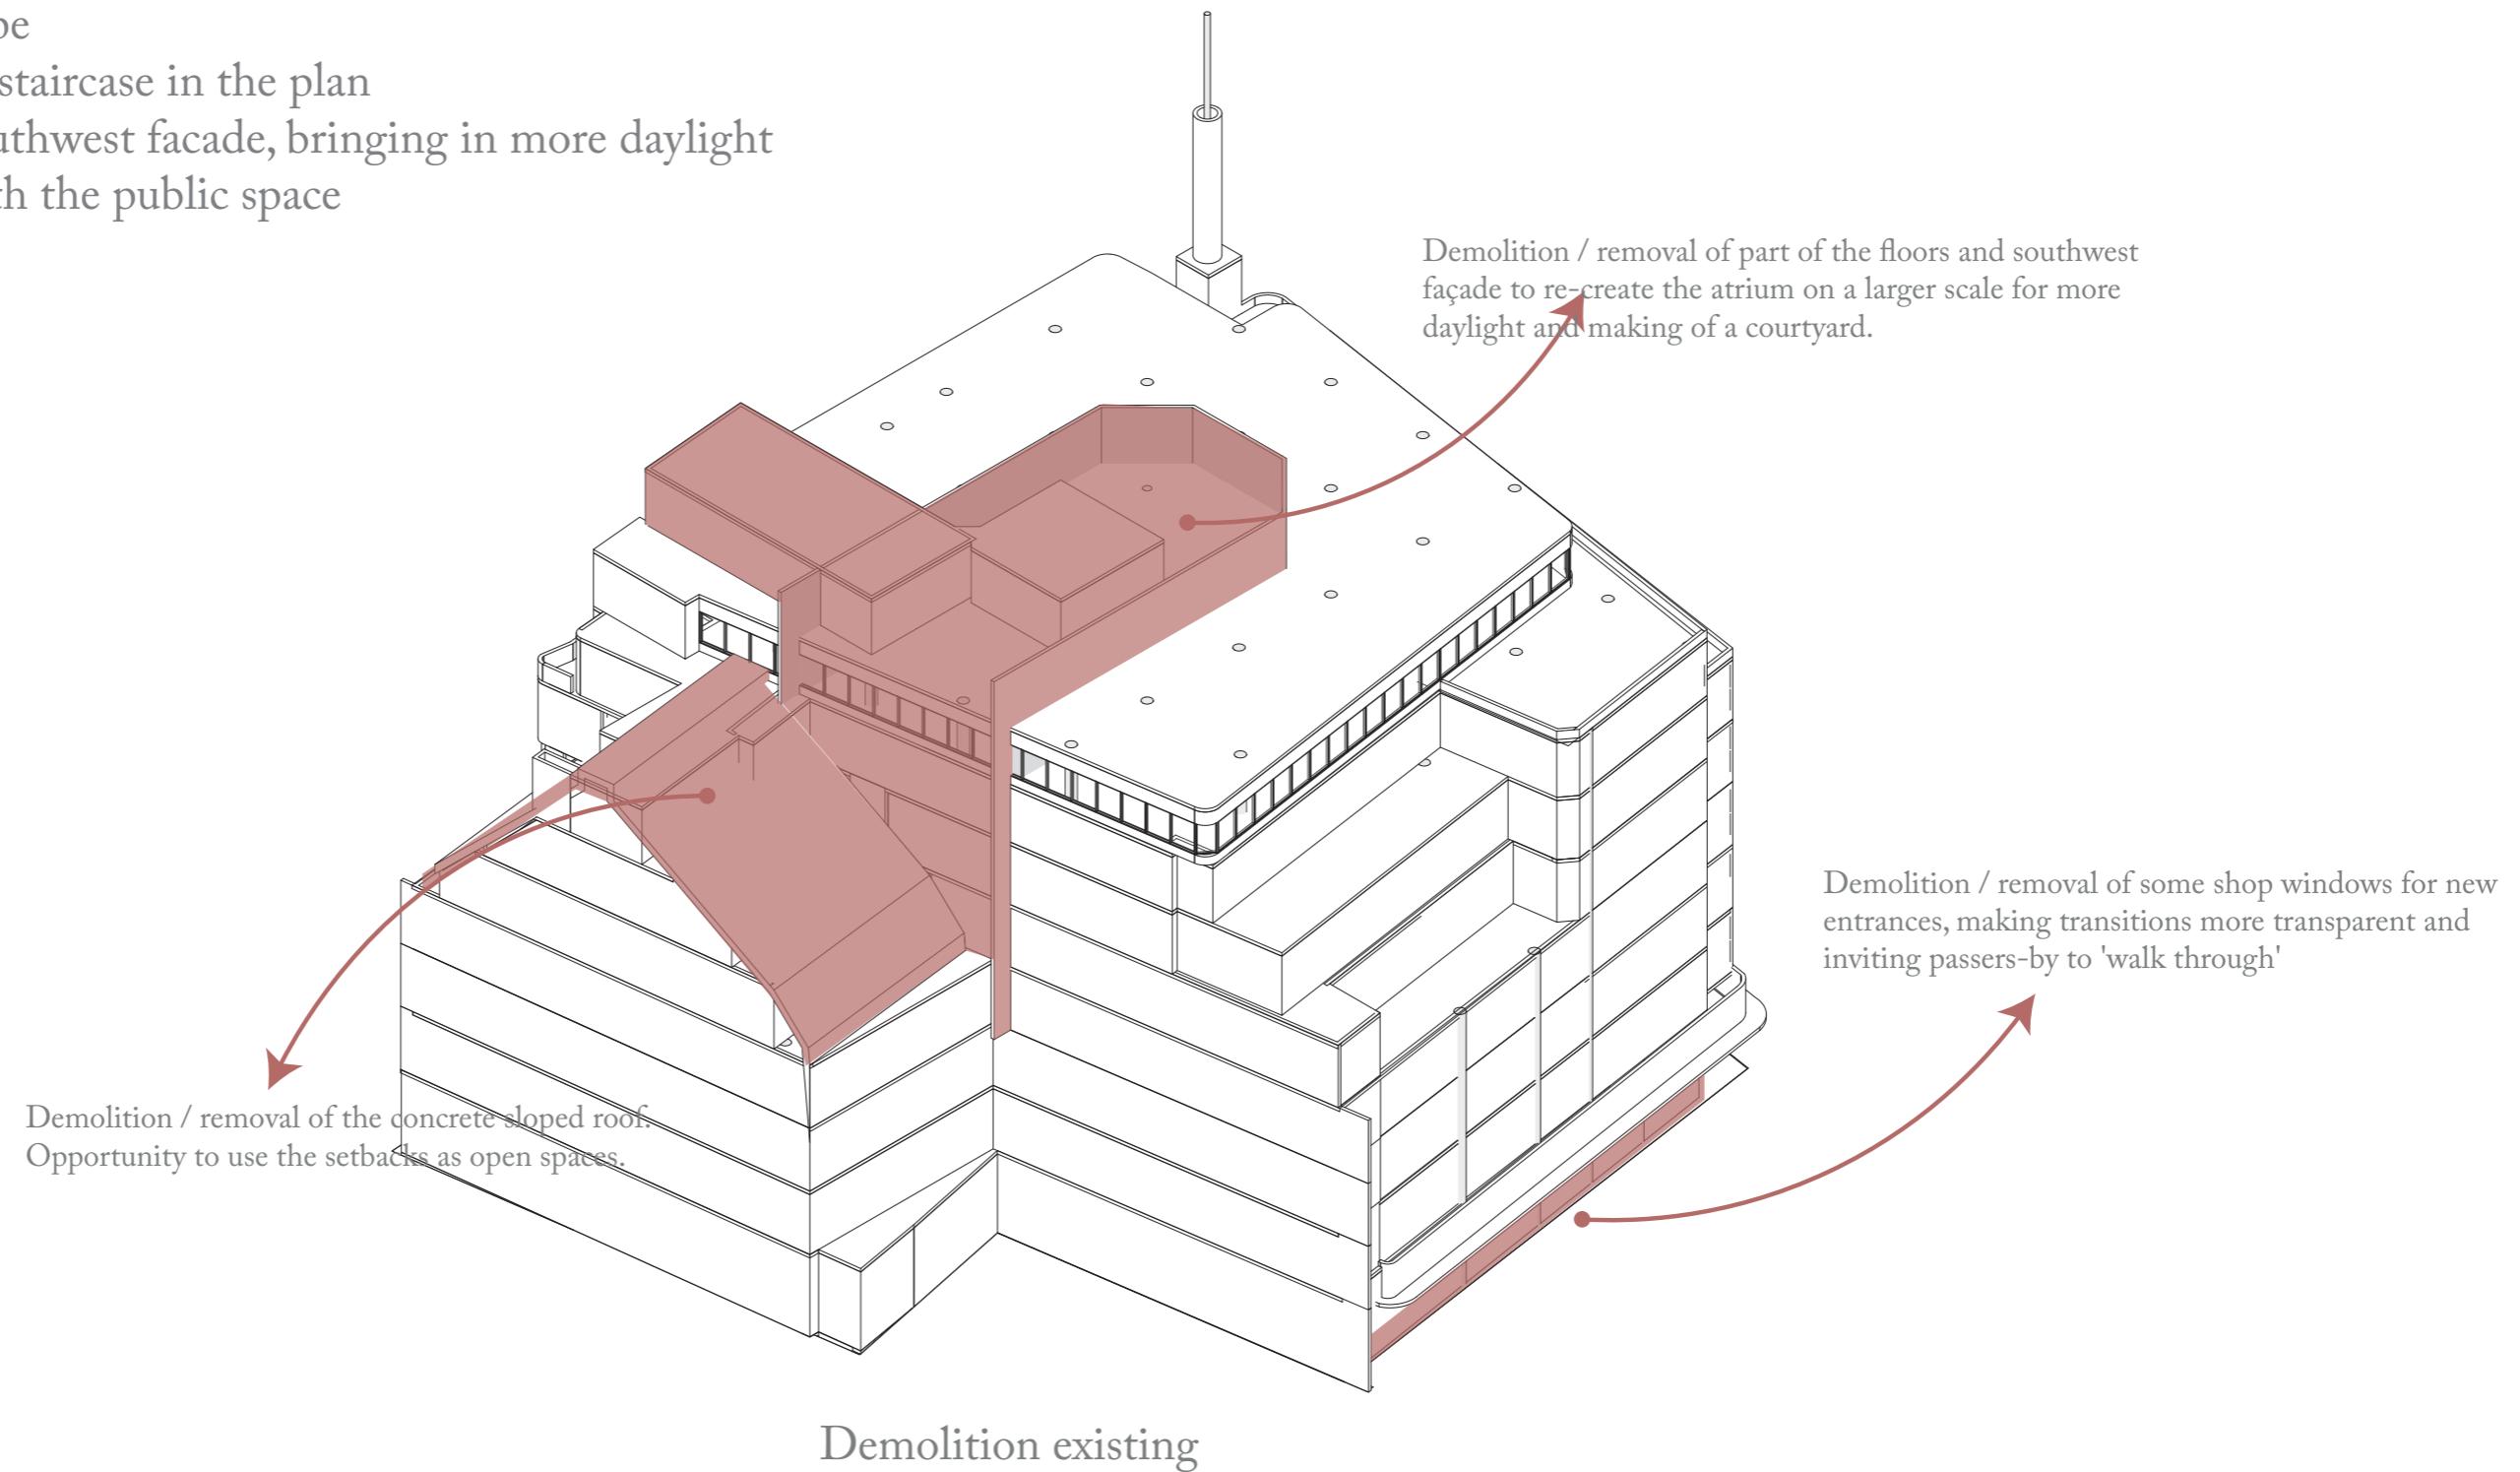
## Transformation Framework - Interventions

- Restoration of the octagonal atrium
- Removal of the escalators, visual view of other floors
- Remove the roof slope
- Reconnect the main staircase in the plan
- Reopening of the southwest facade, bringing in more daylight
- More connection with the public space
