Towards Cost Benefit Analysis of Measures to Improve Structural Safety

to obtain the degree of Master of Science
at the Delft University of Technology,
to be defended publicly on 17 August 2018 at 10.00

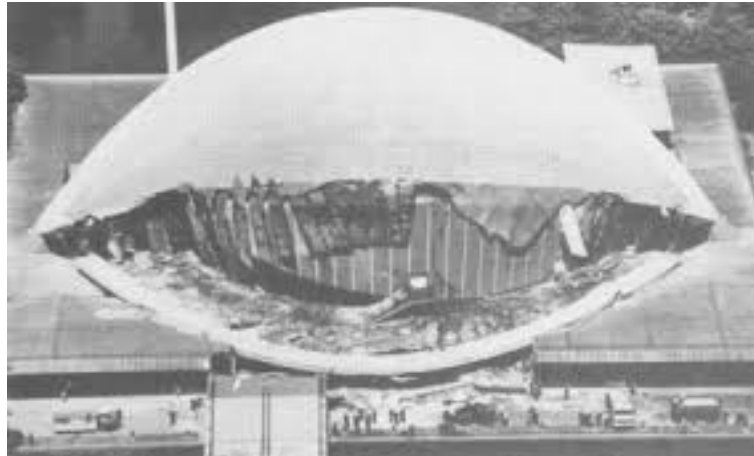
Figure 4.1: Roof collapse of Berlin Congress Hall [31]

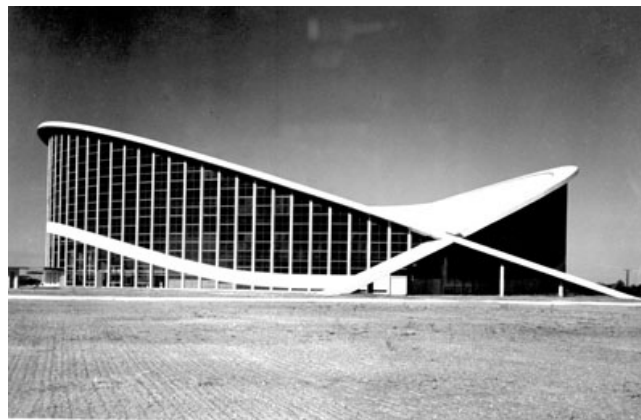
Figure 4.2: J. S. Dorton Arena. (credit: www.ou.edu)

The congress hall was constructed out of hyperbolic paraboloid (hypar shell) made from pre-stressed concrete structure [76]. The structural system of this building was slightly different than J. S. Dorton Arena. In J. S. Dorton Arena, the two slanted concrete hyperboloid roof decks are supported by curves lie on base supports. The hypar shell is loaded in compression, and the facade supported by vertical columns is loaded in tension.

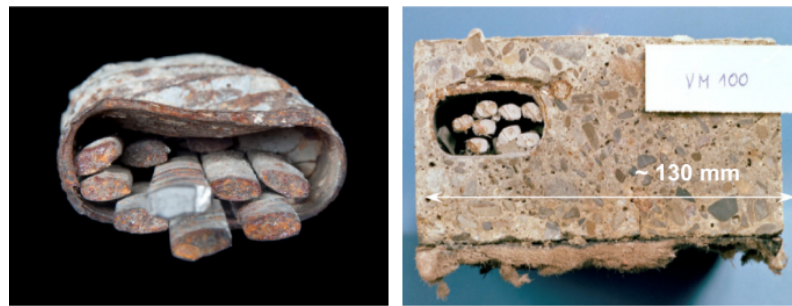
Figure 4.3: Poor workmanship of pre-stressed tendons [31]

Shell structure should be loaded only in compression, but in this case, it also took the tensile stress. Cracks were formed and subsequently allowing moisture to intrude the concrete matrix. A fountain under the southern deck was suspected as the source of humidity [76]. The concrete cover depth of the failed part was only 2cm was insufficient to prevent corrosion. At the time of construction (1957), the requirements for reduced corrosion-inducing and advancing components, as chlorides, in the concrete mass did not exist. For some specimens, chloride content tested in 1980 was exceeding the current (2014) limit [31].

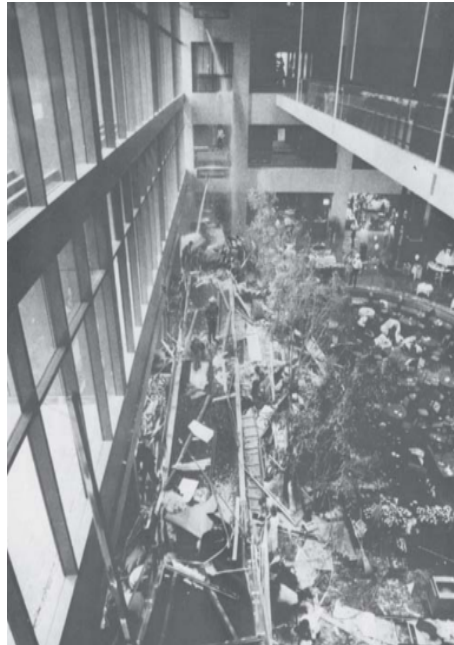
Figure 4.4: Hyatt regency walkways collapse [46]

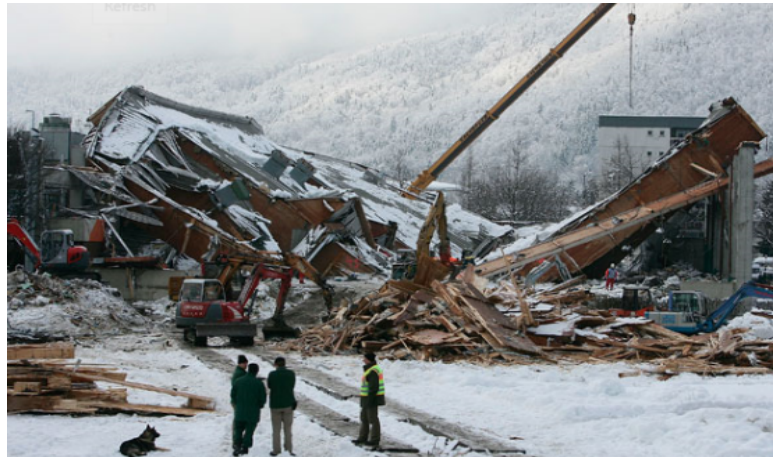
Figure 4.6: Collapse of the ice skating arena in Bad Reichenhall. Credit: www.calgaryherald.com

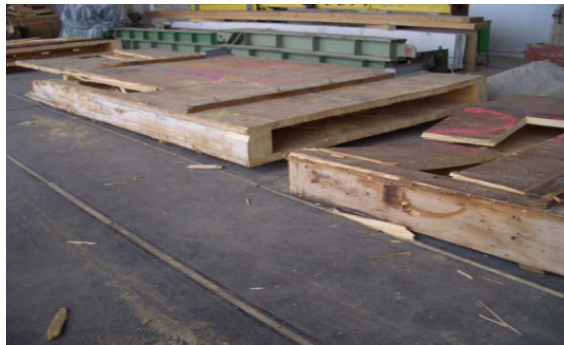
Figure 4.7: Box girder components of the ice skating roof [82]

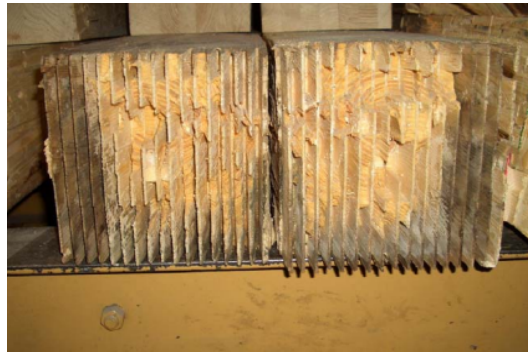
Figure 4.8: Damaged glue laminated box girder [82]

Series of investigations performed by TU Munich and TUV Sud proved that snow was not the cause of failure. The maximum snow load of 1.5kNm^{-2} applied in the static calculation was not exceeded at the time of the accident [82].

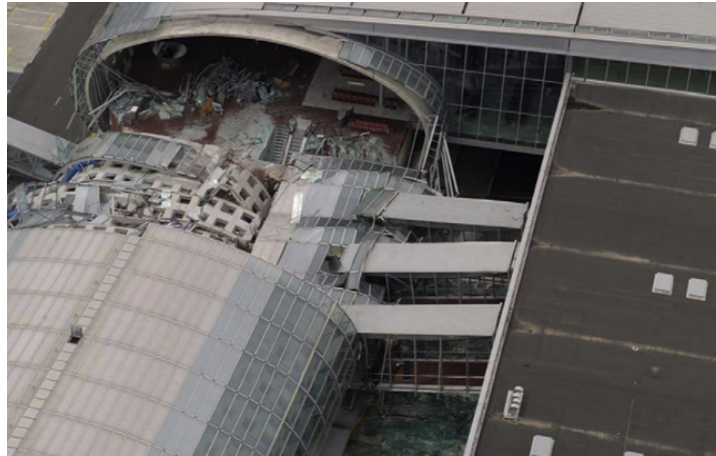
Figure 4.9: Collapse of Terminal 2E Charles de Gaulle Airport [60]

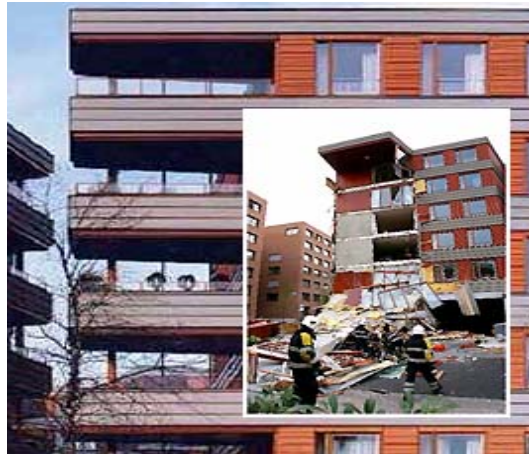
Figure 4.12: Collapse of the balconies of the Patio Sevilla apartment. Credit: www.architectenwerk.nl

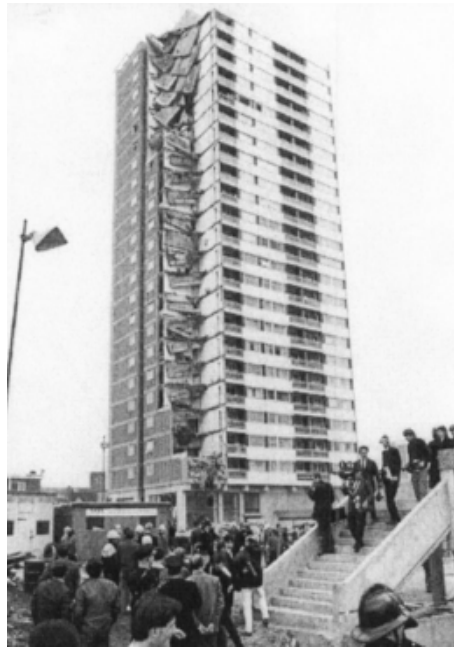
Figure 4.20: The collapse of Ronan Point apartment [11]

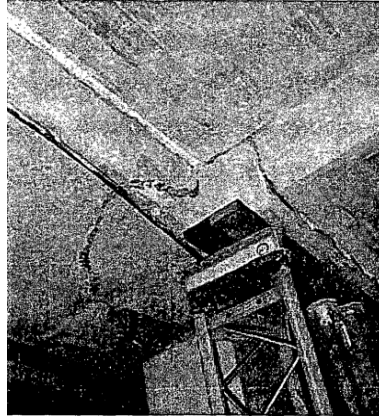
Figure 4.24: Structural failure of the parking lot [27]

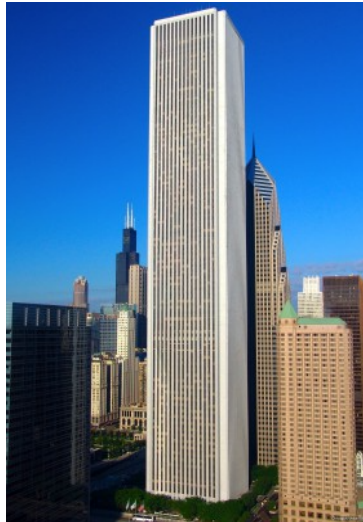
Figure 4.25: Amoco Tower in Chicago suffered from façade problem. Credit: Chicago Architecture Info

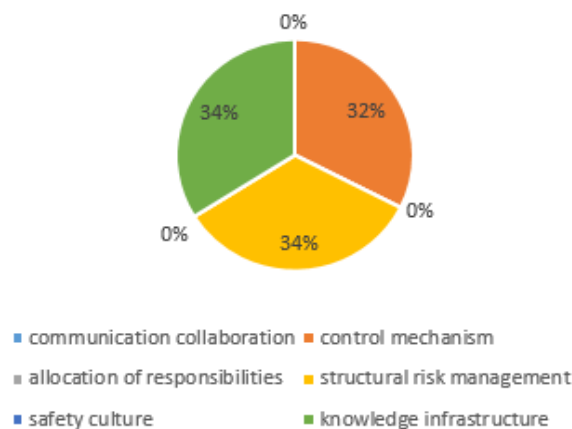
Three factors became the issue in the case of ice arena in Bad Reichenhall: Control mechanism (F2); Structural risk management (F4); and Knowledge Infrastructure (F6). The contribution of the critical factors (α_f) is calculated using Equation 3.6.

Figure B.3: Weight of factor in Case 3: Ice Skating Arena

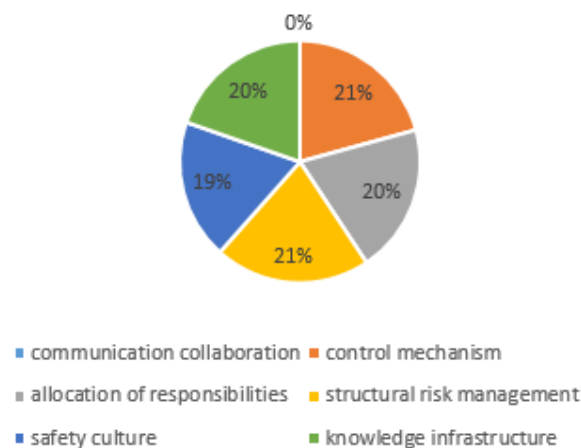
Five factors became the issue in the case of Hartford Civic Centre: Control mechanism (F2); Allocation of responsibilities (F3); Structural risk management (F4); Safety Culture (F5); and Knowledge Infrastructure (F6). The contribution of the critical factors (α_f) is calculated using Equation 3.6.

Figure B.6: Weight of factor in Case 6: Hartford Civic Centre

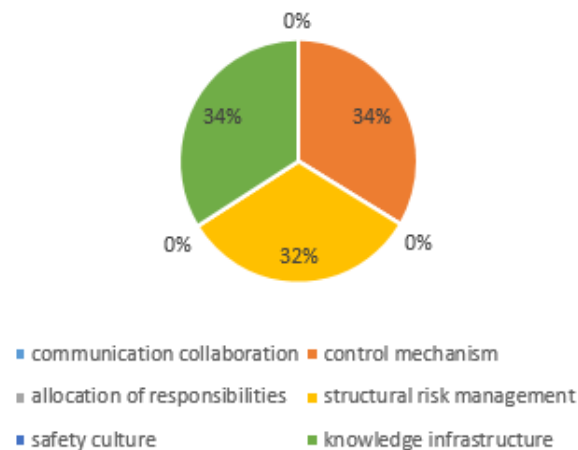
Three factors became the issue in the case of Kemper Arena: Control mechanism (F2); Structural risk management (F4); and Knowledge Infrastructure (F6). The contribution of the critical factors (α_i) is calculated using Equation 3.6.

Figure B.7: Weight of factor in Case 7: Kemper Arena

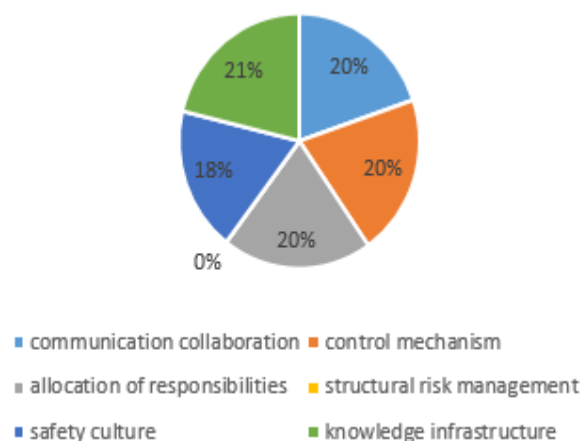
Five factors became the issue in the case of Bos en Lommerplein: Communication and collaboration (F1); Control mechanism (F2); Allocation of responsibilities (F3); Safety Culture (F5); and Knowledge Infrastructure (F6). The contribution of the critical factors (α_f) is calculated using Equation 3.6.

Figure B.9: Weight of factor in Case 9: Bos en Lommerplein
