# Overflow Tests on Grass-Covered Embankments at the Living Lab Hedwige-Prosperpolder: An Overview

**Abstract:** In regions with a temperate climate, a well-maintained grass sod on a clay layer is considered a reliable protection for dams and dikes. In the Living Lab Hedwige-Prosperpolder, on the left bank of the Scheldt river straddling the border between Belgium and the Netherlands, a series of 27 overflow tests with a purpose-built overflow generator has been executed to determine the strength of the protective layer against erosion at various conditions. The goal of this paper is to inform on the executed test program and the initial results. From the results, it was concluded that in general, a high-quality grass cover on the landside dike slope can withstand high overflow discharges well for 12 to 30 h, without severe erosion damage. Anomalies, such as the presence of animal burrows, reed vegetation, and already present deformations can strongly reduce the resistance of the cover layer and may lead to failure within a couple of hours.

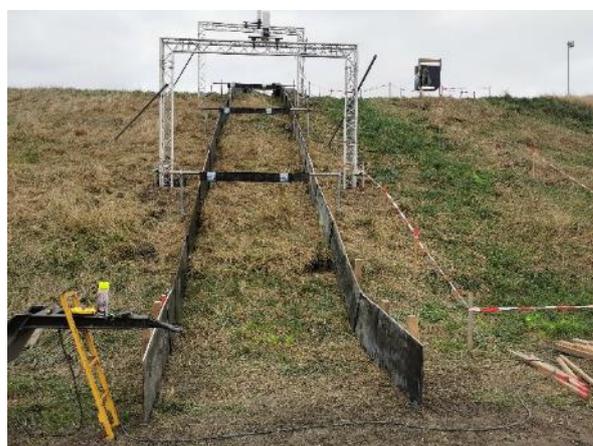
**Figure 2.** Standard setup of an overflow experiment, view from the landside dike toe. Camera and sensor frames are placed across the 2 m wide test section, prior to execution.

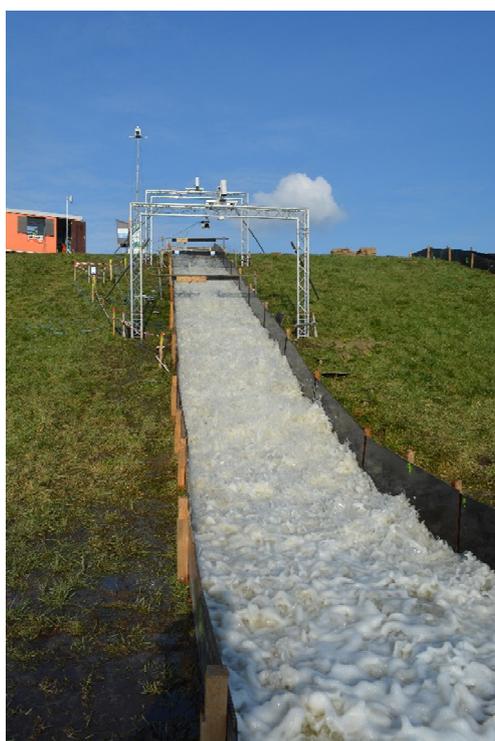
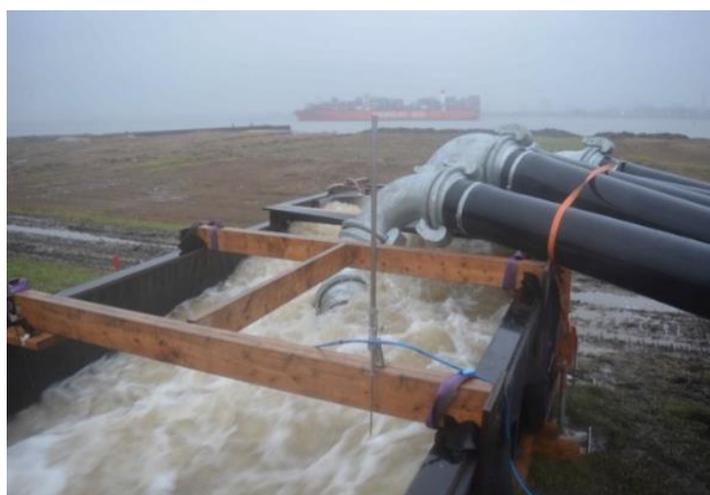
**Figure 3.** (a) Overflow in progress; (b) Overflow generator at maximum discharge of 1100 L/s.

The flow canal used for directing the water flow over the grass cover of the dike was 2 m wide. At the crest of the dike it was connected to the overflow generator. Both sides of the flow canal were made of coated hardboard plates of  $2 \times 0.7 \times 0.01$  m. The plates were hammered and sliced into the ground to a depth varying between 7 and 15 cm deep. The plates were screwed to wooden poles of a size of approximately 0.1–0.1–1.0 m with one pointed end. The poles were hammered into the ground to a depth of approximately 0.2–0.3 m. Figure 3a shows a typical flow canal that was realized on virtually every test section during the overflow experiment. Figure 3b shows the uppermost part at the maximum discharge.

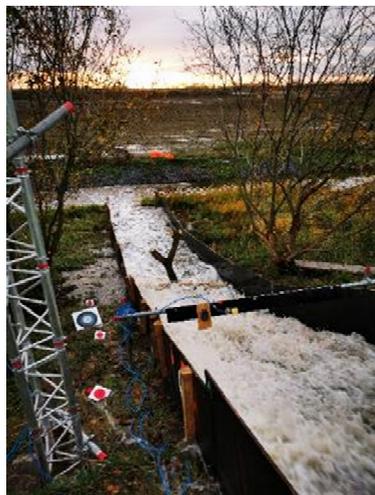
**Figure 4.** Anomaly test section with a tree trunk at the toe of the dike.

1. the presence of a tree at the toe of a dike in the test section (Figure 4);
2. a damaged dike profile at the toe, mimicking damage by animals like grazing sheep;
3. hard structures and transitions on the dike (e.g., concrete staircase).

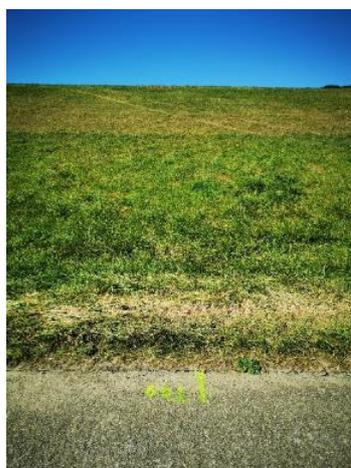
**Figure 6.** Dutch reference test section (September 2020).

The reference tests carried out on an undamaged Dutch dike (see for an impression Figure 6) all had more or less the same proceeding: the test duration could be held for tens of hours (up to 30 h) without any critical damage occurring, despite measured flow velocities ranging from 2 to 4.5 m/s. This result is significantly better than the results collected in [4]. During the proceeding of such tests, it was observed that the density of the grass layer decreased while the grass roots were becoming slightly exhumed (centimetre scale). Due to the ‘jumping’ effect of the water over grass sods, decimetric step structures in the soil profile were observed, but this did not lead to any significant downward or headcut erosion. With increasing discharge, this effect appeared to develop faster and become more prominent.

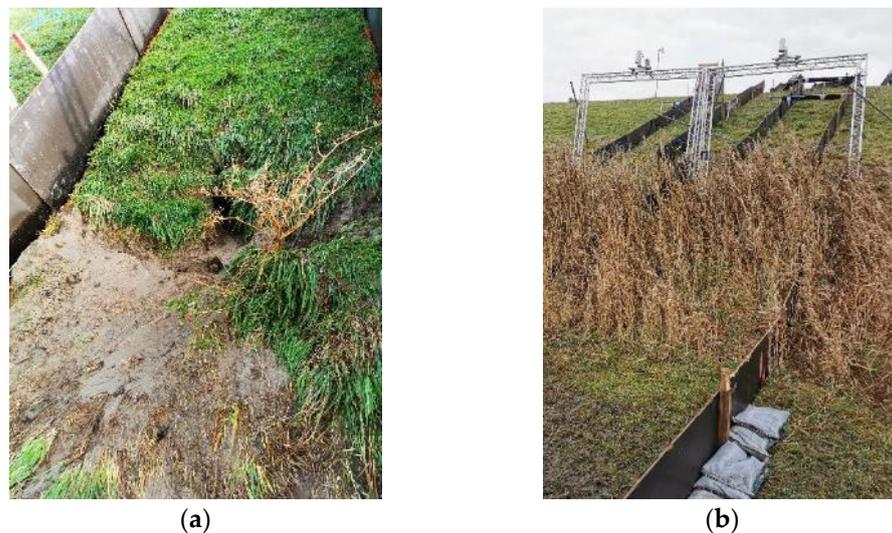
**Figure 8.** (a) Burrow entrance halfway the landside slope on a Dutch dike; (b) Sections with softened, saturated soil and reed overgrowth on a Dutch dike.

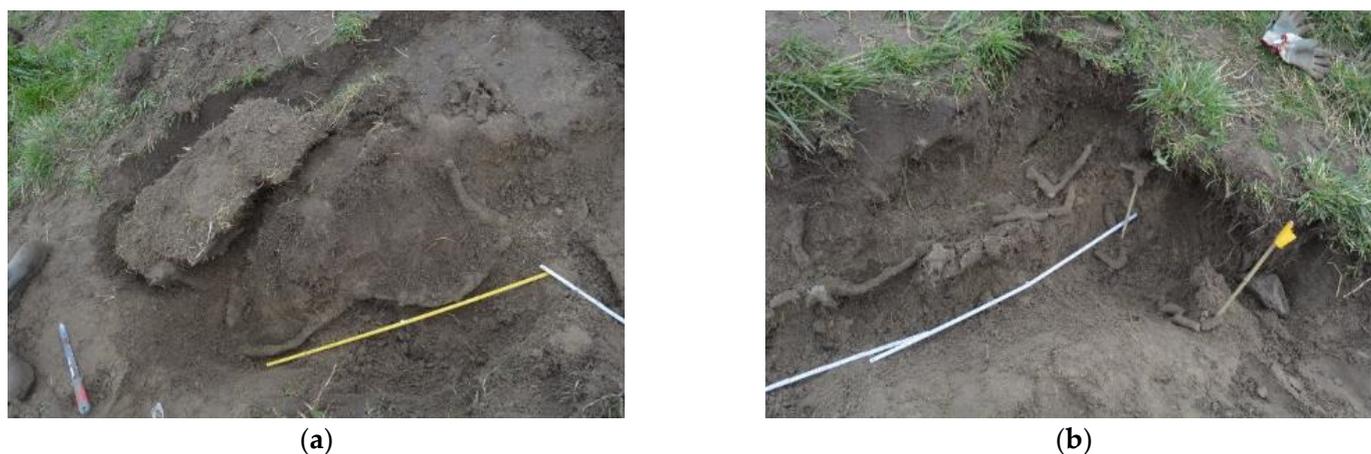
**Figure 10.** (a,b) Examples of excavated grouted animal burrows.

To learn more about the structure, dimensions and depth of animal burrows, some burrow systems were filled with grout and exposed (Figure 10). These activities led to an increased understanding of the processes at hand [16,18]. The critical factor in the damage to develop appears to be whether the burrows are in contact with the sand core and whether sand can be mobilized from within the core and exported to the outside of the dike. The requirements for this seems to be (1) a burrow system that is connected over meters to decameters distances; (2) a burrow system that reaches deep enough so that the dike clay cover is pierced and contact with the sand is made; (3) a flow of water through the burrow system is generated by the overflow process so that core sands are mobilized. Surprisingly, the artificially made holes, supposed to resemble animal burrows, were generally better resistant to flow, even if they were clearly connected to the sand core, with both an entry pipe and an exit pipe. In test B-11 for instance, the artificial hole was the very last part to collapse.

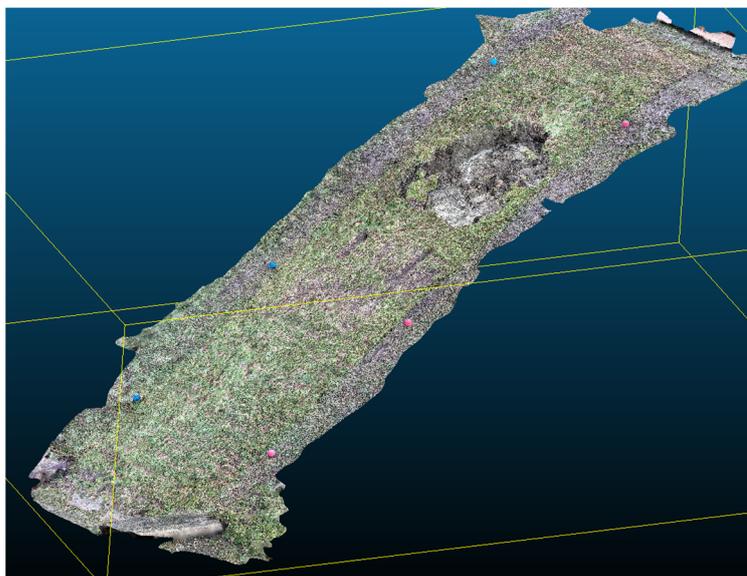
**Figure 11.** Example of a 3D view of the Handheld Lidar point cloud data of a damaged section.

By measuring the same parameter with a variety of techniques the possibility was created to evaluate the effectiveness of different sensors to be applied to field measurements. At discrete moments in time the handheld Lidar system was used to scan the dike surface. The handheld Lidar system consisted of an application on an iPad. The measurements were compared with the output from the 3D laser scans for comparison. Despite the relative

simplistic nature of the handheld LiDAR device, no significant differences were found compared to the 3D laser scans. Therefore, the results appear useful (see Figure 11).
