Nature-friendly banks in the IJssel River - Measurements, analyses and recommendations

NCR DAYS 2022

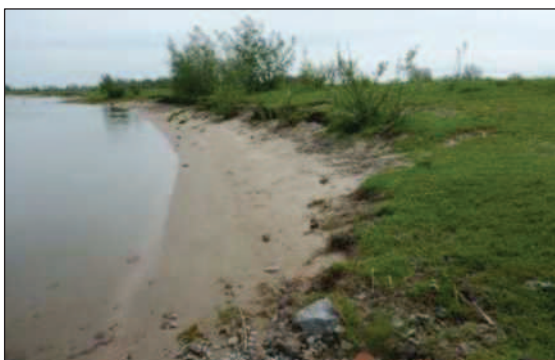
Figure 1. Nature-friendly bank at Welsumer Waarden in 2017, shortly after protection removal and excavation

RWS Oost-Nederland realised 14 new NVOs along the IJssel River in 2016 (e.g. Fig. 1). To prevent too much initial sedimentation in the fairway, the NVOs were pre-excavated during construction, with slopes between 1:10 and 1:3 (Fig. 2). A monitoring programme over 2016–2020 was implemented based on the conceptual model of Baar et al. (2014). The goal of this study was to evaluate the available data to explain differences in morphological evolution of NVOs along the IJssel and generate generic

- Subsurface sand deposits that affect erodibility;
- Detection of cohesive layers at key elevations by soil cores per groyne field prior to selecting new NVO locations (those layers seem to affect erosion rates, e.g. at Welsumer Waarden).

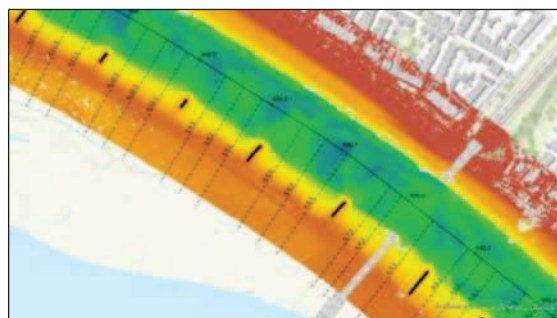
Figure 3. Location of three bank profiles per groyne field in elevation map

Different hypotheses describing the factors that may affect the NVO morphological evolution were evaluated. Parameters to confirm or falsify these included bank geometry (e.g. profile slope and length, see next), water level fluctuations, ship passages, position in the river stretch (straight reach, inner or outer bank), median grain size, presence of cohesive layer, and slump blocks. Three bank profiles were considered in each groyne field (Fig. 3), resulting in a total of 539 bank profiles.

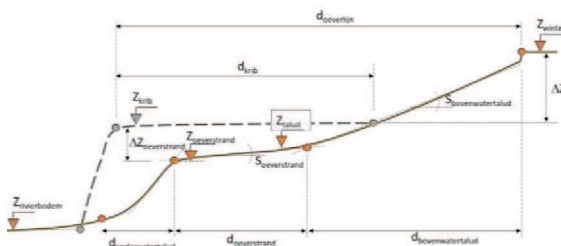
Figure 4. Schematized NVO profile between groynes

Each bank profile was schematised according to a conceptual model with key features (Fig. 4). An algorithm was used to automate the detection of these points, based on slope changes, elevation and proximity.

The four key points of the theoretical profile (circles in Fig. 4) were found in 45% of all analysed bank profiles, whereas another 20% had no clear inflexion point between the terrace and upper bank. The lack of elevation data at many cross profiles partially explains this. Circa 60% of the profiles missed one or more points, which were usually located at the terrace.

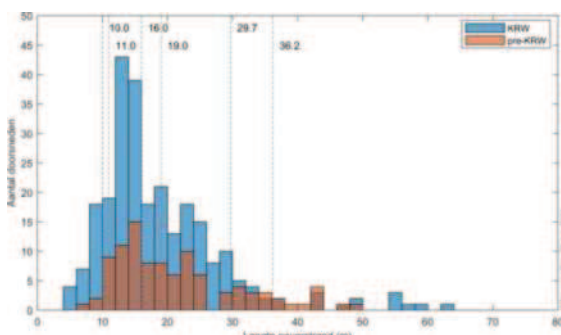
Figure 5. Terrace-length histogram for new and “old” NVOs

For those 65% of profiles, we compared several parameters in search of correlations and causality. Most profiles, however, did not present any clear correlation between potential erosion drivers and morphological changes. A likely explanation is that little morphological changes were observed at the pre-excavated NVOs after 3–4 years of development. Moreover, the new NVOs showed similar terrace and upper-bank slopes as old NVOs (e.g. Fig 5). This suggests that the initial profile of new NVOs closely resembled the long-term or equilibrium profile.
