Shear Experiments of Prestressed Concrete Bridge Girders

Lantsoght, E.O.L.; Zarate Garnica, G.I.; Zhang, F.; Park, Min-Kook; Yang, Y.; Sliedrecht, Henk

2021

ACI Structural Journal

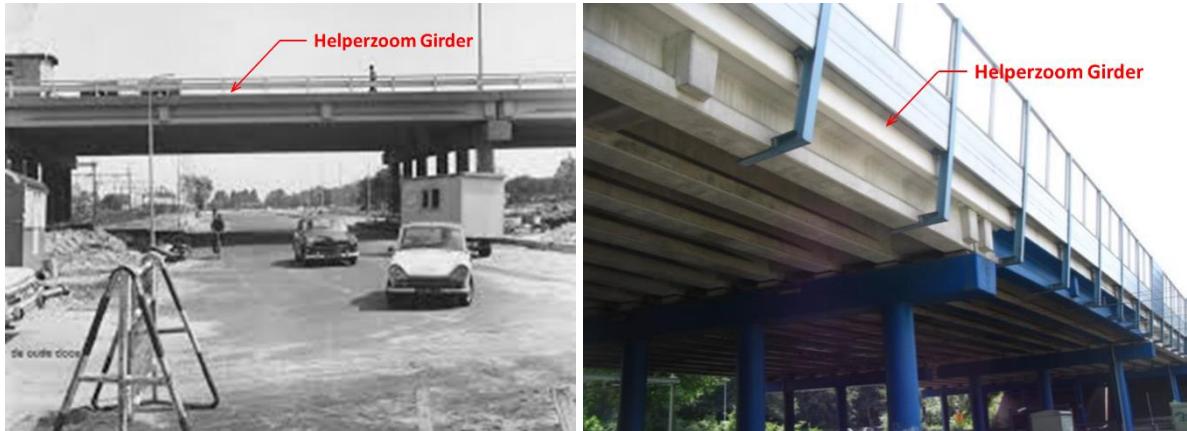
5 **Figure 1. View of the Helperzoom bridge, left: shortly after construction (De Oude Doos**
6 **Groningen, 2020), and right: shortly before demolition (Jayananda, 2018).**

7 The Helperzoom bridge, see Figure 1 ((Jayananda, 2018)), a slab-between-girder bridge
8 from 1965, is demolished as a result of the development of the new perimeter around the city of
9 Groningen. Therefore, it was possible to take girders from the bridge to test in the laboratory. When
10 assessed according to the Dutch codes for the assessment NEN 8700:2011 (Code Committee
11 351001, 2011a), with loads from NEN 8701:2011 (Code Committee 351001, 2011b) and further
12 stipulations for highway bridges in the RBK RTD 1006:2013 (Richtlijnen beoordeling kunstwerken
13 – guidelines assessment bridges) (Rijkswaterstaat, 2013), the outcome for the Unity Check for shear
14 is 1.69 for the edge girders and 1.05 for the interior girders. The edge girder is found to have the
15 largest Unity Check in the shear-tension region, whereas the interior girder has the largest Unity
16 Check in the flexure-shear region (Movares, 2013). As such, the girders are representative of the

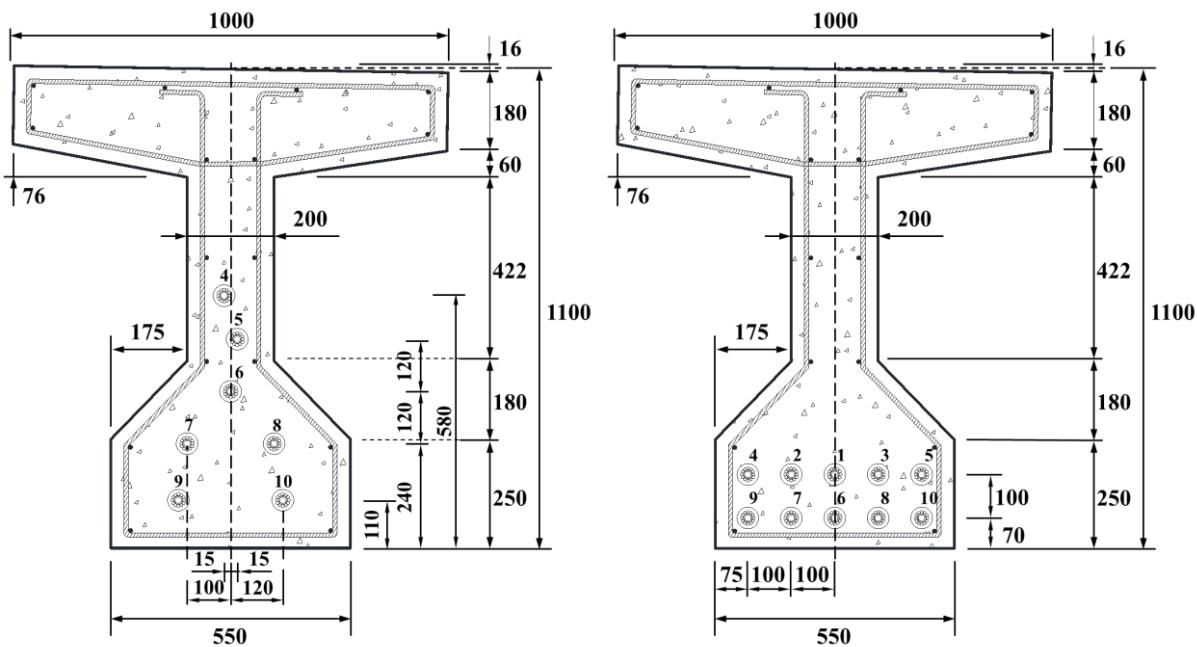
9 **Figure 2. Cross-section of the girder: left, section A-A' and right, section at midspan B-B'. All**
10 **dimensions in mm. Conversion: 1 mm = 0.039 in.**

20 The provided stirrups are $\phi 10 \text{ mm}$ (0.4 in \approx #3 bars) with a spacing of 400 mm (15.7 in).
21 The shape of the stirrups follows the shape of the cross-section, see Figure 2, which is not allowed
22 according to current codes (such as NEN-EN 1992-1-1:2005 (CEN, 2005)), since there is a risk of
23 spalling off of the concrete cover due to tension stresses provoked by the shape of the stirrup
24 (Roosen et al., 2019a). The amount of stirrups is determined as:

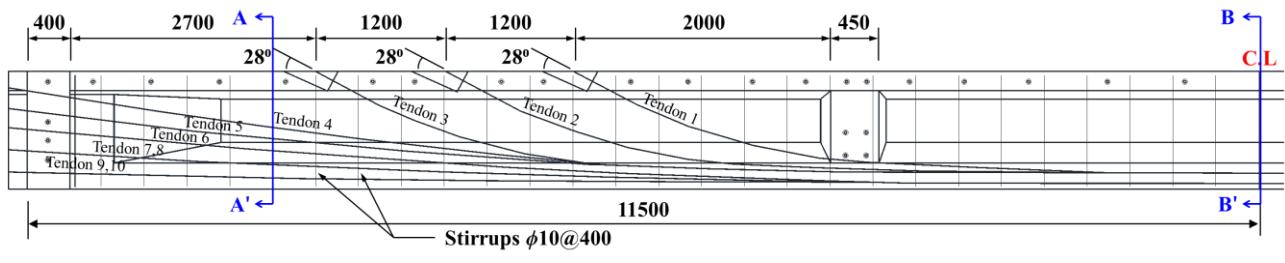
Figure 3. Side view of girder (from support to midspan), showing tendon layout, position of hammerhead and tapering part, as well as position of cross-beam. Cross-sections A-A' and B-B' are indicated on this sketch and refer to Figure 2. All dimensions in mm. Conversion: 1 mm = 0.039 in.

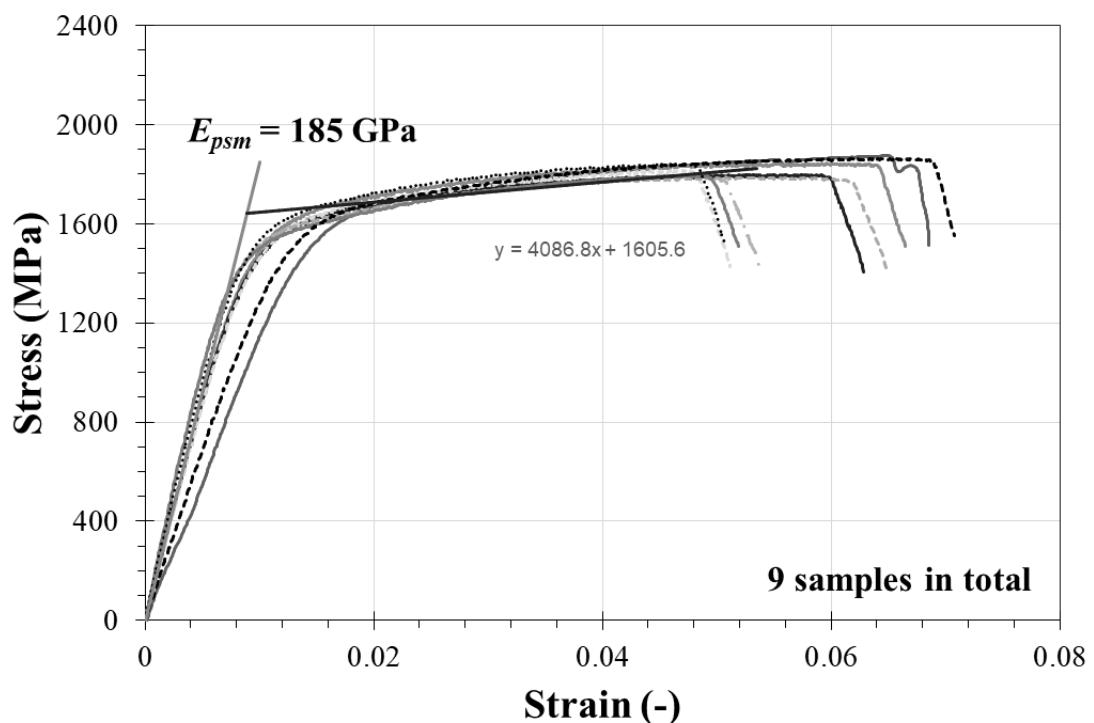
Figure 4. Measured stress-strain diagrams of nine successful sample tests, as well as simplified bilinear diagram. The simplified bilinear diagram uses a first branch with stiffness $E = 185$ GPa (26,830 ksi) and the second branch with the equation displayed in the graph. Conversion: 1 MPa = 145 psi.

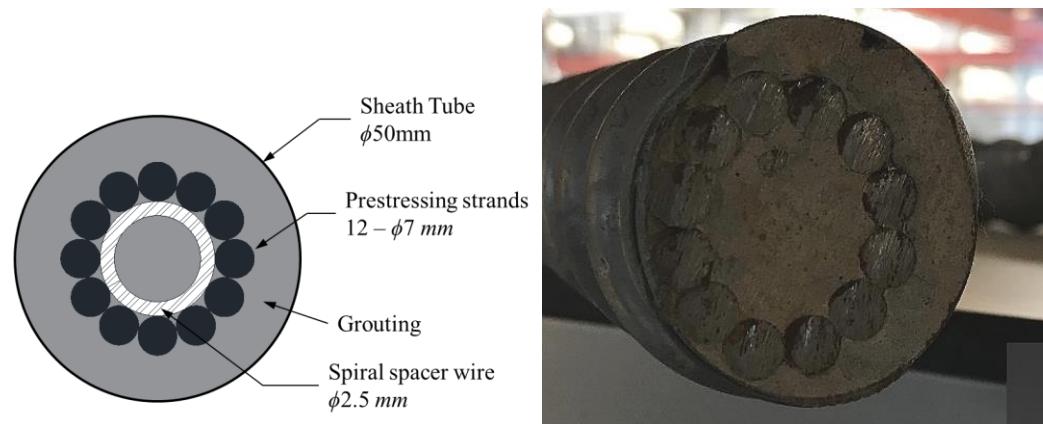
2 **Figure 5. Detail of prestressing strands: sketch and photograph. Conversion: 1 mm = 0.04 in.**

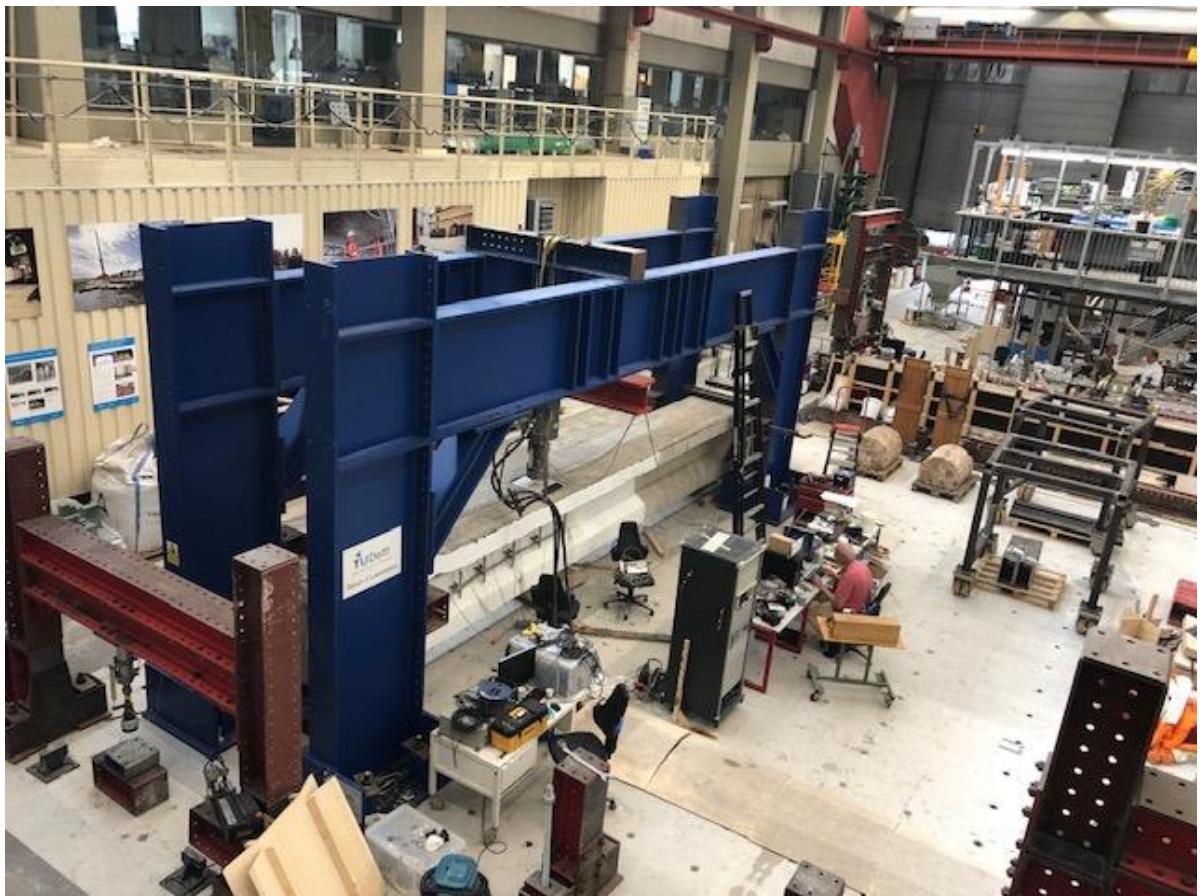
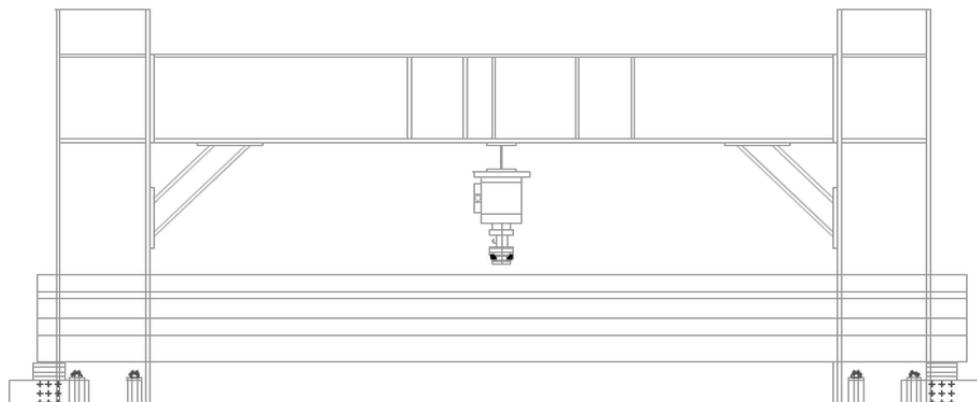
5 **Figure 6. Test setup: (a) Overview photograph of test setup in laboratory, (b) technical
6 drawing of side view.**

The load is applied by means of a hydraulic jack, built into a frame that is anchored to the strong floor of the laboratory, see Figure 6. To study crack opening and development, a loading protocol with different load steps of loading and unloading is used, see for example Figure 9. In Figure 9, three lower load levels with three cycles per load level are shown: before cracking, after flexural cracking, and after shear-flexure cracking. The fourth load level is an incremental loading to failure. The loading speed is 0.02 mm/s (0.0008 in/s) in all cases, except during the first cycles of HPZ01, when a loading speed of 0.01 mm/s (0.0004 in/s) was used.

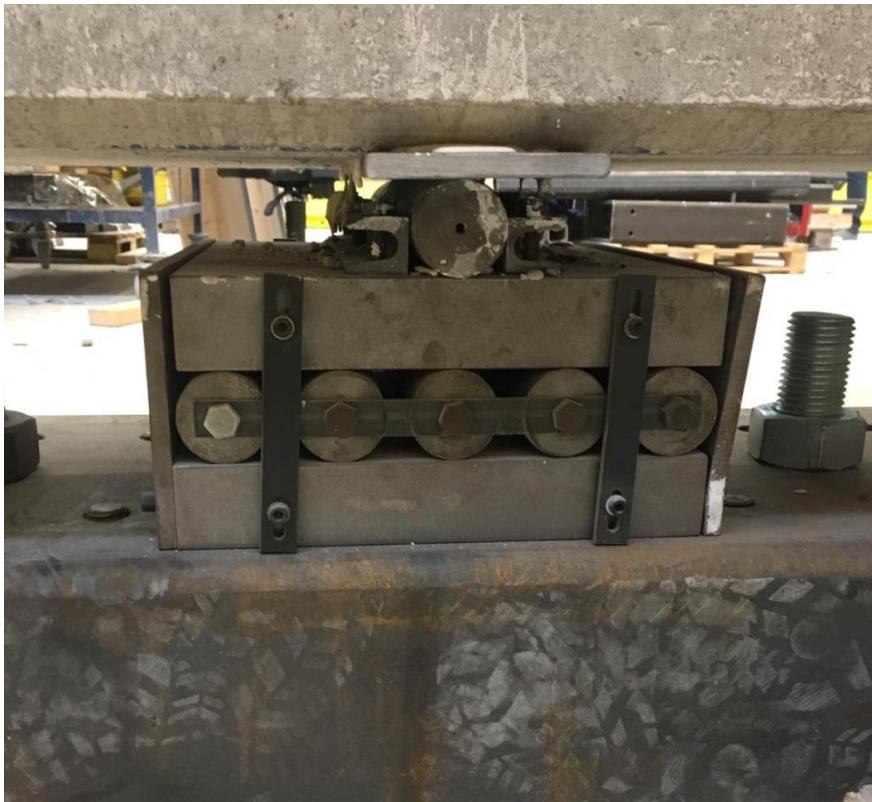
2 **Figure 7. Detail of support conditions.**

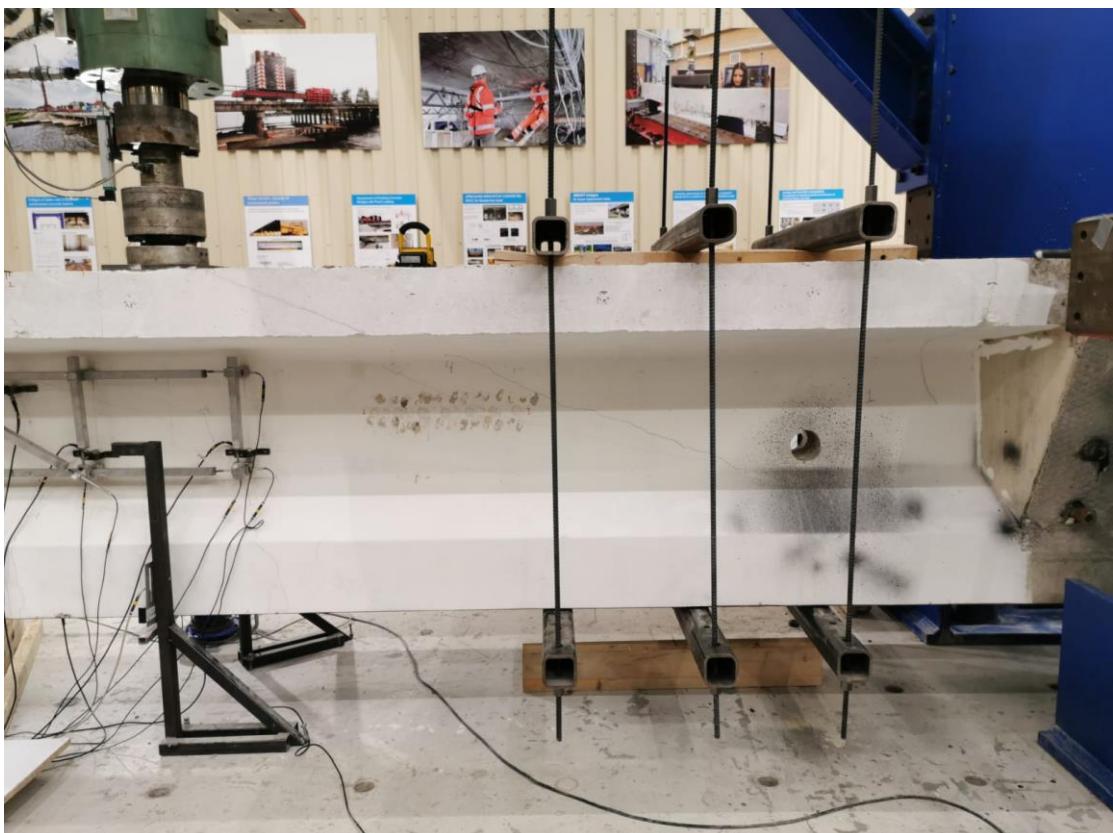
4 **Figure 8. External transverse prestressing applied to avoid possible failure on the unwanted**

1 side. Figure shows HPZ03.

To avoid slipping of the prestressing steel and development of a splitting failure on the side with the saw cut, external transverse prestressing bars are used (see Figure 8). The amount of external transverse prestressing applied varies per experiment.

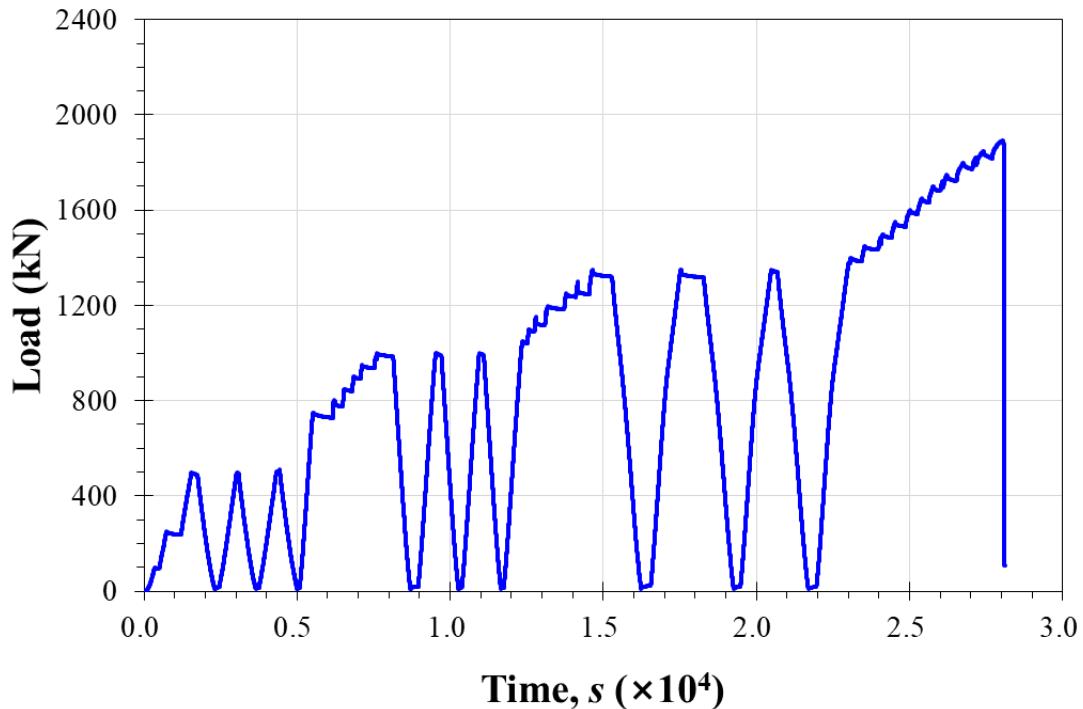
4 Figure 9. Loading graph used during HPZ01. Conversion: 1 kN = 0.445 kip.

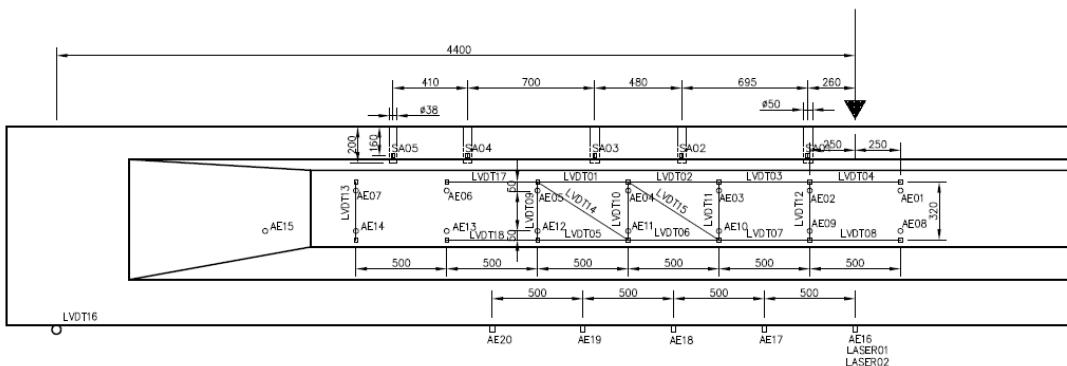
6 **Figure 10. Sensor plan for beam HPZ04 showing LVDTs, lasers, AE sensors, and smart**

7 aggregates SA). All positions in mm. Conversion: 1 mm = 0.04 in.

21 The details of the sensor plan for each experiment, including range of all applied sensors,
22 can be found in the measurement report of the experiment (Lantsoght et al., 2019e), and further
23 analysis of the DIC and AE can be found in (Zhang et al., in review). Figure 10 shows the sensor
24 plan used for HPZ04.

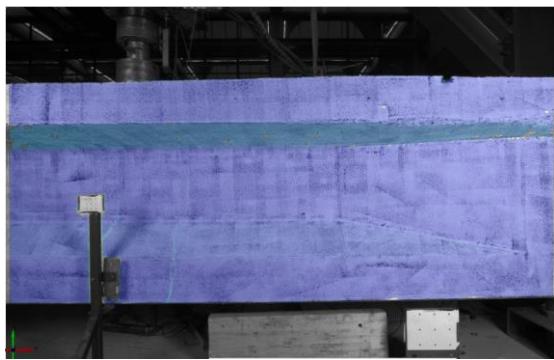
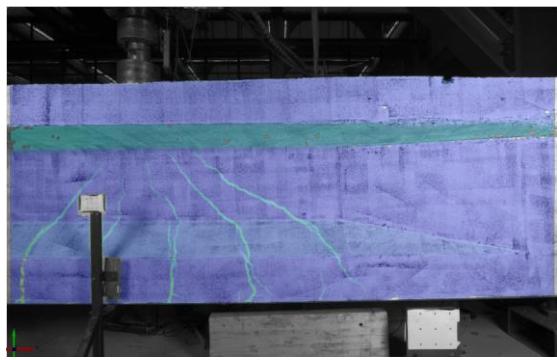
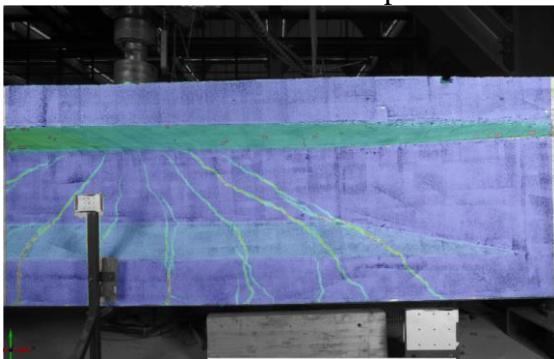
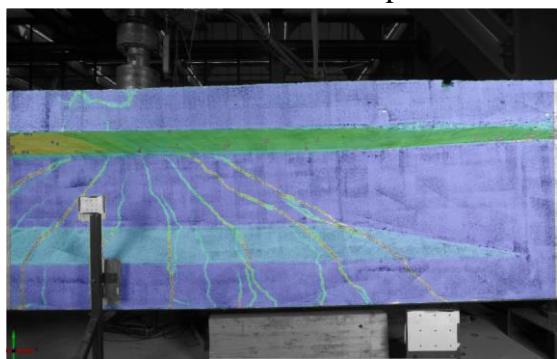
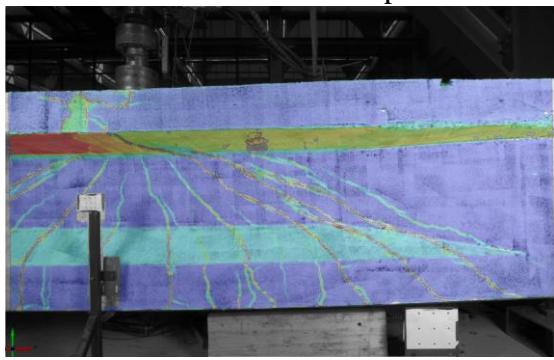
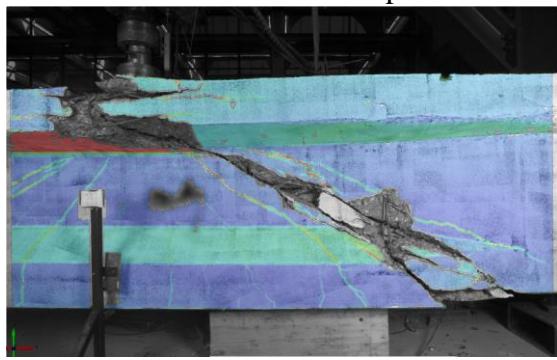
Shear-compression failure

Figure 11. Development of cracks and final failure of HPZ01.

4 Before the beginning of HPZ01, the application of the vertical prestressing at the saw cut led to
5 cracks in the flanges. For the first loading cycles to 500 kN (112.5 kip), the loading speed was 0.01
6 mm/s (0.0004 in/s), afterwards the loading speed was increased to 0.02 mm/s (0.0008 in/s). The
7 first flexural crack developed at 965 kN (217 kip). The first shear crack (a flexure-shear crack)
8 developed at 1344 kN (302 kip). Figure 11 shows the development of the cracks during the
9 experiment. The ultimate load was 1893 kN (426 kip), at which a shear-compression failure took
10 place.

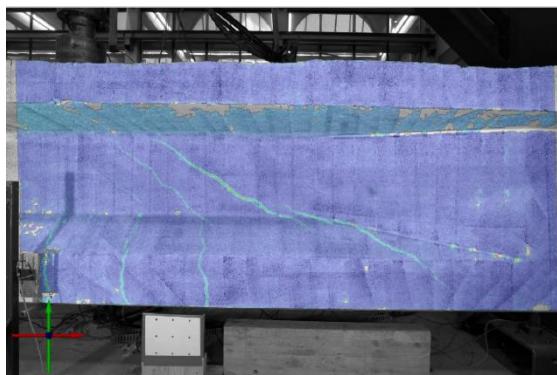
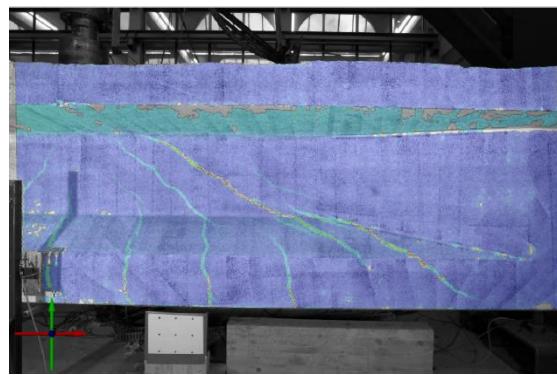
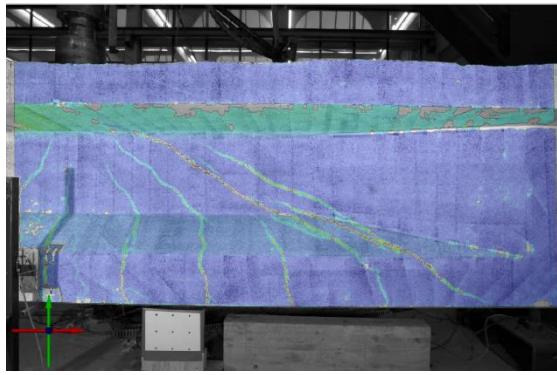
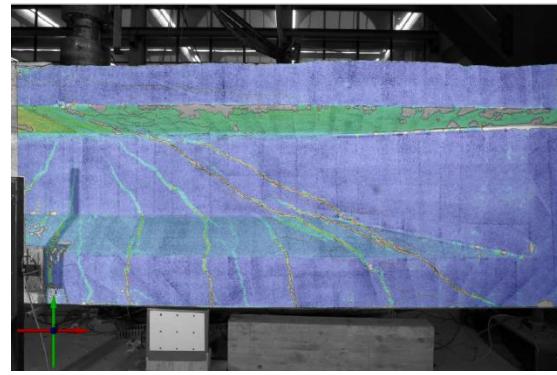
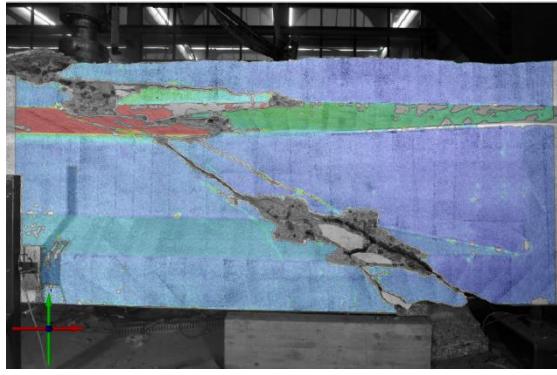
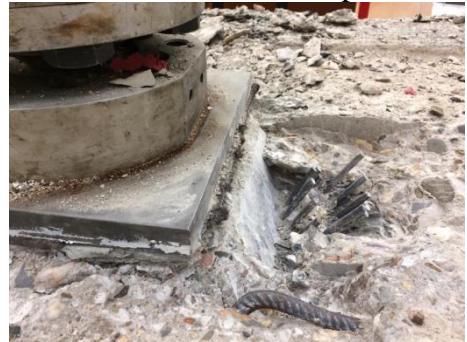
Shear-compression failure

Failure, top view showing anchorage of prestressing tendon

Figure 12. Development of cracks and final failure of HPZ02.

12 HPZ02 is a repeat test of HPZ01, but now the loading speed is constant at 0.02 mm/s (0.0008 in/s).
13 The vertical prestressing bars at the saw cut were applied at with a larger spacing in between and no
14 cracking developed in the flange. The first flexural crack developed at 1001 kN (225 kip). The first
15 two shear cracks, both flexure-shear cracks, developed at 1299 kN (292 kip). Shear-compression
16 failure occurred at 1849 kN (416 kip). In general, the behavior of the girder during this experiment
17 was very similar to the behavior of HPZ01, see Figure 12 for selected DIC-processed photographs
18 of the cracking pattern. After failure, the anchorage end of the prestressing tendon anchored in the
19 flange was visible next to the loading plate.

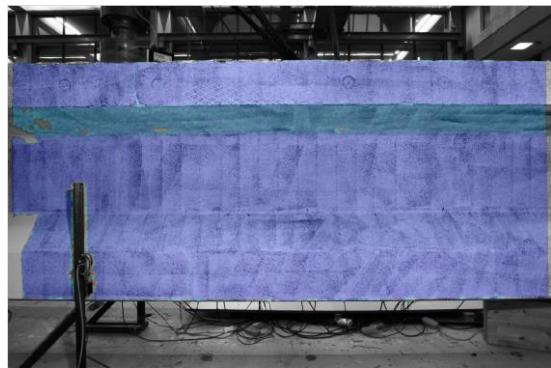
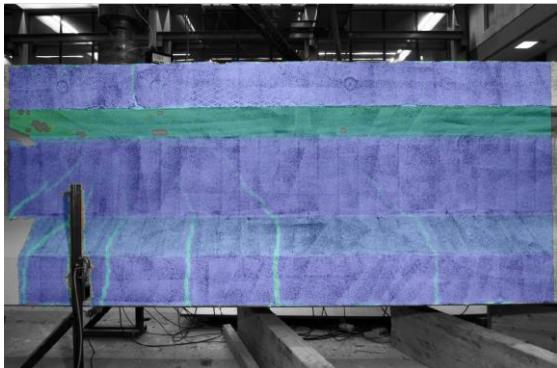
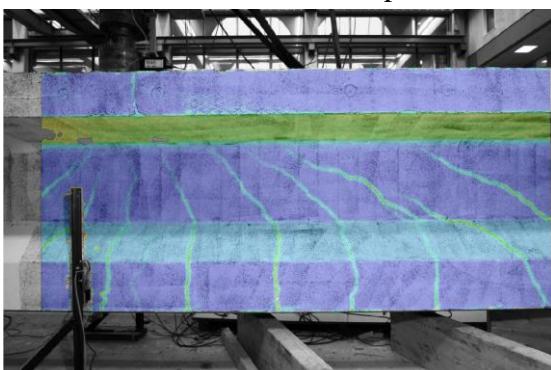
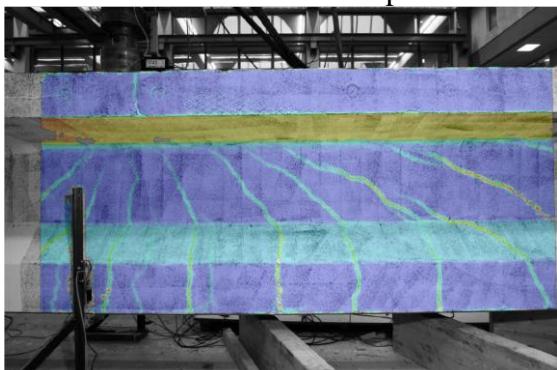
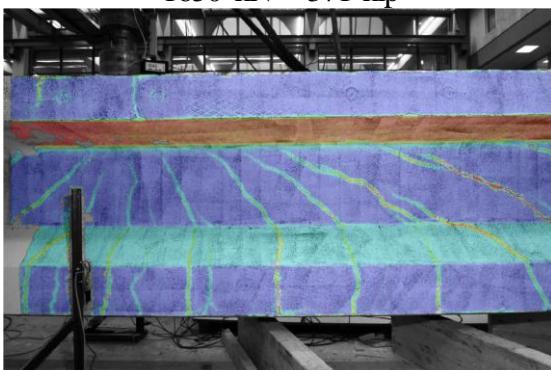
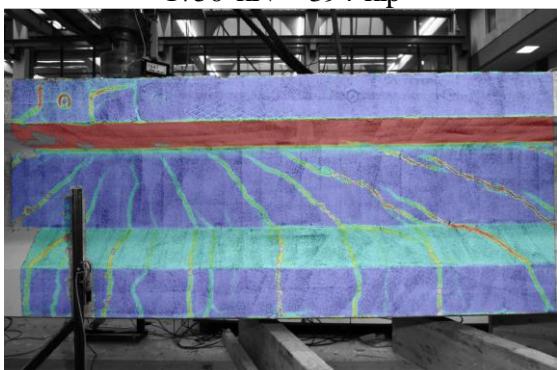
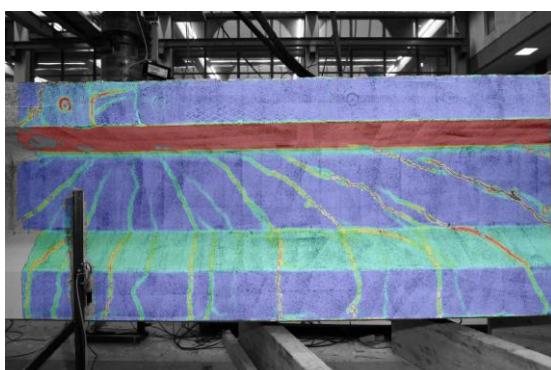
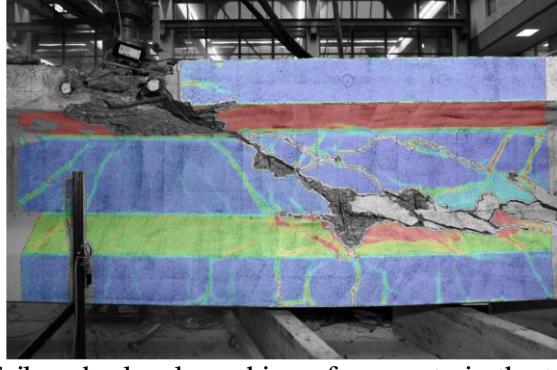
Failure by local crushing of concrete in the top flange

Figure 13. Development of cracks and final failure of HPZ03.

21 In HPZ03, the load was placed farther from the support, at 4.4 m = 14.5 ft. In this experiment, three
22 cameras were used: one to capture the global distribution of strains using a 20 mm (0.8 in.) wide-
23 angle lens, one to capture the opening of the critical shear crack in the web, and one to capture the
24 opening of the shear-tension crack closer to the support. The load was applied using cycles and the
25 duration of the experiment was two days. The first flexural crack developed at 1050 kN = 236 kip.

1 The first shear crack, a flexure-shear crack, developed at 1250 kN = 281 kip between the load and
2 the saw cut. At 1650 kN = 371 kip, a shear-tension crack developed between the load and the saw
3 cut. The shear cracks developed up into the top flange. Failure occurred at 1990 kN = 448 kip by
4 crushing of the concrete in the flange. Figure 13 gives an overview of the development of cracks
5 during the experiment.

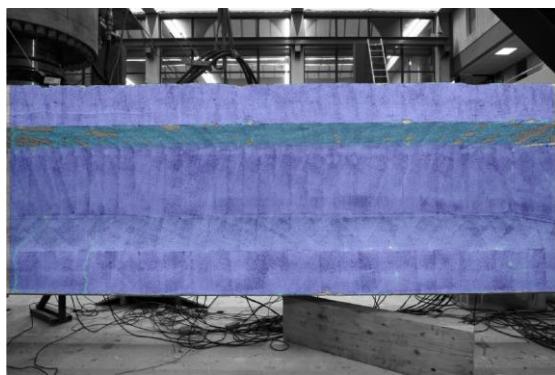
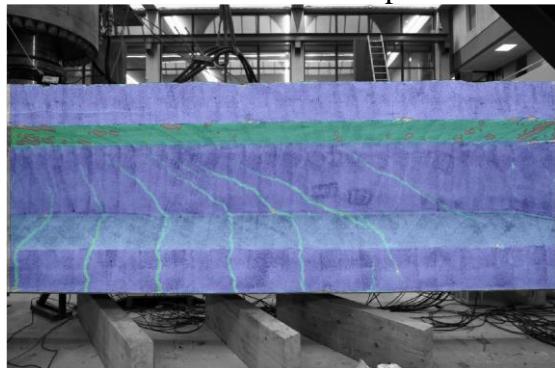
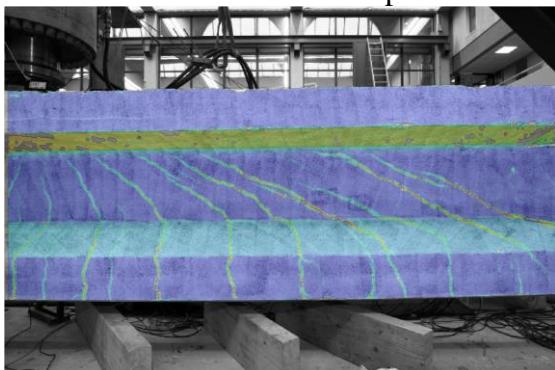
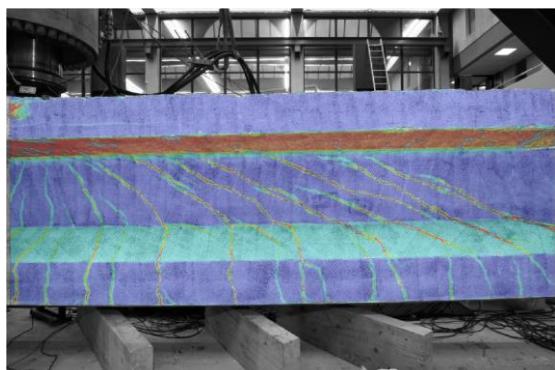
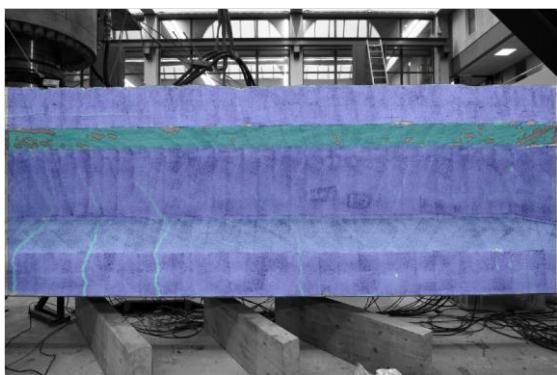
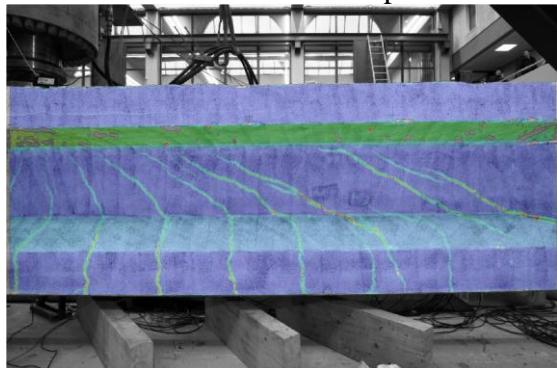
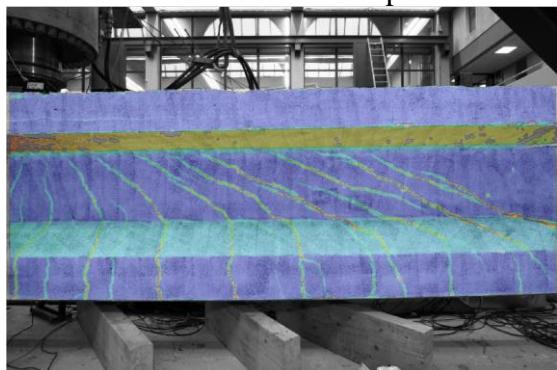
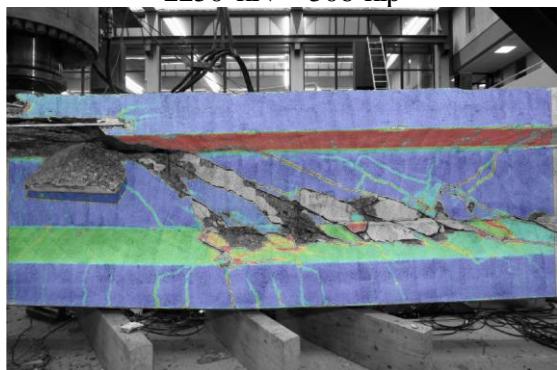
Failure by crushing of concrete in compression field in the web

Figure 14. Development of cracks and final failure of HPZ04.

7 HPZ04 is a repeat test of HPZ03 (including three cameras for DIC), but a different jack was used:
8 instead of the 2000 kN (450 kip) jack, the 10,000 kN (2250 kip) jack was used, as HPZ03 had a
9 failure load close to the maximum capacity of the jack used in that experiment. The first flexural
10 crack developed at 1100 kN = 248 kip. The first inclined crack, a flexure-shear crack, developed at
11 1450 kN = 326 kip. The shear cracks reached the compression flange at 2050 kN = 461 kip. Figure
12 14 gives an overview of the development of cracks during the experiment. Failure occurred at 2380
13 kN = 536 kip by crushing of the concrete in the compression field in the web of the girder.

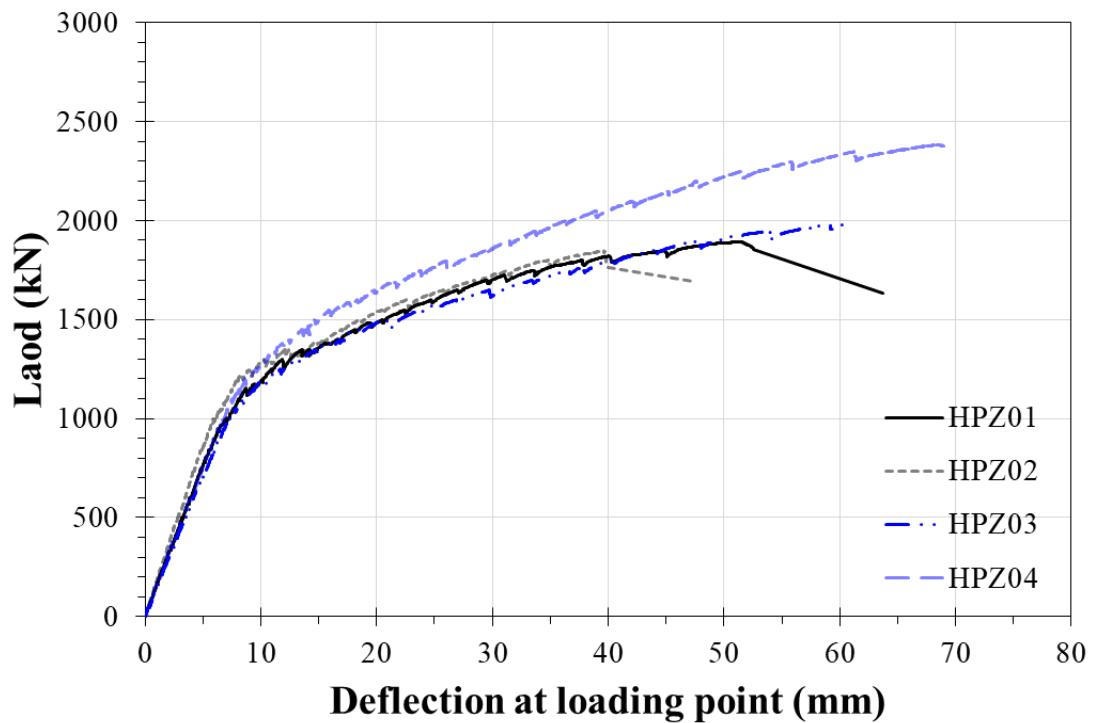
2 **Figure 15. Load-displacement diagrams of experiments. Conversion: 1 kN = 0.225 kip, 1 mm**
 3 **= 0.04 in.**

2 Table 3 gives an overview of the experimental results and Figure 15 gives the envelopes of the
3 load-displacement diagrams of the four experiments. The failure mode is reported based on the
4 mode of shear cracking (before failure occurred) and then the ultimate failure mode. For all
5 experiments, the first shear crack to develop was a flexure-shear (FS) crack. The final failure mode
6 was a function of the position of the load. For the experiments with the loads closer to the support,
7 the failure mode was shear-compression (SC) as a strut could develop between the load and the
8 support. For HPZ03, the failure was initiated by crushing of the concrete under the loading plate,
9 indicated by CC. For HPZ04, failure occurred by crushing of the concrete in the compression field
10 after formation of a truss-like pattern of shear cracks indicated by CF. The acoustic emission
11 sensors can detect micro cracking about 50 kN (11 kip) before the DIC or the bare eye can notice
