Predicting Impact Damage for Carbon Composite Propeller Certification

Master Thesis

Kasper Sijmons 4351088

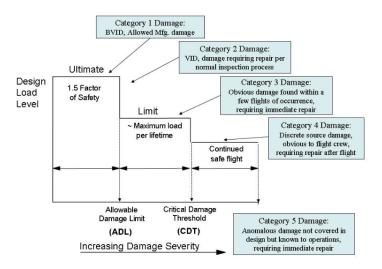
Figure 2.1: Damage Categories based on Detectability [9]

In AMC-20-29 [9], impact damage is split into 5 categories. In Figure 2.1 these categories are shown. These 5 categories are taken from AMC-20-29 [9] and are also used in the Composites Materials Handbook [1]. The 5 categories are explained below.

The first category is damages or defects which will remain undetected. The component must retain the capability to support the ultimate loads for the entire component life [9]. This includes undetected manufacturing defect and Barely Visible Impact Damage (BVID). Category 1 damages will never be repaired. BVID is the main focus of this research.

When damage is reliably detected during scheduled inspections it falls under category 2 damage. This can be called Visible Impact Damage (VID) and Clearly Visible Impact Damage (CVID). Because this type of damage will be repaired during maintenance it is allowed that the residual strength is reduced. The required residual strength depends, among other factors, on the probability of occurrence and the inspection interval.

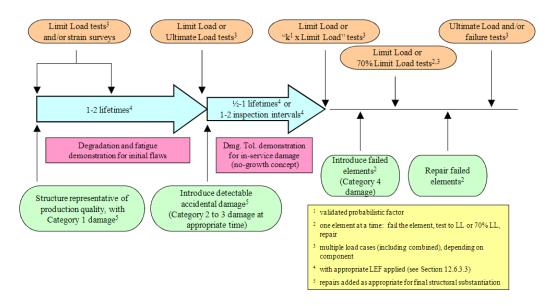
Figure 2.2: Fatigue Test Sequence Example. [1]

The certification strategy used by PAL-V is taken from the Composites Materials Handbook [1]. Fatigue testing will be performed on the structural components in which certain impact damages will applied at various intervals. The test starts with category 1 damages already present as this type of damage can exist in the part for the entire lifetime. After one entire lifetime is simulated category 2 and 3 damages are applied after which the part is fatigue tested again for the expected interval after which this damage is expected to be detected and repaired. An example of this fatigue test sequence is shown in Figure 2.2. At certain moments during the fatigue test the limit load or ultimate load is also tested. At the end of the entire fatigue test the failure load will also be determined. To successfully execute this test it is required to accurately apply the exact amount of impact damage to the component.

This accurate application of impact damage is challenging. The exact energy that is required to inflict a certain impact damage is unknown and dependent on many factors. Currently a lot of impact testing is done to determine the impact energy for certain damage categories. When one impact test is performed the component can be structurally compromised. This may require a new component for every single impact test.

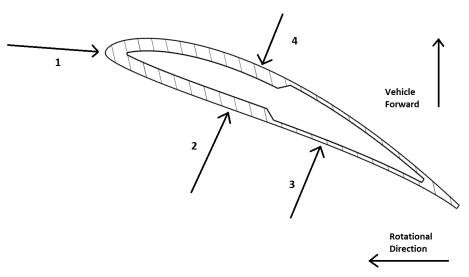
Figure 4.1: A Cross-section of a Carbon Fiber Propeller.

An impact on the skin, number 3 in Figure 4.1, will have a low impact on the structural integrity of the propeller. The skin is not designed to support large structural loads and if this section is damaged, it would not lead to a significant loss in overall structural properties.

When only looking at the propeller cross section it was concluded that an impact on location 2 or 4 was expected to inflict the most structural damage inside the propeller. This information was used to determine the overall critical location on the propeller blade.

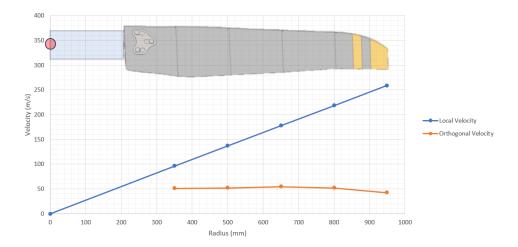
Figure 4.2: The Propeller Velocity and Orthogonal Velocity as a function of Radius.

When the PAL-V Liberty is being used in fly mode, the propeller will be spinning. This will make the impact velocity on the propeller blade dependent on the radius at which an impact event could occur. At the maximum design RPM the propeller is spinning at 2600 RPM or 273 rad/s. The propeller local velocity is plotted against the radius during this maximum RPM in Figure 4.2. The maximum velocity is found at the tip at 259 m/s.

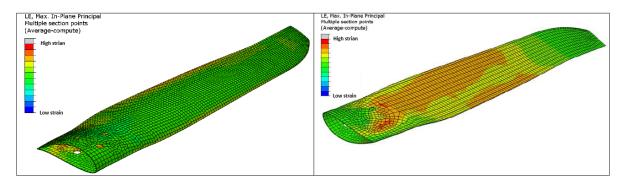
Figure 4.4: The Strain in the Skin of the Propeller in Microstrain. image credit: PAL-V

During the design of the propeller, the internal strains were analysed. The internal strain in the propeller skin and spar are plotted in Figure 4.4 and Figure 4.5 respectively. For both cases the propeller was loaded with a maximum RPM load case with the associated aerodynamic forces and moments. The exact strain values are removed from the plots for confidentiality.

From these illustrations it is clear that the propeller is most critical at the back of the blade. The area near the root shows more strain than the area near the tip. In Figure 4.5 a strain concentration is visible at the blue circle.

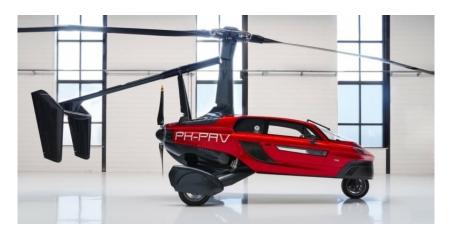
Figure 4.6: A Side View of the PAL-V Liberty in Fly Mode. image credit: PAL-V

The front tire of the PAL-V Liberty is positioned directly in front of the propeller as can be seen in Figure 4.6. This means that when the front tire lofts anything from the ground there is a chance that this piece of FOD will travel through the propeller disc. Which means there is a chance that the spinning propeller blade will hit this piece of FOD.

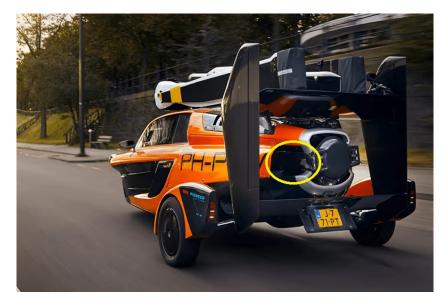
Figure 4.10: A View at the Folded Propeller in Drive Mode with the Exposed Propeller circled in Yellow. image credit: PAL-V

The folded propeller is almost completely protected from damage. In Figure 4.10 it can be seen that the only part that is exposed is the inner part at the rear of the propeller this is however also the critical location identified in subsection 4.3.2. It can also be seen that the propeller is protected from the sides by the vertical stabilizers. This is more clearly visible in Figure 4.11. This leaves the exposed part of the propeller only accessible from the rear.

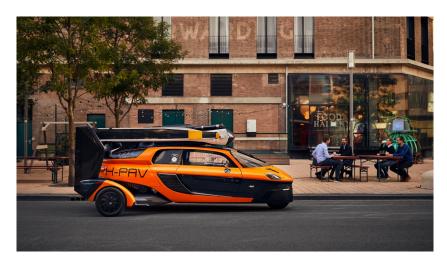
Figure 4.11: A Side View of the PAL-V Liberty in Drive Mode. image credit: PAL-V

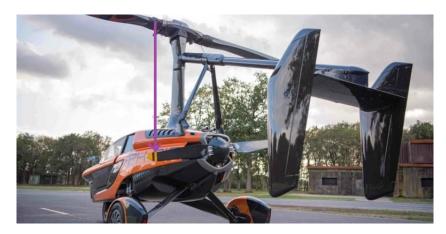
Figure 4.12: Rear View of the PAL-V Liberty in Fly Mode. With a tooldrop scenario in purple. image credit: PAL-V

Ground service equipment is used on larger aircraft to load for example passengers, fuel or luggage or equipment for de-icing or push-back. This sort of equipment is not used around the PAL-V Liberty. If a fuel service truck is used around the PAL-V Liberty, it will not be able to hit the propeller. In drive mode the propeller is tucked away as shown in Figure 4.10. When in fly mode, the propeller is protected by the rear wheels and the tail as shown in Figure 4.12.

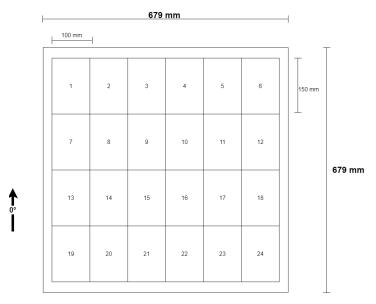
Figure 6.2: Plate Dimensions and Cutting Diagram (679x679mm)

After curing the plates were cut into 150x100 mm coupons as specified in ASTM D7136 [46]. The cutting diagram is shown in Figure 6.2. The plates were cut using a water cooled circular diamond saw.

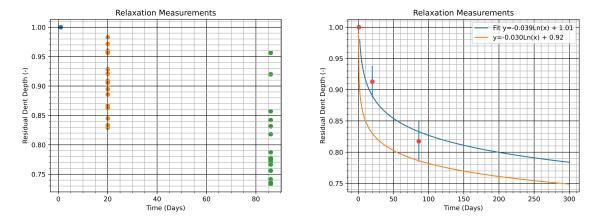
Figure 6.19: Residual Dent Depth Measurements. Without

When looking at the relaxation results shown in Figure 6.12 it was immediately clear that the dent depth measurements have not been completely accurate. The dent depth seemed to increase for some data points which indicate either an error made while reading the dial indicator or, more likely, a clear difference between the two used measurement methods mentioned in subsection 6.1.5. To make some sense of the measurements first the outliers were removed from the data. This is shown in Figure 6.19. These data points were used to calculate the mean with the confidence interval shown in Figure 6.20. As mentioned in subsection 2.3.1 the expected shape of these relaxation results was a logarithmic fit. A logarithmic fit was also applied to the means values and shown in Figure 6.20. The relaxation relation found by Dubisnii et al. [14] is also shown as a reference. These logarithmic approximations were plotted to 300 days in this graph to predict further relaxation of the dents. Even though it seems fair to say that the residual dent depth would be 75% to 80% of the original dent depth after a year, more relaxation measurements have to be performed more consistently to form a proper prediction of the relaxation. If this estimate proves to be correct after more measurements the initial dent depth for BVID would be **0.375-0.40 mm**.

Figure 6.20: Mean, Confidence interval and Logarithmic fit of the Relaxation results.

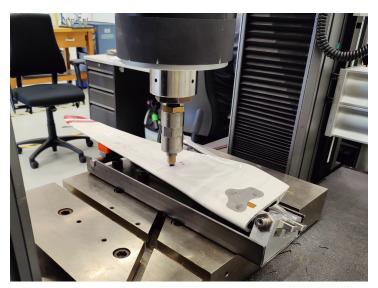
Figure 7.1: The White Propeller in the Compression Test Bench

In this chapter the propeller quasi-static tests are explained. The goal of this test was to determine the structural response of the propeller to quasi-static loading. This response was later used to create the model for impact damage prediction.

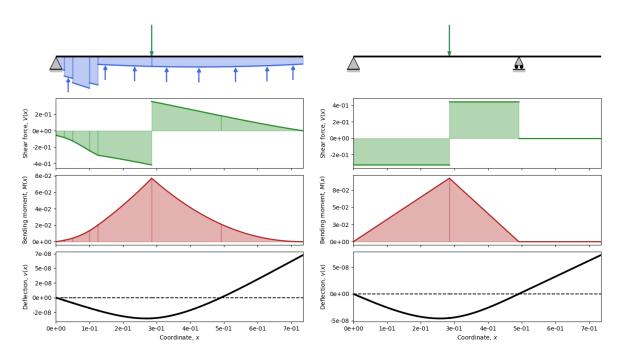
To hold the propeller in the quasi-static test bench a purpose built fixture was designed and built. The fixture was designed to hold the propeller in a way that the critical location determined in subsection 4.3.2 is perfectly horizontal. The propeller had to be placed in a way that mimics the real scenario.

Figure 7.2: A Simple Beam Model to approximate the Rotating Propeller.

Figure 7.3: A Simple Beam Model to approximate the Propeller Fixture

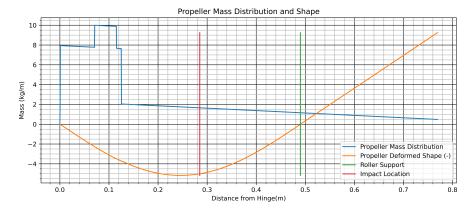
Figure 8.4: Propeller Mass Distribution and Shape

An alternative way to approximate the propeller mass was used. The propeller was expected to bend similar to a sine wave between the hinge and the roller and the tip was expected to remain straight. This shape is shown in Figure 8.4. The propeller mass distribution was the sum of the propeller blade, lug, and bolts which is shown in Figure 8.4. The propeller was sectioned into small sections with a local mass and a displacement compared to the displacement at the impact location. The local displacement was used to factor in both the relevant displacement compared to the impact location and the mechanical advantage compared to the impact location. If a location on the propeller only moves half compared to the impact location, it not only has to physically be displaced over half the distance but the impact location also has a factor 2 mechanical advantage. This means the local propeller mass was multiplied by the relevant displacement squared. This is shown in Figure 8.5. The sum of all the local effective masses was **0.713 kg**. This was used as the local propeller mass.

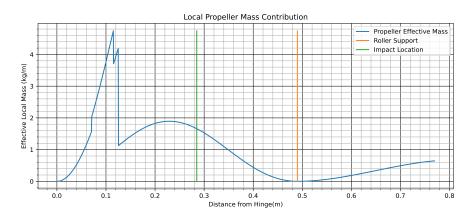
Figure 8.5: Propeller Effective Local Mass

The local propeller mass is the effective mass of the propeller at the impact location. This local mass can be approximated by looking at the spring constant of the propeller and the eigenfrequency of the propeller in a similar oscillation mode. A frequency analysis was performed when the propeller was designed but this was not around the hinge and without the mass of the lug and bolts.

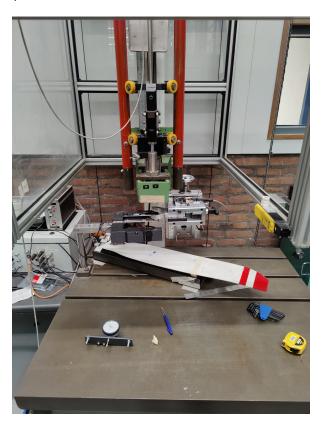
Figure 9.1: Propeller Impact Test Setup

The original goal of the propeller impact test was to create BVID on a PAL-V propeller. However, in chapter 8 it became apparent that the contact force expected during propeller impact testing will not be enough to cause BVID. This meant that this test had a new goal. The goal of the propeller impact test was to validate the model created in chapter 8 and determine its accuracy.

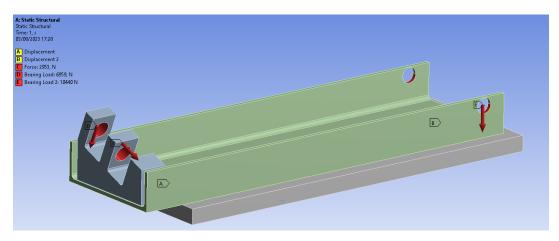
Figure B.1: ANSYS loadcase for the Propeller Fixture Analysis

In this appendix the strength and deformation analysis of the propeller fixture is provided. Figure B.1 shows the loadcase on the fixture when supported on the compression test bench. In Figure B.2 the deformation in the vertical direction of this propeller fixture is shown with a scaling factor of 79 to visualize the deformation. The maximum deformation found in the vertical direction is 0.15 mm. The internal stresses in the aluminium block and the roller pin holes are shown in Figure B.3 and Figure B.4. Both stress values are well below the yield strength of the steel and aluminium used.
