Improve the future,  
Renovate the past

A research on improving the balance between  
cultural value, sustainability, and costs in  
industrial heritage renovation projects.

This thesis for my graduation is within the domain Adaptive reuse of the master track Management of the Built Environment at the University of Technology in Delft.

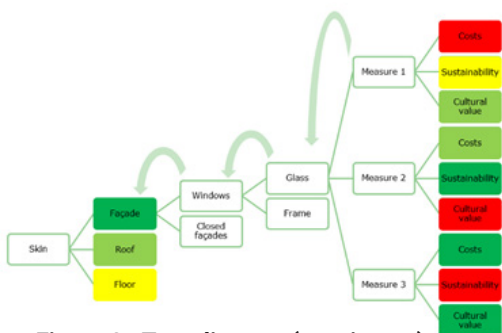
Figure 2 . Tree diagram (own image)

The second part of the decision-support model is a tree diagram (see figure 2) whereas the trade of matrix compares the types of measures within their category (exterior insulation, interior insulation, frames, and glass), the tree diagram compares the categories to each other taking into account their current condition and the number of square meters that they occupy in the building. This will give the assessor an overview of what building part has the best potential for renovation.

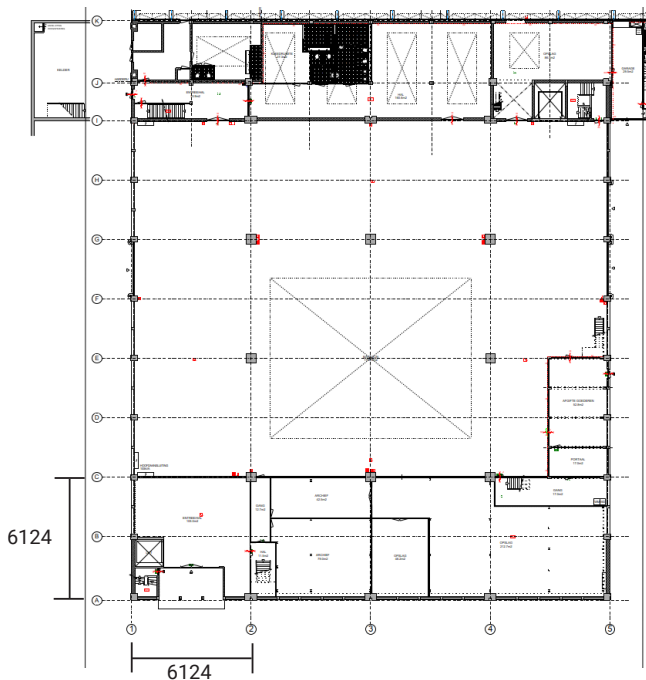
**Figure 16 Ground floor plan (before renovation) (ABT, n.d.-c)**

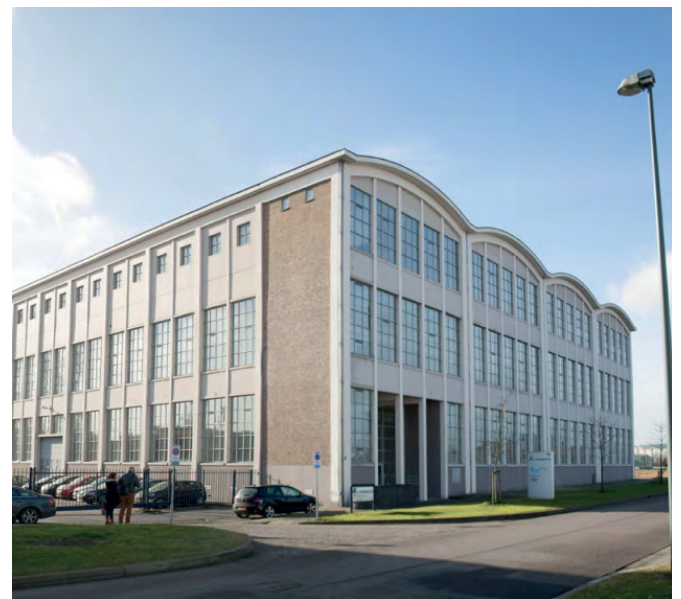
**Figure 17 Gusto Msc Schiedam (ABT, n.d.-c)**

**Structure:** A robust reinforced concrete skeleton structure supports the concrete floors and roof. The columns were placed in a grid of 6124 x 6124 mm (See Figure 17) with a profile of 520 by 650 mm. The concrete structure in the façade was in good condition.

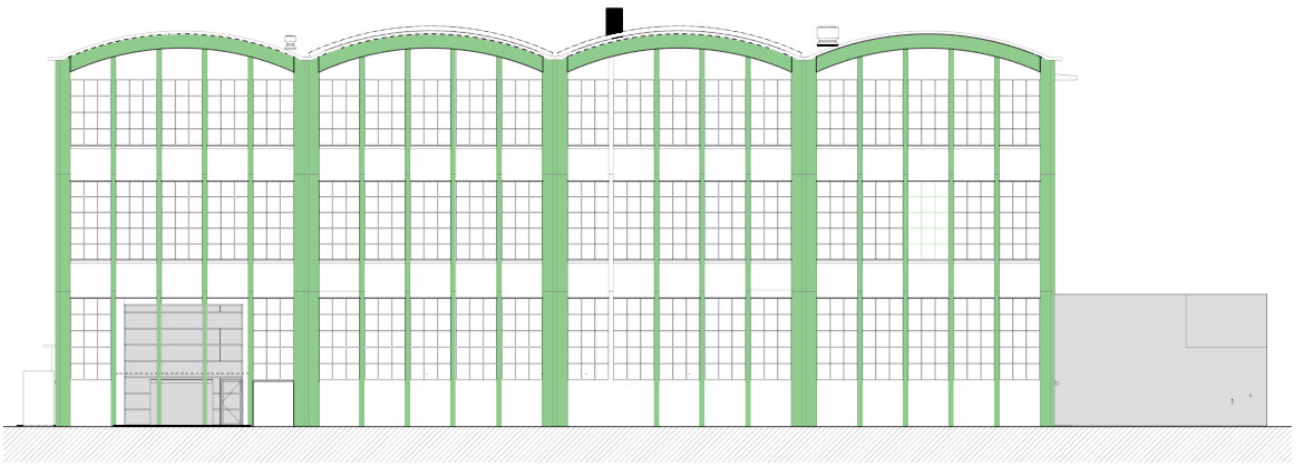
Figure 19 Head Facade Gusto MSC. Column structure highlighted in green

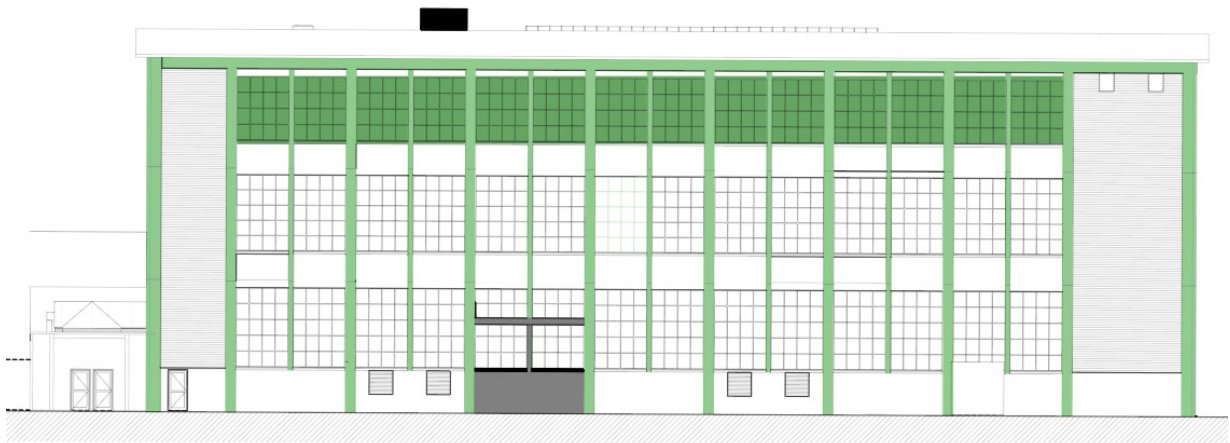
Figure 20 Side Facade Gusto MSC. Column structure and new windows highlighted in green

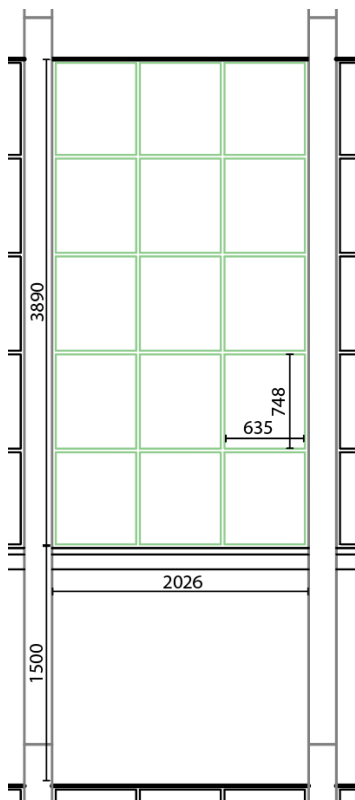
Figure 21 Windows head facade. Frame structure highlighted in green.

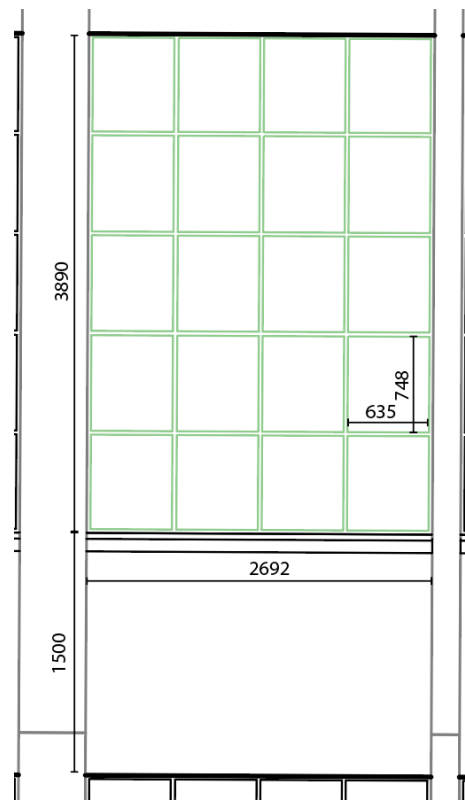
Figure 22 Windows side facade. Frame structure highlighted in green

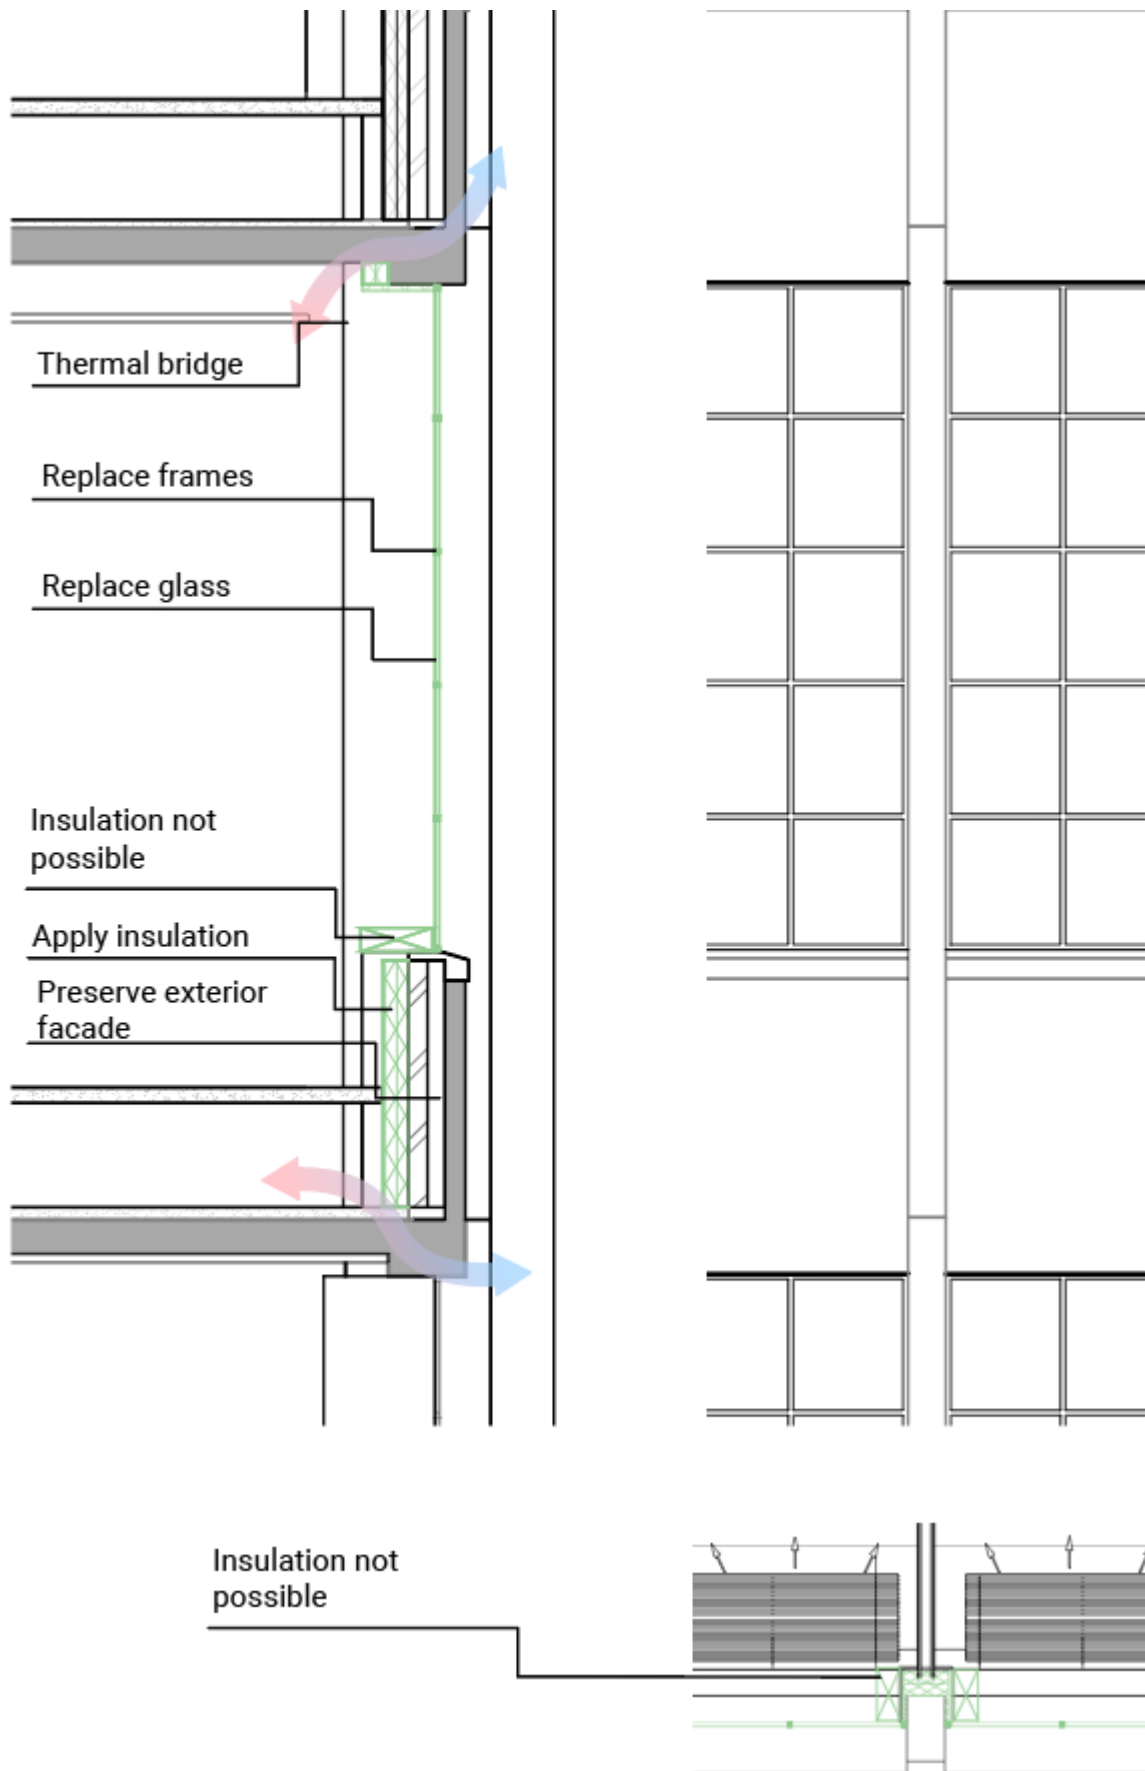
Figure 23 Facade section with new adaption in green (own image)

Insulation foils were applied on the ground floor and the first floor to minimize heat accumulation caused by daylight. This led to a U-value of 2,8 W/m<sup>2</sup>K and a ZTA value of 0,39. On the places where the sunlight is more than 300 W/m<sup>2</sup>, blinds with a light colour were installed on the inside (ABT, 2014). The colour of the insulation foil was selected so it would have the least impact on the cultural values. (Mecking, 2014)

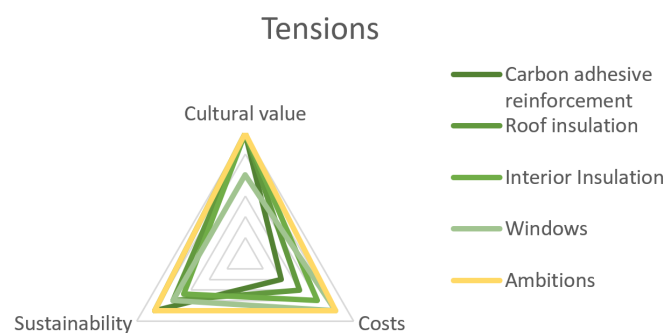
**Figure 24 Balance measures Gusto MSC. Cultural values and sustainability are on a positive axis and cost on a negative axis, meaning that when the costs are low, the value is further from the center. (own image)**

- △ The heat resistance of the façade had to be improved because they valued the exterior façade more than the interior due to the visible concrete columns; they decided to do the insulation on the interior façade. It was not possible to wrap the column with the optimal thickness for insulation since the windows were directly connected to the columns. The decision to not invest in an expensive thin insulation with a high R-value shows that the priority for sustainability is lower than cost and cultural value.

△ The windows were already replaced before the renovation. The new windows matched the surrounding windows, to enhance the cultural values. The new windows fitted in the façade quite nicely and it did not interfere that much with the cultural values.

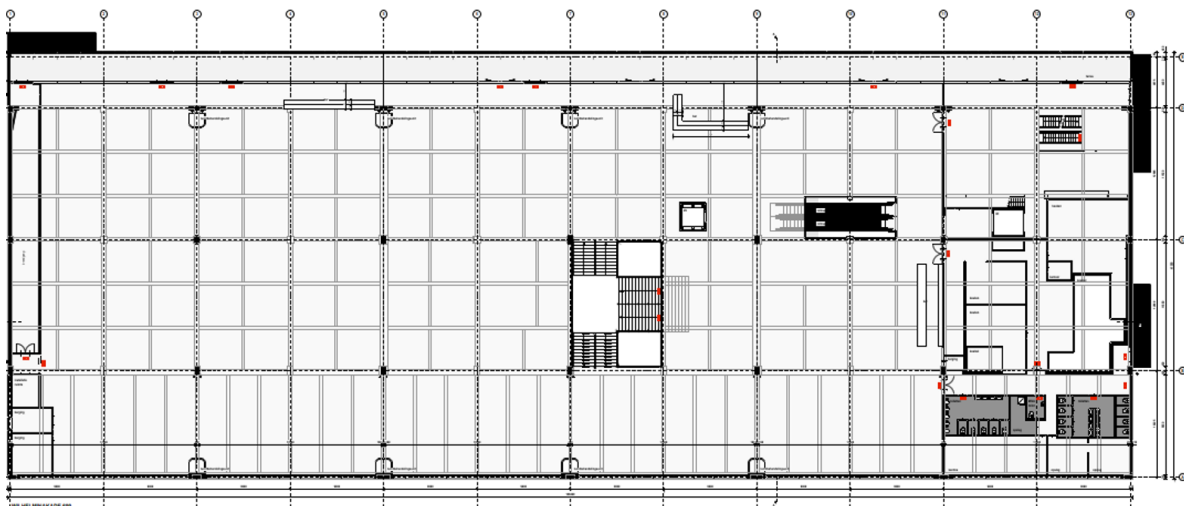
Figure 26 First floor (ABT, n.d.-b)

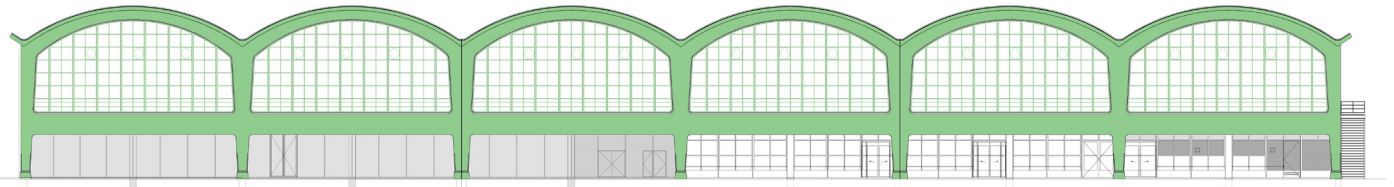
Figure 28 Street facade (own image)

**Skin:** The street façade of the building is divided in two. On the ground floor, the majority of the glass façades are replaced. Only the three fronts on the right side are original (see figure 31). The upper façade rests on columns and has an overhang of 10 meters over the ground floor. This façade exists of large glass panels that rest on the parapet. On the water side, the majority is still original compared to the ground floor. This side is also completely glass, the glass runs from the balcony to the bottom of the curved roof. Whereas the front façade has the concrete structure visible (see figure 28).

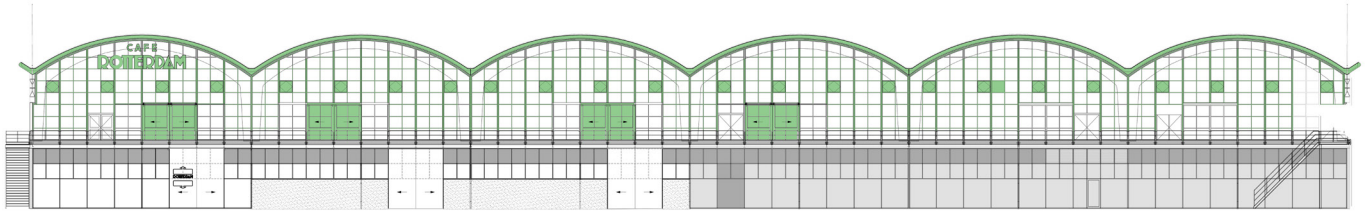
Figure 29 Water facade (own image)

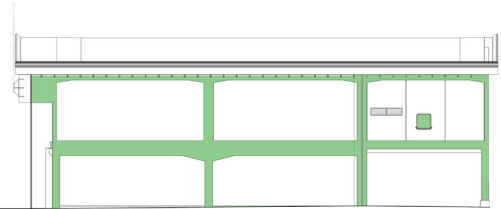
Figure 31 East end facade (own image)

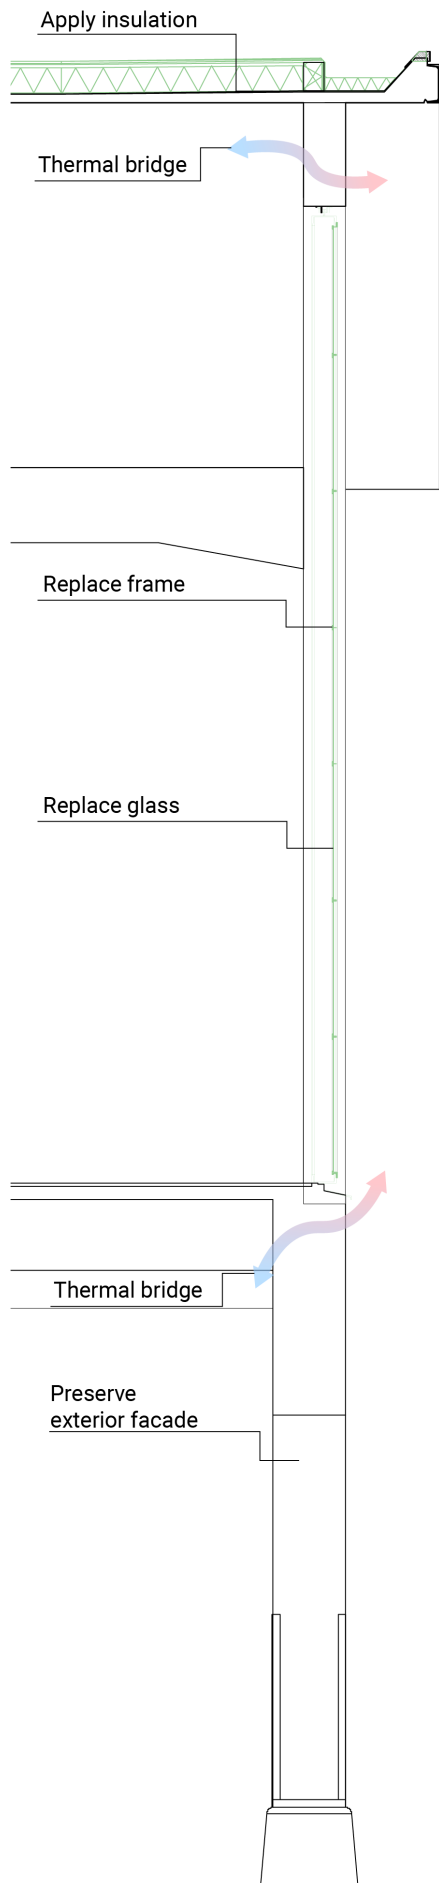
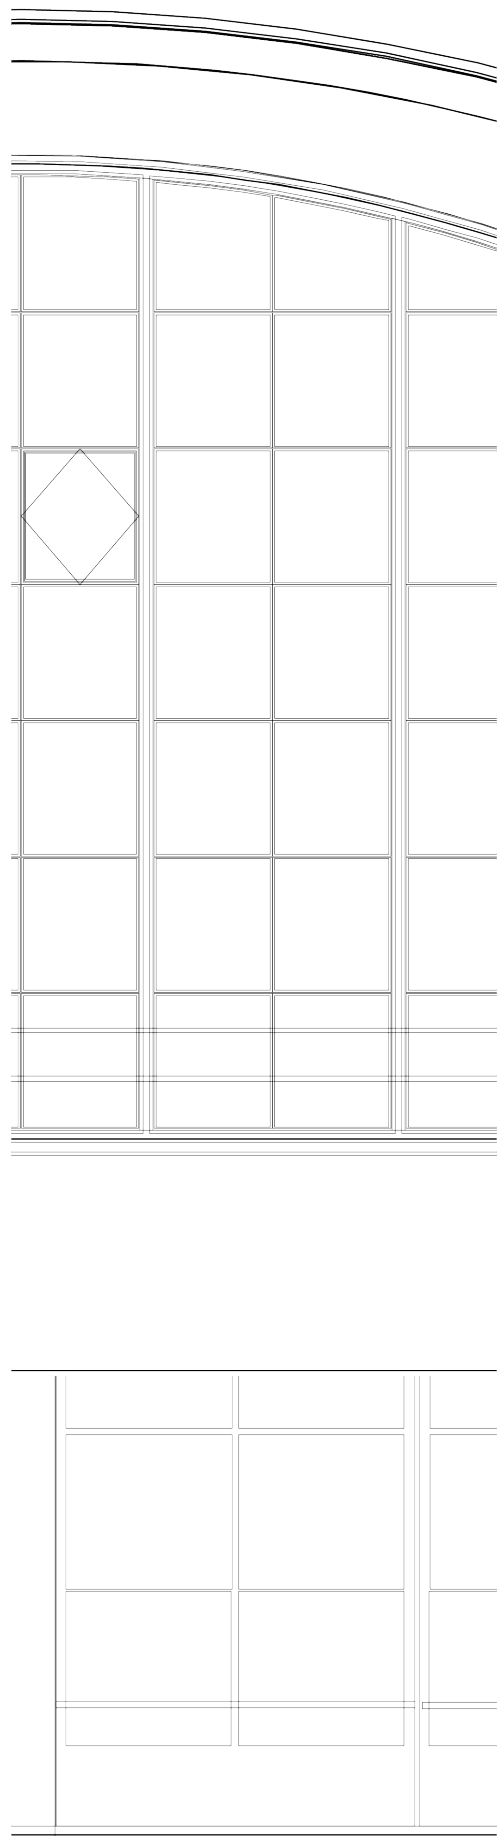
Figure 34 Facade section with new adaptations in green (own image)

**Open façades:** The glass façade is replaced to increase the comfort, acoustic insulation, and the poor condition of the façade. The plan before the renovation was to preserve as much of the original material as possible, however during the execution, the frames appeared to be in such a bad condition that they had to be replaced (figure 34). For the new frames, the architectural quality commission demanded that the thickness of those frames had to be the same as the original to keep the cultural values of the façade intact. This meant investing more money in new custom made steel renovation frames with a thickness of 40 mm. (Hartman, 2014)

The placed glass in the frames, attribute to the acoustic insulation and the thermal resistance of the building. The thickness of the frames also limits the thickness of the glass, this meant the glass that is installed is monumental double 4-6-4 clear glass and has a U-value of 2.5 W/m<sup>2</sup>K. Other glass types can provide a lower U-value to increase the sustainability, but because of the restrictions that the cultural values in the façade bring this was not possible. (Hartman, 2014)

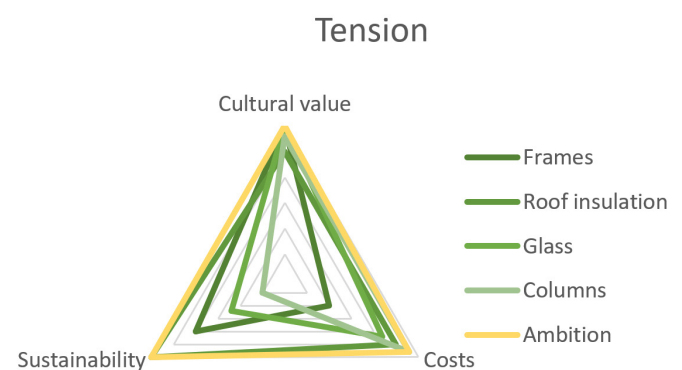
**Figure 35 Balance measures** Cruise terminal Cultural values and sustainability are on a positive axis and cost on a negative axis, meaning that when the costs are low, the value is further from the center. (own image)

was due the poor condition of the windows and the fact that the majority of the façade was open. It was more efficient to focus on this part.

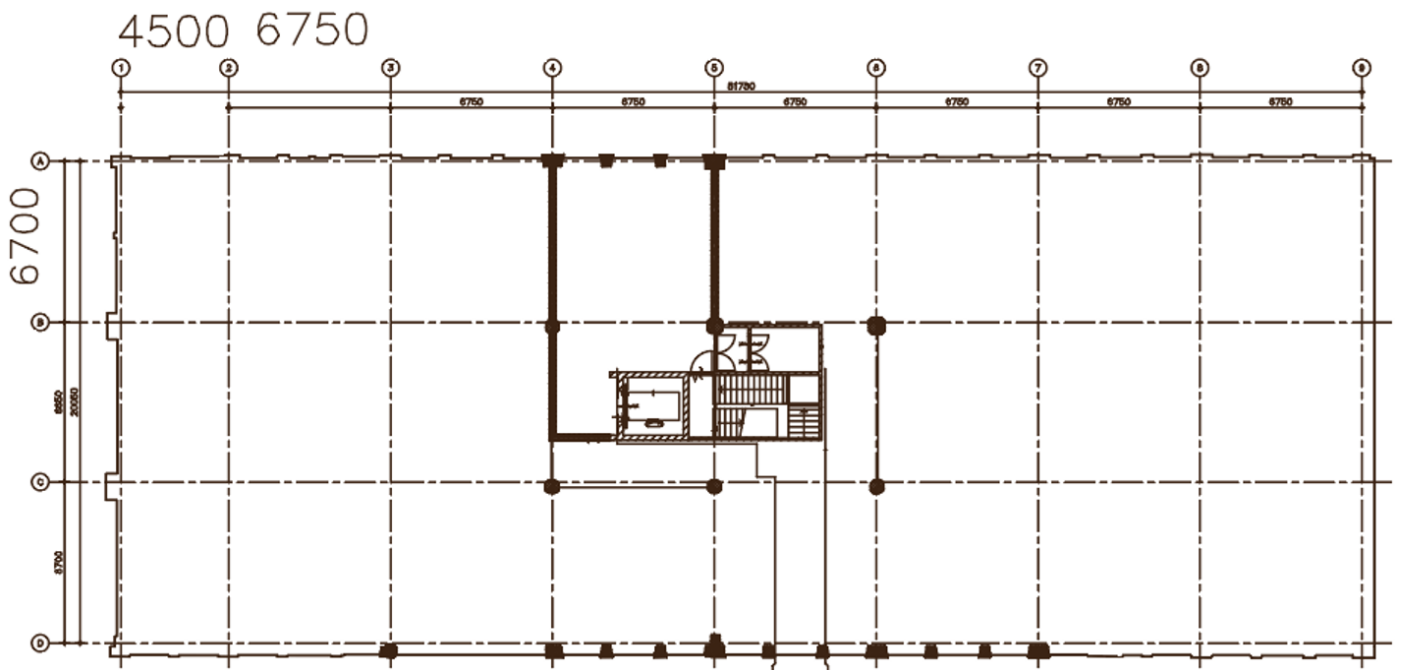
Figure 37 Floorplan (ABT,2002)

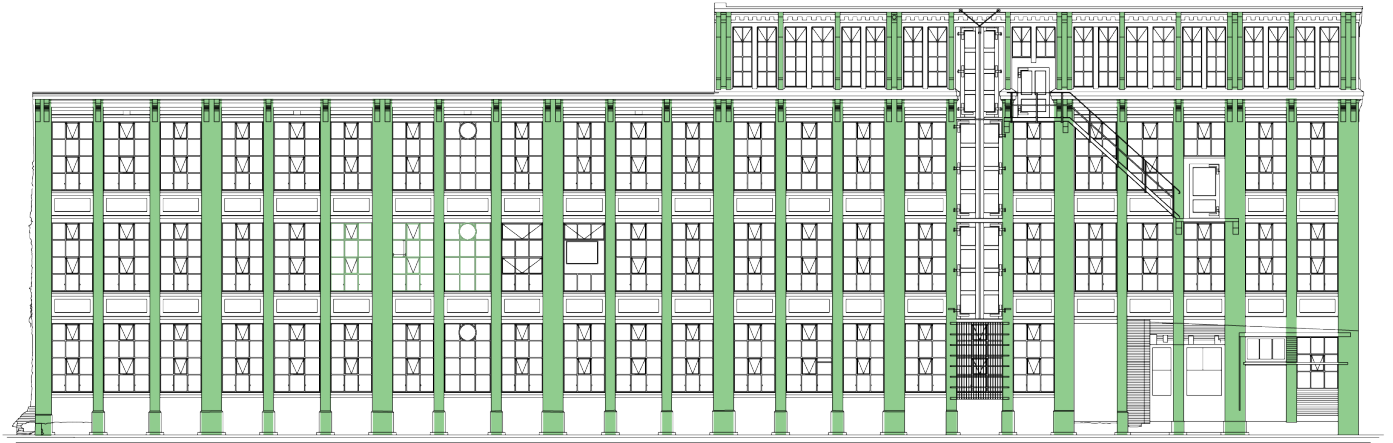
Figure 39 Longitude facade with column structure in green (own image)

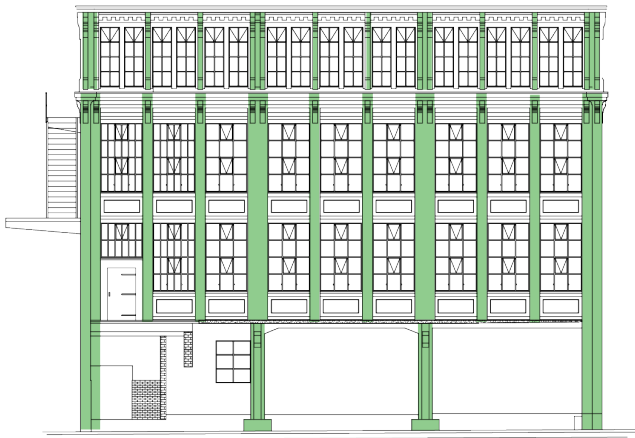
Figure 40 West facade with column structure in green (own image)

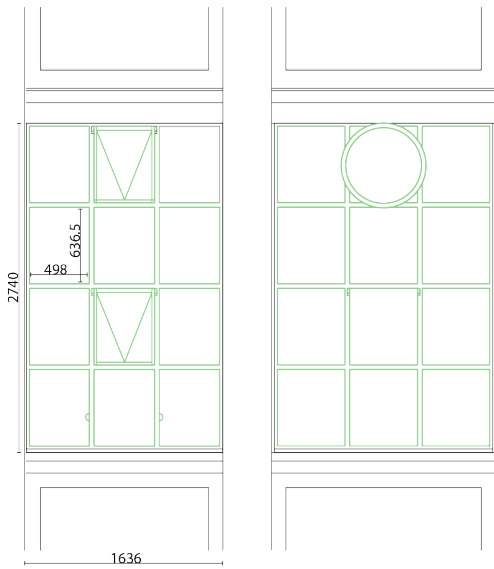
Figure 41 Windows with grid structure in green (own image)

**Open façades:** On the first three floors, the windows are 1636 by 2740 mm with a divided twelve-square (3x4) grid (see figure 42). The glass panels are 498 by 636,5 mm. The windows on the fourth floor separate from the others with two eight-square (2x4) grid instead of one twelve-square (3x4) grid, and a decorative 'bloktand' as molding (see figure 43). The window frames are made of cast iron and have a thickness of 38 mm. The window frames are directly connected to the columns. These frames were still in good condition to preserve, the single glass in the frame was for the most part broken or missing.(ABT, 2002)

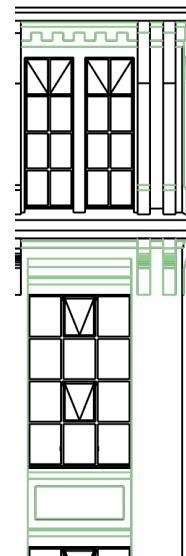
Figure 42 Ornaments in green (own image)

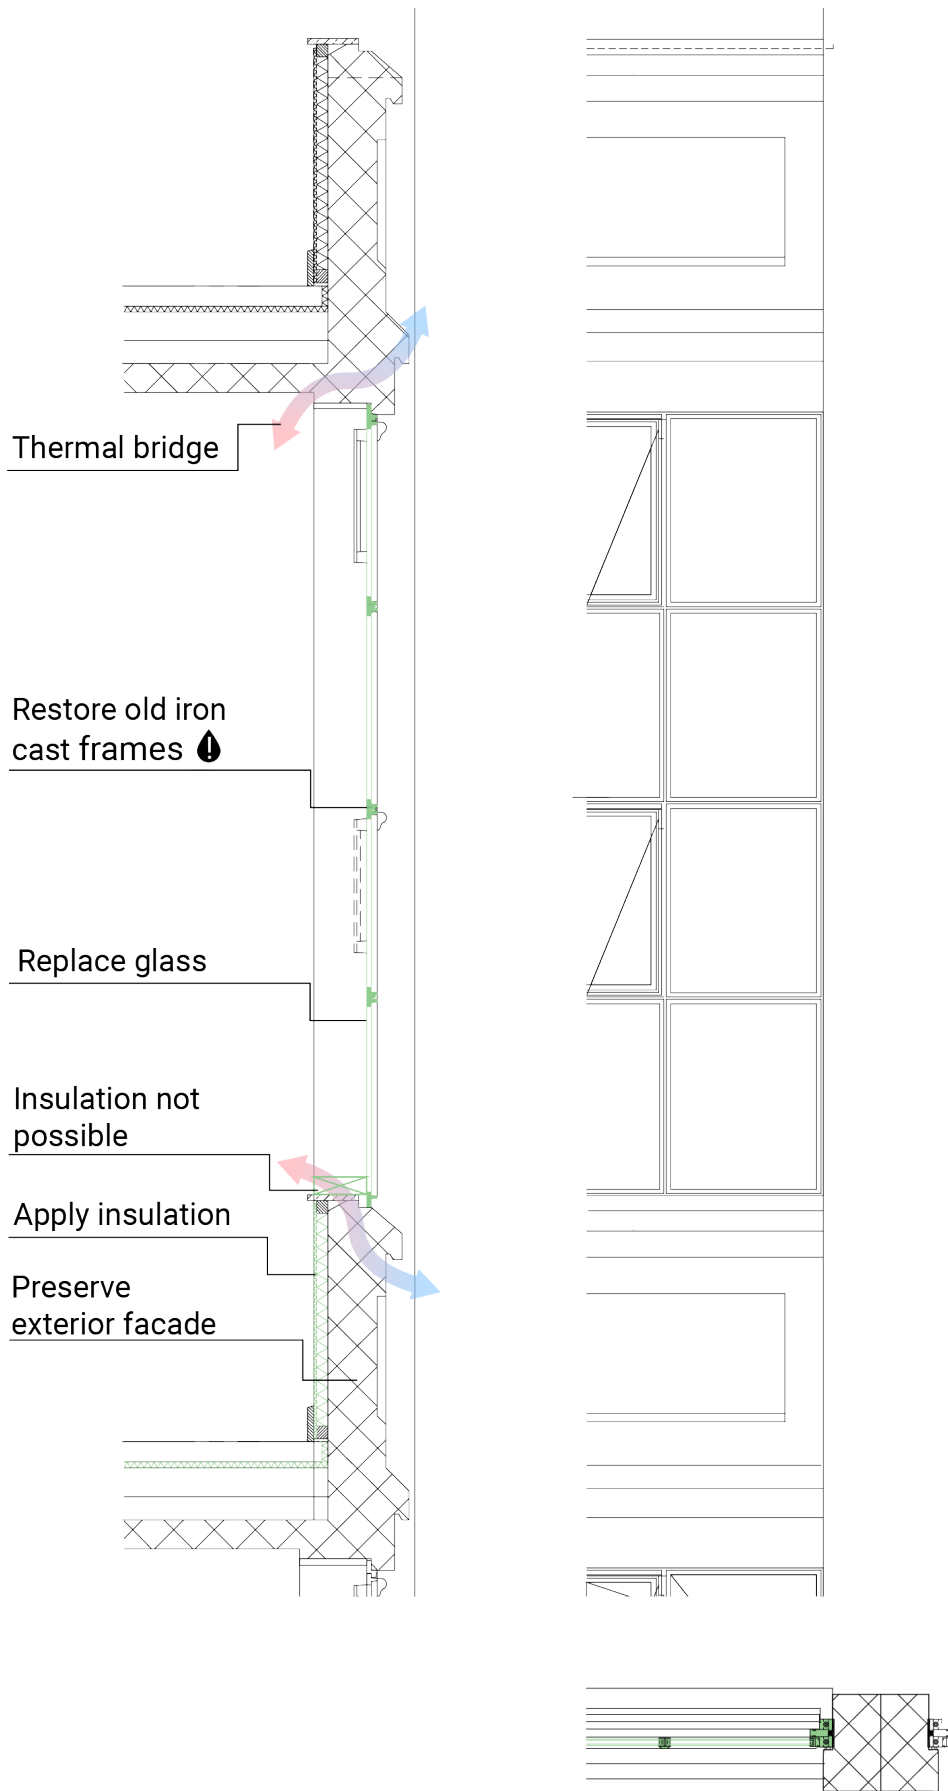
Figure 43 Facade section Tricot (own image)

**Open façades:** The costs for placing glass with a U value of 1.4 W/m<sup>2</sup>K and a thickness of 10 mm costs around 40 €/m<sup>2</sup>, the repair of the cast iron frames is more difficult to trace the costs because it is not a standard procedure. But this procedure is close to the original plan of the cruise terminal. This means that the costs are approximately 150 €/m<sup>2</sup>.

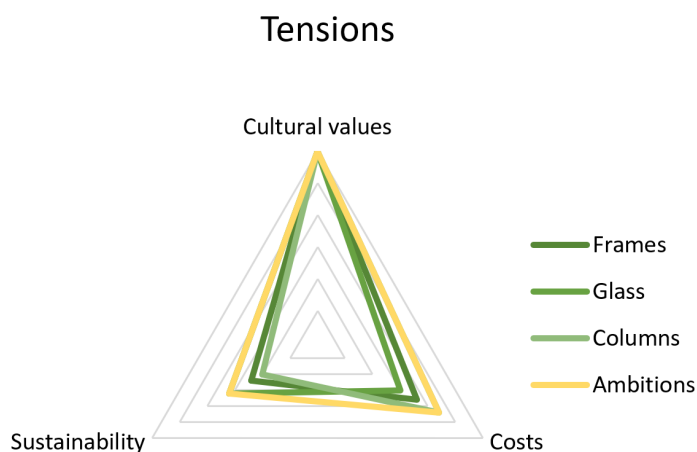
**Figure 44** Balance measures Tricot Cultural values and sustainability are on a positive axis and cost on a negative axis, meaning that when the costs are low, the value is further from the center. (own image)

A lesson learned from this case study is that condition of certain building parts has an influence on the decision making. In this case study, the east façade and the glass were no longer present. This led to the logic decision to replace them completely. Overall the Tricot project was a successful transformation from a vacant old building to an

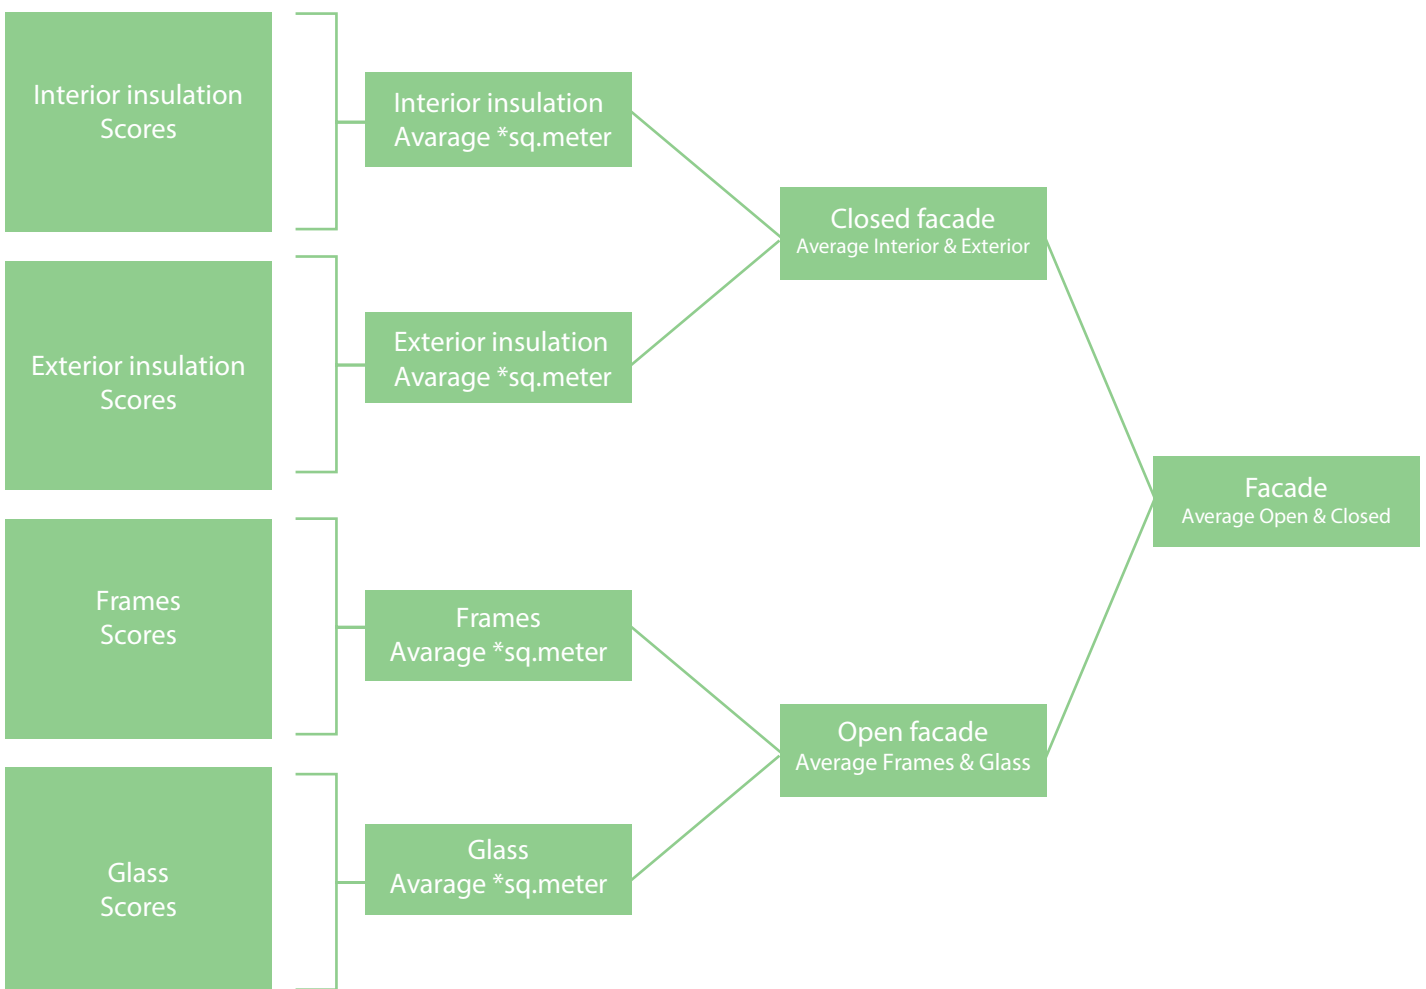
Figure 47 Concept of tree diagram (own image)

square meters but there is more glass than closed façade (such as cruise terminal, chapter 4.4.4) it is better to focus on changing the glass because you would achieve more by doing so, but it also is more expensive than applying the insulation. Next to the amount of square meter, the condition of a building part also has an impact on the decision making (see chapter 4.4.4 & 4.5.4). When a building part has a poor condition, it is better to focus on that part instead of the building part that already is in a good condition. The tree diagram will show which building part would have the best potential to renovate by multiplying the average of the score of all the measures with the percentage of square meters of that particular building part and the condition in percentage (see figure 47).
