MSc thesis

3D imaging and microstructural
characterization of reinforced
concrete structures naturally-
deteriorated due to corrosion

Master of Science
in Building Engineering

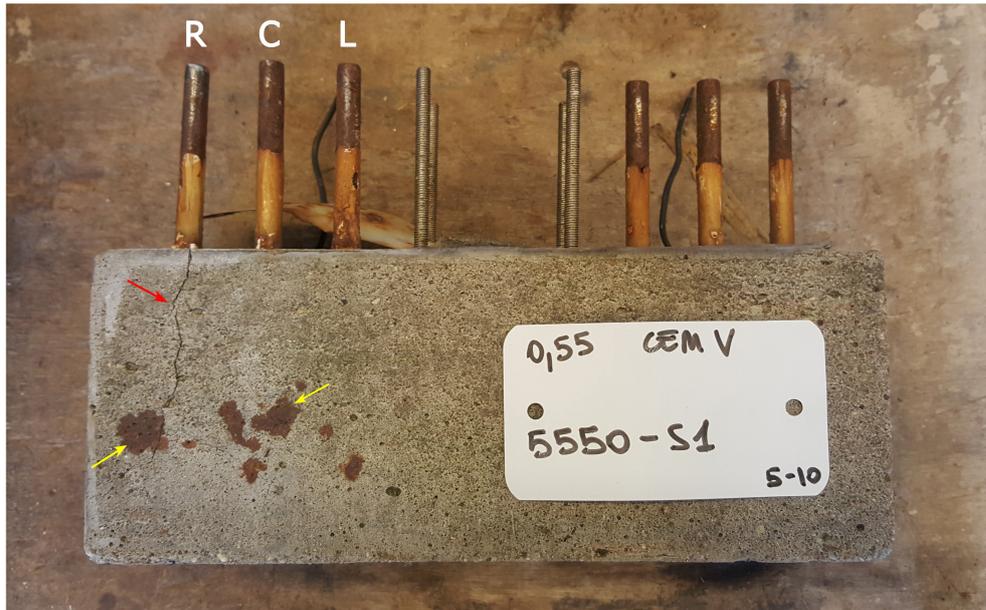
Figure 5.5: Example of visible cracks (red arrow) and rust (yellow arrow) at the surface of one prism (5550-S1); R, C and L to label the location of each bar.

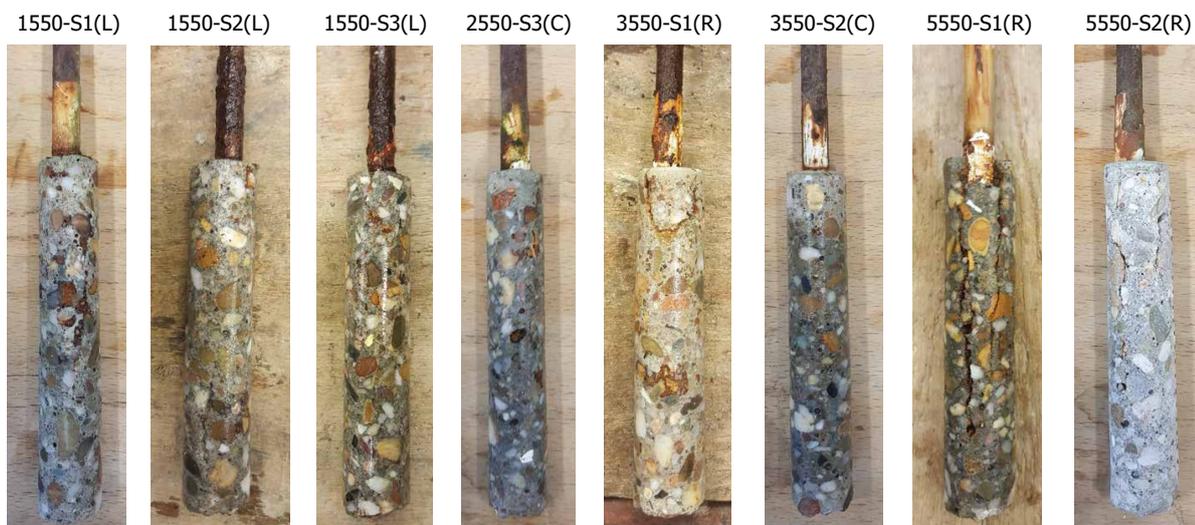
Figure 5.6: Drilled reinforced concrete cores
