# Processes and controls of meander development in the Allier, France

a case study on meander change in the period 1960 – 2003

Maarten Bakker  
9907610  
Department Physical Geography  
Faculty of Geosciences

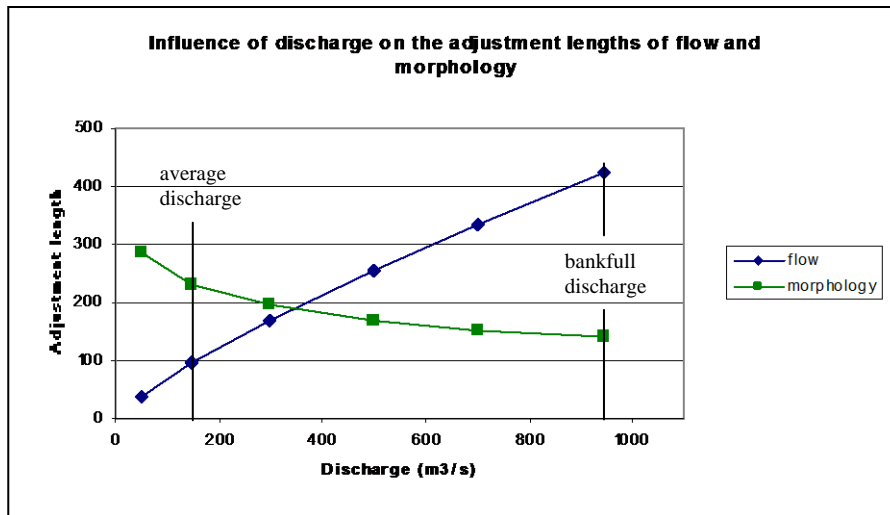
Figure 3.8: Adjustment lengths of flow and morphology as a function of discharge.

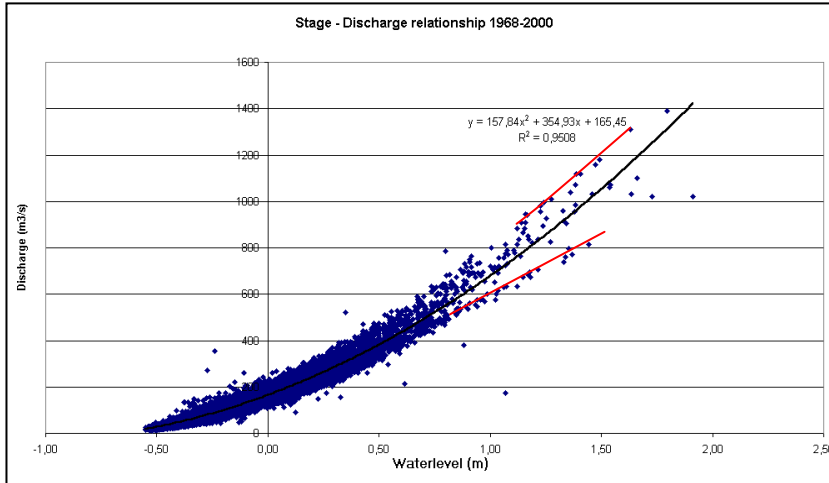
Figure 5.1: Stage discharge relationship and regression (including two additional sub-relationships marked in red). Discharge is placed as unknown variable (y) that is determined by the known waterlevel (x), even though waterlevel is dependent on discharge. The waterlevels were measured at Moulins.

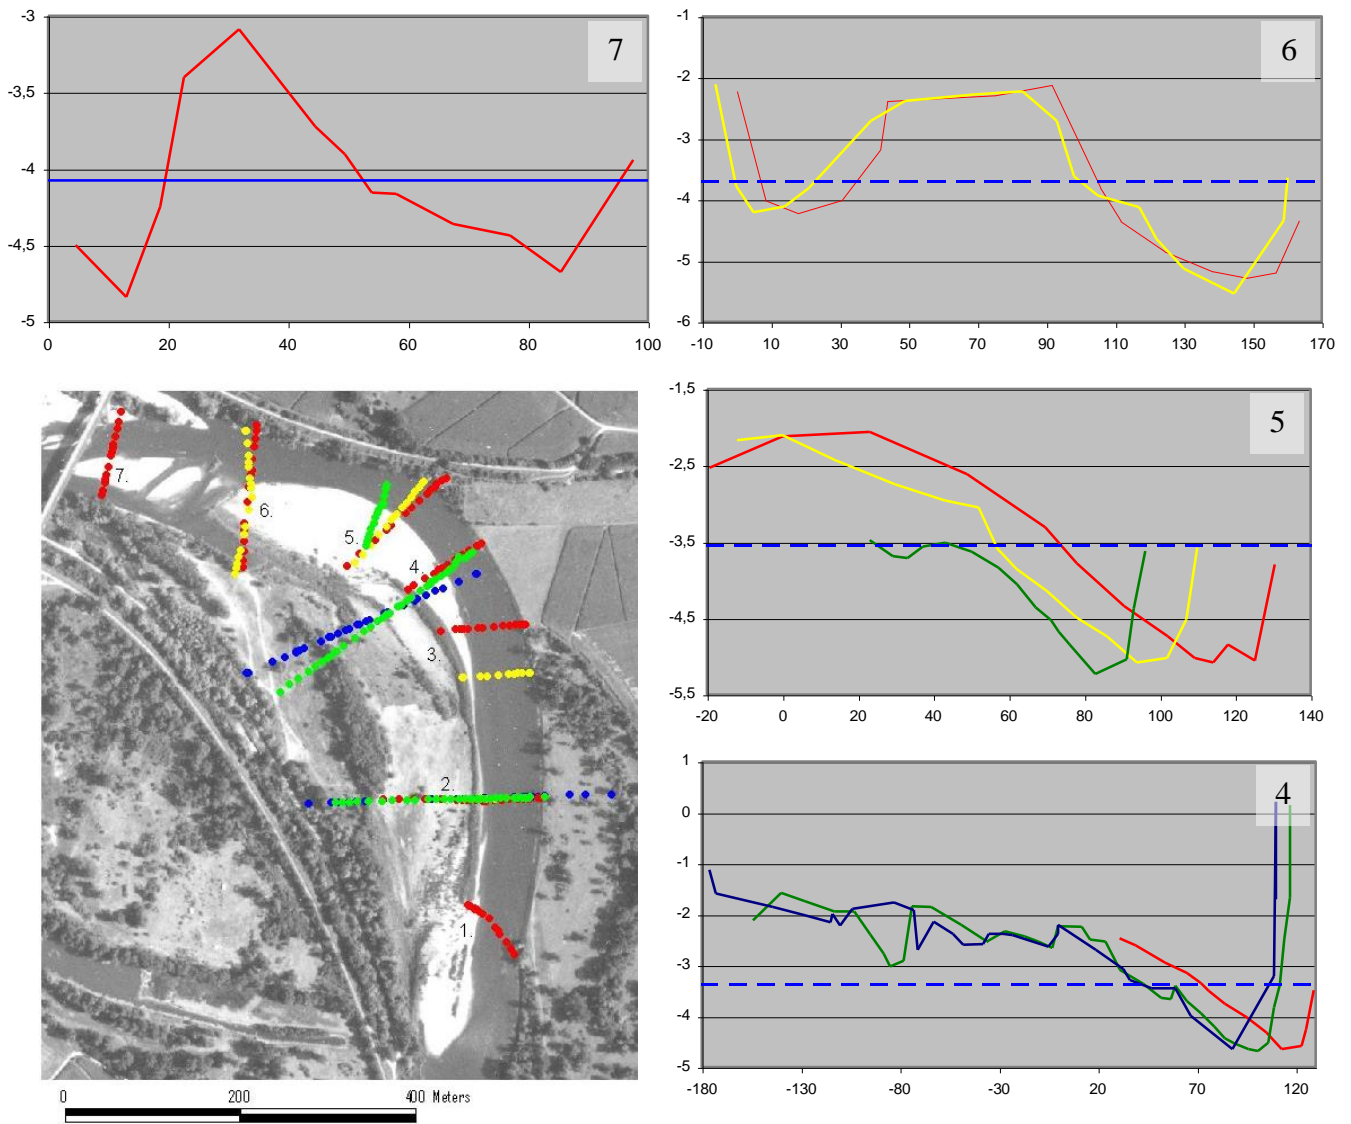
Figure 6.9. The location of profiles from 1995 (blue), 1996 (green), 2002 (yellow) and 2003 (red) with the aerial photo from 2002 on the background. The numbered profiles are displayed around the location map. On the x and y axis are height and distance, both in meters. Heights are related to a fixed point (nail in tree). Distances are related to a zero point where the profiles are closest together or in the case of profile 3 the outer bend was taken as zero point.

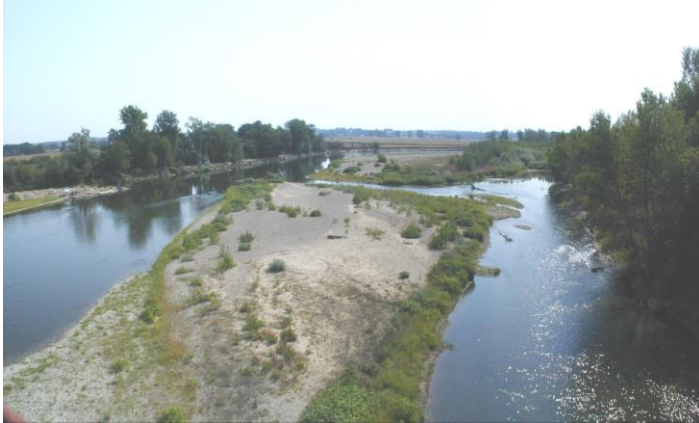
Figure 6.10b: Meander overview St. Loup in 2003. Picture taken from the bridge downstream of the pointbar in ESE direction.

The swale, behind the point bar, held stationary water that had a waterlevel equal to that of the downstream riffle to which it was connected. Cross channels developed because the waterlevel gradient across the pointbar was greater than that between the outer bend and the downstream riffle. Vegetation played an important role in their stabilization, catching in sediment, and steepening of banks, limiting erosion to the edges (figure 6.10a,b).

In cross section 7 a bar, just visible beneath the shoreline (maximally 15 meters wide) was recently added to the downstream section of the pointbar. A similar bar was seen in figure 6.10b at the left bottom of the picture. The bar was slightly asymmetric (steep on the inside of the bend) caused by weak helicoidal flow that has developed in the last part of the bend.

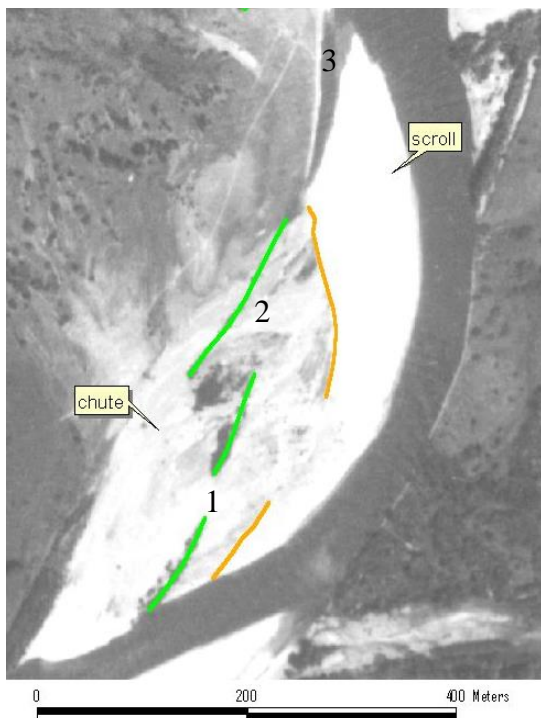
The 1960 aerial photograph of the Châtel de Neuve pointbar (figure 7.1) can be divided into two sectors (separated by orange lines). The upstream half of the pointbar was dominated by chute processes. Paths of concentrated sedimentation (1,2) crossed through vegetation (including strokes of trees formed during earlier lateral sedimentation). The downstream end of the pointbar was characterised by lateral sedimentation, containing an extending scroll bar complex separated from the surrounding land by a large swale (3).

Figure 7.1: 1960 aerial photo; old vegetated scroll contours in green, and the boundary between scroll and chute processes in orange.

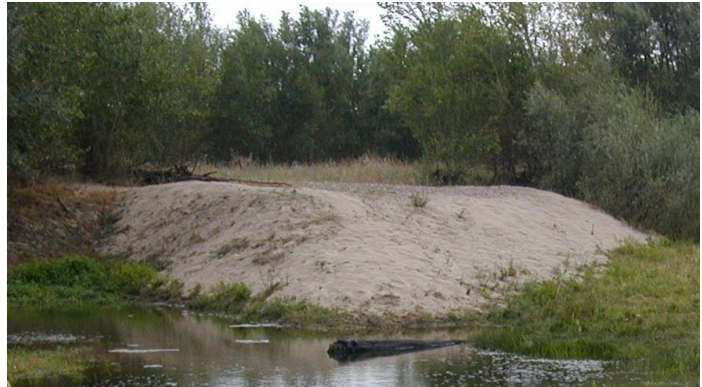
*Figure 7.11: At the end of a chute a bar develops, where flow enters the swale.*

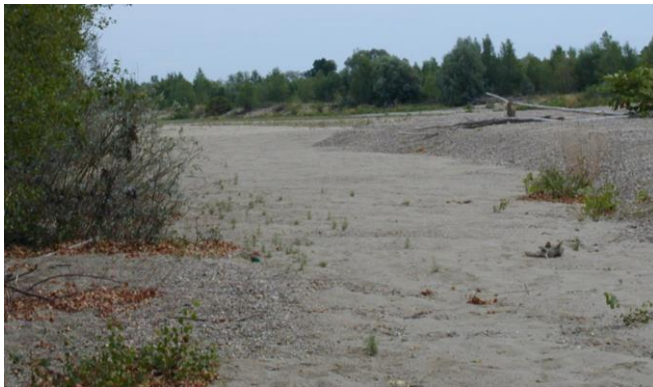
*Figure 7.12: Looking downstream through a crossing channel along stroke of poplars (left) and with the main channel on the right.*

A swale developed as result of the quick downstream development of the bend (sedimentation had trouble keeping up; figure 7.8; 1). Sedimentation occurred along the main channel, but also in the swale behind the pointbar. Sedimentation occurred at the end of the cut-off channel (from 1985), that was in use during high discharges in the early 1990's (figure 7.8; 2). In the late 1990's a similar a similar process occurred in the form of a chute bar (figure 7.9). Water flowed across the pointbar (arrow figure 7.9) in a unvegetated depression (figure 7.10). Flow diverged when it entered the deep swale, allowing its sedimentary load to settle (figure 7.11). A third source of sediment in the swale was a crossing channel (figure 7.8; 3). It crosses the narrow pointbar to benefit from an increase the waterlevel gradient, as opposed to flowing along the long pointbar (similar to St. Loup, section 6.2.2). The channel started out as a lateral swale, the upstream part was nearly parallel to the shoreline, and ends crossing the pointbar draining water and releasing sediment. The highwater deposit marked in figure 7.9 and the sediment plume in at the end of figure 7.8 (3), resulted from crossing channels. The high water deposit expanded substantially due to the concentration of flow in crossing channels that lie along a stroke of trees (figure 7.12). The channels cannot cross further upstream. In

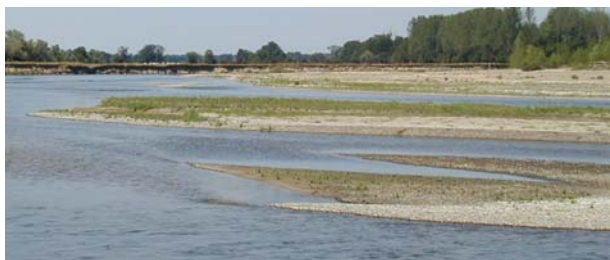
Figure 10.10 b: A photograph from 2003 of the scroll patterns visible in figure 10.10a.

The dent at the upstream end of the resistant bank (1) was sharpening and slowly eroding upstream, in south-eastern direction. The sharp bend and the direction of incoming flow (low sinuosity) allowed the occurrence of chute cut-offs (figure 10.10).

Bars that made up a cut-off island, in the upstream part of the bend (1998) showed a change in sedimentation direction eastwards (figure 10.10). Erosion could only make room for sedimentation in this direction because of the resistant bank. The cut-off island grew in size and migrated inward, towards the pointbar. The northward expansion was enabled the decreasing size of the “cut-off” channel that also migrated northwards. In 2003, the downstream end of the high water channel was located in a former swale (1).

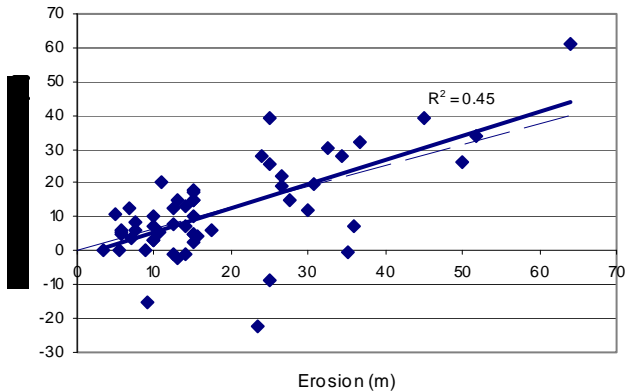
Figure 14.1: Correlation between erosion and lateral sedimentation. The dotted line represents equilibrium, where average erosion equals average lateral sedimentation.

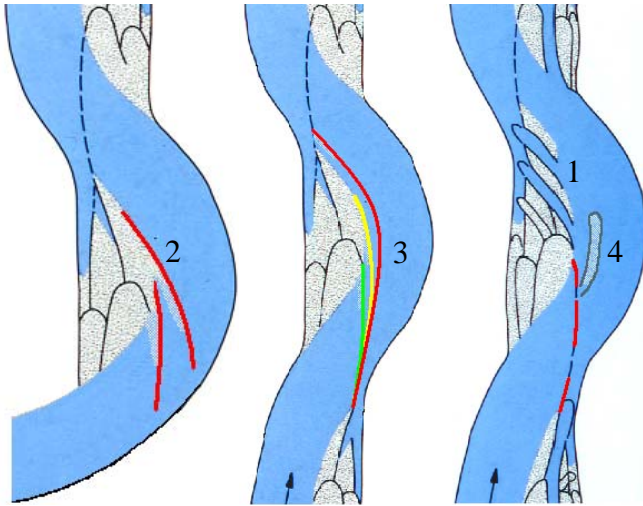
Figure 15.3: Riffle / scroll bar interaction. In situation 1 the pointbar is crossed by low-water flow channels, in 2 riffle/scroll margins (red) develop along a long (complex) bend, in 3 riffle margins (green, yellow and red) overlap, to various extents, with the pointbar and in situation 4 a bar develops at the end of an erosive crossing channel.
