# Experimental and Numerical Assessment of Historical Steel-Concrete Composite Bridge Decks Without Mechanical Connectors

**Abstract.** In old Dutch inner cities like Amsterdam a large number of steel-concrete bridge decks built between 1880 and 1960 remain in service nowadays and currently need assessment of their bearing capacity. A significant number of these decks were designed without any mechanical connectors like shear studs in the interface between concrete and steel. Moreover, the concrete decks were designed with only shrinkage reinforcement in both directions on the top layer of concrete. No additional transverse reinforcement was placed that can ensure proper (re)distribution of loads after cracking. In order to study the bearing capacity of this deck typology, two specimens of an existing bridge were taken to the Stevin Lab of TU Delft and tested until failure. In this work, the experimental results of both tests are presented. Then, finite element models including nonlinear behaviour of the materials and the interface are presented and compared with the experimental observations. Experimental results show that the bearing capacity is achieved after yielding of the st

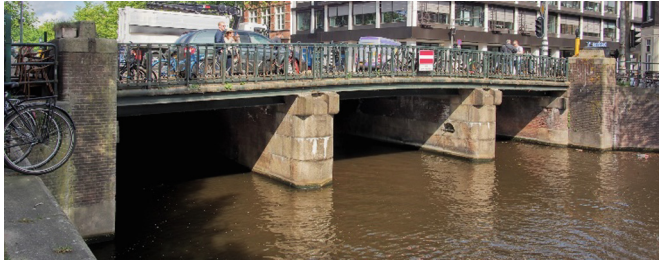
**Fig. 1.** Picture Bridge 70 Vijzelstraat, Amsterdam. Picture adapted from Google.

A particular type of bridges that has brought attention lately is the steel-concrete-composite slab deck. These bridges were designed and built between 1880 and 1960, and around 150 are still in operation in Amsterdam [1]. These bridges are multi-span bridges, and the cross-section of the deck is composed of partially encased steel beams, see Fig. 1 and Fig. 2.
