## A new prototype of Fibre Optic Sensor (FOSS) to monitor bridge scour

### Abstract

Building on this need, this paper presents the early development and initial findings of a Fibre Bragg Grating (FBG) based fibre optic sensor, called FOSS (Fibre Optic Scour Sensor), installed at a bridge site in the Northern Ireland region.

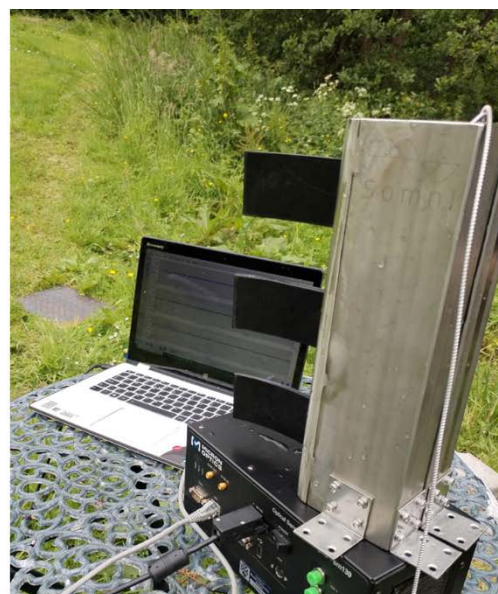
The developed sensor consists of a fibre optic cable with three FBGs, each placed between two thin rubber layers to form three individual fins

positioned at different depths (Fig. 1). These fins can detect any changes by generating signals when they shift from their mean position. The entire system is enclosed between two stainless steel sections, forming a bluff body that shields the optical components. FOSS is capable of capturing real-time data related to both the scouring and infilling processes which may occur during floods.

Figure 1. The FOSS Sensor with the three fins, each containing a FBG sensor

A folded stainless-steel baseplate provided a secure mounting for the sensor and a stainless-steel bracket stabilised the top of the sensor. The steel brackets also act as a frame and provide the protection to the Fibre optical cable (FOC). A High-visibility tape on the sensor is applied which allows the inspectors to visually confirm its exposure without checking data outputs. A stainless steel angle section is used to secure the FOC by means of cables applied at every 100 mm.

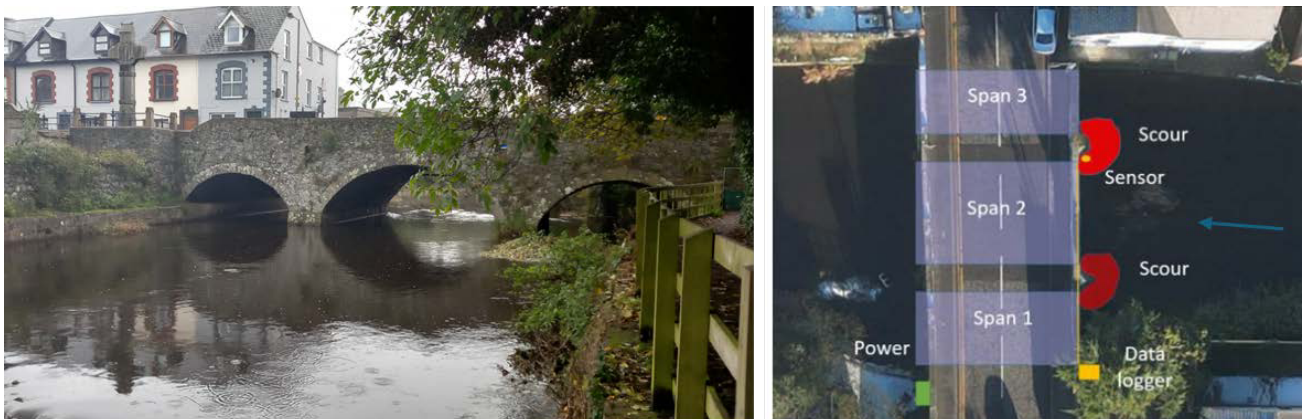
Figure 2. Regents Bridge

Considering the above criteria and using Geographic Information System (GIS) map layers, Regents Bridge in Dromore (County Down, Northern Ireland) was chosen as the testing deployment site (Fig. 2).

The selected bridge is a 3-span masonry arch over the Lagan river and was built in early 19<sup>th</sup> century; it has a total length of 21.4 m and width of 11 m. Regents bridge was listed in 'B1' category (from 'A', 'B+', 'B1', 'B2' grade) for its historic importance; hence, interventions must not impact negatively the historic integrity of the bridge.

The installation of scour sensor was done in February 2023 (dry weather, approx. 400 mm water level). A green lockable cabinet powered from nearby street light is installed at the downstream side (Fig. 2). It has an isolator for providing steady 240 V power supply to testing

equipment. A stainless steel water proof enclosure was set 3 m above the river edge set back from a masonry wall mounted to a RC wall closed to span 1 ("data logger" in Fig. 2).
