Campbell, K., Lydon, M., Pregnotato, M., Arora, R. K., Lydon, D., & Nieuwland, R. (2025). A new prototype of Fibre Optic Sensor (FOSS) to monitor bridge scour. In D. Leonetti, H. H. Snijder, B. De Pauw, & S. van Alphen (Eds.), *IABSE Congress Ghent 2025: The Essence of Structural Engineering for Society* (pp. 1912-1917). International Association for Bridge and Structural Engineering (IABSE).

## A new prototype of Fibre Optic Sensor (FOSS) to monitor bridge scour

### Abstract

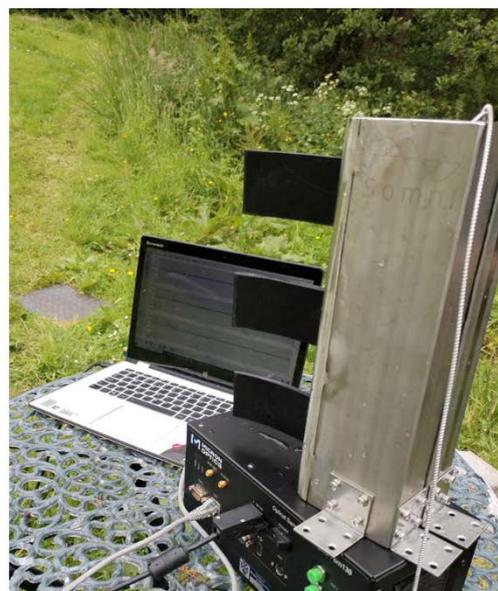
The developed sensor consists of a fibre optic cable with three FBGs, each placed between two thin rubber layers to form three individual fins

positioned at different depths (Fig. 1). These fins can detect any changes by generating signals when they shift from their mean position. The entire system is enclosed between two stainless steel sections, forming a bluff body that shields the optical components. FOSS is capable of capturing real-time data related to both the scouring and infilling processes which may occur during floods.

Figure 1. The FOSS Sensor with the three fins, each containing a FBG sensor

A folded stainless-steel baseplate provided a secure mounting for the sensor and a stainless-steel bracket stabilised the top of the sensor. The steel brackets also act as a frame and provide the protection to the Fibre optical cable (FOC). A High-visibility tape on the sensor is applied which allows the inspectors to visually confirm its exposure without checking data outputs. A stainless steel angle section is used to secure the FOC by means of cables applied at every 100 mm.

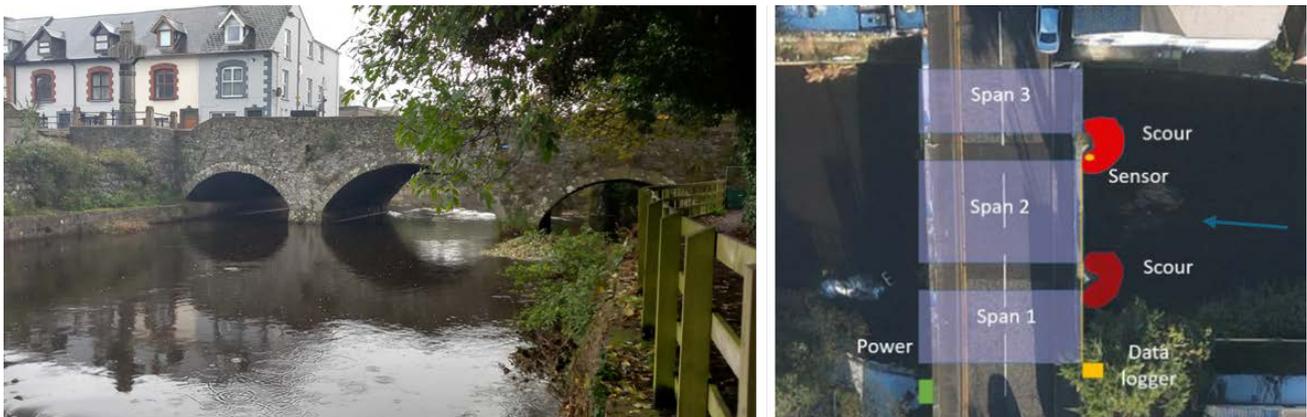
Figure 2. Regents Bridge

Considering the above criteria and using Geographic Information System (GIS) map layers, Regents Bridge in Dromore (County Down, Northern Ireland) was chosen as the testing deployment site (Fig. 2).

The selected bridge is a 3-span masonry arch over the Lagan river and was built in early 19<sup>th</sup> century; it has a total length of 21.4 m and width of 11 m. Regents bridge was listed in 'B1' category (from 'A', 'B+', 'B1', 'B2' grade) for its historic importance; hence, interventions must not impact negatively the historic integrity of the bridge.

The installation of scour sensor was done in February 2023 (dry weather, approx. 400 mm water level). A green lockable cabinet powered from nearby street light is installed at the downstream side (Fig. 2). It has an isolator for providing steady 240 V power supply to testing

equipment. A stainless steel water proof enclosure was set 3 m above the river edge set back from a masonry wall mounted to a RC wall closed to span 1 ("data logger" in Fig. 2).
