FINAL RAPPORT

12/12/2011

Recife

Coastal Protection Plan

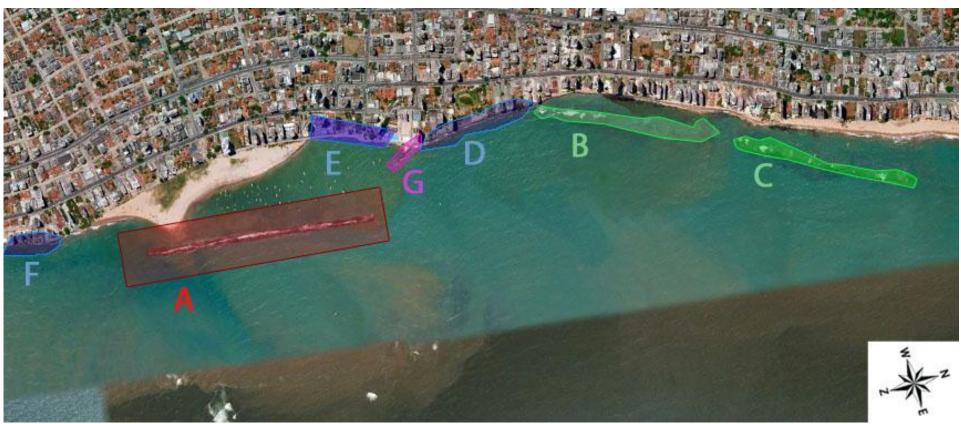
Figure 4: Overview Candeias (Source: Google Earth) (red:breakwaters green: distinctive reefs, blue: revetments, purple: groynes)

The large breakwater in Candeais was probably built in order to preserve a beach. When assessing Figure 4 it can be seen that there is a relatively small beach in front of a relatively large breakwater. One would expect a larger beach from such a breakwater. Next to the breakwater there are also some revetments present. Since it is not very clear what the true purpose of the breakwater was with respect to the size of the beach, it is assumed that there would be a beach present between structures F to G (Figure 4Error! Reference source not found.). Note that the assessment will be based on this preassumption.

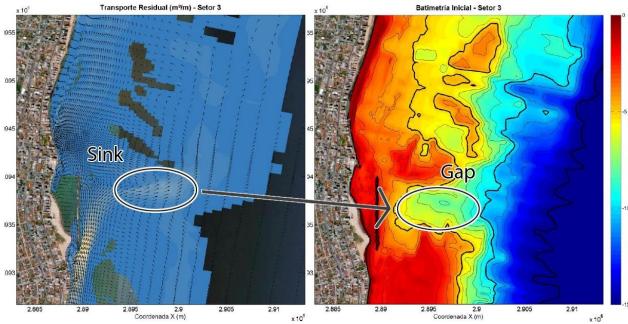
Figure 6: Annualized Sediment transport Cassa Caiada (left) Bathymetry Cassa Caida (right) (CPE, 2011)

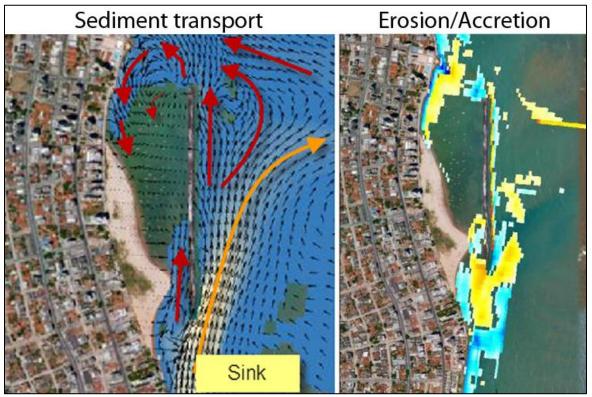
Figure 8: Annualized Sediment transport (left) and Erosion/Accretion after 1 year (right) (CPE, 2011)

In this part the model results will be compared to pictures from Google earth. Figure 8 shows the local sediment transport near the breakwaters, the red arrows have been added for clarification and the orange arrow refers to the sink transport. One can see that there is a circulation on the north part of the breakwater; this is probably due to diffraction (this phenomenon is clearly visible in Figure 9Jan 26, 2007). On the right side of Figure 8 a prediction of the amount of erosion/accretion after 1 year is shown. One can see erosion on the south side of the salient, on the top of the salient and north of the salient a small stroke of erosion along the coast. Thus, in time, flattening of the top of the salient is expected.

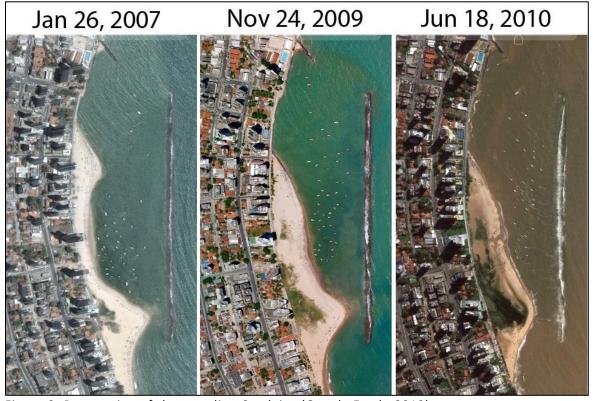
Figure 9: Progression of the coastline Candeias (Google Earth, 2010)

Although the CPE report was published in April of 2011, the resulted beach profile changes on the google earth pictures could for the bigger part also be found in the 1 year model such as: 1) erosion of the top of the salient, erosion of the south side of the salient and slight erosion north of the salient. What was not found in the model was the accretion in the middle of the salient; this is clearly between 2007-2009 and slightly visible between 2009-2010.

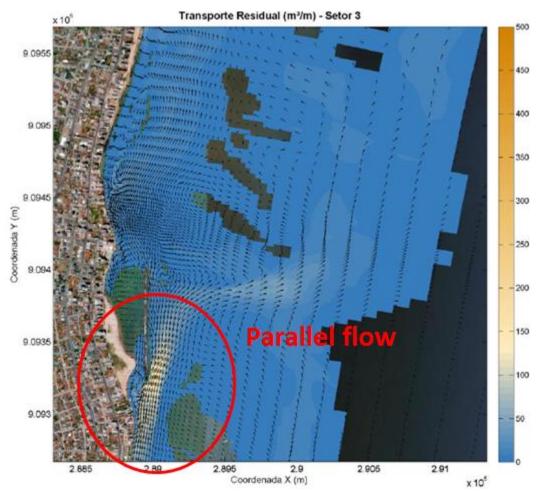
Figure 11: Sediment transport direction (CPE, 2011)

What can be seen in Figure 11 is that the sediment is transported along the shore, nearly parallel to it. On the landwardside of breakwater A there is a large salient which blocks the sediment transport, which forces the sediment to flow towards ocean. This is the sink explained in the problem assessment. With the aid of structures, this loss could to some degree be reduced.

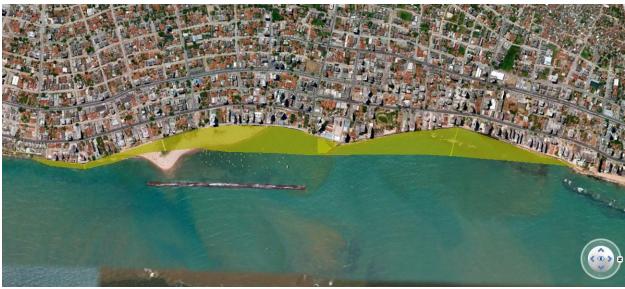
Figure 12: Indication of the desired coastline and required nourishment

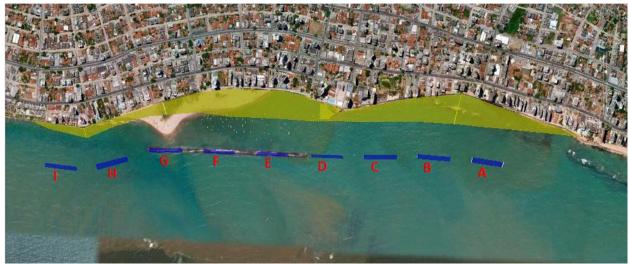
Figure 13: Alternative 1 with the 'hard' and 'soft' measures

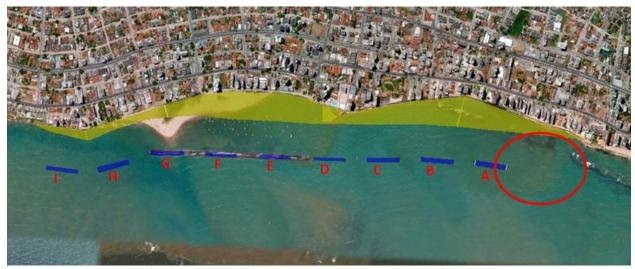
Figure 14: Indication of the gap between the new breakwater and reef C in Candeias

The gap between breakwater A and reef C (Figure 4) is currently about 300 meters, which most probably will allow the sediment to be transported to the north. But if an additional breakwater will be built, the future gap will become 100 meter and then it will be doubtful whether there will be enough sediment transport to the northern area. Because of this, the choice is made to leave out this additional breakwater.

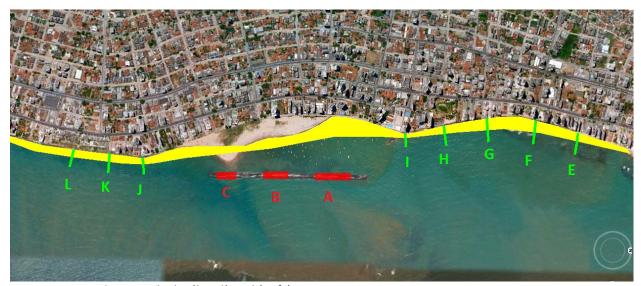
Figure 15: Candeias with the 'hard' and 'soft' measures

A sketch of the situation with the new 'hard' and 'soft' measure is displayed in Figure 15. Here the relative location of the breakwater and groynes to each other is visible. Figure 15 is merely an indication of the proposed alternative.

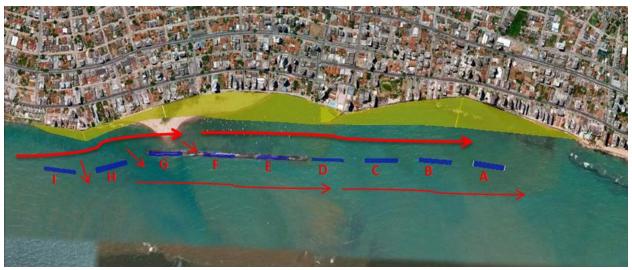
Figure 16: Expected main flow of the sediment with Alternative 2

It can be seen that the sediment will move along the coast (accreting in the meanwhile), and it's plausible that some of this sediment will reach the beaches in Piedade. This assumption is enforced by the solution (see Figure 17) and models (see Figure 18) of the (CPE, 2011). Alternative 2 in particular presents a similar solution as the (CPE, 2011). The expected sediment transport is also similar to the one presented above (see Figure 16). Thus can be said that it is plausible that some sediment continues to Piedade.

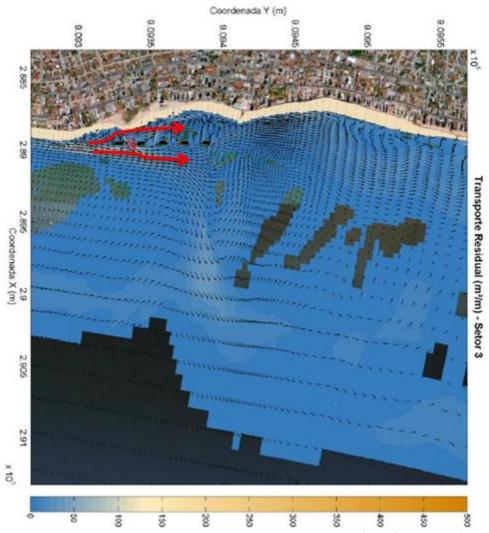
Figure 18: Modeled sediment transport with the solutions of the (CPE, 2011) and the main transport

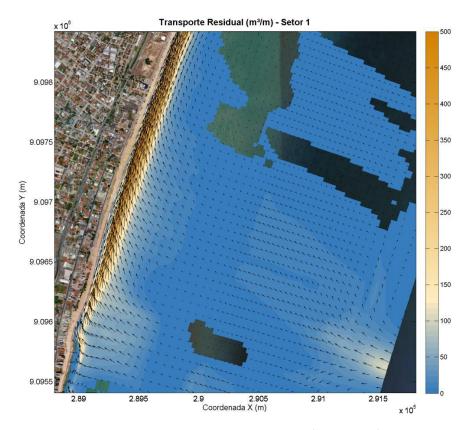
Figure 20: Transport rates and direction Piedade (CPE, 2011)

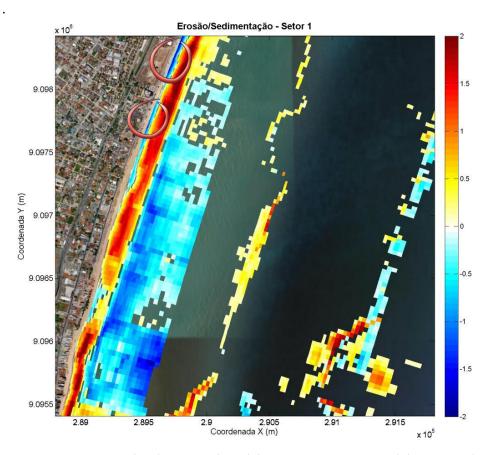
Figure 21: Accretion (red) Erosion (blue) (Scenario 5 years later) (CPE, 2011)

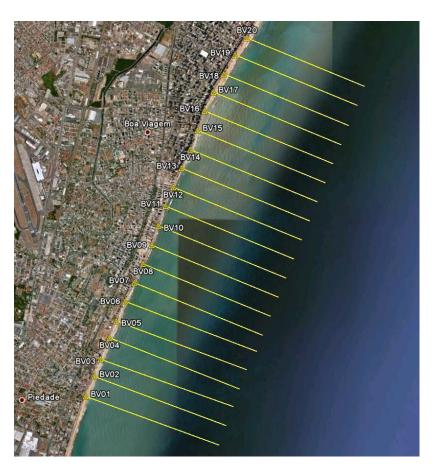
Figure 24: Beach profiles in Piedade (Only profile BV01 to BV05 are in Piedade – The remainder are in Boa Viagem

Beach nourishment seems like a clear cut solution for the area. The sector slightly upstream in Boa Viagem requires beach nourishment as well. It is therefore recommended to nourish the area in a single stretch. The amount of nourishment required has been calculated in (CPE, 2011). The equilibrium profile was compared with the current profile and from both a construction profile was determined. The deficit of sand to attain the construction profile is the amount that will need to be deposited. The amount required is displayed in Table 5. The profiles that will be nourished are BV1 to BV5 (See Figure 24)

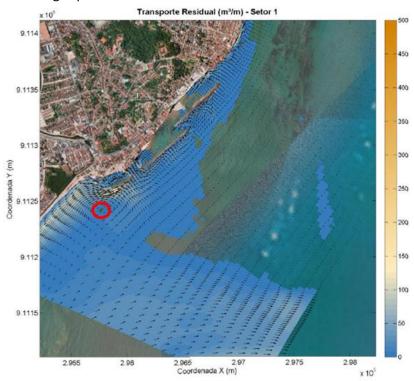
Figure 39: Circulation of the water body

At the relatively long beach in the south the circulation leads to a flow from north to south with high velocity that causes much turbulence due to interaction with the coast. In the end this leads to much erosion of the beach, which seems to be healthy at the moment.

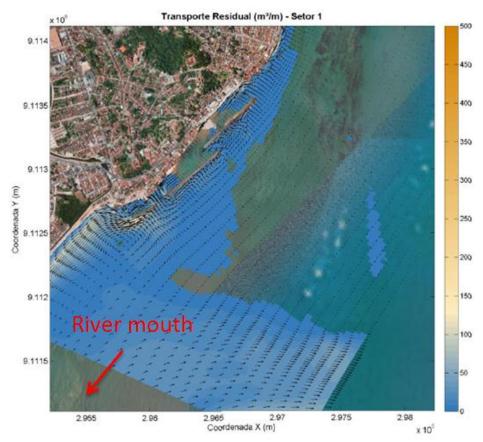
Figure 40: Sediment transport direction in Fortim (CPE 2011)

Reef I has a large influence on the total system and adds much to the complexity of the sediment flows (see Figure 40). The direction of the sediment transport in the south is predominantly from north to south at the coast further offshore it is from south to north. The water circulates anti-clockwise around the red circle (see Figure 39) in the water body which is very close to breakwater C. This is causing a lot of the high speed flows and a lot of erosion on the seaward side of breakwater C.

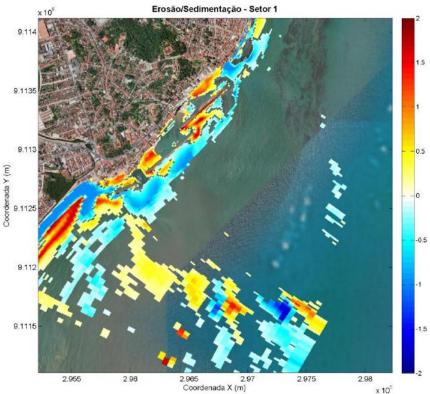
Figure 42: Sedimentation/erosion in Fortim after 5 years (CPE, 2011)

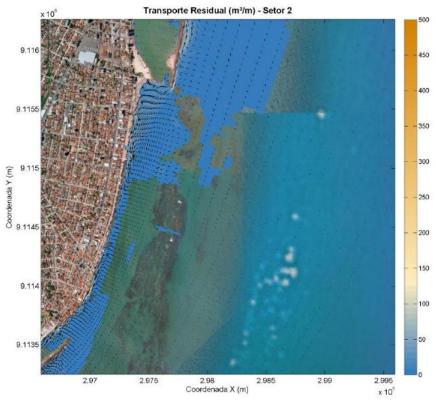
Figure 52: Sediment transport direction (CPE, 2011)

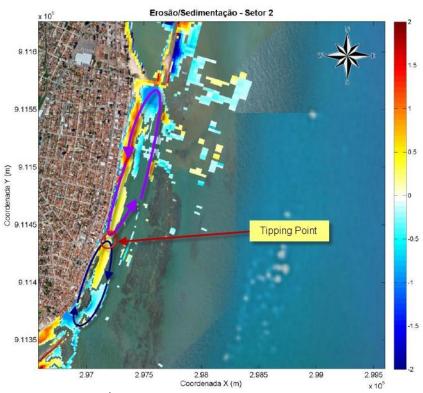
Coordenada X (m) $\times 10^5$ Figure 54: Erosion/accretion according to the 5 years model and sediment transport direction (CPE, 2011)

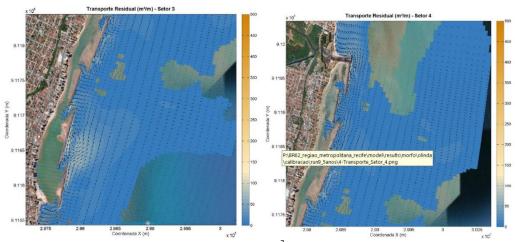
Figure 63: Annualized residual transport in m^3/m /year left the southern part, right the Northen part of the Casa Caiada area.

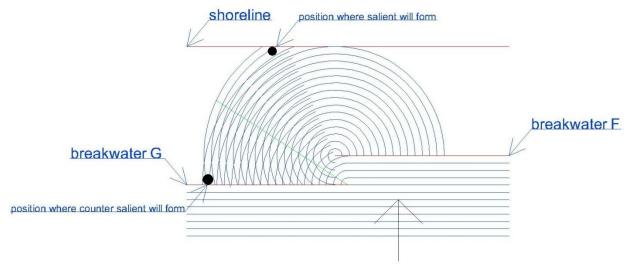
Figure 64: schematically view of the diffraction pattern at breakwaters G and F.

In theory breakwaters works by interrupting the long shore sediment transport. By sheltering an area the sediment transports stops and starts again past the sheltered area. In the area where the sediment transport stops accumulation will occur, this is a very coarse explanation of the way breakwaters work. In the Casa Caiada area there is no significant long shore sediment transport close to the shore present. The long shore sediment transport of the Casa Caiada area is blocked from the south by groyne L. The breakwaters prevent that the long shore transport starts up again. In the north the area is closed off by jetty K. The combination of these structures ensures that the sediment supply of the area is dependent on the small gaps in between the structures. Due to alignment of the gaps and diffraction of waves at the gaps, the sediment transport has a different direction at each gap. The direction of sediment at each gap can contribute to a sediment import or export in the area. See Figure 64 for an example of the diffraction pattern at one of gaps.

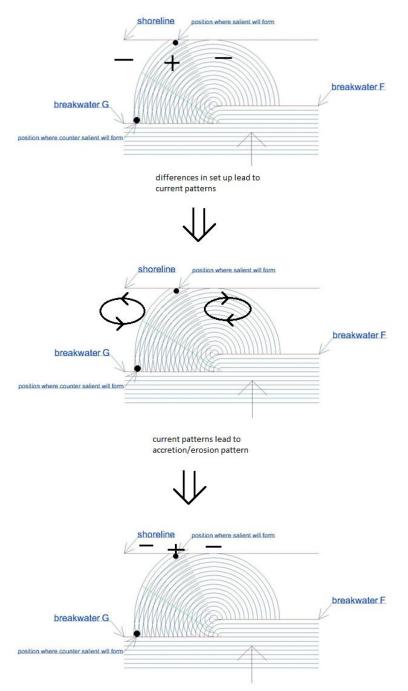
Figure 65: a schematical view of the water level setup, current and sedimentation/erosion pattern

The diffraction pattern will also cause for set up differences in the water level. This set up difference leads to a current pattern which in it turns leads to a sedimentation and erosion pattern see Figure 70. The salient and reverse salient at breakwater F is a perfect example of this see Figure 66.

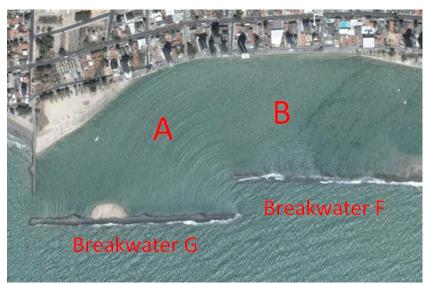
Figure 67 Diffraction patterns at breakwater F and G

The orientation of the breakwaters relative to each other is another important aspect. In the current situation the breakwaters have different distances offshore and they overlap each other. Because of this, the incoming waves at breakwater G form only one-sided diffraction patterns at area A, so there is almost no diffraction patters at area B (see Figure 67). This is also explained in the assessment of the problem. The solution for this is to place the breakwaters next to each other instead of altering the distances offshore.

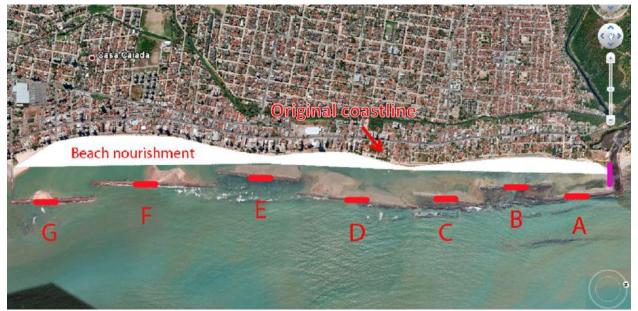
Figure 68: Sketch of alternative 1, breakwater lengths not on scale

A rough estimate of the sediment amount will be made to get an idea. In Casa Caiada, about 3500 m of coast will need beach nourishment. With information from the bathymetry can be calculated that the amount of nourishment needed is approximately 600.000 cubic meters of sand, about 170 cubic meters/m sand.

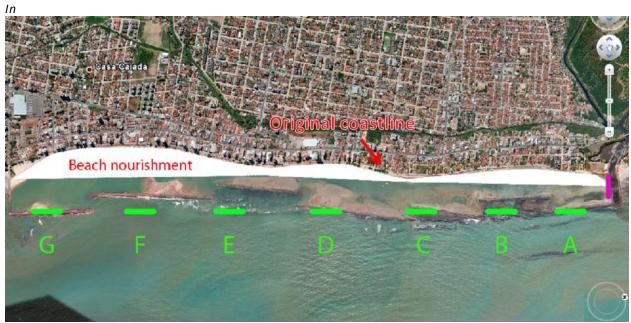
Figure 69: Sketch of alternative 2, breakwater lengths not on scale

Figure 69 a sketch is made of the proposed changes for alternative 2. Note that the breakwaters in this figure are not to scale and the length are not representative, the image just shows the idea of alternative 2. The exact dimensions cannot be determined with the current information. Only an indication of the lengths will be given with the use of rules of thumb.

As mentioned some of the current breakwaters will be removed. These are breakwaters B, D, E, F. Some of the breakwaters are only partially removed. These are breakwaters A, C, D and G.

New Breakwater	L/D ratio	Distance offshore [m]	Length [m]
A	1.00	180	180
В	1.00	180	180
С	1.00	180	180
D	1.00	180	180
E	1.00	180	180
F	1.00	180	180
G	1.00	180	180

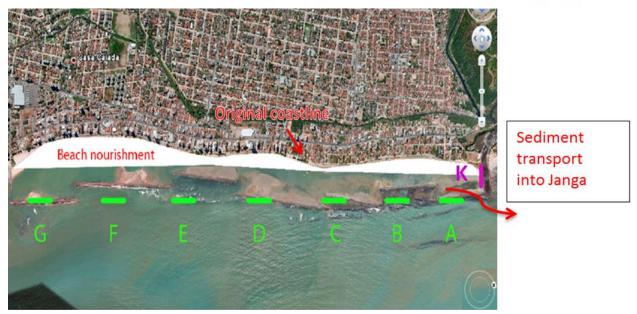
Figure 70: Sediment transport out of Casa Caiada

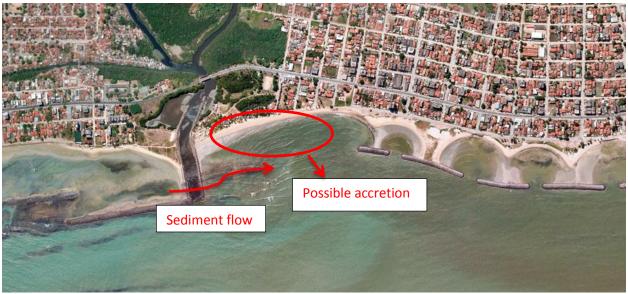
Figure 71: Sediment transport into Janga

Another possible consequence is that beach south in Janga starts accreting more due to the increased sediment input (see *Figure 71*).

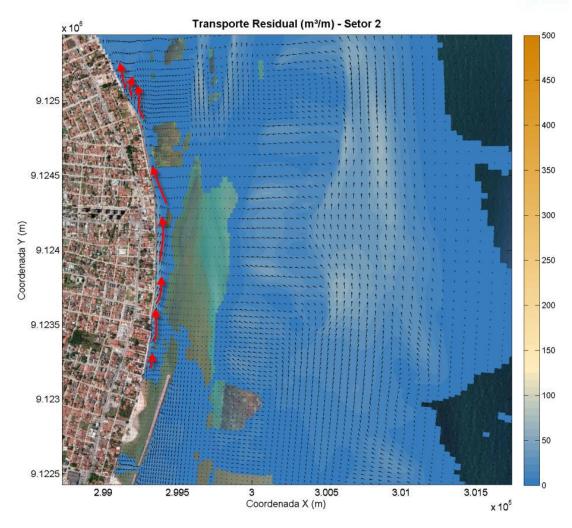
Figure 79: Transport rates sector 2 Janga (CPE, 2011)

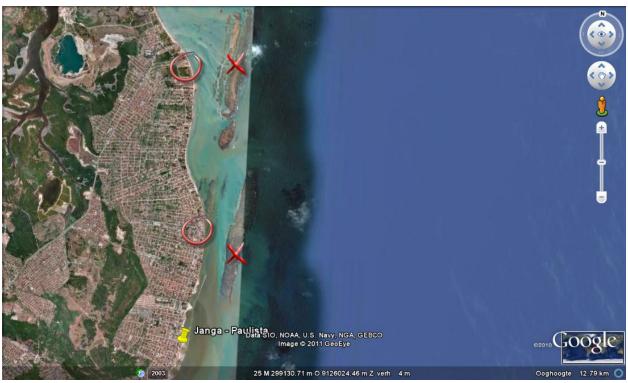
Figure 81: Shaping of the coastline by reefs (notice the bulges behind the large and shallow reefs – This is likely not coincidence)(Image Source: GeoEye, 2011 – Image date: 24-11-09)

On a very large scale the protection of the reef can be seen. In Figure 81 one can see the effects of reefs on a very large scale. Every location which has a large barrier reef in front of the coastline bulges forward and the small gap where there is no reef present, it bulges backward. The shapes of the "bulges" are quite similar to those of a salient, which is the expected shape behind artificial breakwaters.

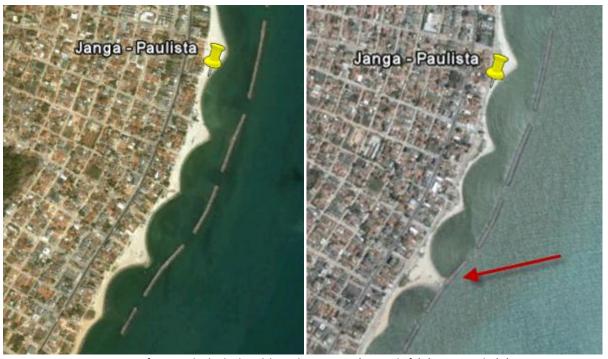
Figure 82: Formation of a Tombolo behind breakwater H (2003 left) (2007 right) (Image source: GeoEye, 2011)

It can also be seen that the problem was never expected to happen because in 2003 and 2007 there were no revetments and no indications that any were under construction, but in 2009 they started appearing behind several breakwaters. This can be examined from Figure 83 and Figure 84. The most logical reason for their construction is fixation of the coastline because it eroded.

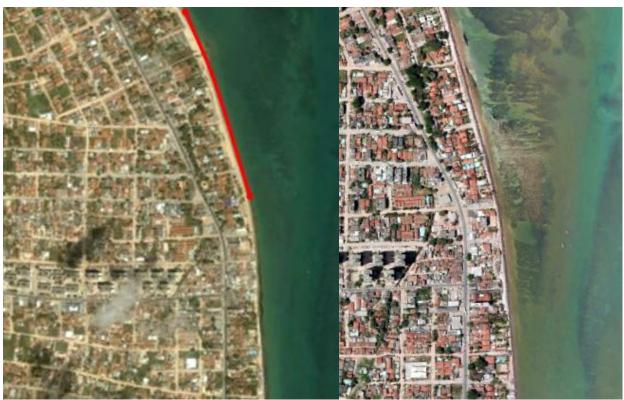
Figure 85: Revetments in the North (2003 left - small revetment) (2007 - Enormous revetment) (the extension of the revetment has been marked in red) (Image Source: GeoEye, 2011)

Length of revetments constructed in 2003	993,3 m
Length of revetment constructed in 2007	1785,3 m

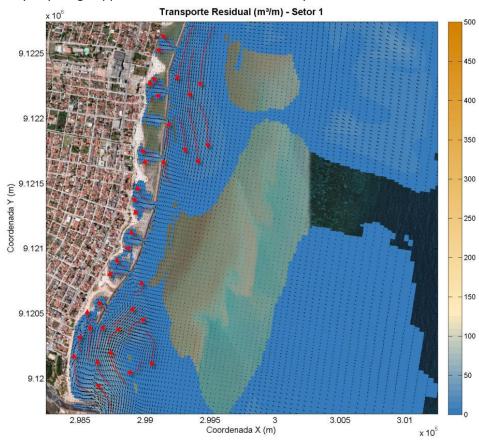
Figure 86: Transport rates sector 1 Janga (CPE, 2011)

The sediment transport rates found in (CPE, 2010) using DELFT3D of the area further enforce the hypothesis of almost no sediment coming in. There is almost no long shore transport coming in and hardly anything happens behind the breakwaters anymore. The situation looks balanced.

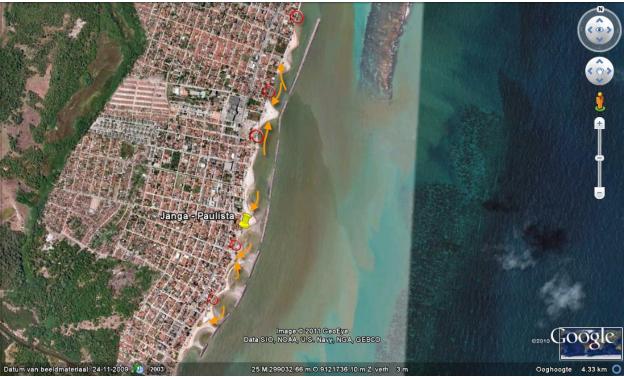
Figure 87: Reorganization of the shoreline due to breakwaters (Image Source: GeoEye, 2011) (The arrows indicate where sediment was moved from to form the tombolos) (The red dots indicate where revetments were built) (notice that the areas where sediment was taken from to form tombolos and where revetments have been built coincide? This is probably not coincidence)

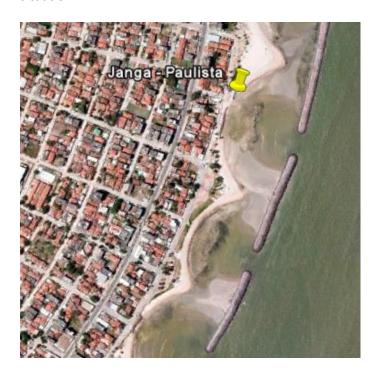
Figure 90: Janga Beach - Area seems too shallow for the draught of the hopper - Shoreface nourishment seems like the only alternative (image: GeoEye, 2011)

The Janga region has breakwaters in place approximately 150 meters from shore which makes direct nourishment on the beach only possible if pipelines are used. The area also seems rather shallow on satellite images. (See Figure 90) Shore face nourishment seems to be the only option, given the situation.

The only feasible option is placing the nourishment on the shore face. Larger volumes of sand are required for shore face nourishment because only 30 % to 50 % (COASTAL DYNAMICS, 2010) will reach the beach zone. The costs per m3 for shore face nourishment are 50% to 70% less (COASTAL DYNAMICS, 2010) which does make it an attractive measure due to cost balance.

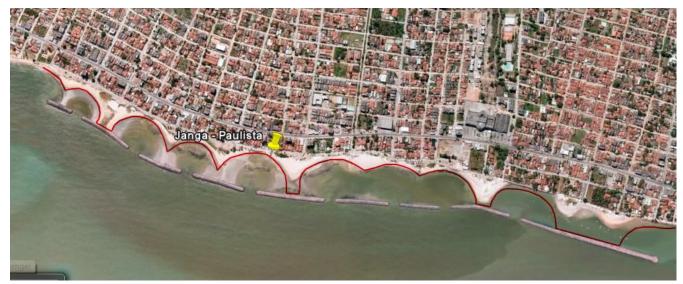
Figure 91: Prediction of what the shoreline should look like if there were no sediment deficit - The size of the Tombolo behind breakwater A is debatable but It will definitely be large (image: GeoEye, 2011)

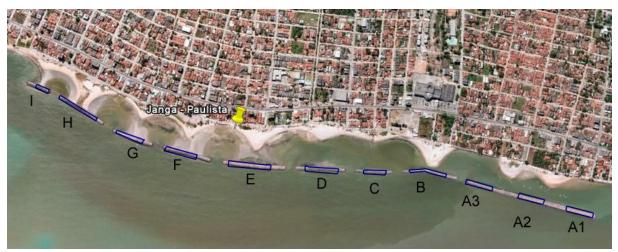
Figure 92: Breakwaters with adjusted lengths and gap sizes

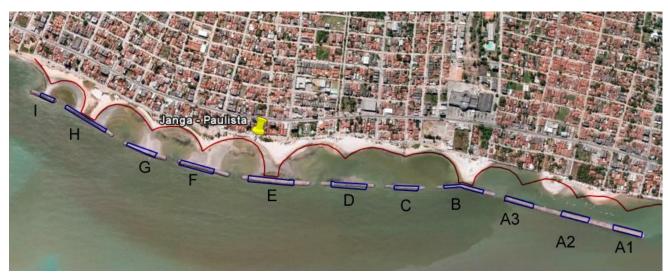
Figure 93: Expected Pattern behind breakwaters post-modification according to guidelines from (COASTAL Dynamics, 2010)

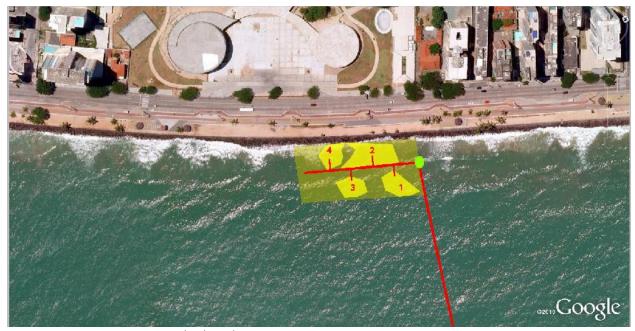
Figure 104: Pipe system on the beach

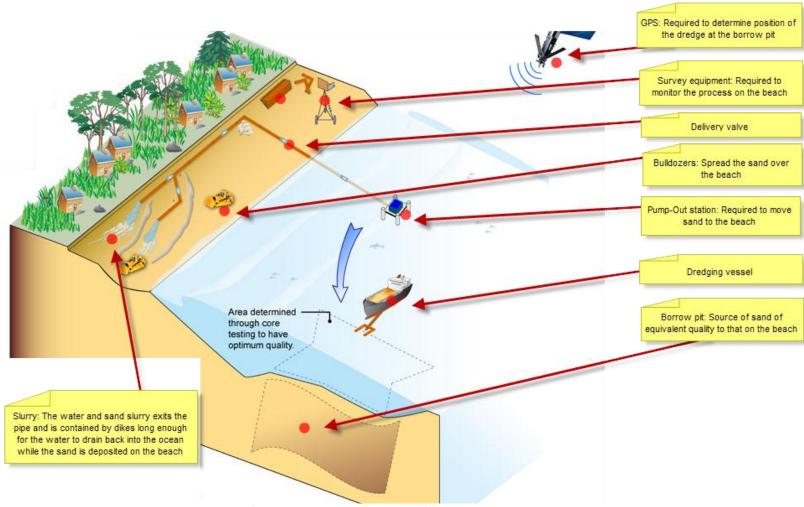
Beach nourishment schematic

Figure 105: The beach nourishment process (Image source: USACE, 2011)
