# Housing obsolescence in practice; a pilot study.

## **Abstract**

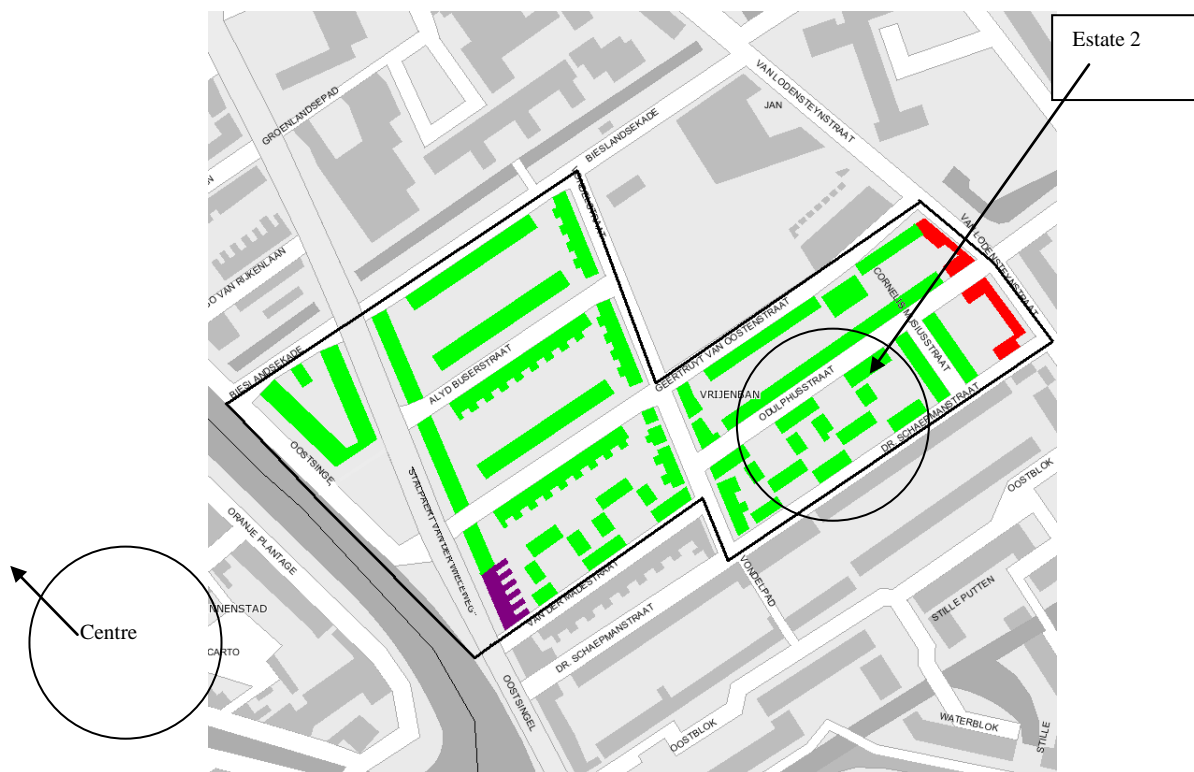
Estate 2 in the Dr. Schaepmanstraat and the Odolphustraat is in the Eastern part of Delft in the neighbourhood Vrijeban. It comprises 65 dwellings built in 1921. 51 dwellings are single family dwellings and 14 are 'double maisonettes' (in Dutch: beneden boven woningen).

In the eighties the facades of the dwellings were insulated from the outside using ISPO. Due to lack of experience with this type of insulation and insufficient knowledge of residents how to handle insulated dwellings large condensation problems and problems with moisture occur. The housing association is now deliberating about the future of the estate. Because of the age and the low rent it is not feasible to solve the problems by removing the old and adding new insulation. On the other hand the dwellings are cheap and quite popular and it is nowadays impossible to construct new ones with the same quality

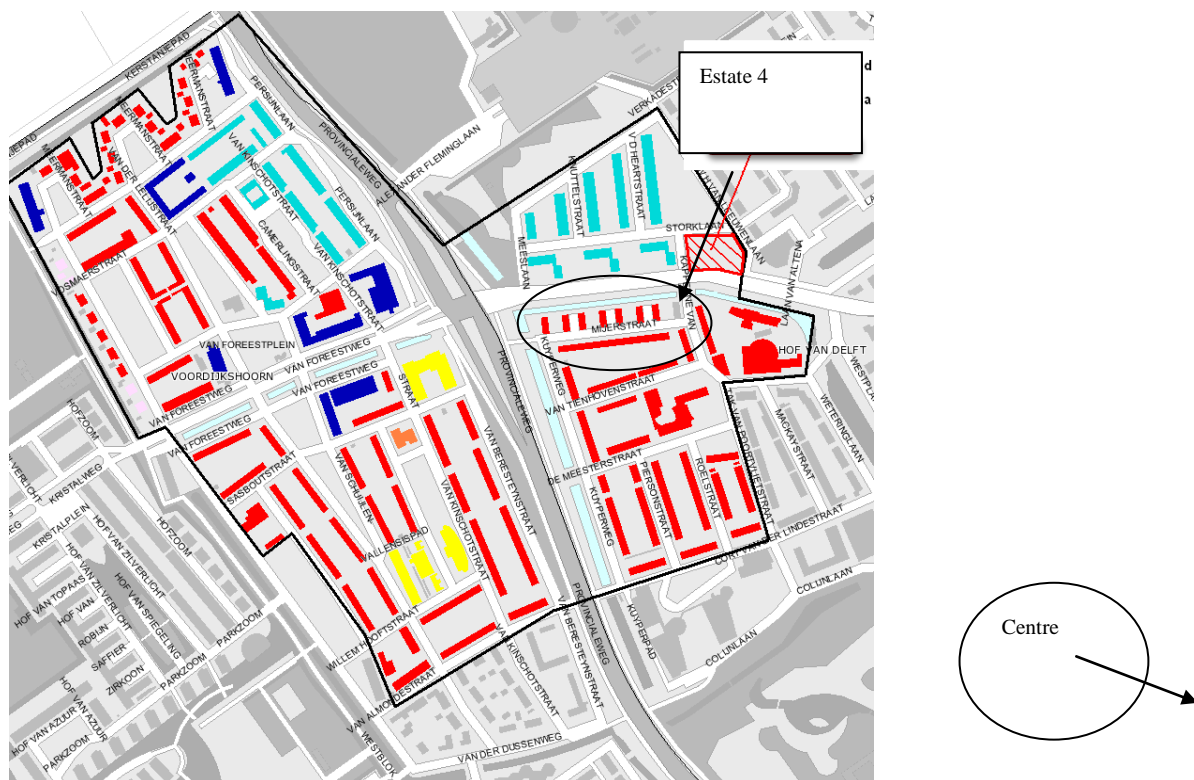
It comprises 75 dwellings built in 1955. 39 are single family dwellings (picture below) and 36 are ‘double maisonettes’ (in Dutch: beneden-boven woningen).

The main problems of the estate are physical. In 1989 the cavity walls were insulated and the window frames replaced by aluminium ones but in a wrong way. This resulted in thermal bridges and condensation problems. In 2009 the policy of the housing association regarding the estate was reconsidered. Given the popularity of the estate and the favourable quality - price ratio the association proposes to extend the life cycle of the estate with at least 30 year. The renovation will focus on the

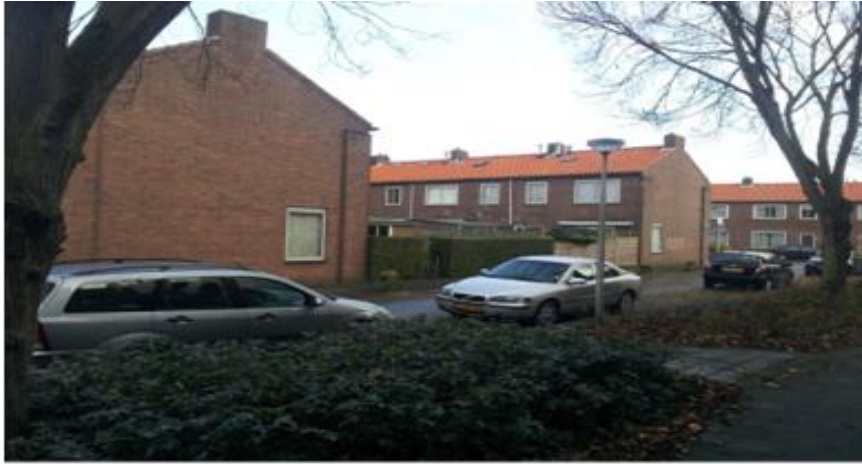
façade and the energy performance, leaving the inside to the residents. After the renovation the dwellings will probably be offered in *Te Woon*, which means that the residents may choose between renting the dwelling and buying it (Koch and Breedveld 2012 and van Hemmen and Winkels 2012).

1. De Mijerstraat is a clear case of physical building obsolescence (A). The 60 years old buildings have suffered deterioration due to wear and weathering and a low energy performance. Additionally the mistakes of an earlier intervention have to be remediated. Given the age of the dwellings there will be probably be functional problems (C). These have already been remedied by the tenants themselves or are left to them for the future. There are no problems related with the location (B) of the estate. Behavioral obsolescence is almost absent: the social cohesion is positive and the dwellings are quite popular on the housing market (D). All the problems mentioned can be classified by means of the model.

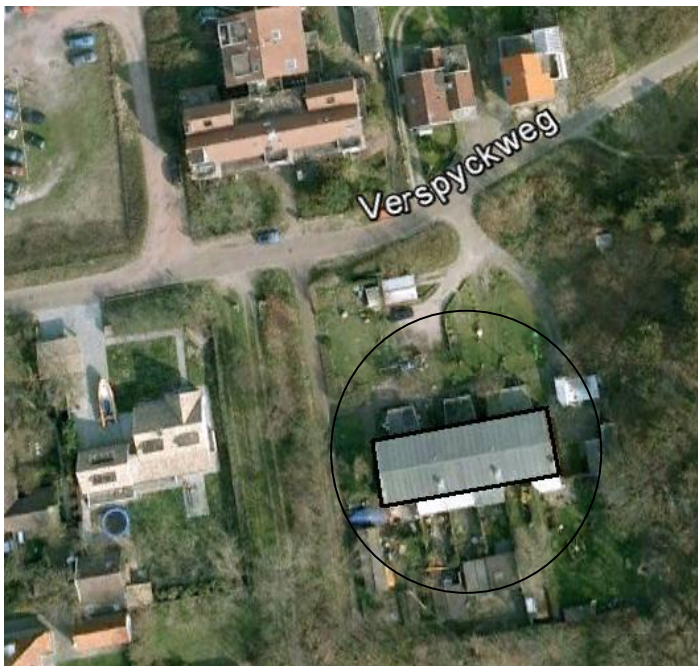
The main motives for the demolition were the poor physical and energetic quality i.e. the absence of thermal insulation, the insufficient noise reducing capacity of the main partition walls, the low quality of the small bathroom (shower) and its location on the ground floor and the poor quality of the timberwork windows, frames etc. suffering from substantial backlogged maintenance. The replacement was motivated by the expectation that the costs of renovation to up to date standards would equal the costs of new construction (Van Grinsven, 2012).

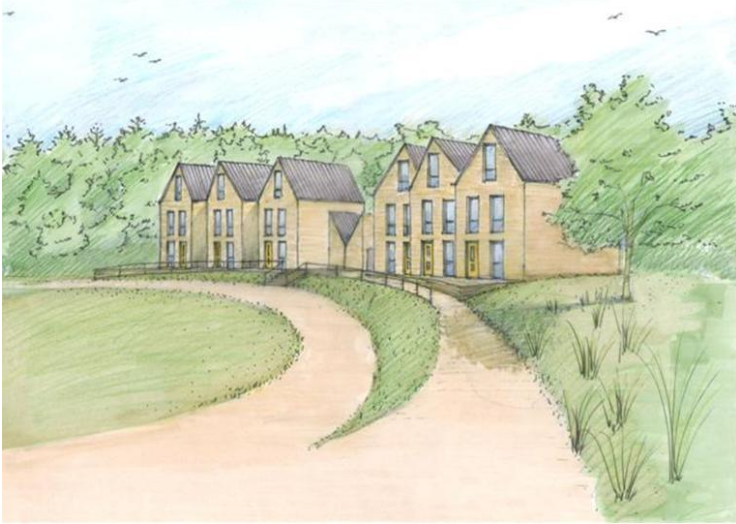
The replacement plan (see below) consists of 2 x 3 single family row houses and 8 apartments in the social rented sector. Up to now, the project is still in the planning state. Due to a disagreement about the rents: category 1 (affordable) as the local authorities demand referring to the demolition agreement, or category 2 (market) as the housing association wants referring to the high expected unprofitability of category 1, plan approval and building permit are still under discussion (Van Grinsven, 2012). Regarding the up scaling of the market category and the number of dwellings it may be discussed to what extent the demolition was motivated by physical obsolescence or by acquiring the land value of the plot.

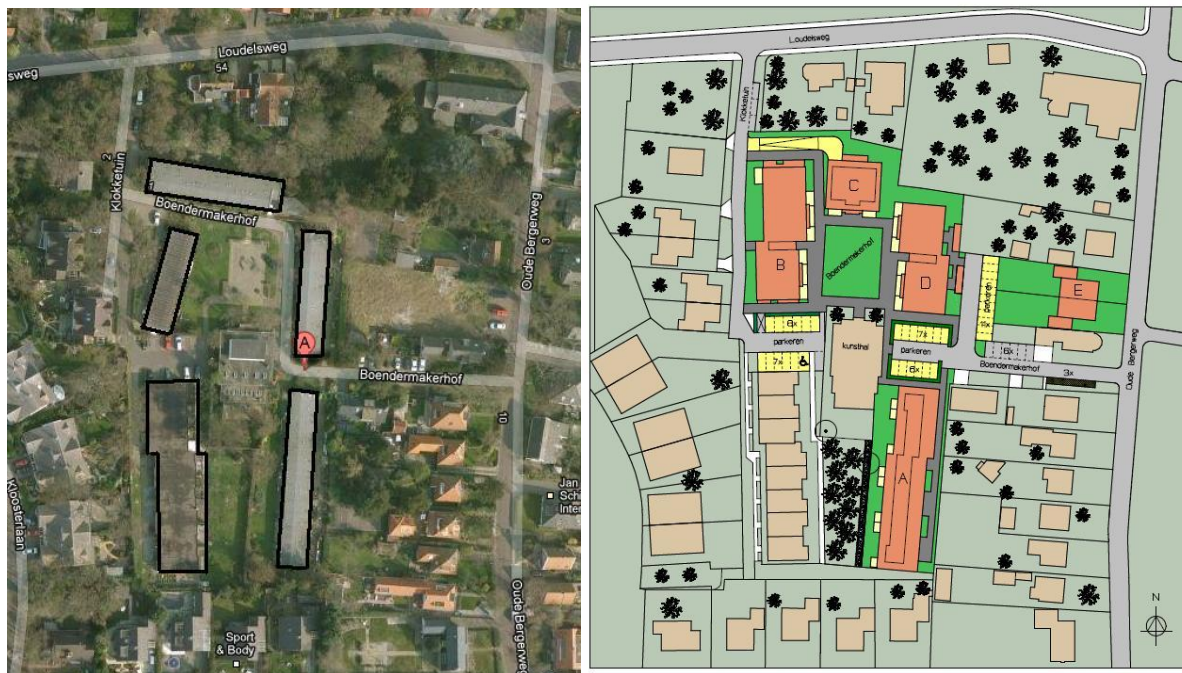
The case Boendermakerhof consists of 34 small dwellings for elderly in the social rented sector, 16 as single floor row houses and 10 apartments in 2 layers, built in 1957. The estate is renowned because it surrounds the 'Kunstzaal', the workshop of the late Lucebert, the famous multi artist and poet.

The tenants were originally working class elderly couples, later mainly female singles; the dwellings were originally very sought after with a long waiting list and a low relets rate. The rent prices are moderate, due to the small floor space (approx. 50 m<sup>2</sup>) and the limited original early postwar quality that has not been upgraded by renovation.

According to the website of Kennemer Wonen, 26 of the dwellings, 8 of the single floor and all apartments will be demolished to be replaced (Kennemer Wonen, 2012b). The residents will use or have used the opportunity to move to an attractive replacing apartment or nursing home combined with a removal subsidy. The main motive for the demolition is according to the website that the dwellings are 'due for replacement'. In more detail, the underlying reasoning rests on the poor physical and energetic quality and substantial backlogged maintenance. The replacement was motivated by the low quality, the weakening market position and the opportunity to rebuild (Van Grinsven, 2012). Why this does not refer to the 8 single floor dwellings with the same age and quality that will be maintained is not motivated.

1. De Boendermakerhof is primarily a case of physical building obsolescence (A). The 55 years old buildings show physical shortcomings due to ageing, low energetic and acoustical performance and lacking improvements. The outdated physical quality may be expected to have caused behavior related shortcomings (C) but this is not mentioned by landlord or residents. No locational (B) or housing market related reasons are mentioned, except the implicit land and housing market related desirability of more attractive dwellings and acquisition of the land value (D).
