**Borders and Territoriers Graduation Studio**  
**Delft University of Technology**

**P5 PRESENTATION**  
**26 June 2023**

**"ARCHITECTURAL REHABILITATION OF THE DESTROYED CITY OF ASSOS"**

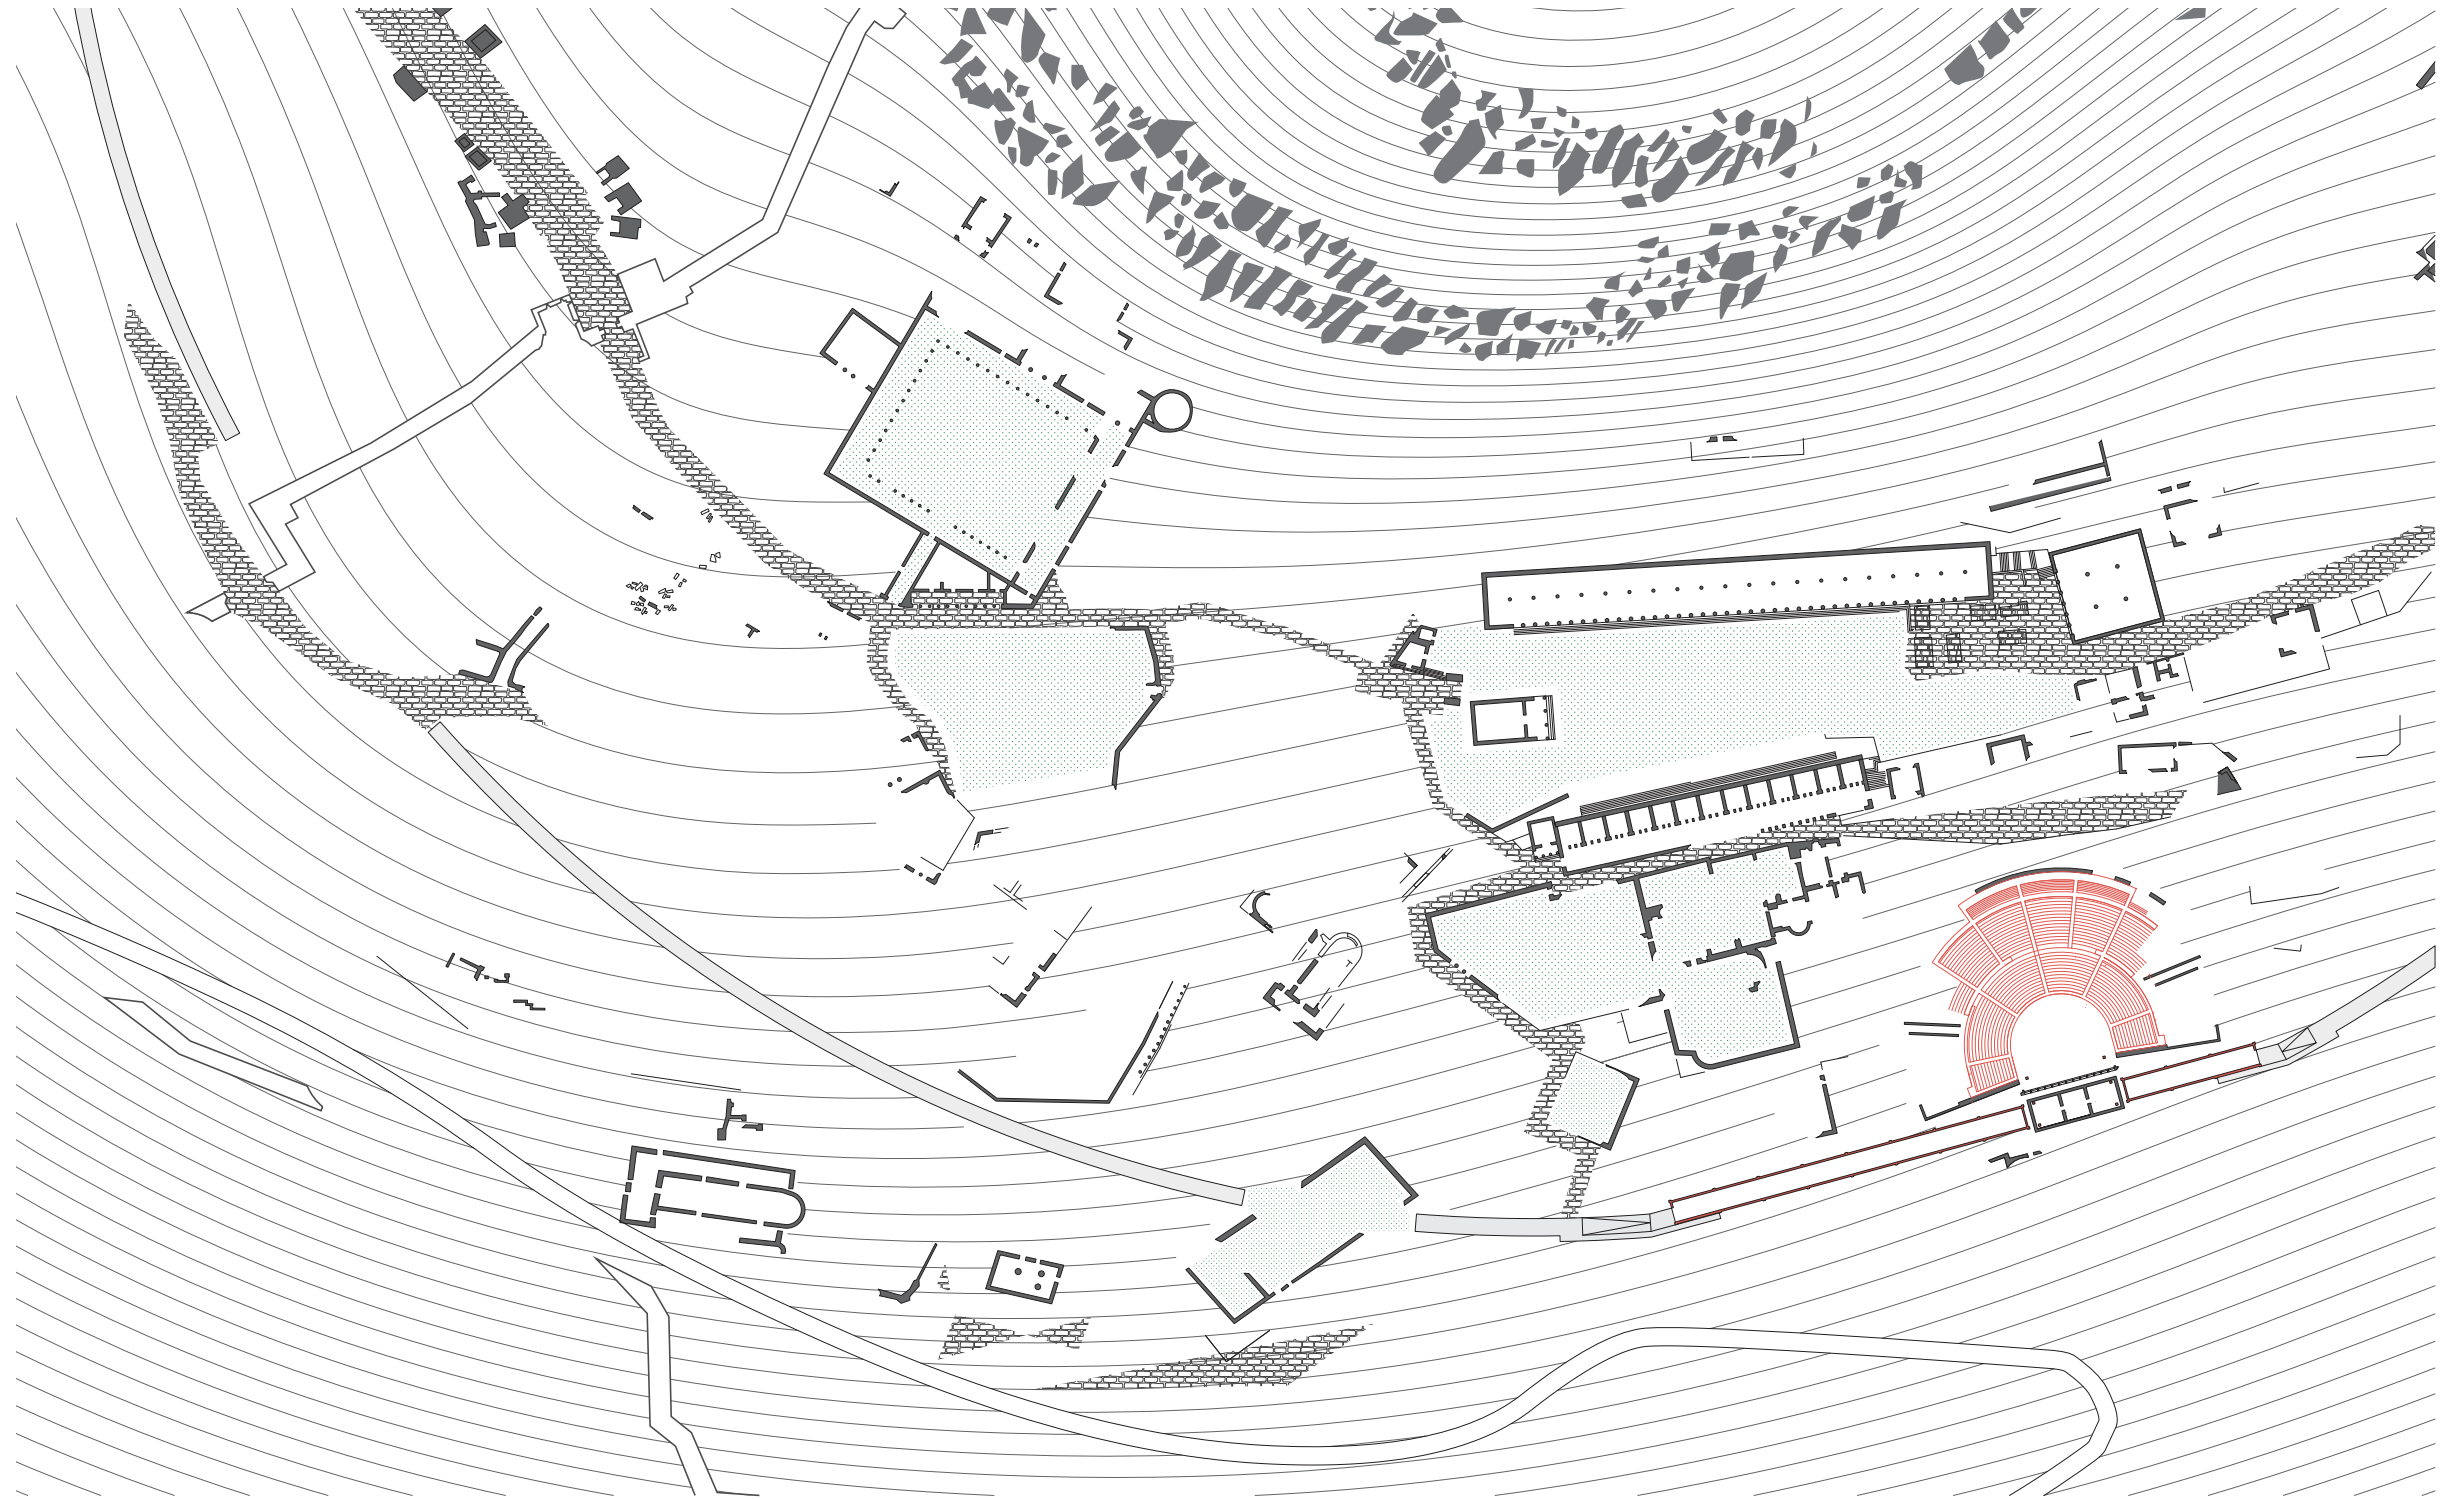
DETAIL OF THE MASTERPLAN: REHABILITATION OF THE ANCIENT PAVED ROADS AND PROPOSAL OF ACCESSIBLE GREEN SPACES
