## A NEW VIEW ON FALLING APRONS

### ABSTRACT

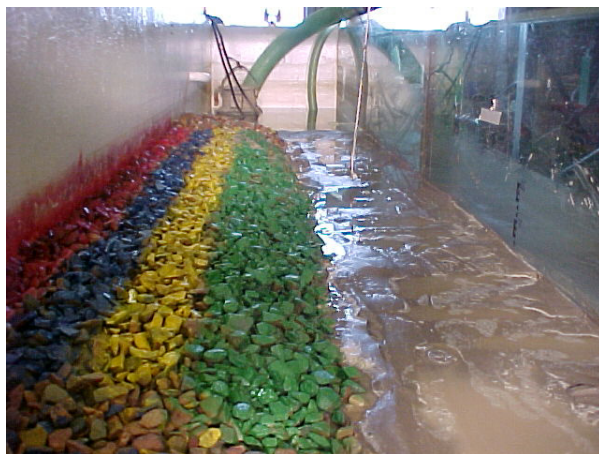
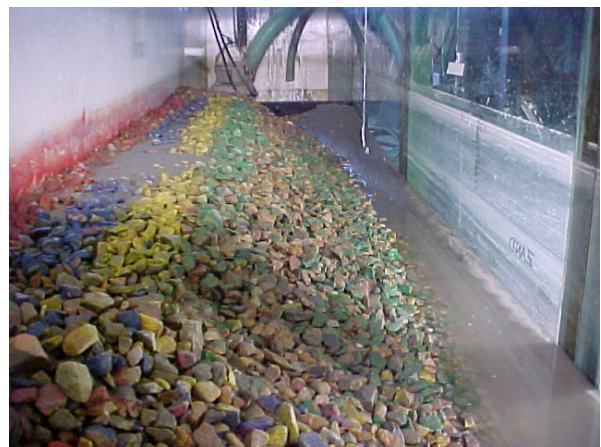
*Situation before the test*

*Situation after the test*

**Figure 3: model in the flume before and after the test (25 mm rock)**

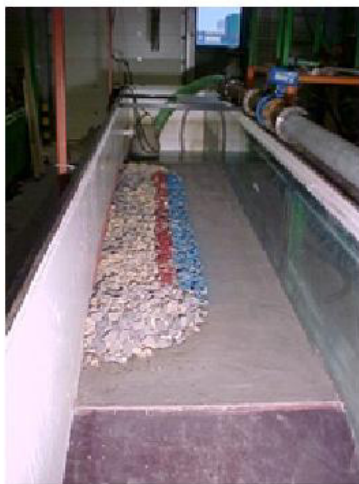
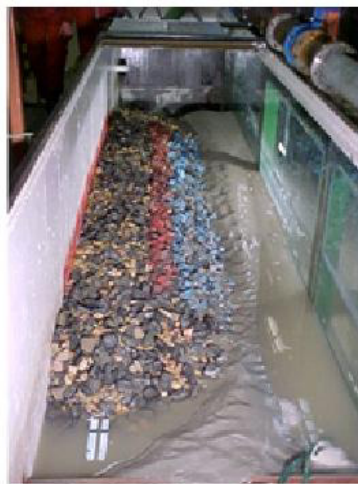
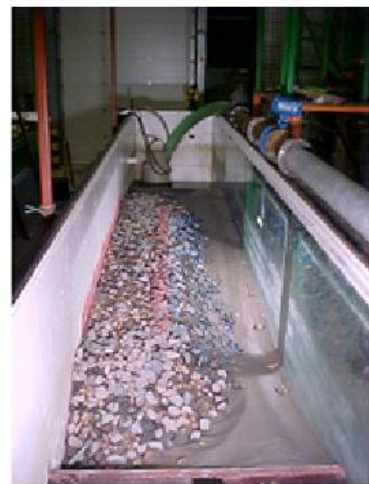
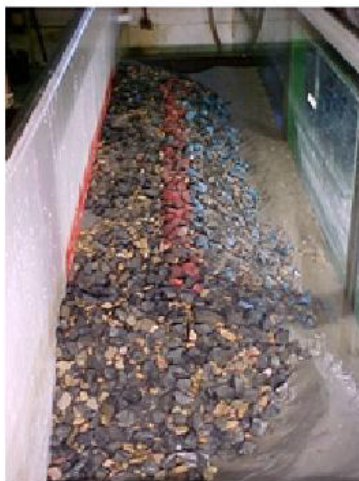
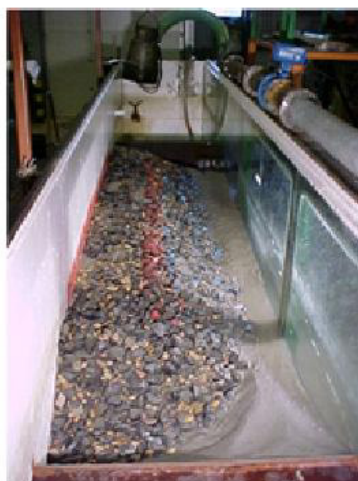
Experiment 1  
run 0, t = 0 min

Experiment 1  
run 1, t = 90 min

Experiment 1  
run 2, t = 180 min

Experiment 1  
run 3, t = 270 min

Experiment 1  
run 4, t = 360 min

**Figure7: Several steps in the experiment using the poorly graded material**
