Pre-collapse spaceborne deformation monitoring of the Kakhovka dam, Ukraine, from 2017 to 2023

2024

Communications Earth and Environment

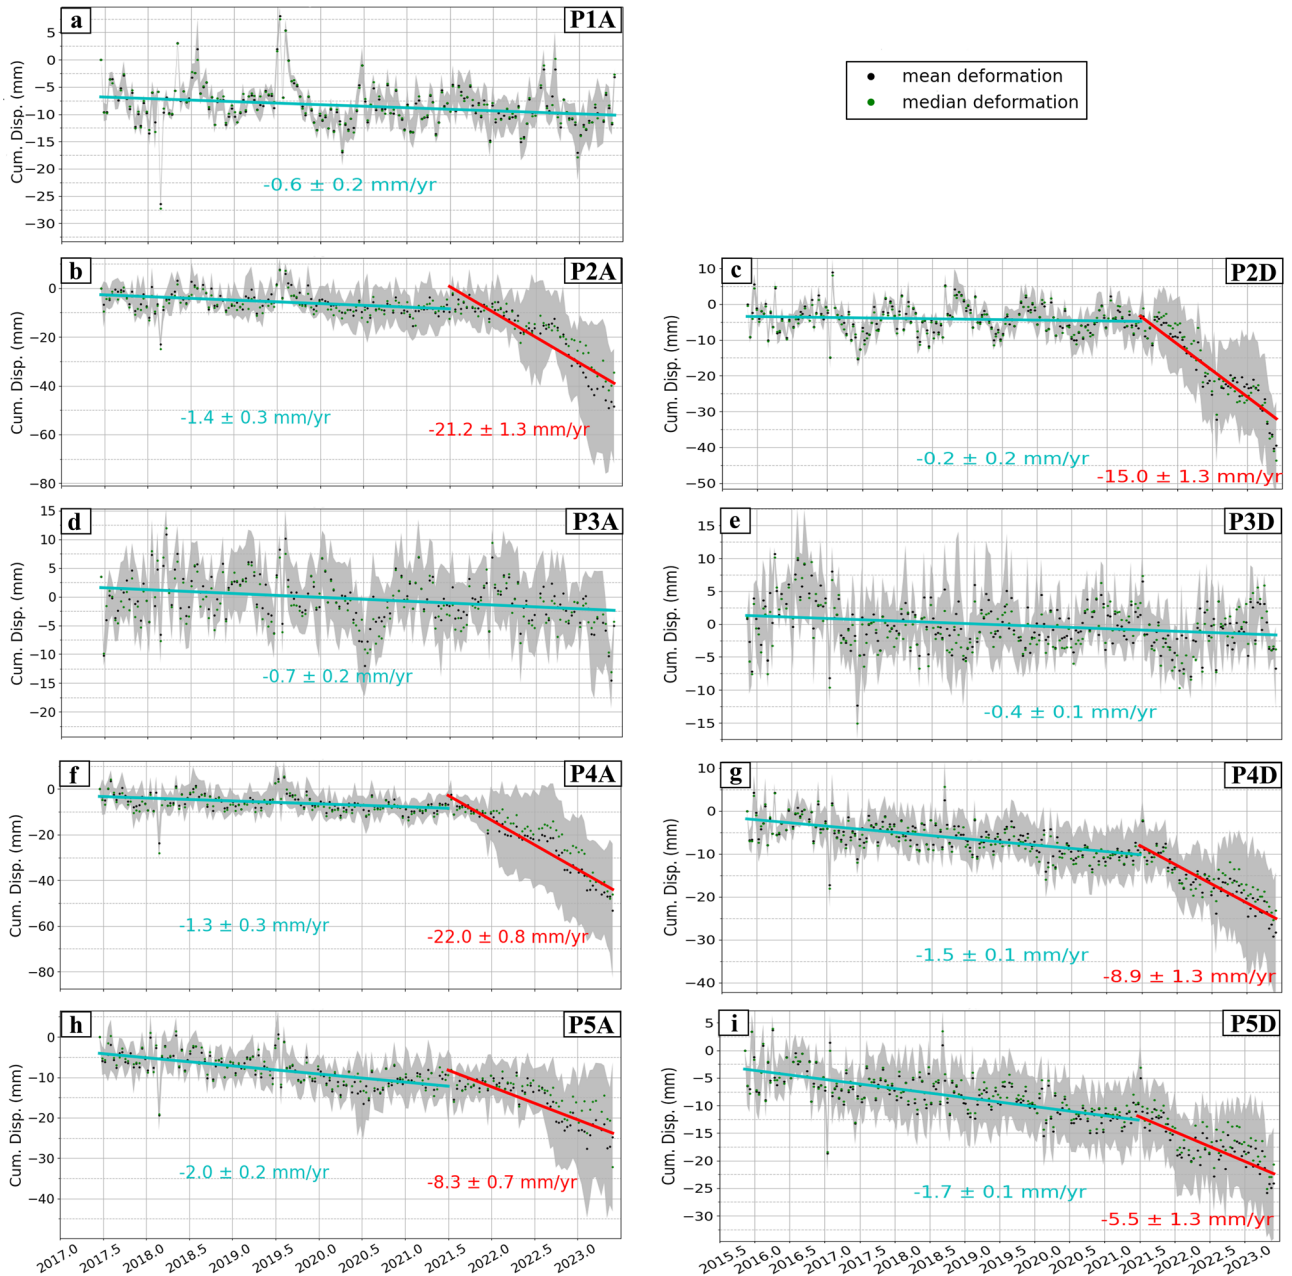
Fig. 2 | Average line of sight deformation time-series for polygons I, II, III, IV, and V extracted from Fig. 1. Images a, d, f and h represent the ascending deformation time-series and images c, e, g and i are the descending deformation time-series, respectively. Positive values point to moving toward the satellite. The Cyan line represents trends between the beginning of each time-series and June 2021 while the red lines indicate trends observed during the period July 2021–2023. Mean and median deformation is represented as black and green dots respectively. Grey

error bars represent limits indicating one standard deviation. The titles of the panels have been abbreviated for clarity, following the pattern: Px(A/D), where “P” represents “Polygon”, x is the number indicating the polygon number, and “A” or “D” stands for “ascending” or “descending” geometry, respectively. Just one measurement point has been found for polygon I descending (PID) and therefore has not been displayed in this figure.

We used two Sentinel-1 InSAR dataset comprising both ascending and descending tracks. The ascending (ASC) track included a total of 180 images acquired by Sentinel-1A and Sentinel-1B, spanning from July 2017 to June 2023 (Table 1). Similarly, the descending (DSC) track dataset consisted of 226 images acquired by Sentinel-1A and Sentinel-1B, covering the period from November 2015 to June 2023. By analyzing the time-series of deformation over each of the five polygons (Fig. 1), five distinct patterns of deformation were observed in both the ASC and DSC geometries, indicating the presence of displacement in different directions, including vertical (up/down) and horizontal (east/west) (Fig. 2 and Table 2). It is noteworthy that upon analysing the data, it becomes apparent that polygons I and III remained remarkably stable, with no substantial deformation observed throughout the entire period. In contrast, polygons II, IV, and 5 exhibited the most pronounced changes, particularly starting from June 2021. Polygon V, which is situated above a nearby dam facility, shows a linear deformation trend starting in 2015. This trend reached a rate of nearly 2±0.2 mm per year, amounting to a cumulative displacement of 10 mm over the 5 years prior to the collapse (Fig. 2h). Starting in June 2021, the rate of deformation in polygon V accelerated by 4 times, reaching a trend of 8.3±0.7 mm year⁻¹ until the dam’s collapse (Fig. 2h). Conversely, polygons II and IV, which are positioned over the section of the dam that experienced breaches, exhibit an average deformation of 21.5±1.5 mm year⁻¹ and 12±1.8 mm year⁻¹ for the ascending and descending geometries, respectively (Fig. 2b, c, f, g). Figure 3 illustrates the distribution of selected persistent scatters (PSs) along with their respective mean velocities, including both ASC and DSC geometries. The ascending track perspective is observed from the southern side of the dam (see Fig. 2a, c), characterized by a smaller look angle compared to the descending (Table 1). Consequently, the chosen PSs are primarily located in the southern portion of the dam. Conversely, the descending track is characterized by a higher look angle, and it originates from the northern side, resulting in PSs that encompass both the northern and southern regions of the dam. Therefore, for a fair comparison, the observed deformation in these polygons is localized and confined to the southern side of the dam. The DSC dataset reveals slightly lower velocity

values and similar activation dates due to its reduced sensitivity to vertical displacements as the descending is characterized by a larger look angle, (Tables 1 and 2).

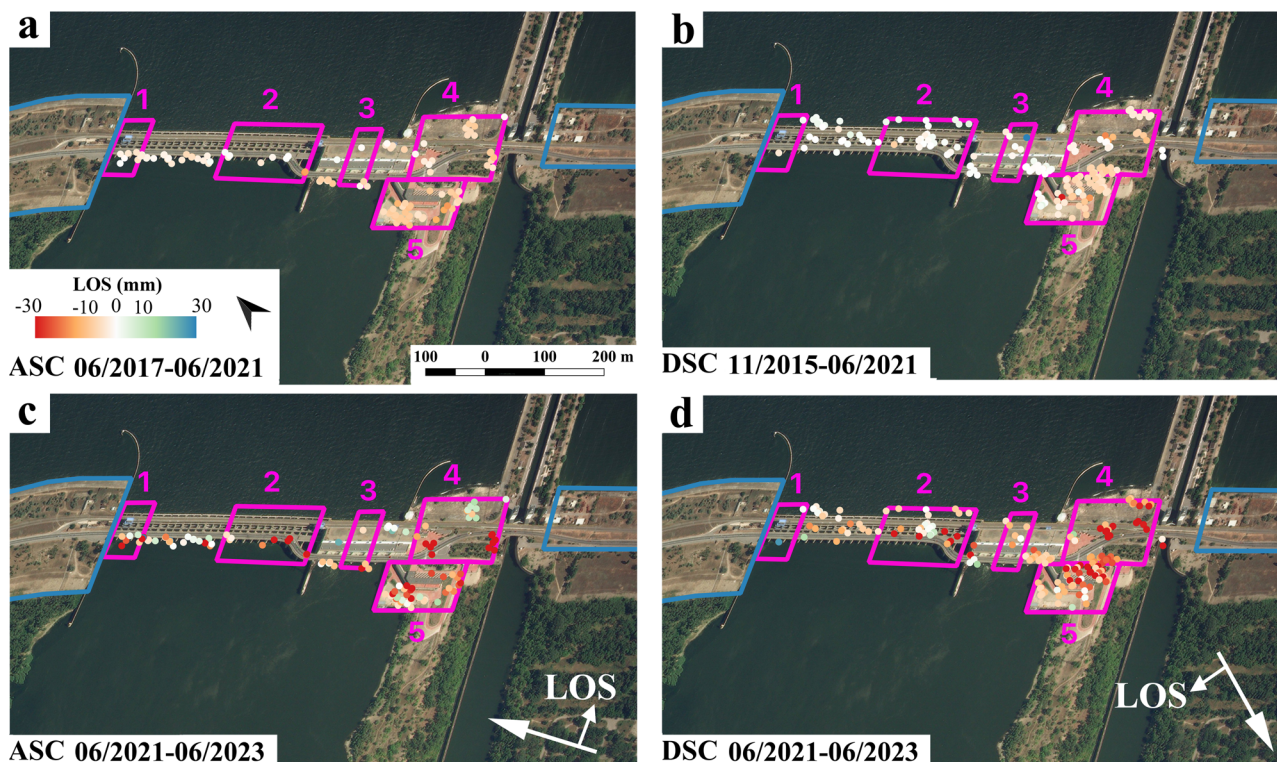
Fig. 3 | Mean velocity maps showing the location of the measurement points. a and b show pre-event velocity maps for ascending and descending tracks, respectively. c and d represent velocity maps after deformation acceleration begin for

both ascending and descending geometries, respectively. Negative values point to moving away from the satellite. Map data: Bing, © 2023 TomTom, © 2023 Maxar (<https://www.bing.com/maps>).

respectively (Supplementary Fig. 1a and Supplementary Fig. 1b). The correlation coefficients over polygon II and IV for zero-day time-lag remained approximately the same between June 09th, 2022 and June 1st, 2023, 5 days before the collapse (Supplementary Fig. 1c and Supplementary Fig. 1d). This indicates a linear relationship between decreasing water level in the dam basin and movement along the PDW component of the dam. To confirm this conclusion, we also analysed the correlation between water levels and the PDW component of the MT-InSAR cumulative displacements on other parts of the dam. Our data reveal a similar negative correlation between points situated amidst polygon I and polygon II (Supplementary Fig. 2a), as well as those positioned between polygon III and polygon IV (Supplementary Fig. 2b). Nevertheless, it is worth noting that the PDW displacement component of the road segment spanning from polygon II to polygon III does not exhibit any significant correlation with changes in water level, probably due to the amount and the spatial distribution of the measurement points (Supplementary Fig. 2c). With the rise in water level changes from 2022 onward, the PDW component of the deformation signal becomes more pronounced over polygons II and IV, maintaining their correlation with basin water levels, and reaching rates of about 28.3 ± 0.3 mm year⁻¹ upstream. Such increased rate does not affect the portions of the dam where signs of structural distress did not manifest (i.e. between polygon I and II, III and IV Fig. 3).
