## Bank erosion processes in waterways

# Bank erosion processes in waterways

## Case study: Meuse River

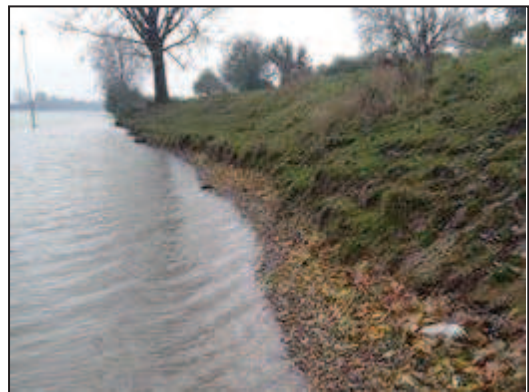
Figure 1. Uniform erosion pattern characterized by short grass-covered banks with gravel at the toe.

Two distinct patterns are identified after six years of their restoration: uniform (Fig. 1) and bay-shaped (Fig. 2). The uniform pattern has low or zero erosion rates at present, hypothetically due to the toe protection of a gravel layers, whereas the embayments are hit by ship waves, especially in areas where the base level is low enough to allow them reach the banks virtually without energy dissipation. The primary ship waves also induce shear stresses onto the banks, in particular over terraces where the wave energy dissipation occurs. It is noticeable the presence of trees along the banks that delays the erosion rates in some cases, but not in others.

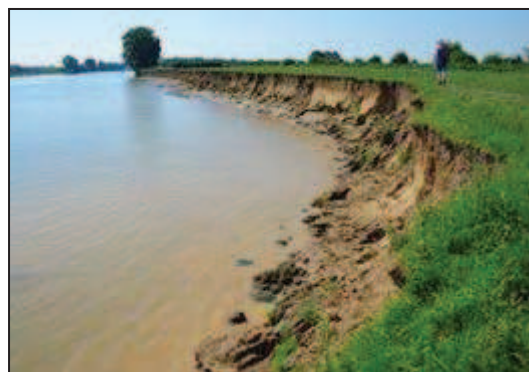
Figure 2. Bay-shaped erosion pattern characterized by high banks and contrasting erosion rates.
