Decision-making in the intervention on buildings affected by rising damp

Lubelli, Barbara

3 - Decision-making in the intervention on buildings affected by rising damp

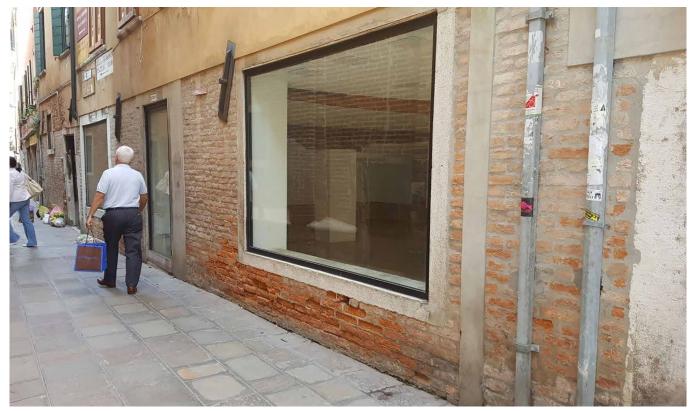
FIG. 3.1 Salt crystallization damage due to the presence of salts and rising damp, Venice, Italy / Photo: B. Lubelli

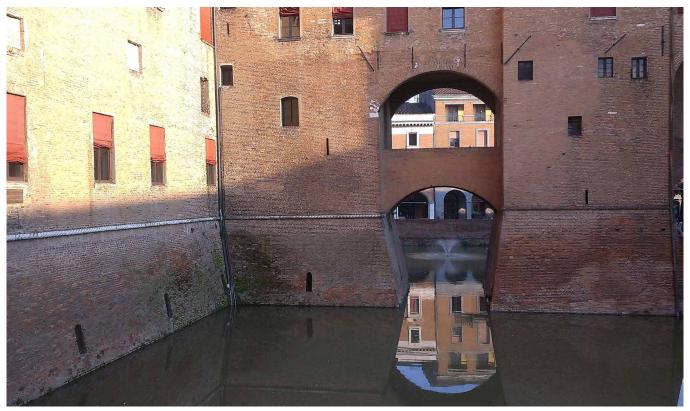
FIG. 3.2 The height of rising damp is generally limited to 1,5-2 meters, Ferrara, Italy / Photo: B. Lubelli

Capillarity is the mechanism governing rising damp in a wall. Capillary forces can transport water from the ground into the wall, countering gravitational forces. Theoretically, water can rise up several metres through capillarity, depending on the pore size of the material. However, the maximum level reached by rising damp in brick and stone masonry is generally limited to 1,5-2 metres in practice, due to resistance to the flow of water, evaporation and the presence of boundaries between materials with different pore sizes (e.g. example mortar and brick) [FIG. 3.2].

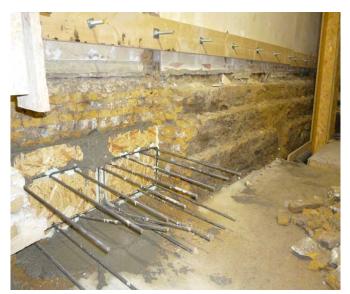
FIG. 3.10 Huis Nolet, basement: reinforcement for insertion of concrete floor (December 2016) / Photo: B. L.ubelli

additional effort. A concrete floor, originally planned to be inserted into the perimetral walls of the buildings at intervals of 50 cm, was made through the entire section of the wall [FIGS. 3.10/3.11]. The part of the walls in contact with the ground was protected with an impermeable layer in order to avoid sideward penetration of water. In this way an effective intervention against rising damp was obtained with relatively limited additional costs. This shows that for each situation a bespoke approach is required, defined by considering all aspects: even a complex and expensive intervention, such as mechanical interruption, may become feasible and suitable in specific situations.

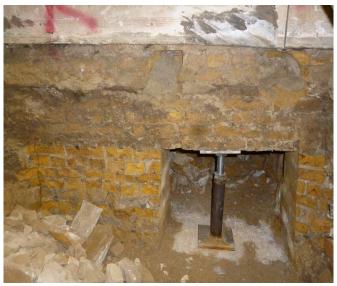
FIG. 3.11 Huis Nolet, basement: temporary support of the wall during insertion of concrete floor (December 2016) / Photo: B. L. ubelli

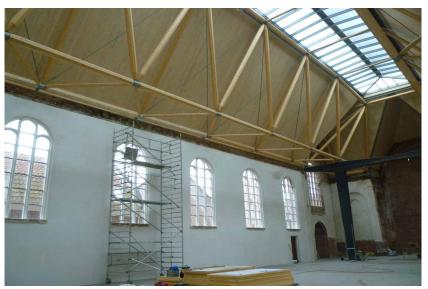
FIG. 3.12 Interior of the Elleboog church: water used to extinguish a fire had accumulated on the concrete floor and risen up in the wall, leading to a moisture content distribution similar to that observed in the presence of rising damp from groundwater / Photo: B. L.ubelli

damp from groundwater [FIG. 3.12]. A further investigation of the groundwater level and of the moisture content in the soil, clarified that rising damp from groundwater was indeed present, but only up to a low height in the wall [FIG. 3.13]. The high moisture content (MC) measured in the wall in the interior of the church was not due to rising damp from ground water, but to the capillary rise of water used to extinguish the fire, which had accumulated on the concrete floor of the church. No intervention against rising damp was thus necessary; after 6 months the walls were dry enough to be safely plastered.
