## Conservation of natural stone

Quist, W.J.

Quist, W. J. (2025). Conservation of natural stone. In B. Lubelli, U. Pottgiesser, W. Quist, & S. Rexroth (Eds.), *Dealing with Heritage: Assessment and Conservation* (pp. 17-36). TU Delft OPEN Publishing.

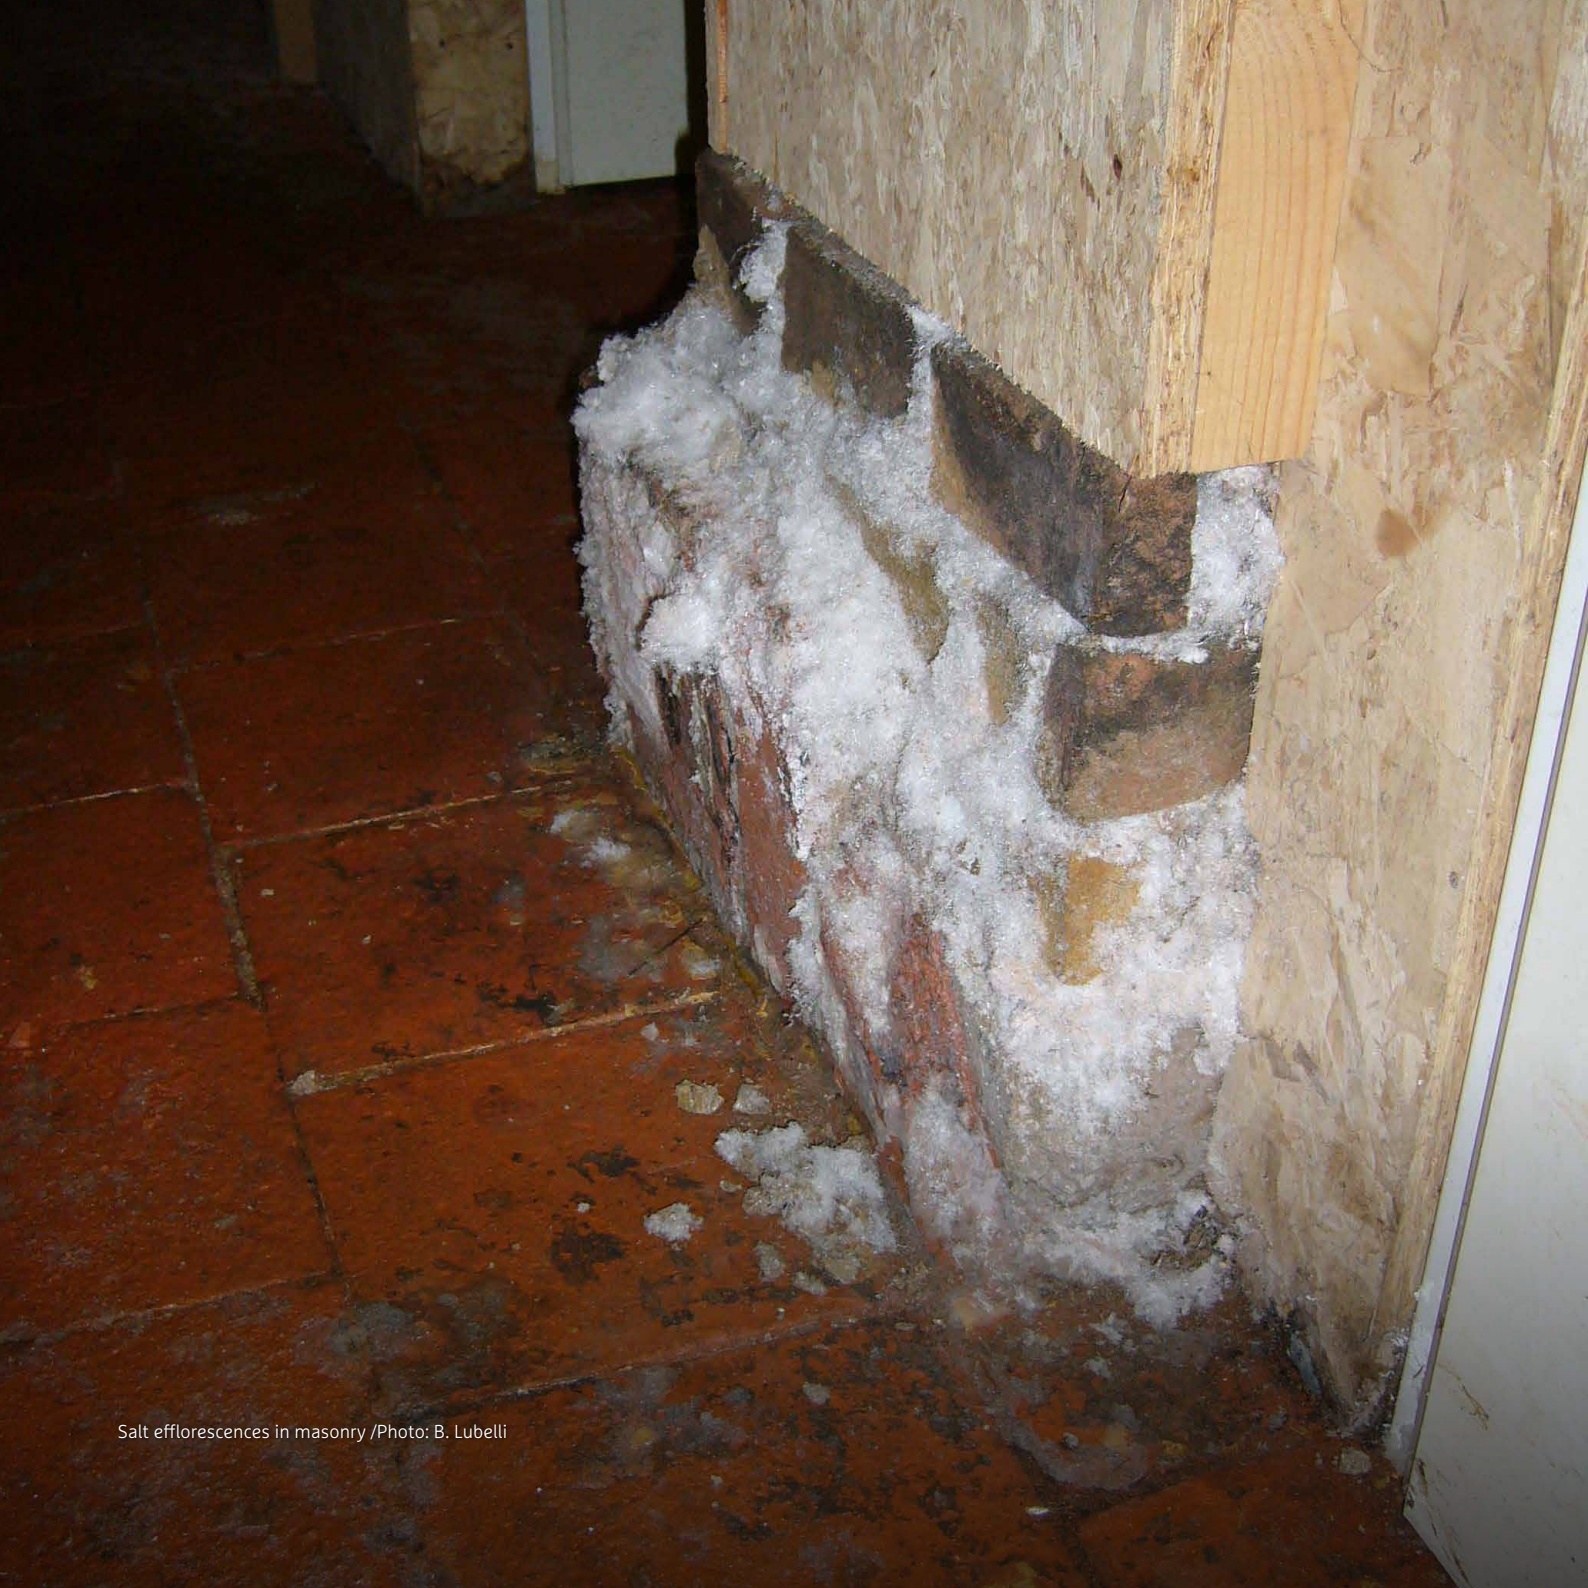
Salt efflorescences in masonry /Photo: B. Lubelli
