## Forensic Analysis of Levee Failures: The Breitenhagen Case

International Journal of Geoengineering Case Histories

**ABSTRACT:** Forensic analysis of past failures is valuable to improve our understanding of levee behavior. In this article a new systematic approach of forensic analysis for levee failures is proposed and applied to the Breitenhagen levee breach that occurred along the river Saale in Germany in 2013. The purpose of this study is to identify the cause of the breach based on the proposed approach, even though limited data is available. Based on the information prior, during and after the breach of the levee, a slope stability model is developed for the entire event. First, results from this model are obtained based on the expected values of the uncertain parameters and the best estimates of the situation. Uncertainty of the model is included in the calculation subsequently by defining possible failure scenarios. The most likely failure scenarios are derived from the data and included into the model so that it is possible to eliminate or validate all possible causes by means of a sensitivity calculation. It is concluded that the levee breach is likely caused by loca

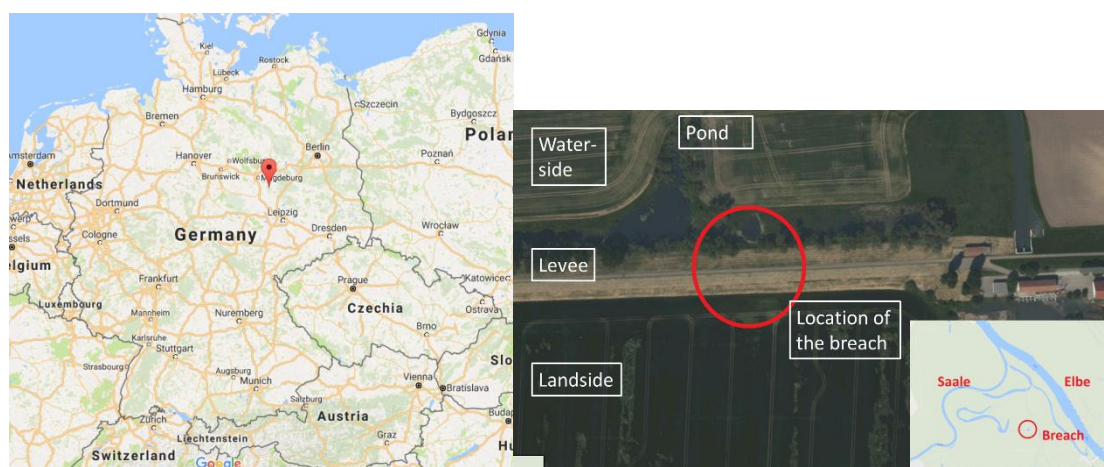
Figure 2. Overview of the location of the breach (GeoBasis-DE/BKG, 2009).

The data collected prior to the breach provide an indication of the condition of the levee prior to the breach. The overview photo shows a pond in front of the levee possibly caused by an earlier breach (Figure 2). This indicates the possibility of a direct connection between the outside water level and the aquifer below the levee. The photos show a row of trees at the riverside toe of the levee which might influence the conductivity of the levee due to the intrusion of the roots inside the levee, or might indicate the presence of a more conductive layer inside the levee (Figure 2). The slope of the levee is very steep (about 1:2.1 vertical to horizontal) with a gradient that exceeds the friction angle of most soil types. The slope at the landside is prone to instability (Figure 5).

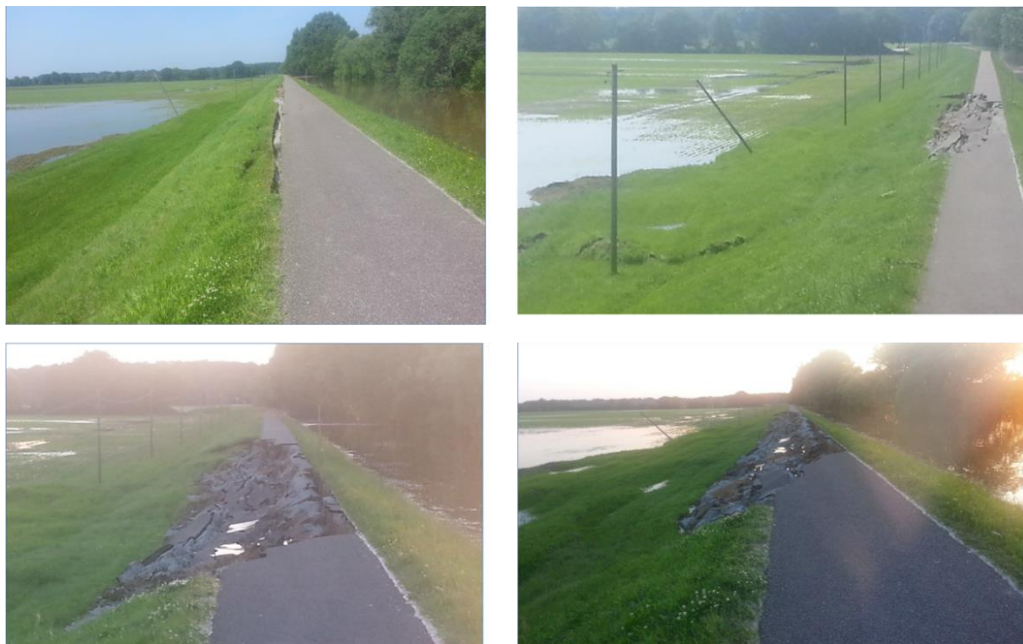
Photo data were collected during the breaching process as well, showing recognizable indications of the levee failure. The indicators were used to identify the deformations and the geometry of the slip circle (Figure 6). Also, ponding due to possible seepage of water at the landside is shown. Possible high water pressures in the aquifer may cause seepage and saturation of the soil at the landside of the levee.

*Figure 6. Photo series over time (upper left: 08.06.2013–10:37, initial break at the edge of the slope, upper right: 08.06.2013–14:10, horizontal shifts, bulge of the toe, lower left: 08.06.2013–20:51 continuing failure, lower right, 08.06.2013–20:55, continuing failure with the visual predictors (Grubert, 2013). Riverside of the levee is on the right for all photos.*

On the left side of the picture an electricity pole is recognized which seems to tilt over time, until it is almost completely horizontal (Figure 6). Also the slip circle is expanding until the road is completely damaged indicating an increasing deformation over time. The initial failure is considered to have weakened the levee to such a level that the levee lost all its retaining capacity.

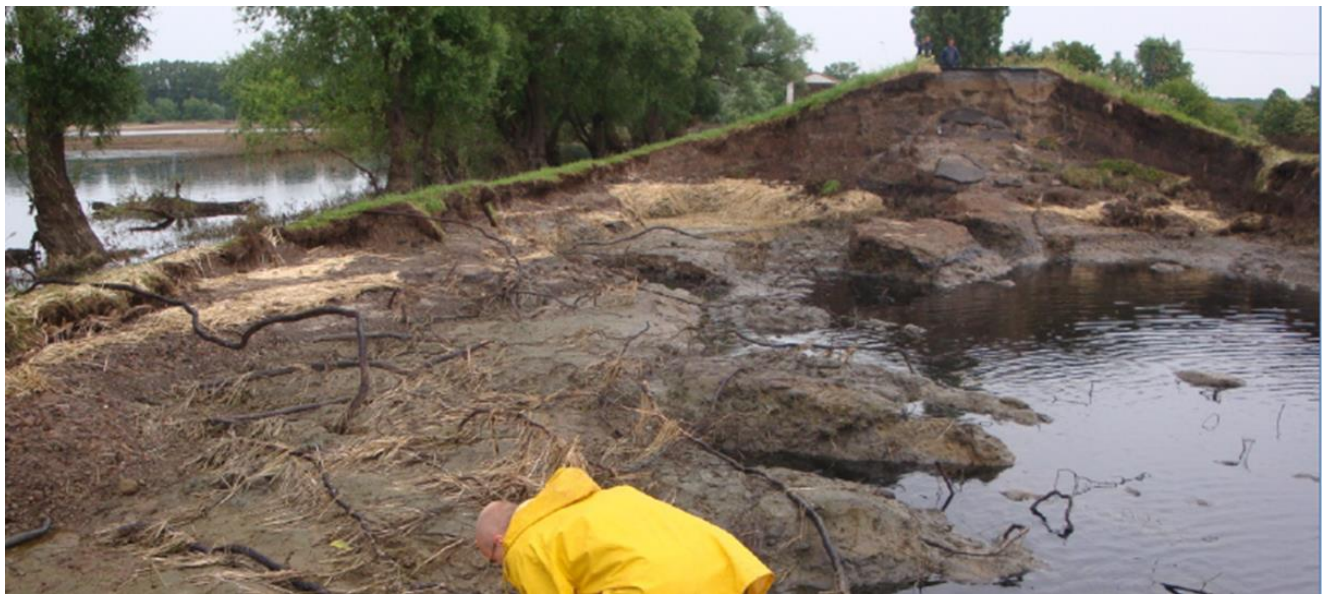
The photos taken after the breach show the presence of roots in the cross-section even after the breach as shown in Figure 7. The roots are numerous and the length of the roots indicate that they have grown deep into the levee. The presence of the tree roots might indicate a highly conductive layer which could have a direct effect on the local pore pressures inside the levee. The soil surface that is exposed by the breach, seems to consist of a cohesive material.

*Figure 7. Photo of the cross-section of the breached levee (Grubert, 2013).*
