# Correlating laboratory tests with service life performance of marine coating systems

**Msc. Materials Science and Engineering**  
Hemchandran Coimbatore Govindarajan

# Abstract

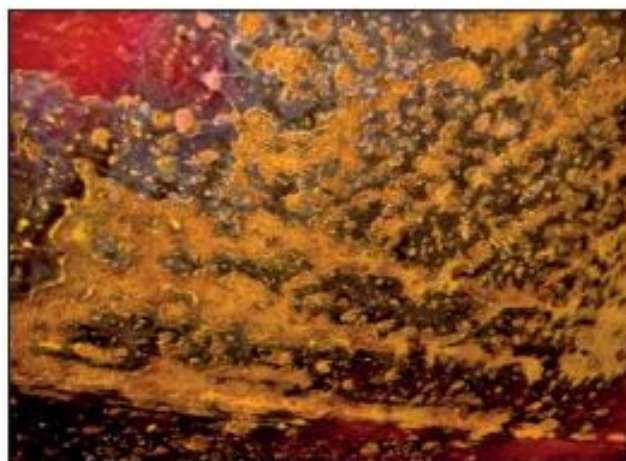
Figure 1.3: Coating deterioration after 4 years of service with conventional hull coating like a foul releasing coating or anti fouling coating [93]

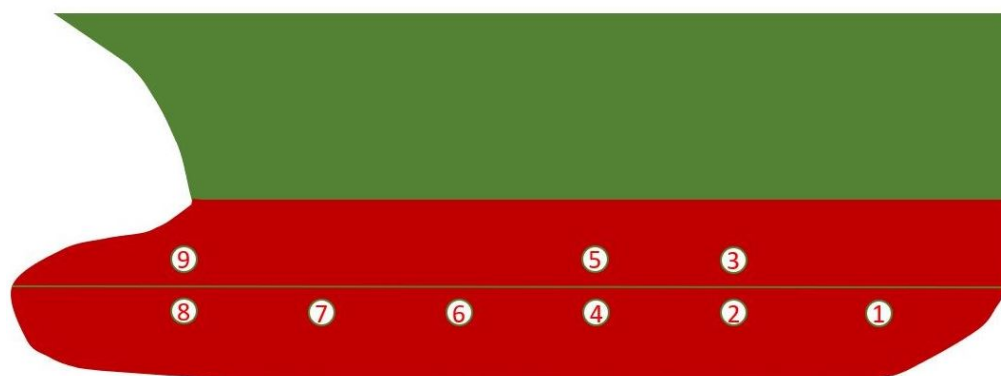
Figure 2.4: Schematic of measurement points on Paivi
