## Proceedings of SWBSS 2021

### Fifth International Conference on Salt Weathering of Buildings and Stone Sculptures

22-24 September 2021  
Delft, the Netherlands

Edited by  
Barbara Lubelli, Ameya Kamat & Wido Quist

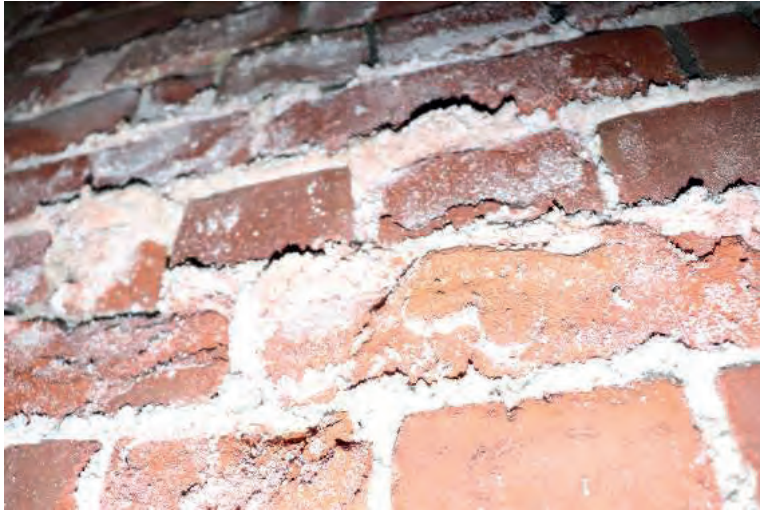
Figure 2: Brick surfaces and salt at the south side of the brick chimney in October 2019

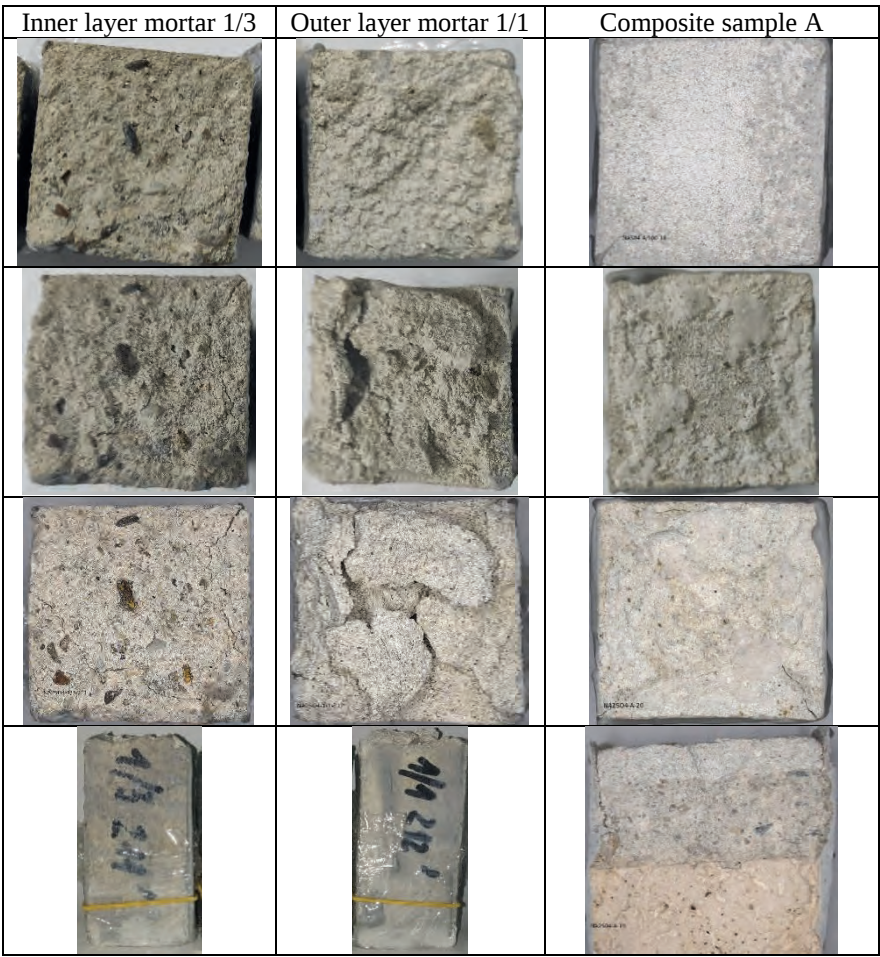
Figure 5: Composite and standardized specimens with rendering mortars 1/1 and 1/3 after 1<sup>st</sup>, 3<sup>rd</sup> and 5<sup>th</sup> cycle, treated with Na<sub>2</sub>SO<sub>4</sub> solution.

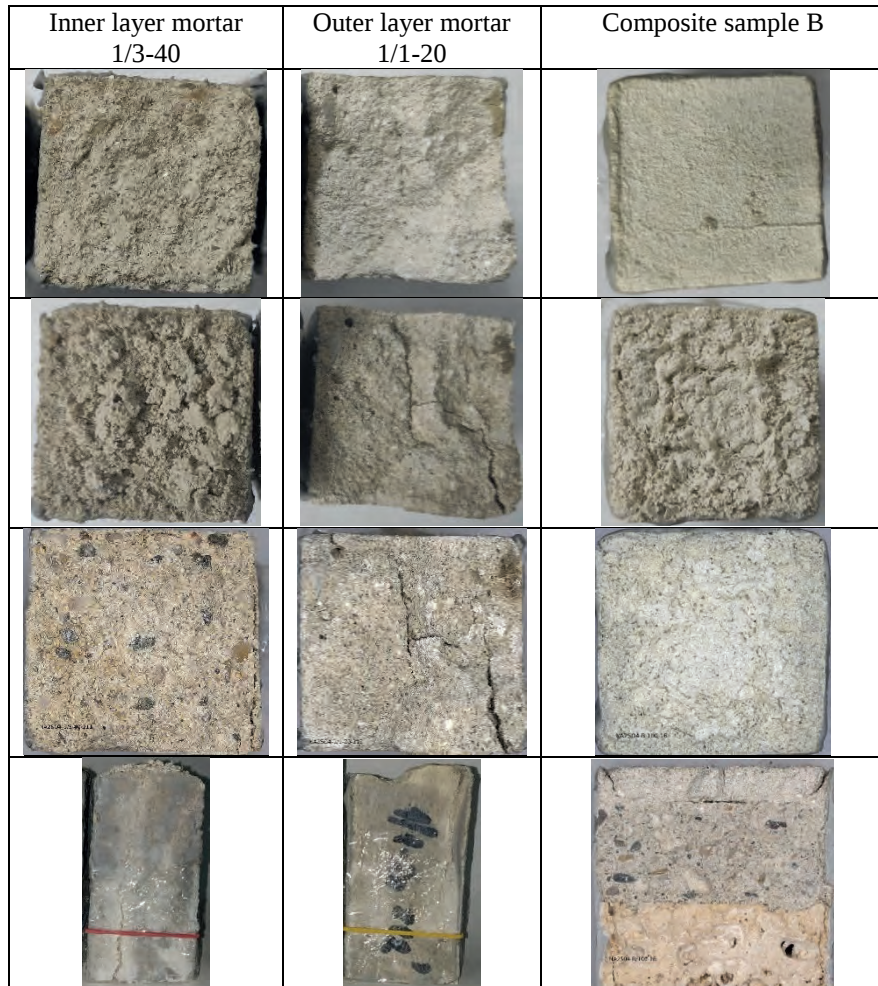
Figure 6: Composite and standardized specimens with rendering mortars 1/1-20 and 1/3-40 after 1<sup>st</sup>, 3<sup>rd</sup> and 5<sup>th</sup> cycle, treated with Na<sub>2</sub>SO<sub>4</sub> solution.

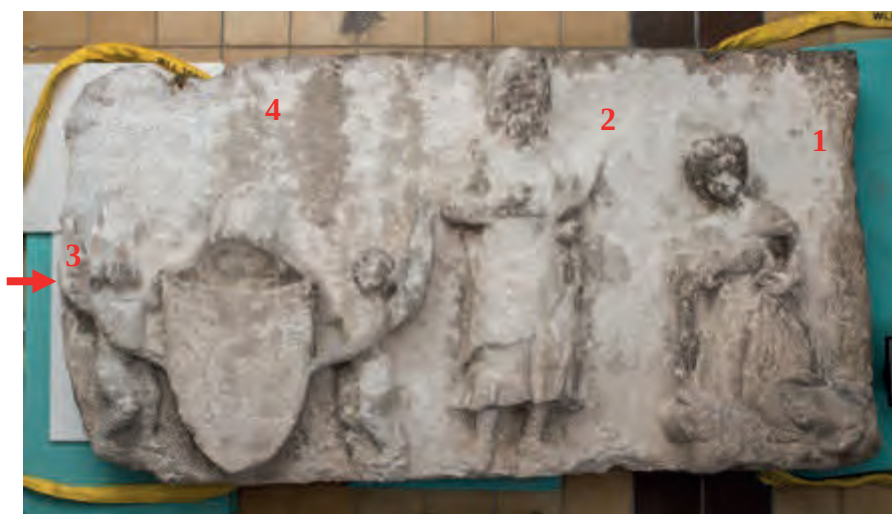
Figure 2: Photograph of stone relief with sample points.

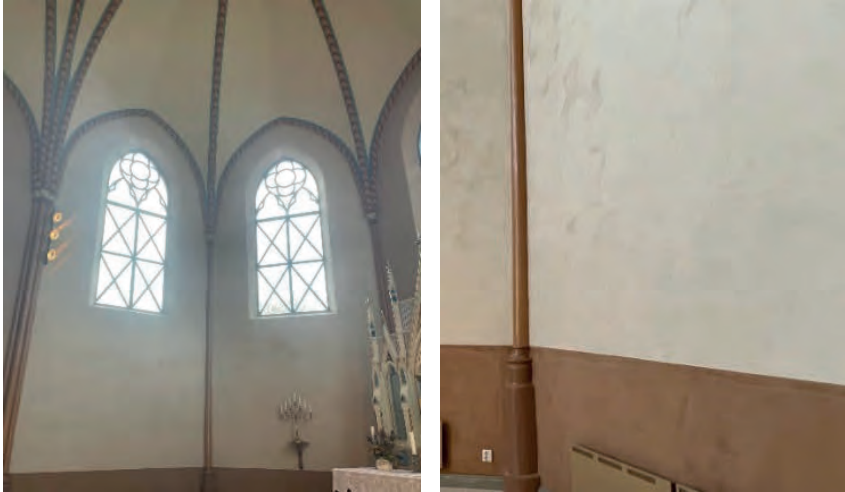
Figure 5: The two walls that have been plastered with hemp-lime in the choir. After two years there are no signs at all of salts on the surface. Only the normal liveliness of the lime wash gives the surface its expression.

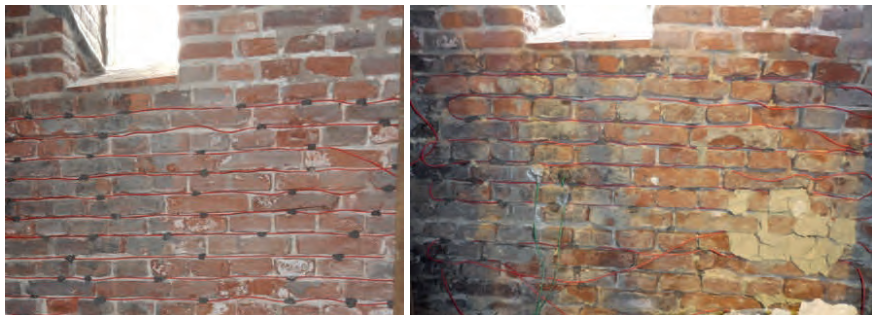
Figure 8: Location C (heated) before desalination (left) and after desalination (right): no further damage due to desalination is observed.

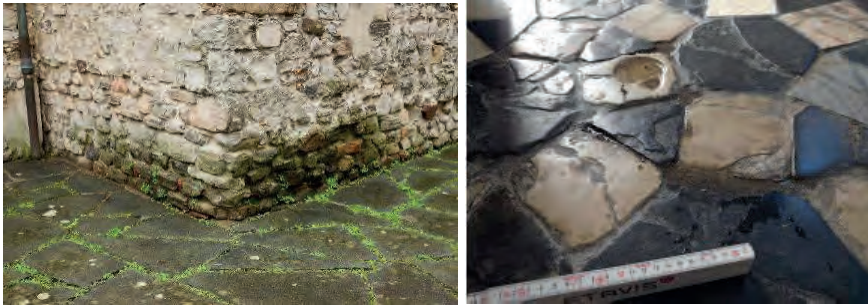
Figure 2: a) Phenomenon of capillary rising damp along the perimeter and biological colonization; b) Puddles of rainwater formed following water entry from the main door during heavy rains.
