Performance Study of a Double Crossover for Facing and Trailing Directions

ABSTRACT: This paper presented the performance study of two frogs in a double crossover in the railway network in the Netherlands. These frogs are located on the same track line. Each train passes through Frog 1 in the facing direction and Frog 2 in the trailing direction. Both frogs are monitored with ESAH-M crossing dynamic behaviour measurement tool and remote displacement measurement system Video Gauge.

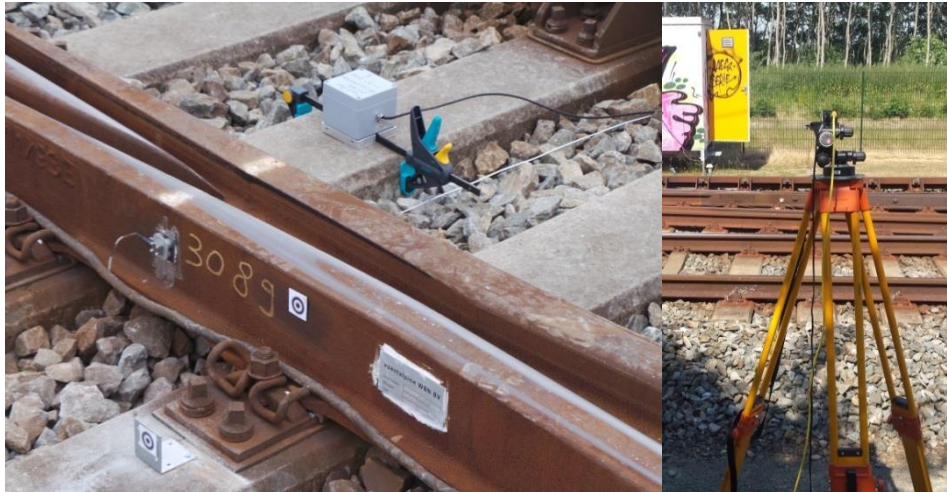
Figure 2.1 Instrumented frog with ESAH-M sensors and Video Gauge targets/camera

The main unit of each ESAH-M is located out of the track with extension cables connecting to all the sensors attached in the crossing. An accumulator supplies power for each ESAH-M, which guarantees ESAH-M to measure up to 500 passing trains continuously. Video Gauge is a system with extreme reliability on hard disk storage and power supply, continuous measurement is difficult to implement. Video Gauge measurements performed with intervals of 2-3 weeks. Waterproof targets were installed on the interested positions in advance. With all these preparation, measurements can be done without access to the track.

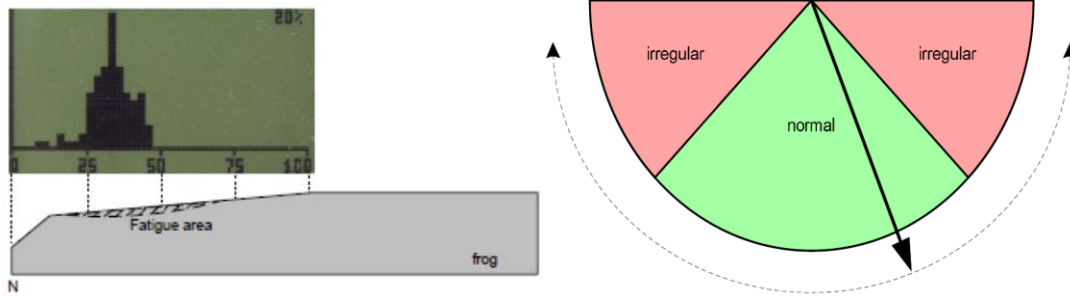
Figure 3.1 Fatigue area (Left) and wheel passing condition (Right) definition

ESAH-M records the frog acceleration signal with a sampling frequency of 10 kHz, automatically calculates maximum accelerations of each passing wheel. Based on the time point of maximum vertical acceleration of each passing wheel, the wheel/rail impact positions are collected to detect the fatigue area on the frog. The wheel passing condition according to the wheel/rail contact angle is also detected [9-11].

In Frog 1, trains pass through it in trailing direction. The datum point of contact position is crossing nose, fatigue area on the wing rail. In Frog 2, fatigue area on the crossing nose, same as given in Figure 3.1. The figures below are contact position development in both frogs.

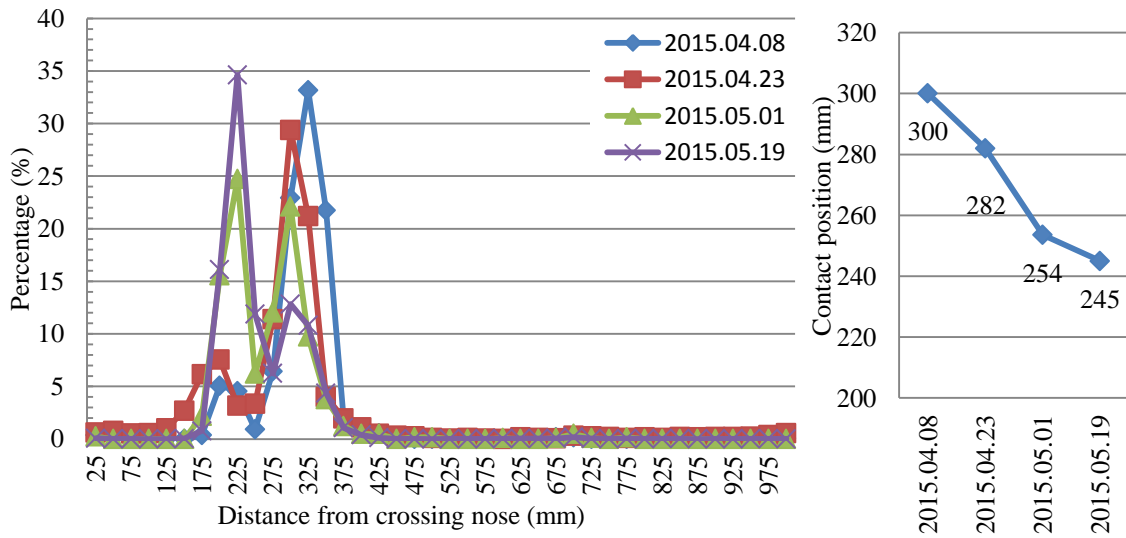
Figure 3.2 Wheel/wing rail contact position in Frog 1

Figure 3.2 manifests two contact bands on the wing rail, one around 225mm and another around 325mm from the crossing nose. In the monitoring period, the main band shifted from 325mm to 225mm, and the average contact position decreased from 300mm to 245mm. Frog fatigue area centralized in 150-400mm.

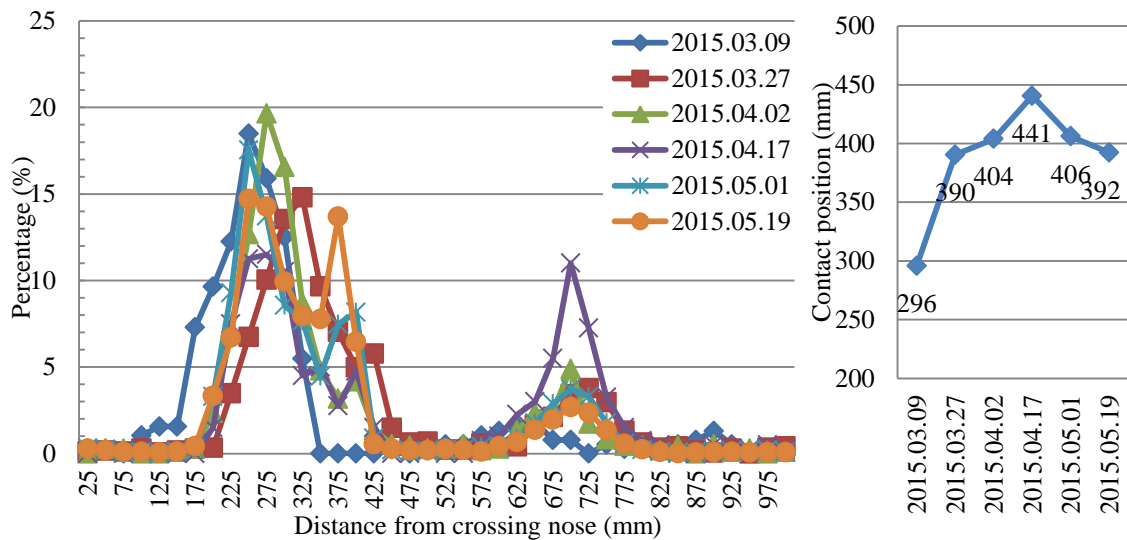
Figure 3.3 Wheel/crossing nose contact position in Frog 2

In the initial operation period of Frog 2, wheel/rail impact area mainly distributes between 150mm and 350mm with an average value of 296mm. After 2 weeks, wheel/rail contact area gradually separates into two parts: main band in 200-450mm and minor band around 700mm. On 2015.04.17, wheel/rail contact in the minor band accounted for around 30%, and the average contact position is 441mm. In the other measurements, the average contact positions are around 400mm and minor band accounted for around 15% (Figure 3.3).

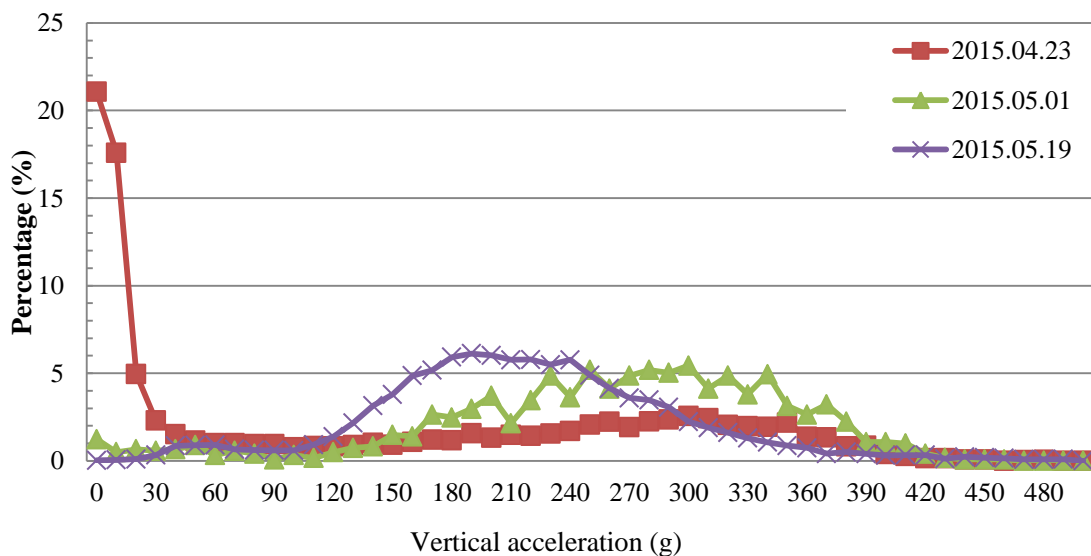
Figure 3.4 Vertical acceleration distribution of all passing wheels in Frog 1

On the first record day in Frog 1, the majority passing wheels with rail vertical accelerations below 50g generated higher lateral accelerations. In normal passing condition, the vertical acceleration distributed mainly between 120g and 420g. During the monitoring period, the overall distribution shifted from around 300g to around 200g.

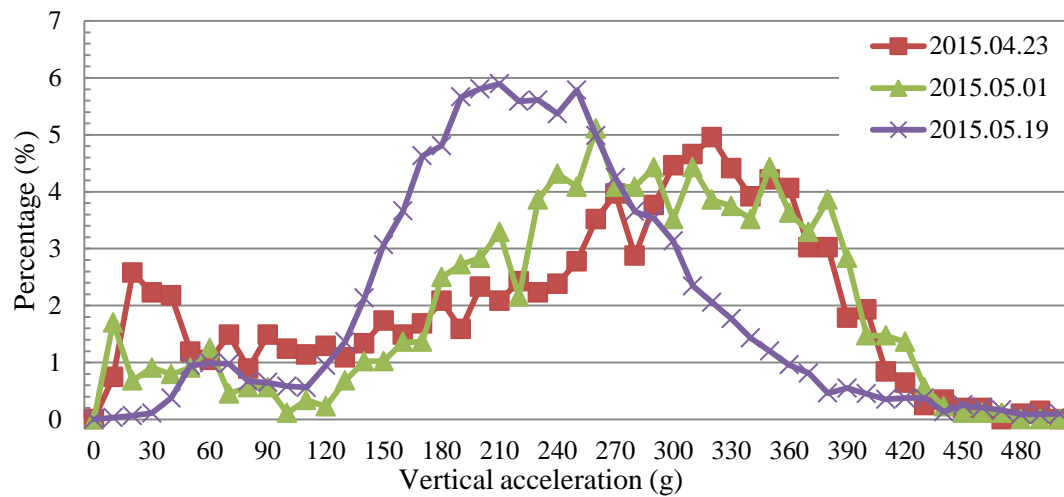
Figure 3.5 Vertical acceleration distribution of normal passing wheels in Frog 1

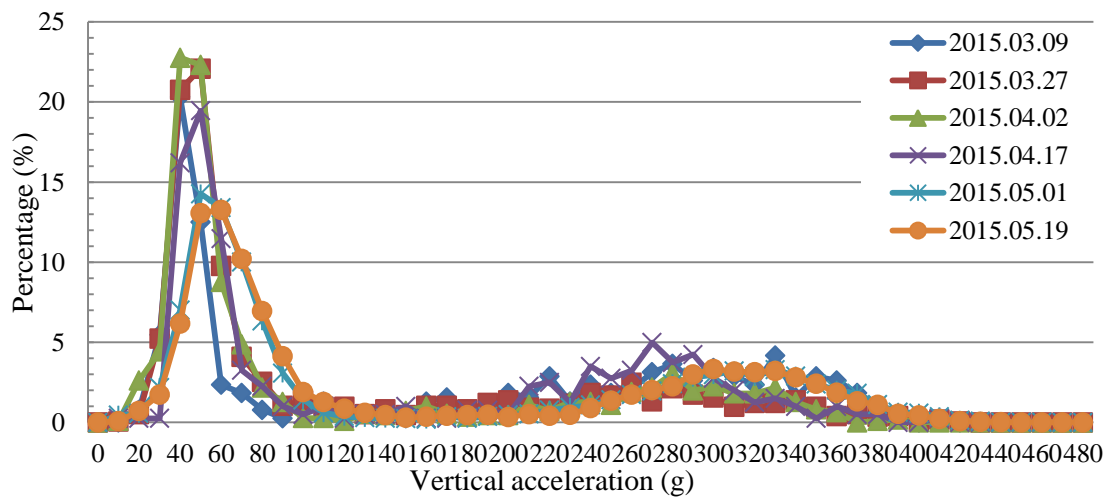
Figure 3.6 Vertical acceleration distribution of all passing wheels in Frog 2

In Frog 2 measurement, the responses of regular passing wheels are mainly in the range of 20g to 100g. Irregular passing wheels generate high impact in lateral direction as well as in vertical direction.

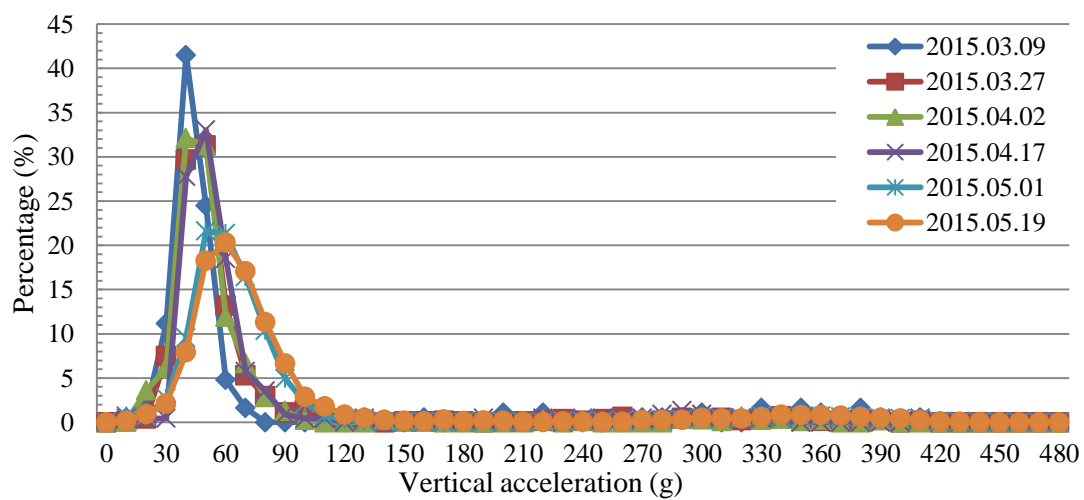
Figure 3.7 Vertical acceleration distribution of normal passing wheels in Frog 2

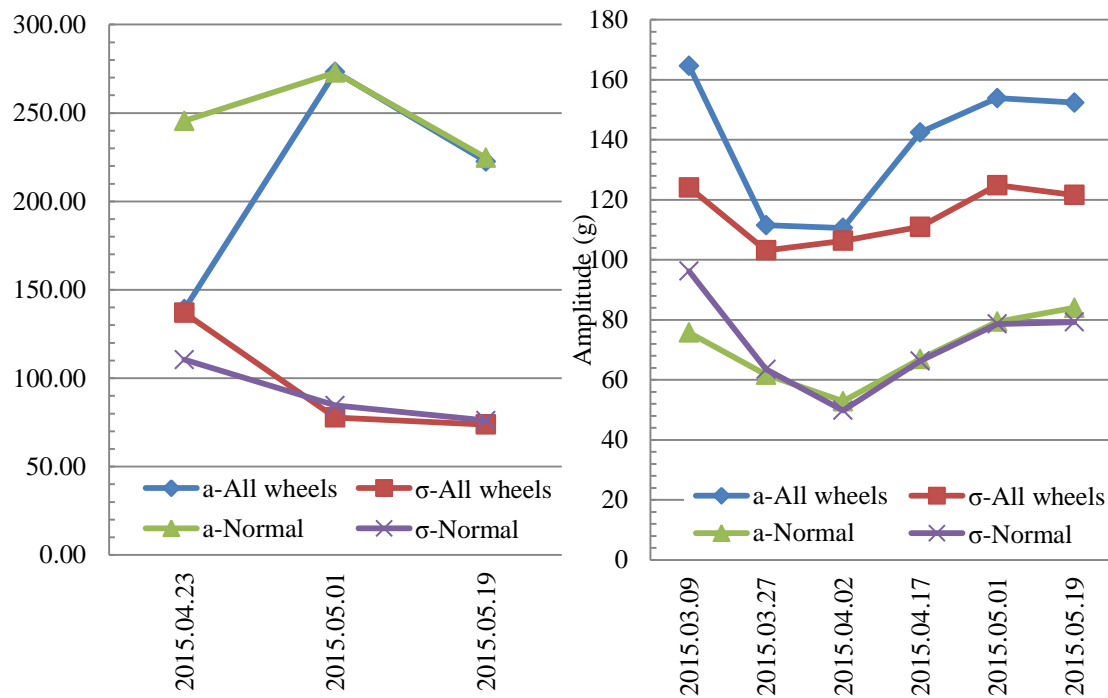
Figure 3.8 Average value and standard deviations of vertical acceleration in Frog1 and Frog 2

Figure 3.8 and Figure 3.9 indicate that in the first record day of Frog 1, 2/3 of the wheels pass through the frog irregularly. In the following two record days, the proportion of irregular passing wheels dramatically decreased.

In the initial operation stage of Frog 2, half of the wheels pass through the frog irregularly. This ratio decreased in the next two record days and then increased again. In Frog 2, the average vertical acceleration value, standard deviation and the ratio of irregular passing wheels have positive correlation.

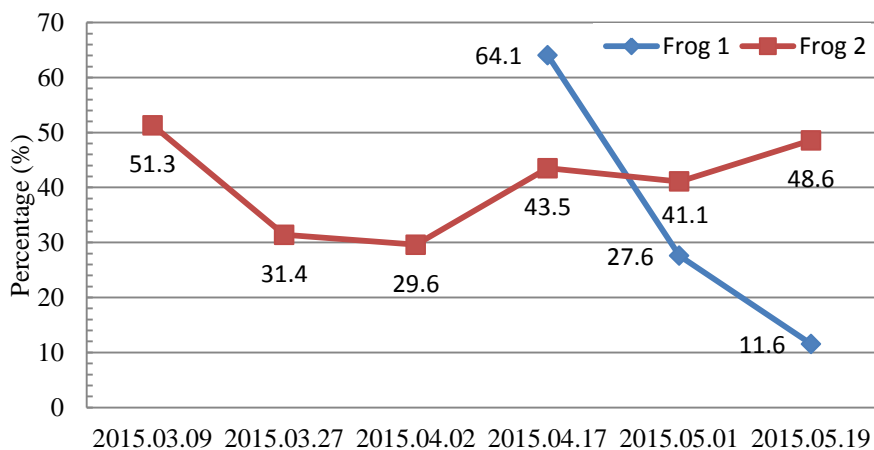
Figure 3.9 The development of the proportion of irregular passing wheels

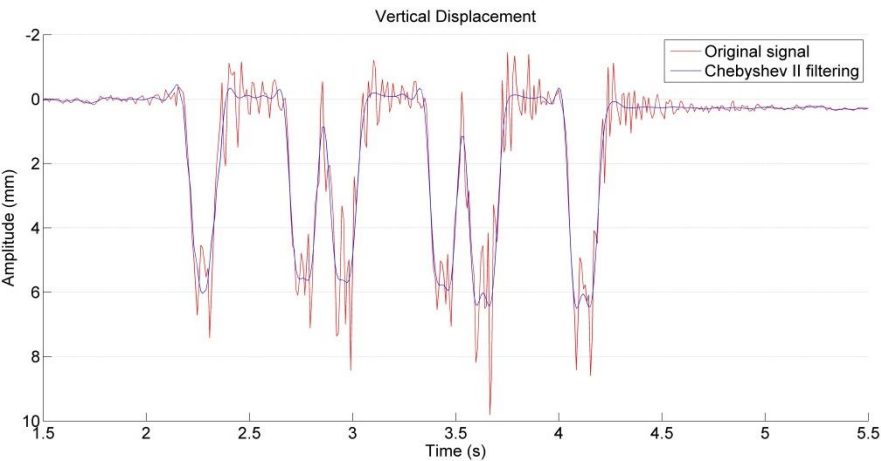
Figure 3.10 Chebyshev II filtering effect

Figure 3.10 indicates that Chebyshev II Filter effectively eliminates the structural vibration. The rest part is mainly the vertical movement of sleeper with the impact of passing train, which reflects the void under the sleeper. The measurements comparisons describe the void development in both frogs in the monitoring period.

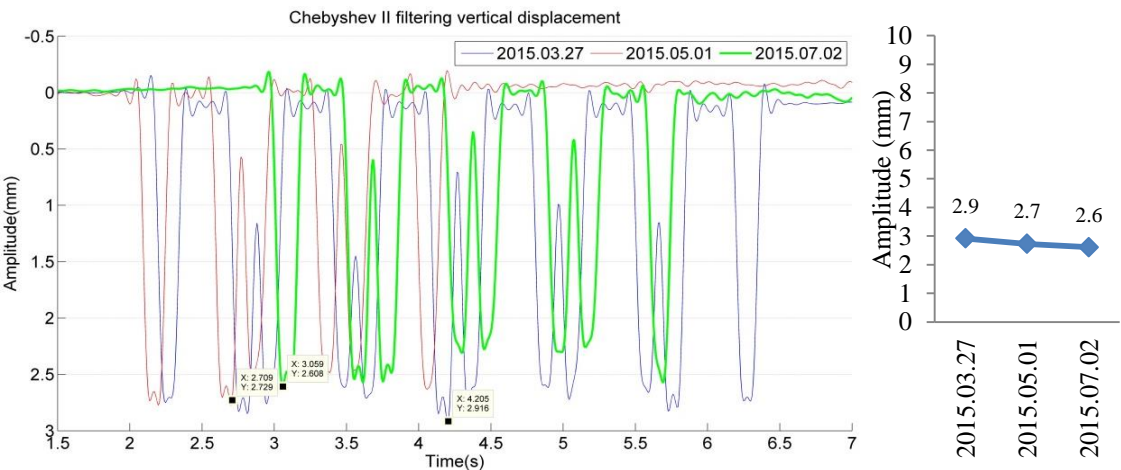
Figure 3.11 Vertical displacement development in Frog 1

In the monitoring period, filtered sleeper displacements in Frog 1 is constant, ballast condition is stable, approximately 2.7mm. In Frog 2, from 2015.03.09 to 2015.04.17, sleeper displacement increased from 3.4mm to 9.3mm. In the very last measurement, the amplitude decreased to 6.5mm.

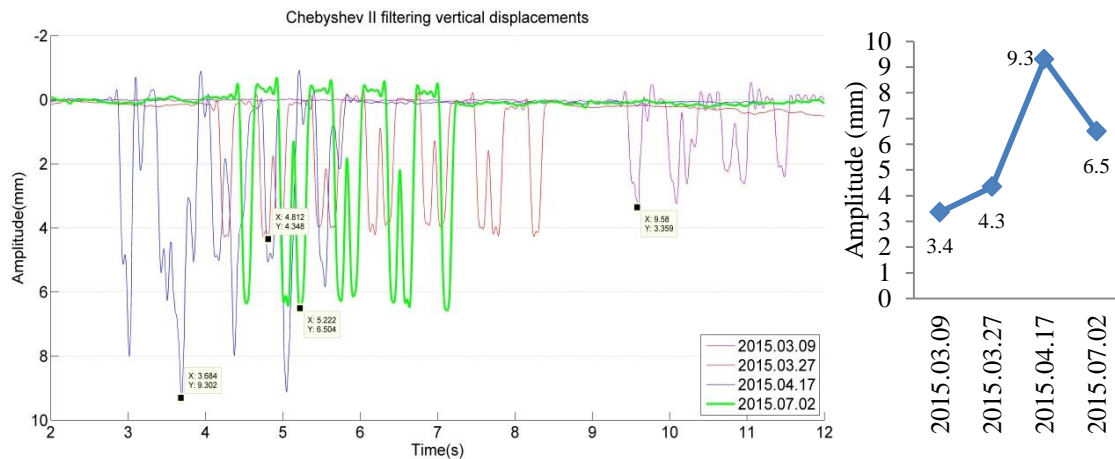
Figure 3.12 Vertical displacement development in Frog 2

The structural instability increased the difficulty of monitoring, also reflects the shortcomings of the experimental devices. In Figure 3.12, the measurement results on 2015.04.17 illustrate short frequency coverage of Video Gauge System. System updating is necessary for better field performance.
