## Colour, Form and Space

### Rietveld Schröder House Challenging the Future

# 1 / THE RESTORATION OF THE EXTERIOR

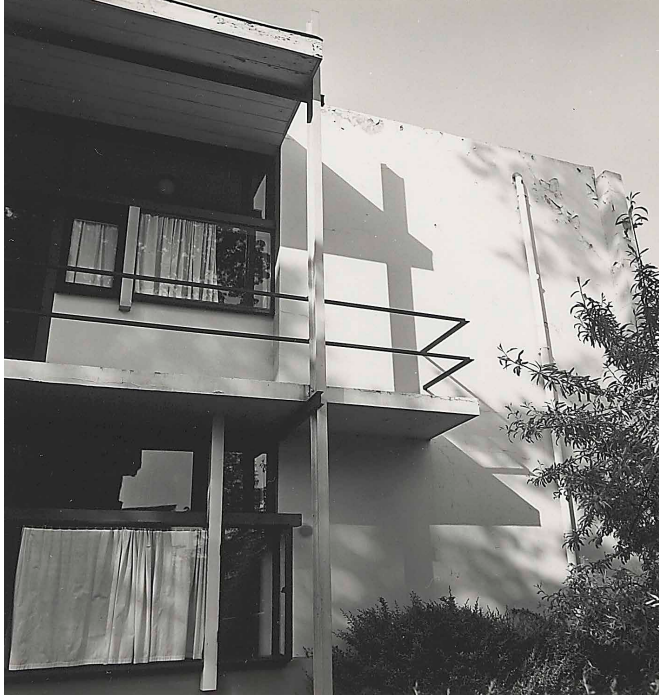
FIG. 1.2 Damage to the house became increasingly visible

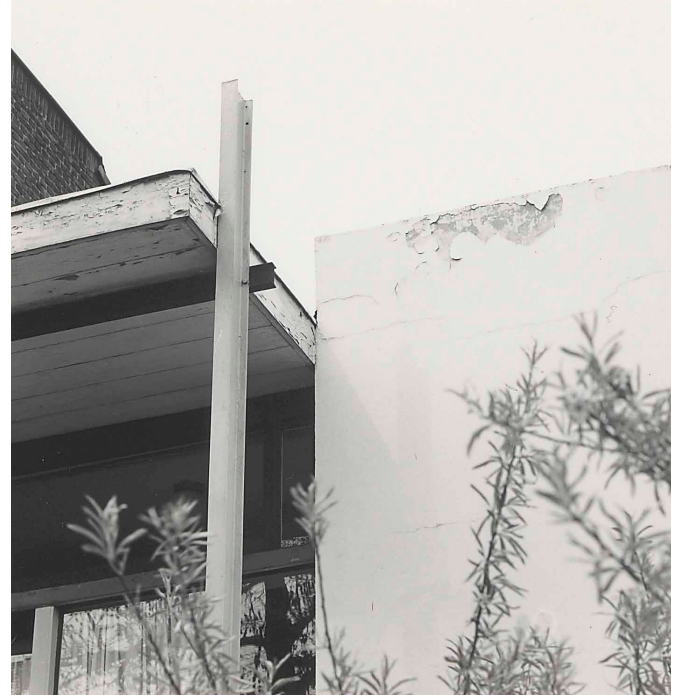
FIG. 1.3 Plasterwork and wood exhibited serious blemishes

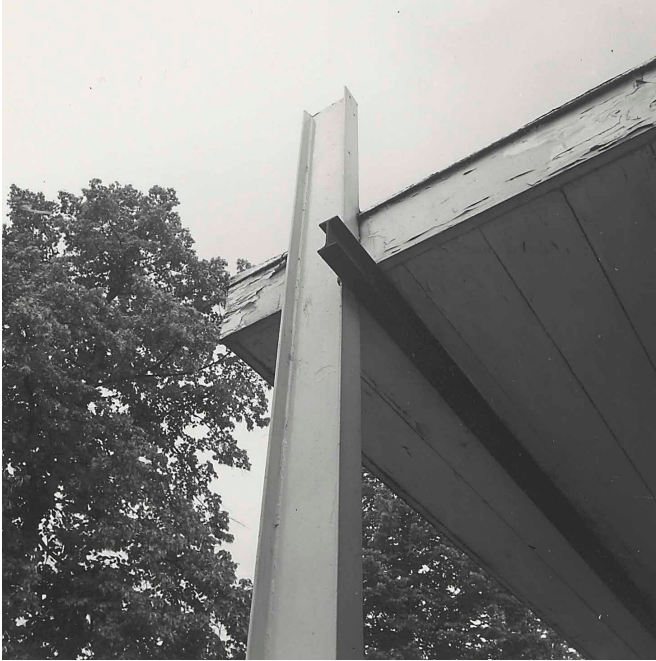
FIG. 1.4 Unconventional constructions made the house vulnerable

This was mainly because Rietveld considered the spatial effect and associated appearance, and the optical effect, more important than a stable and sound construction [FIG. 1.4]. This had resulted in unusual combinations of traditional and modern materials (and their properties) and techniques which, after the passage of so many years had started to exhibit all manner of defects. For example, the way the steel beams had been tailed into the (single-skin) brickwork had led, through the action of moisture, to rust and hence to cracks in both brickwork and plaster. At Rietveld's insistence, the concrete slabs used for the balconies had to be very thin so that here, too, moisture had been able to corrode the steel edges, which had started to rust, and the concrete had begun to display cracks [FIG. 1.5].

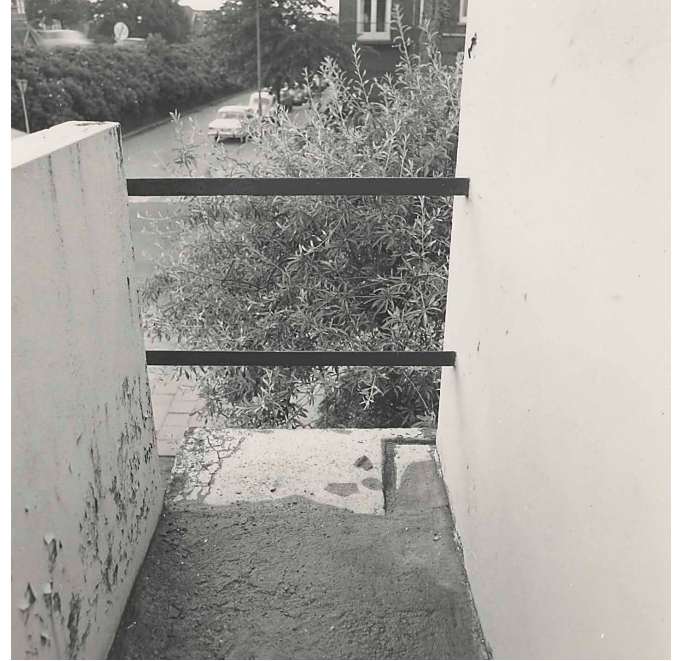
FIG. 1.5 After 50 years the concrete of the balconies also showed signs of cracks and damage

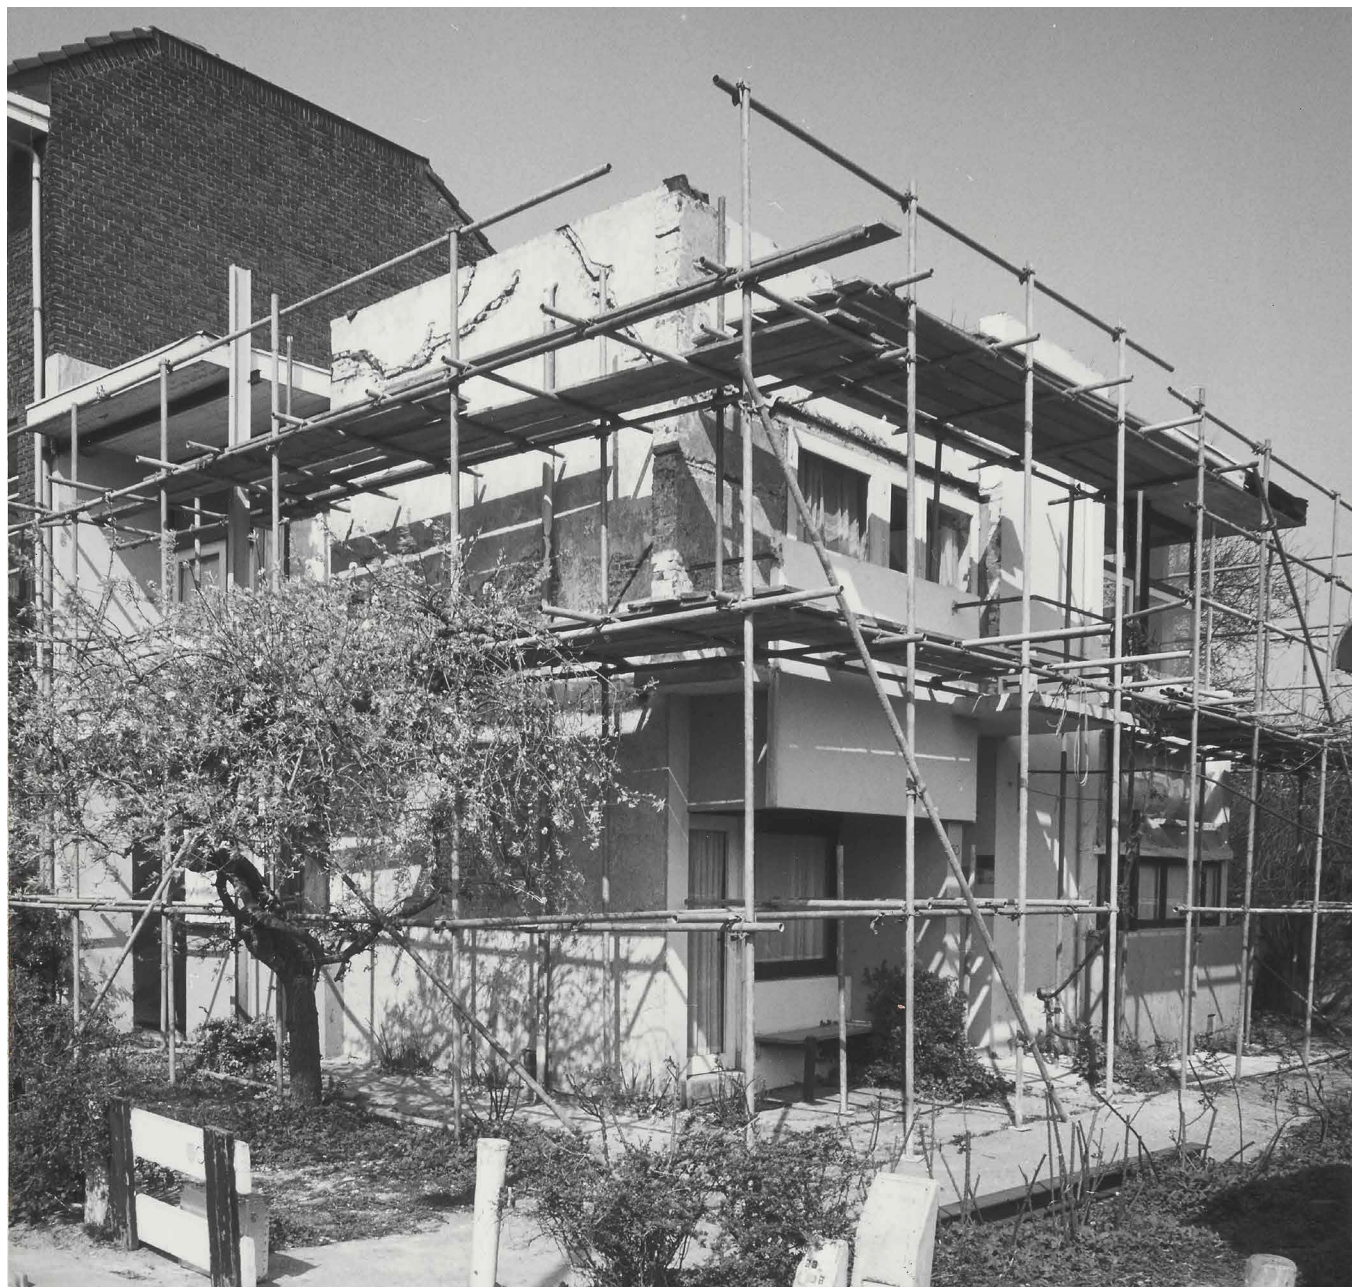
Once the house was surrounded with scaffolding, work could begin on the necessary repairs and replacements [FIG. 1.6]. The house had numerous defects and was not very stable.

FIG. 1.6 Scaffolded Rietveld Schröder House at the start of the restoration of the exterior, 1974

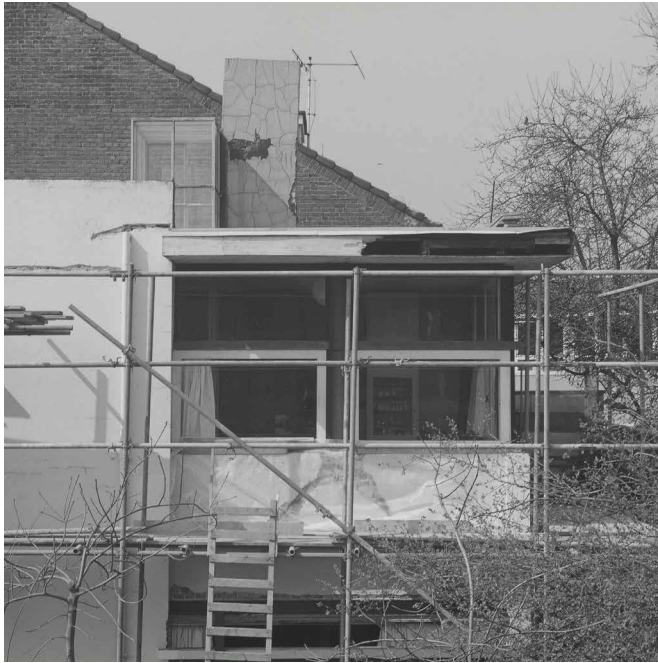
FIG. 1.7 The roof required extensive repairs to prevent further sagging and leaks

The roof construction and finishing employed had given rise to sagging, resulting in numerous leaks [FIG. 1.7]. The skylight needed to be replaced. Likewise, much of the timber used in windows and doors, which Rietveld had dictated should be flush with internal and external walls, in other words without sills or projecting edges, was due for replacement. This was especially true of the windows and balcony door in the east elevation, followed by Truus's room. The damage and defects were treated invasively by Mulder, using contemporary materials and techniques, in order '[to] achieve the durability desired by Truus Schröder [FIG. 1.8]. Not through restoration according to traditional standards, but to a large extent through reconstruction of the form using a new, technically superior method.' According to Mulder this was the result of the RDMZ's 'wise decision' to keep the agency's officials well away from the work.<sup>28</sup>

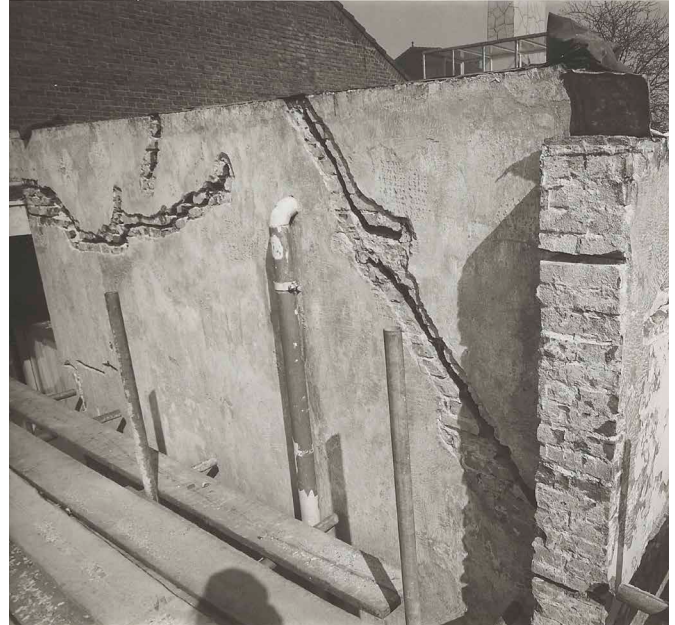
The restoration of the exterior was carried out between March and September 1974. The cracks in the plasterwork were mainly in the east and south elevations and once that plaster had been chipped away cracks were also discovered in the brickwork behind it [FIG. 1.9].<sup>29</sup> The Stichting Onderzoek en Voorlichting (Foundation for Research and Information, SOV) of a firm specializing in plastering, terrazzo and plasterboard (STS) had been asked for advice and in February it had provided detailed instructions for the repair and treatment of damaged sections of brickwork and plaster, for the joints between plasterwork and wood, and for the concrete. SOV's J.F. (Hans) Geerken provided advice on the method as well as on the specific composition of the materials to be used. In accordance with this advice, Mulder

FIG. 1.9 The brickwork displayed deep cracks

had the cracks in the brickwork treated with a synthetic mortar that was then coated with a synthetic dispersion to ensure that the rendering coat would adhere. Where the cracks were only in the plasterwork, the mortar layer was re-rendered and then plastered to the same level as the existing plasterwork, on which the existing layers of paint were still present. Instead of applying a fine render to the base coat, Rietveld had the plasterer impart texture directly to the (hardened) rendering coat. The circular motion of the trowel produced a grainy effect.<sup>30</sup> Geerken saw to it that the various stages of this work were carried out according to instructions.

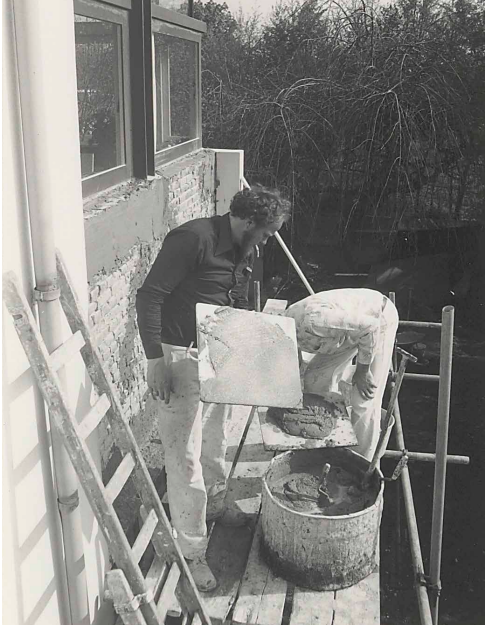
FIG. 1.10 Plasterers at work on the wall between corner window and kitchen

Work started at the end of April and after the removal of the layer of mortar it was discovered that the repairs to the brickwork using synthetic mortar had held up well. The substrate was homogeneous, and according to Geerken the brickwork was of reasonably good quality.<sup>39</sup> Thus the problems lay with the rendering. Even more radical decisions were then taken on site. 'The render that had remained in place during the restoration also had to be removed in order to achieve a single homogeneous plaster coat and to avoid problems with joins between old and new work [FIG. 1.10/1.11].'<sup>40</sup> Whether this literally meant that all the

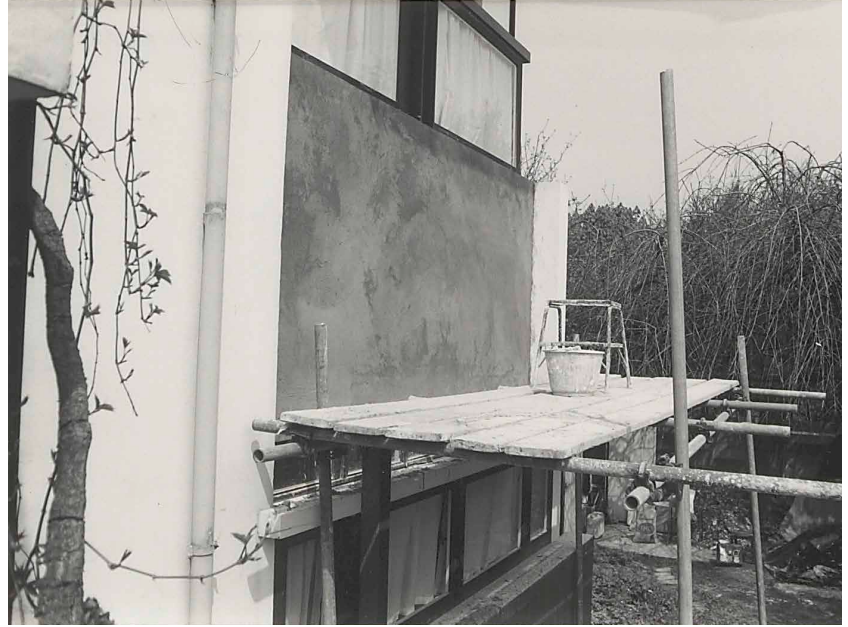
FIG. 1.11 After the plaster with hairline cracks was removed, the new render was applied in a single homogeneous coat

All kinds of repairs had been carried out, and the house was also a melange of different materials and constructions. It was consequently decided that it would be best to limit the number of materials and adhesive surfaces as much as possible. The new coat would be applied in one operation.<sup>38</sup>

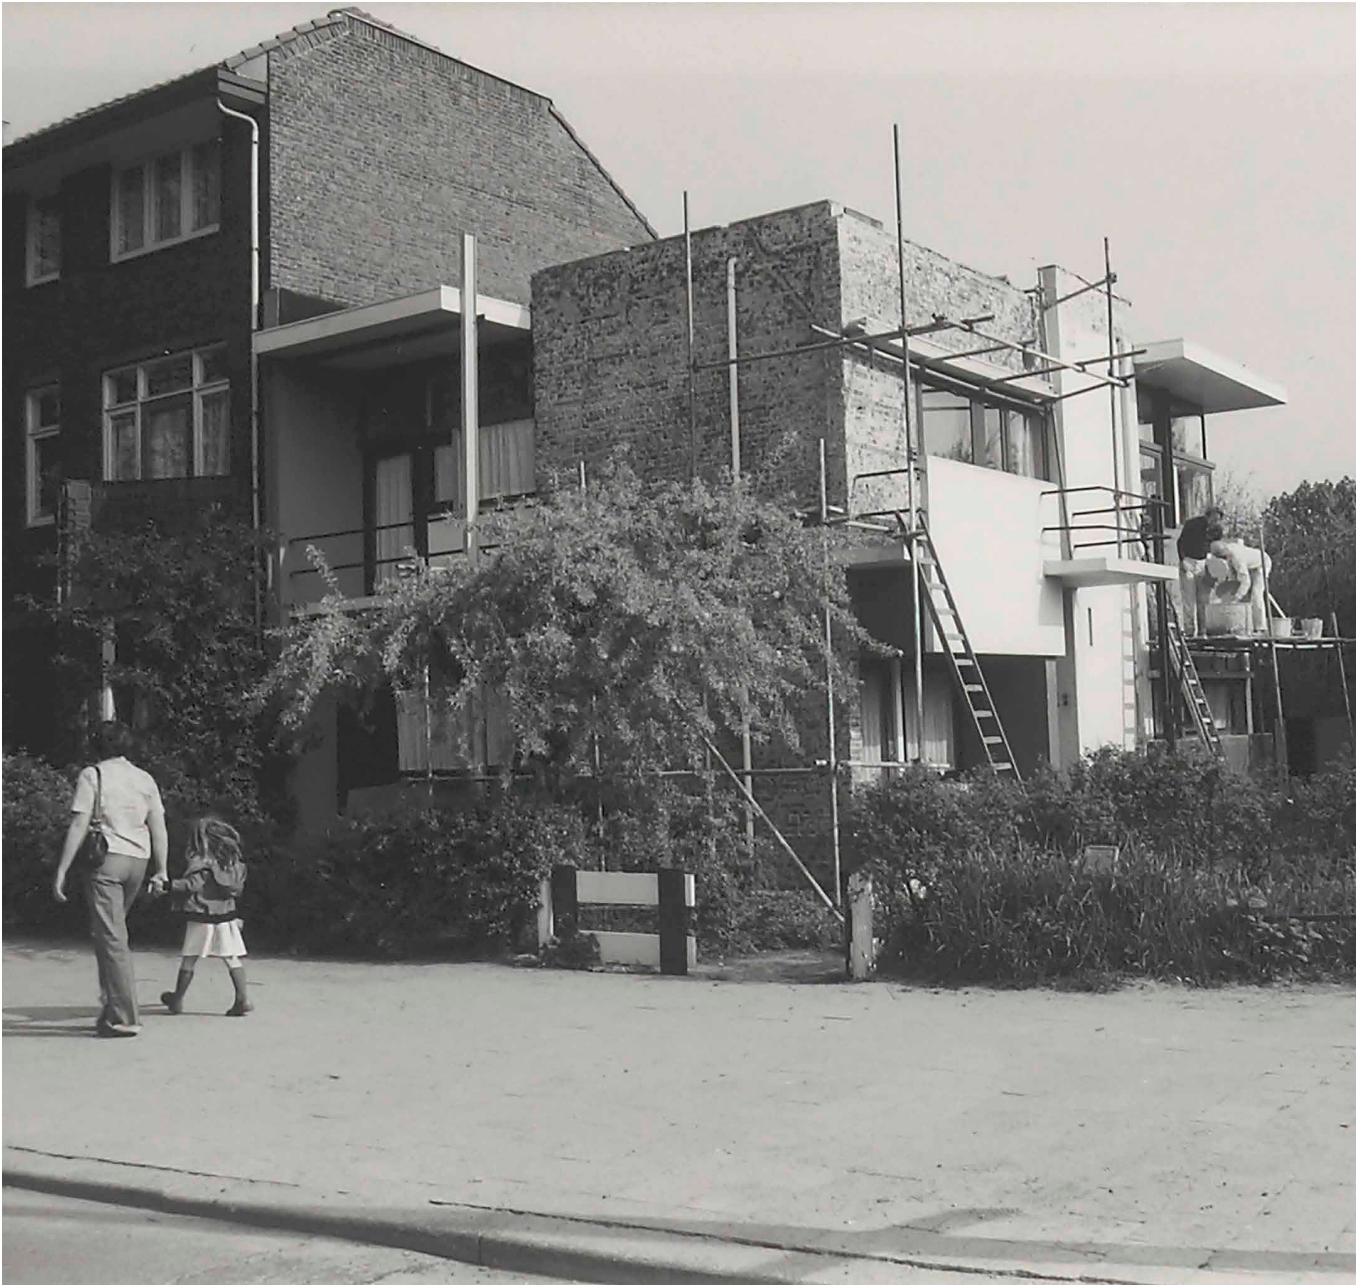
FIG. 1.12 South elevation (Prins Hendriklaan) with bare brickwork

walls of the house should be replastered or just the walls with problems is not entirely clear from the report. Photographs taken during the restoration show bare brick walls but also sections with the render still intact, such as the surfaces below the kitchen window and the studio on Prins Hendriklaan [FIG. 1.12/1.13/1.14]. Because the photographs are undated it is difficult to determine whether the areas of render still visible in the photos were retained or perhaps also removed. When asked about this, Mulder was initially unable to recall precisely what had happened. However, in 2018 he wrote: 'Only on smaller surfaces that had not been repaired did the original render remain in place, such as the ground-floor walls below the windows in the kitchen and on Prins Hendriklaan. Large sections also remained in place on the white surfaces in the entrance elevation and the rear elevation.'<sup>41</sup>

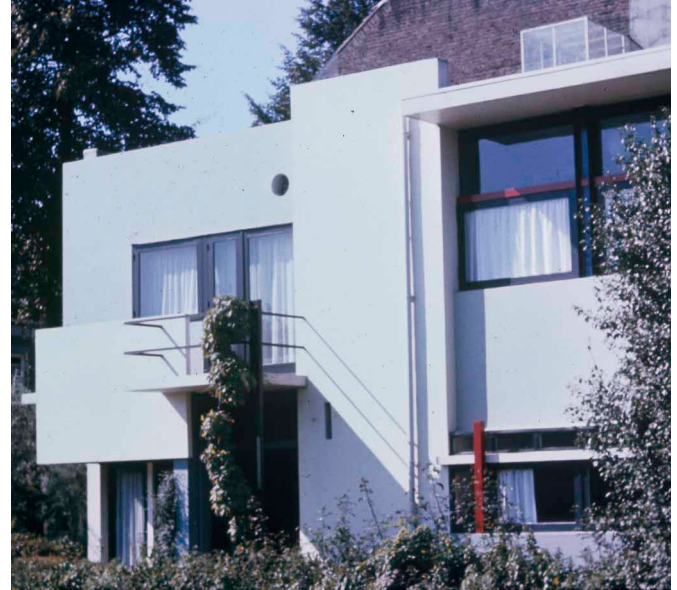
Most of the photographs dating from the early 1970s show the damage and poor state of repair – or perhaps the mediocre outcome of the Van Poppel paintwork – of the Schröder House. The contrasts between the greys are barely discernible, even in the colour photographs. According to Mulder, the greys from the period before the restoration were bluish as well, because back then the greys were only mixed with black [FIG. 2.5].<sup>11</sup>

FIG. 2.5 A colour photograph from before the restoration shows that the greys had become bluish

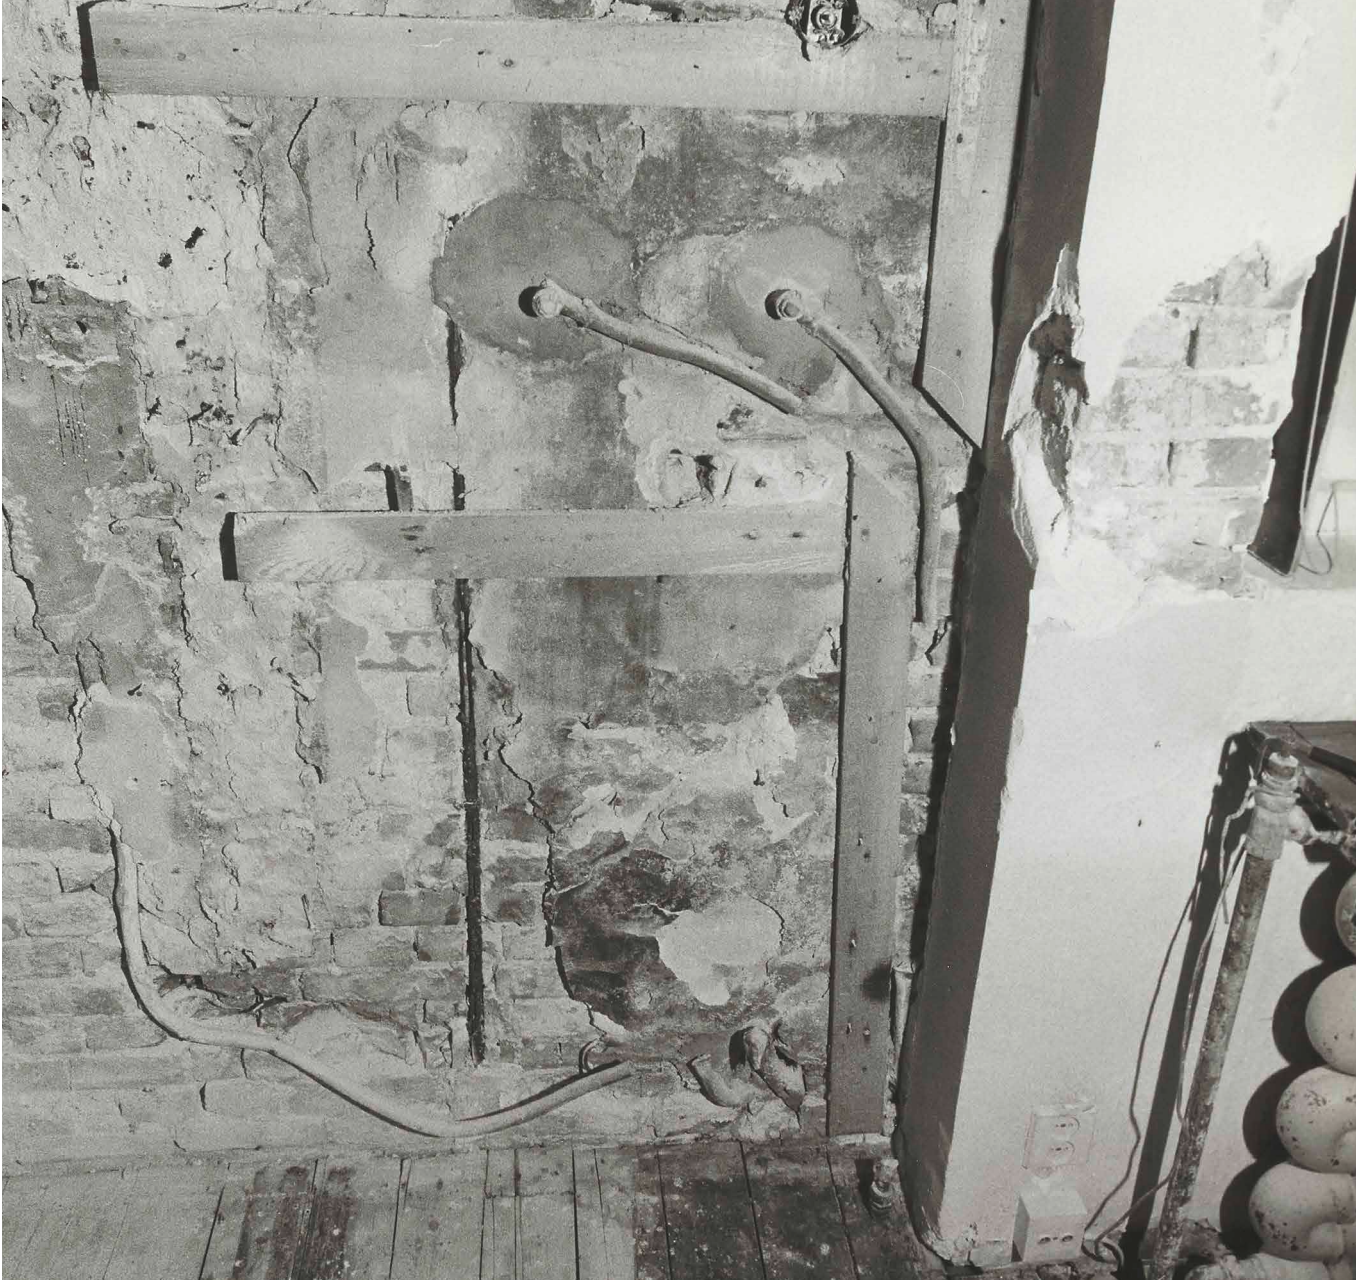
FIG. 3.1 The dismantling of wall, floors and ceiling yielded a lot of information about pipes, connection points and the attachment of furniture

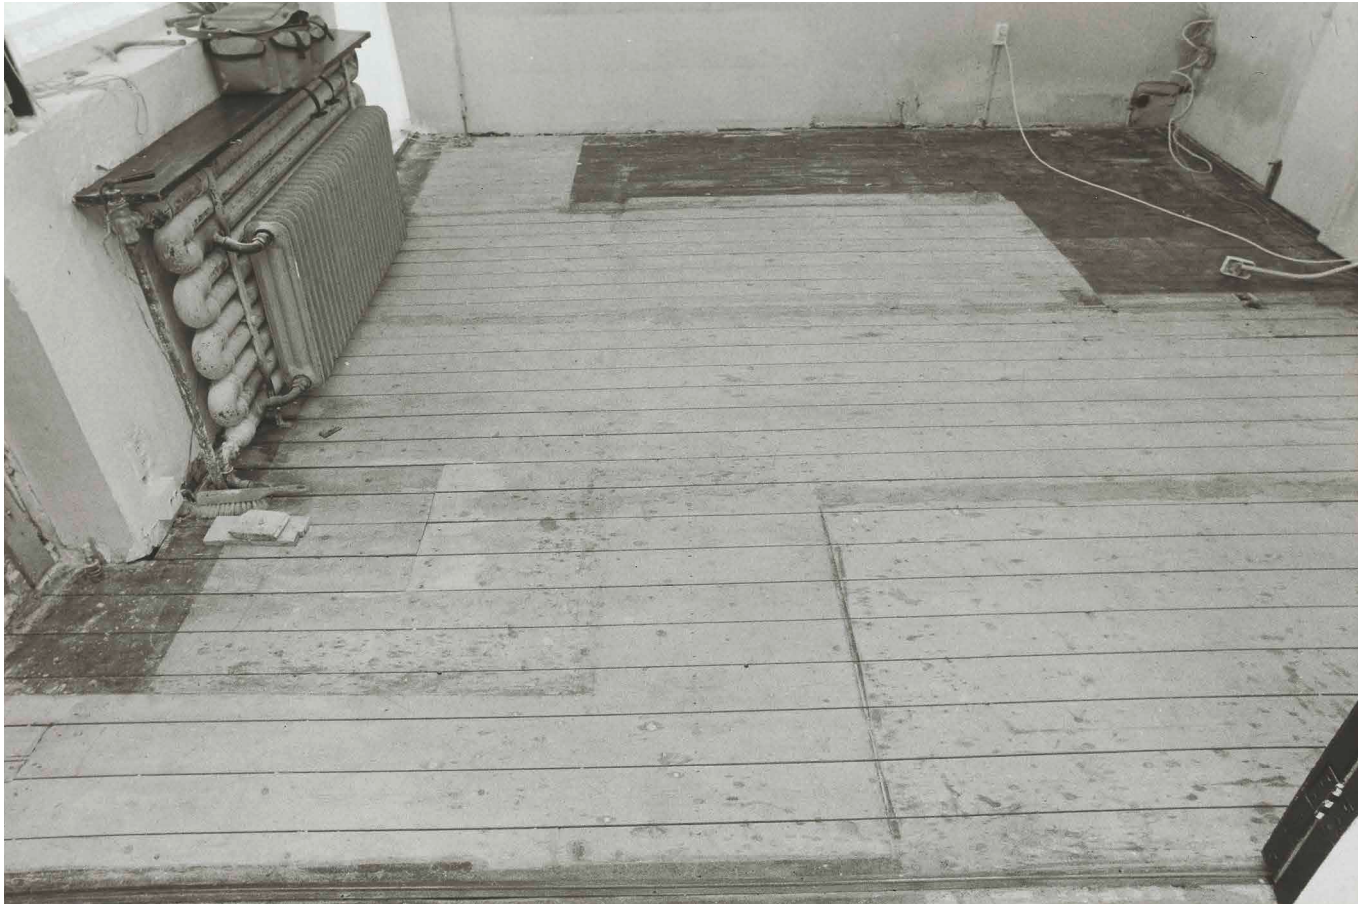
FIG. 3.2 The floor gave an indication of the division of the floor surface and the position of the beds

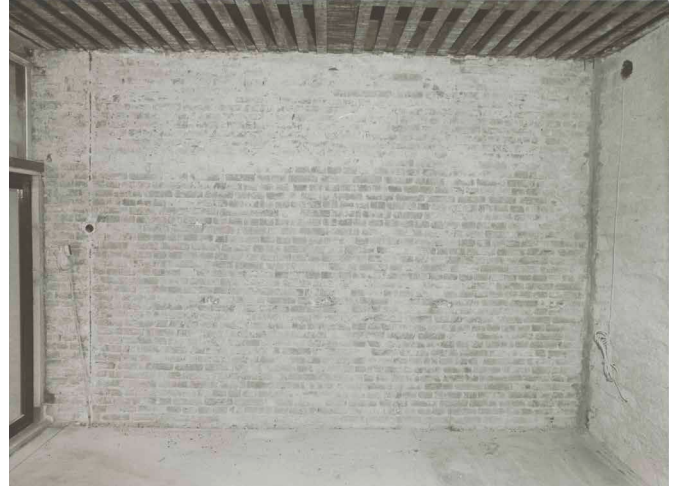
FIG. 3.6 Bare brick wall and stripped ceiling

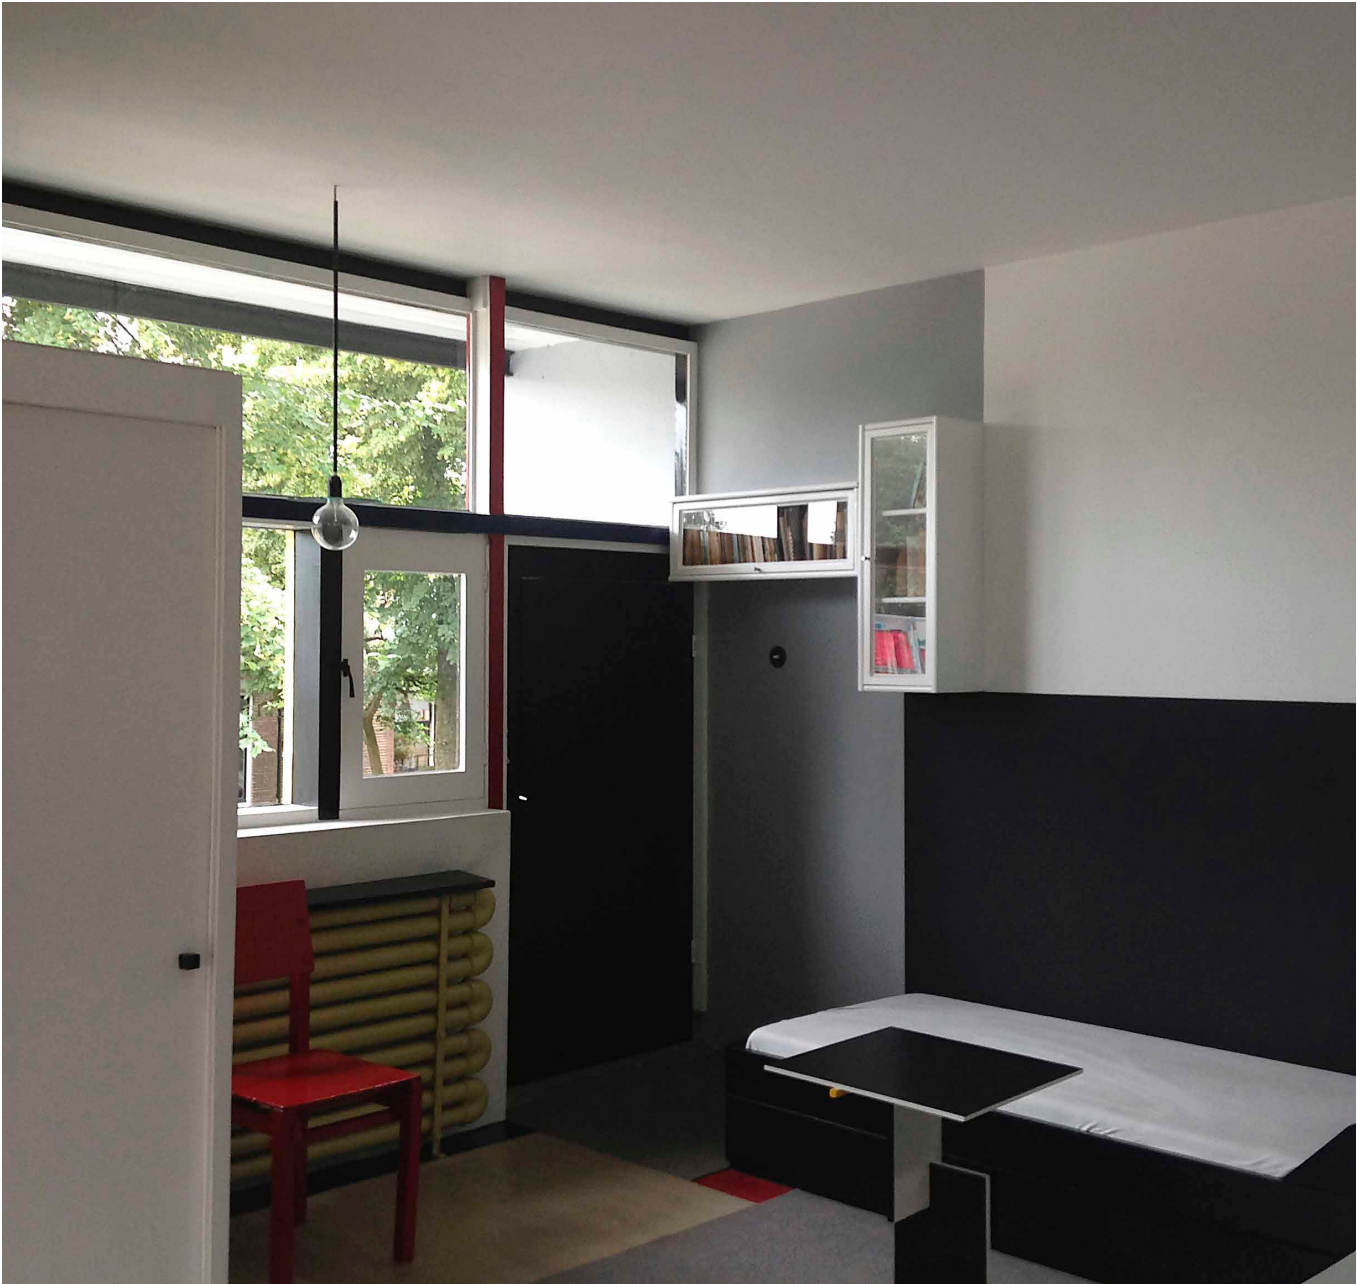
FIG. 3.9 The wall in the girls' room runs from inside to outside, so B. Mulder had both the inner and outer sides of the wall painted in the same shade of grey, 2015

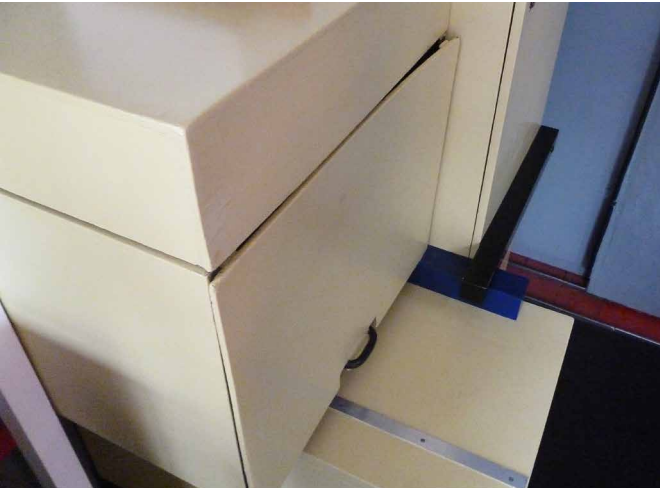
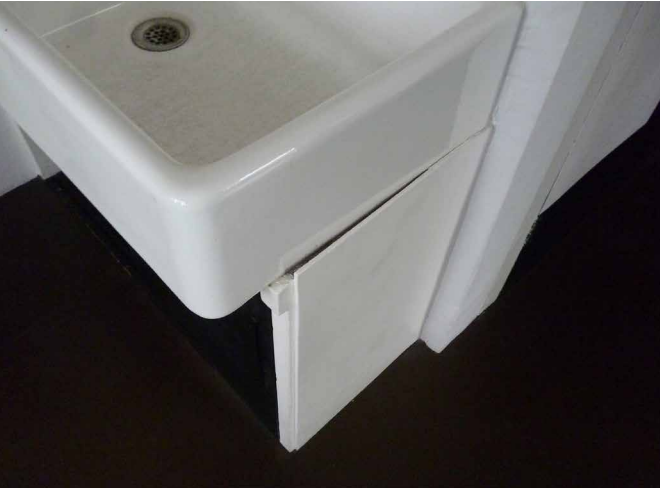
FIG. 5.2 Deformation of thin timber elements of furniture

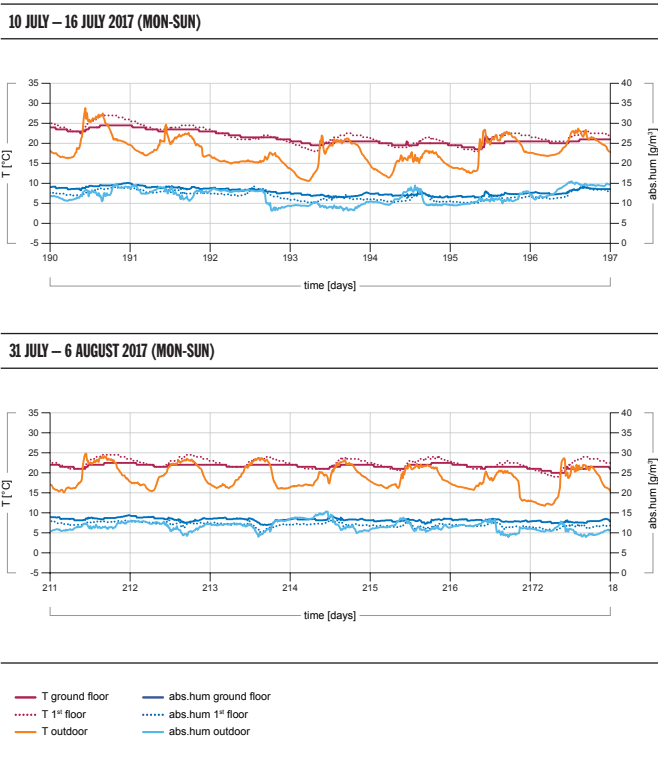
FIG. 5.5 Indoor and outdoor temperature and absolute humidity on the ground and 1<sup>st</sup> floor during two weeks in the summer period

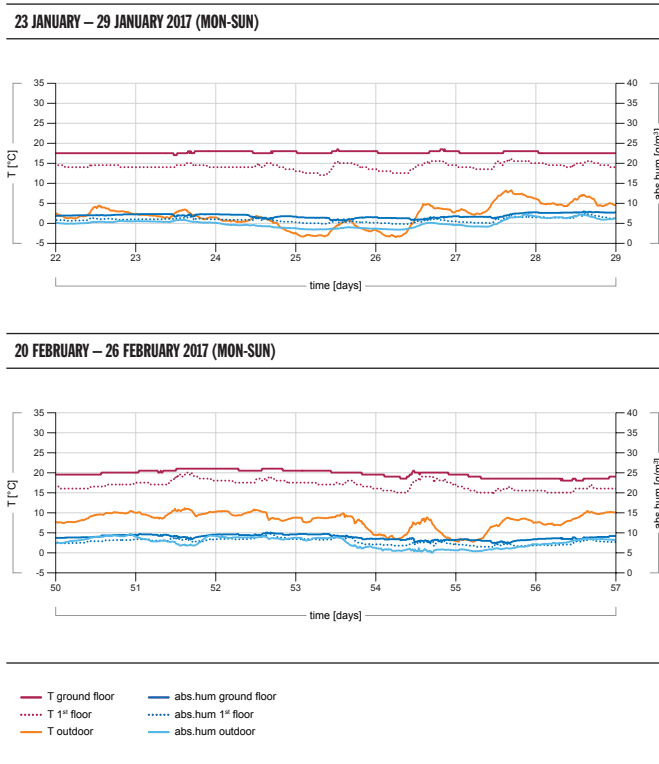
FIG. 5.6 Indoor and outdoor T and absolute humidity on ground and 1<sup>st</sup> floor during two weeks in the winter period

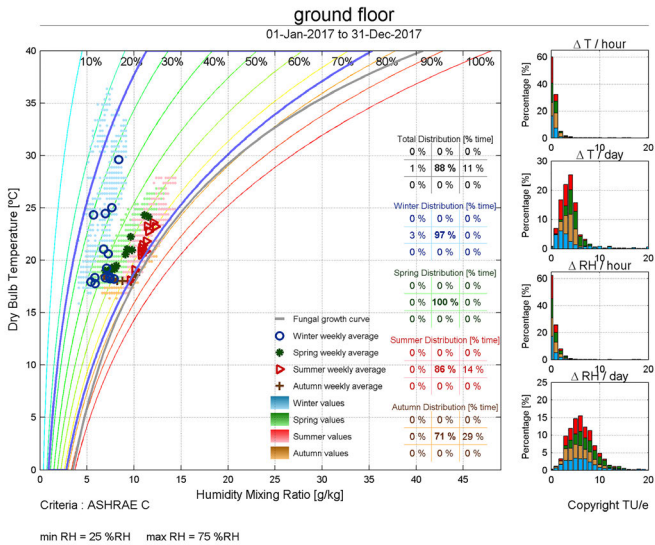
FIG. 5.8 Temperature and RH data recorded on the ground floor of the building in 2017 compared to the specifications for class C; graphical elaboration performed using the web tool available at <http://www.monumenten.bwk.tue.nl/>

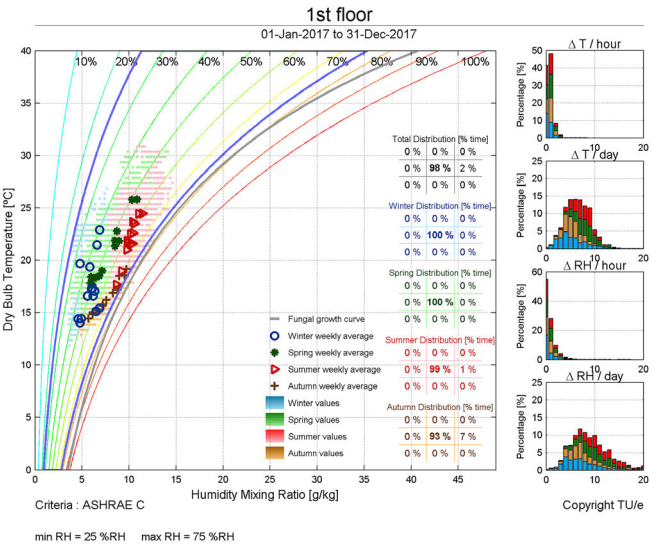
FIG. 5.9 Temperature and RH data recorded on the first floor of the building in 2017 compared to the specifications for class C; graphical elaboration performed using the web tool available at <http://www.monumenten.bwk.tue.nl/>
