INDUSTRY

WINTERSWIJK

Analysis Report
Heritage & Architecture

"DEPOL"
1913

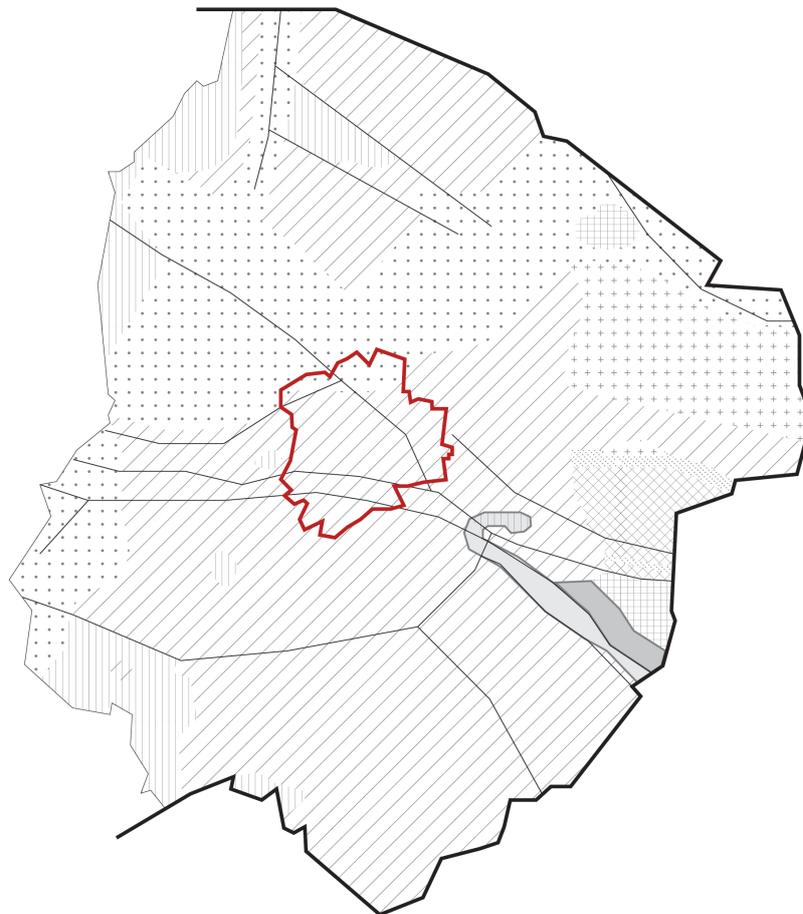
- Quarter
- Pliocene
- Oligocene
- Upper-Chalk
Cenomane
- Under-Chalk
Albien
- Jura - Dogger
- Jura - Lias
- Trias Muschelchalk
- Trias Bunter
- Fault line
- Winterswijk

Figure 15 Soil cracks and movement. (Own image based on J. Neefjes & N. Willemsse, 2009)
 Figure 16 Soil mosaics of Winterswijk and surroundings. (Own image based on W. Peletier & H.G. Kolstee, 1986)

The area of Winterswijk and its surroundings is characterized by layers of centuries old soil which stay very close to the surface. This unique situation is caused by locally moving pieces of the earth shell, pushing and pulling land up and down (W. Peletier & H.G. Kolstee, 1986). The complex soil structure of the area contains much clay and therefore natural

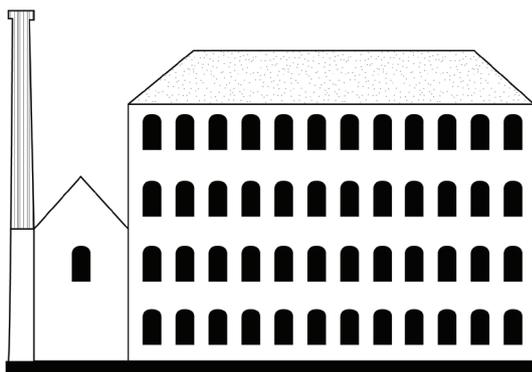
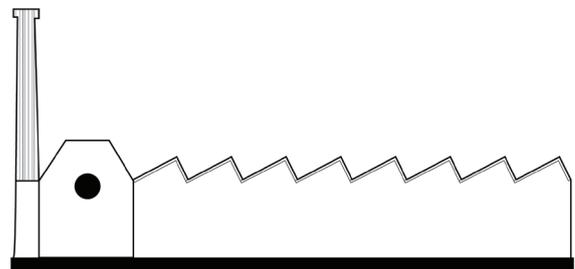
A factory for weaving purposes needed a different approach. Mechanical looms (powerlooms) weigh way more than spinning machines. They also cause a lot of resonance on the structure of the building. Because of this, a multi-storey factory for weaving would be way too expensive. A new type of building was adopted from England: the saw-tooth roof factory. This type of building with cast iron columns had rooflights facing the north for perfect light distribution into the hall. The south facing parts were covered (Tuinstra, 2006).

Figure 22 English model spinning factory. (Own image based on Tuinstra, 2006)
Figure 23 English model saw-tooth roof factory. (Own image, 2019)

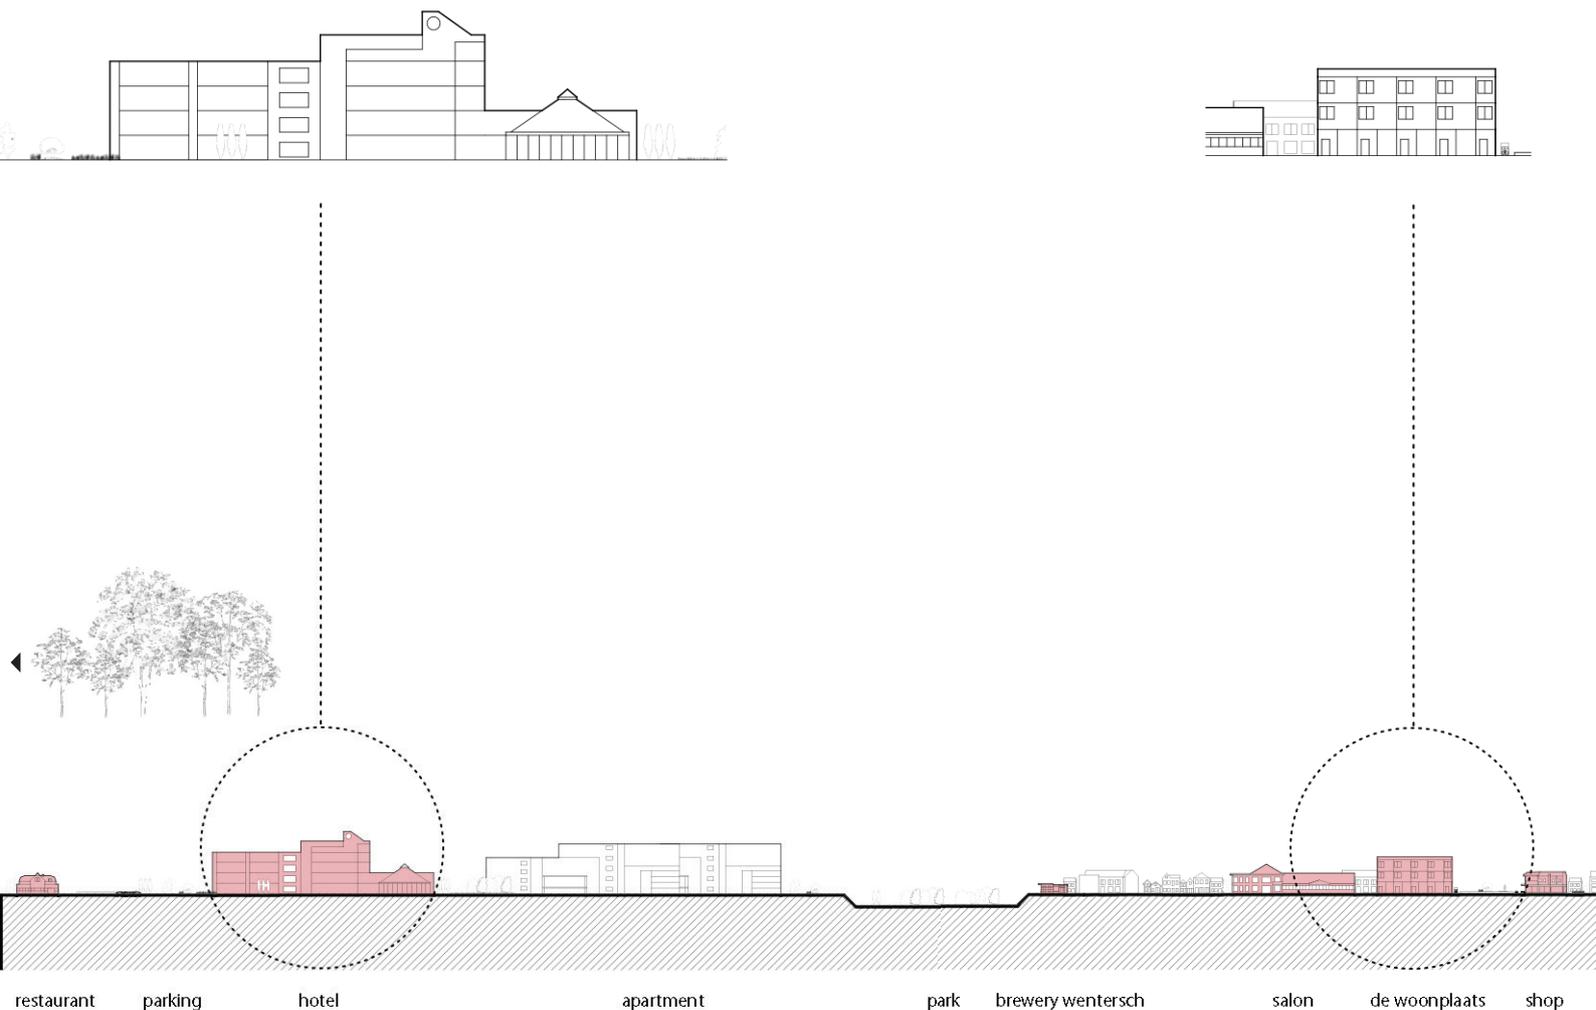
Bigger buildings emerged alongside the edge of the village where the city centre is quite horizontally structured with no big tall buildings, except for the three towers: the 'Raadhuis', 'Jacobuskerk' and 'Jacobskerk' (only one church is shown). The music school 'Boogie Woogie' is situated very close to the industrial area, just like the city centre itself, all in walkable distance from each other. Again we see the unique position of the industrial area towards the hinterland.

Figure 40 Urban section of Winterswijk. (Own image based on Google, 2019)

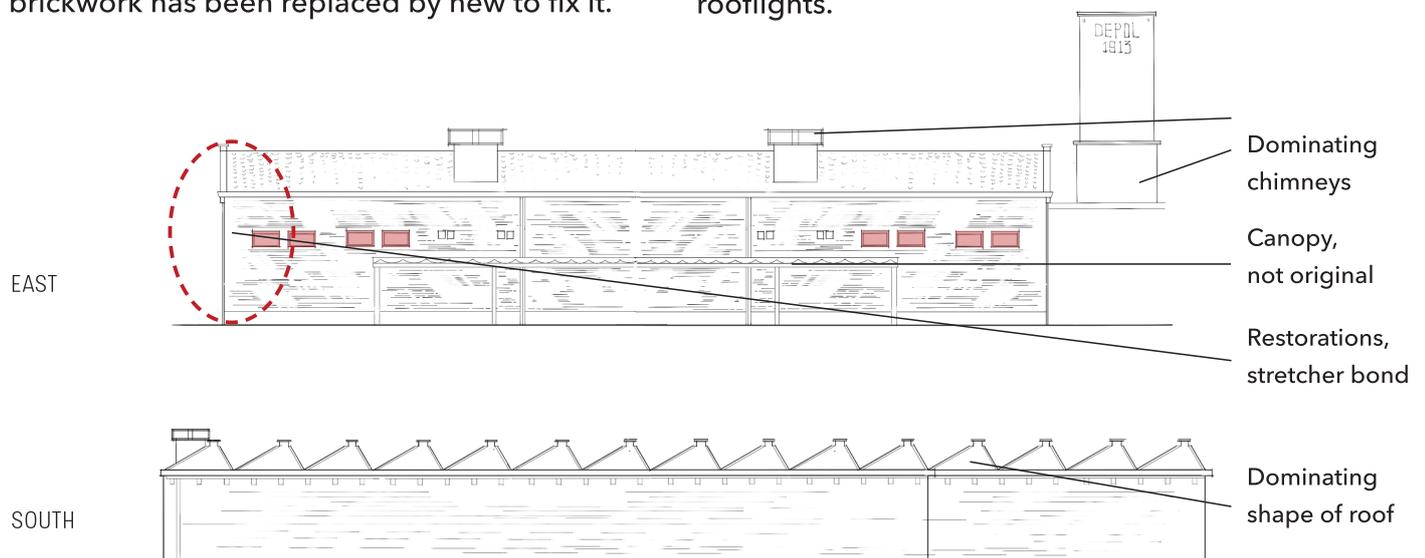
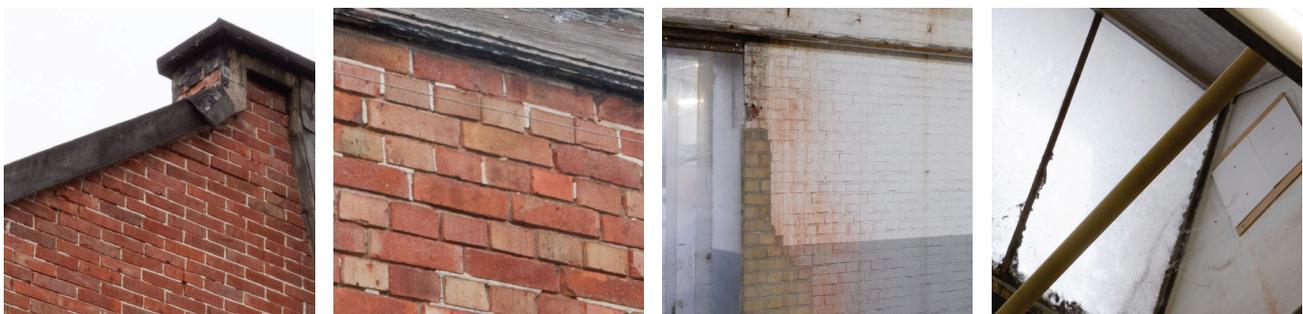
This façade of the saw-tooth roof structure shows clear marks of aging. Sometimes old brickwork has been replaced by new to fix it.

Almost no openings are visible in the façade, since daylight comes from the characteristic rooflights.

Figure 101 Façades. (Own images based on Beltman, 1913)
 Figure 102 Materials. (Photos by Dinand Kruize, 2019)

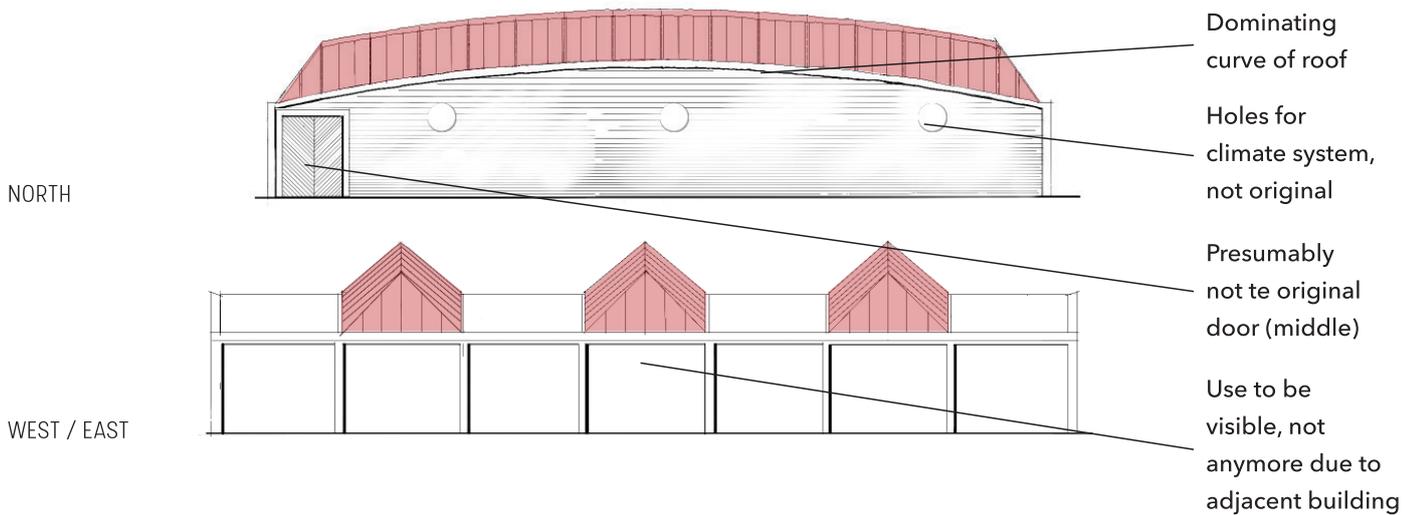
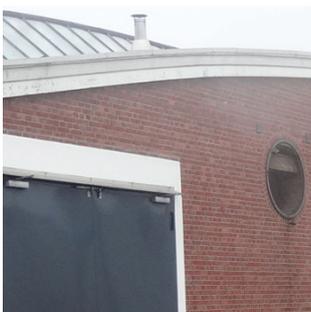
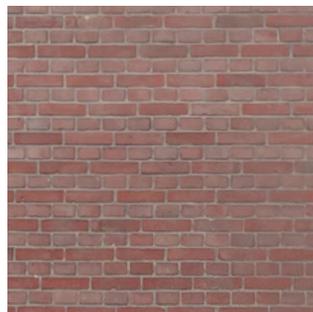
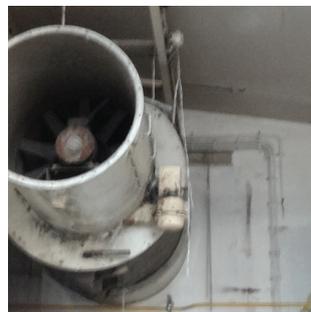
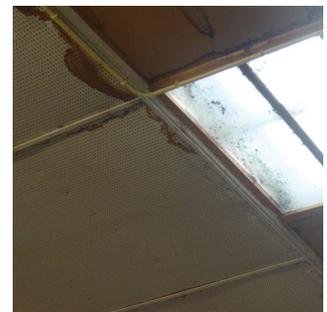
This façade is also not in its original condition. The current holes (which have no glass in it whatsoever), were originally not there. The big door on the left was designed in the

middle. This one could also have been moved, although there are no clear traces of this. The façade shows no openings. The only incoming daylight comes from the rooflights.

Figure 105 Façades (Own images based on Pannekoek, 1957)
 Figure 106 Materials (Photos by Joost Joosse, 2019)

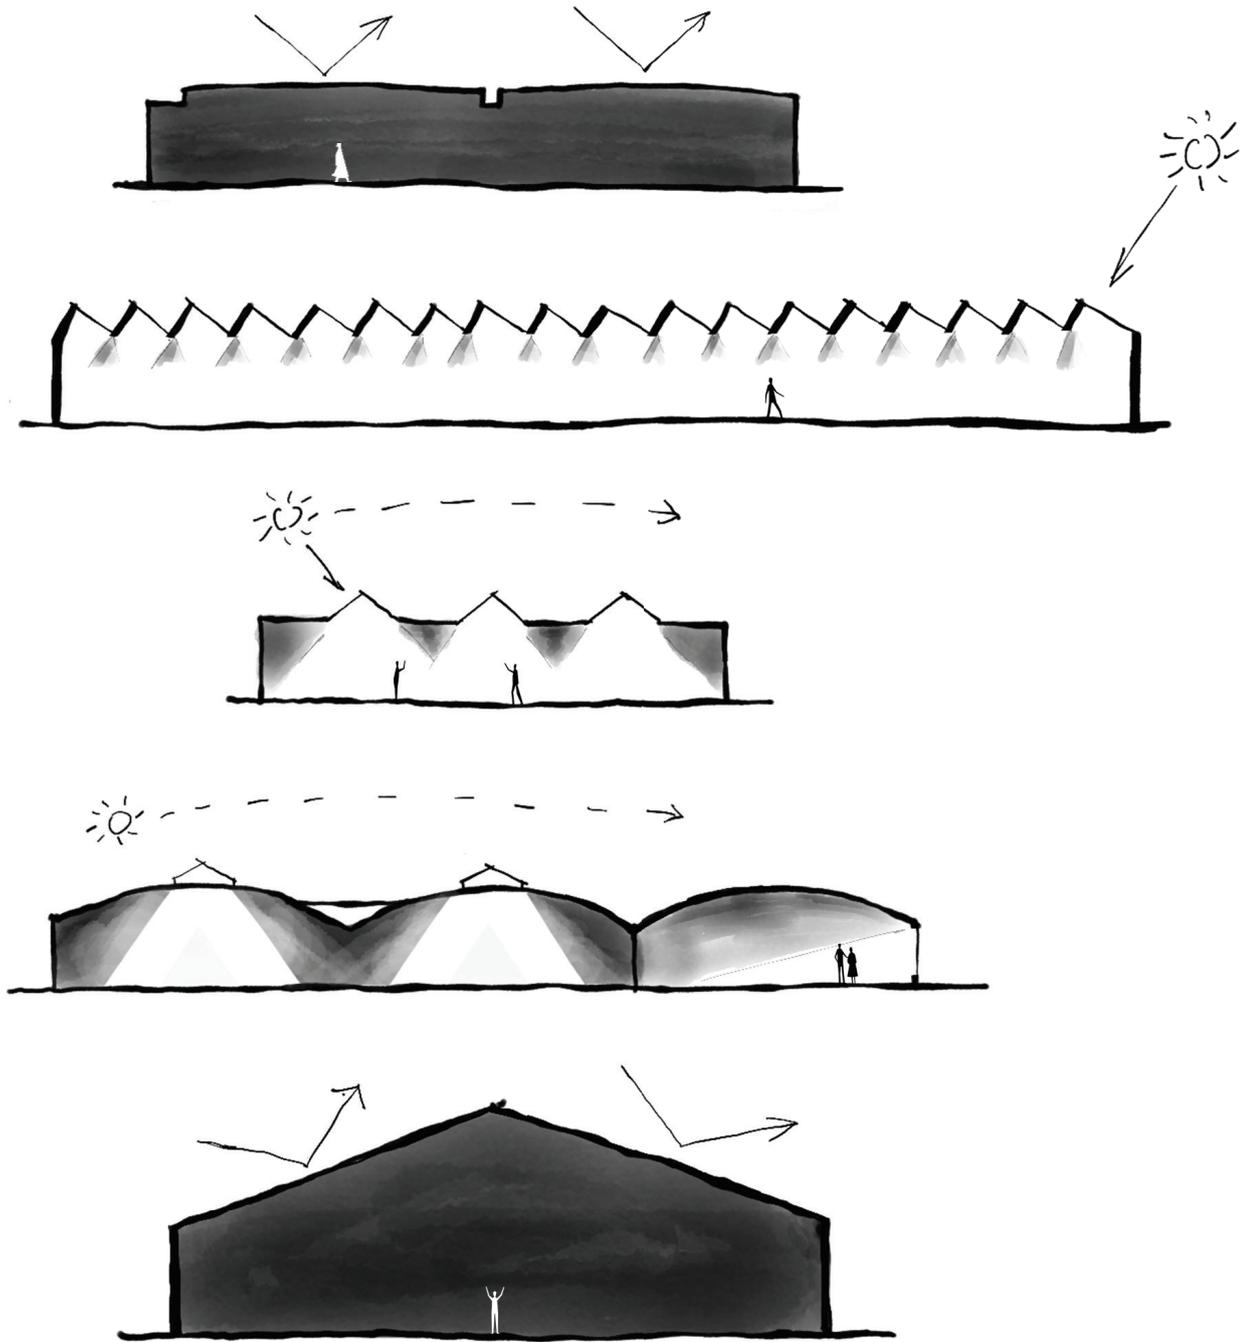
Figure 111 Daylight. (Own image based on fieldwork, 2019)

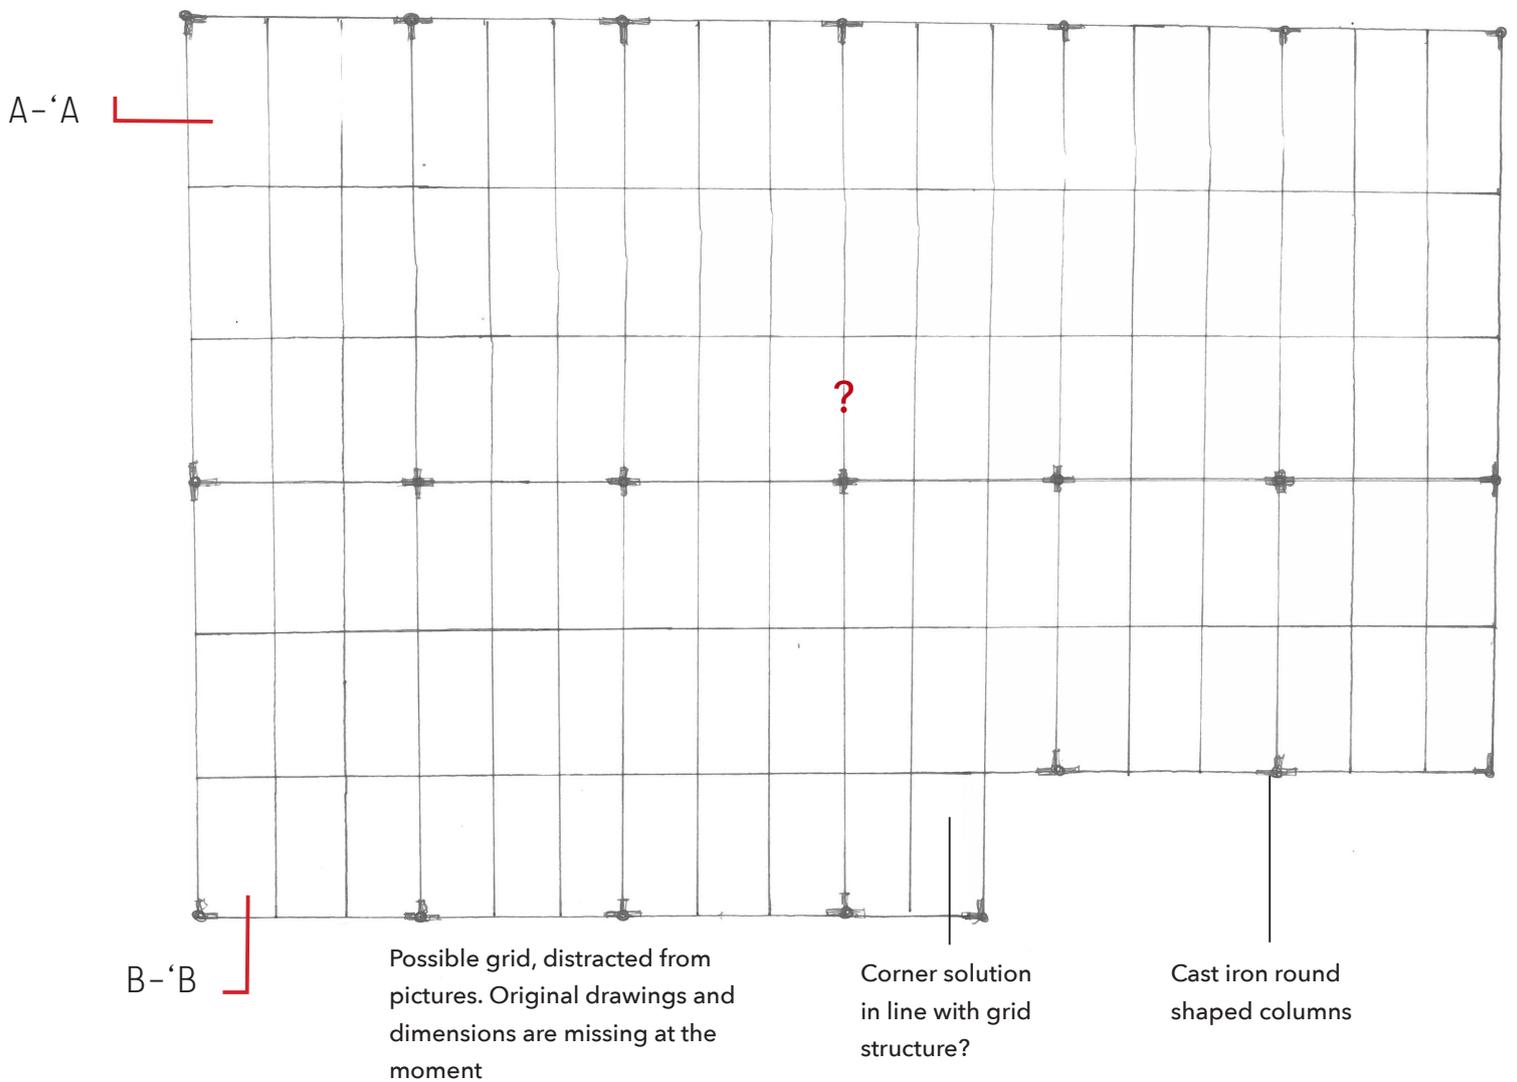
Figure 170 Structural plan/diagram (Own images based on Bouwkundig Ingenieurs Bureau Beltman, 1938)

before. The characteristic saw-tooth roof allows big spans and difused daylight coming in from the North.

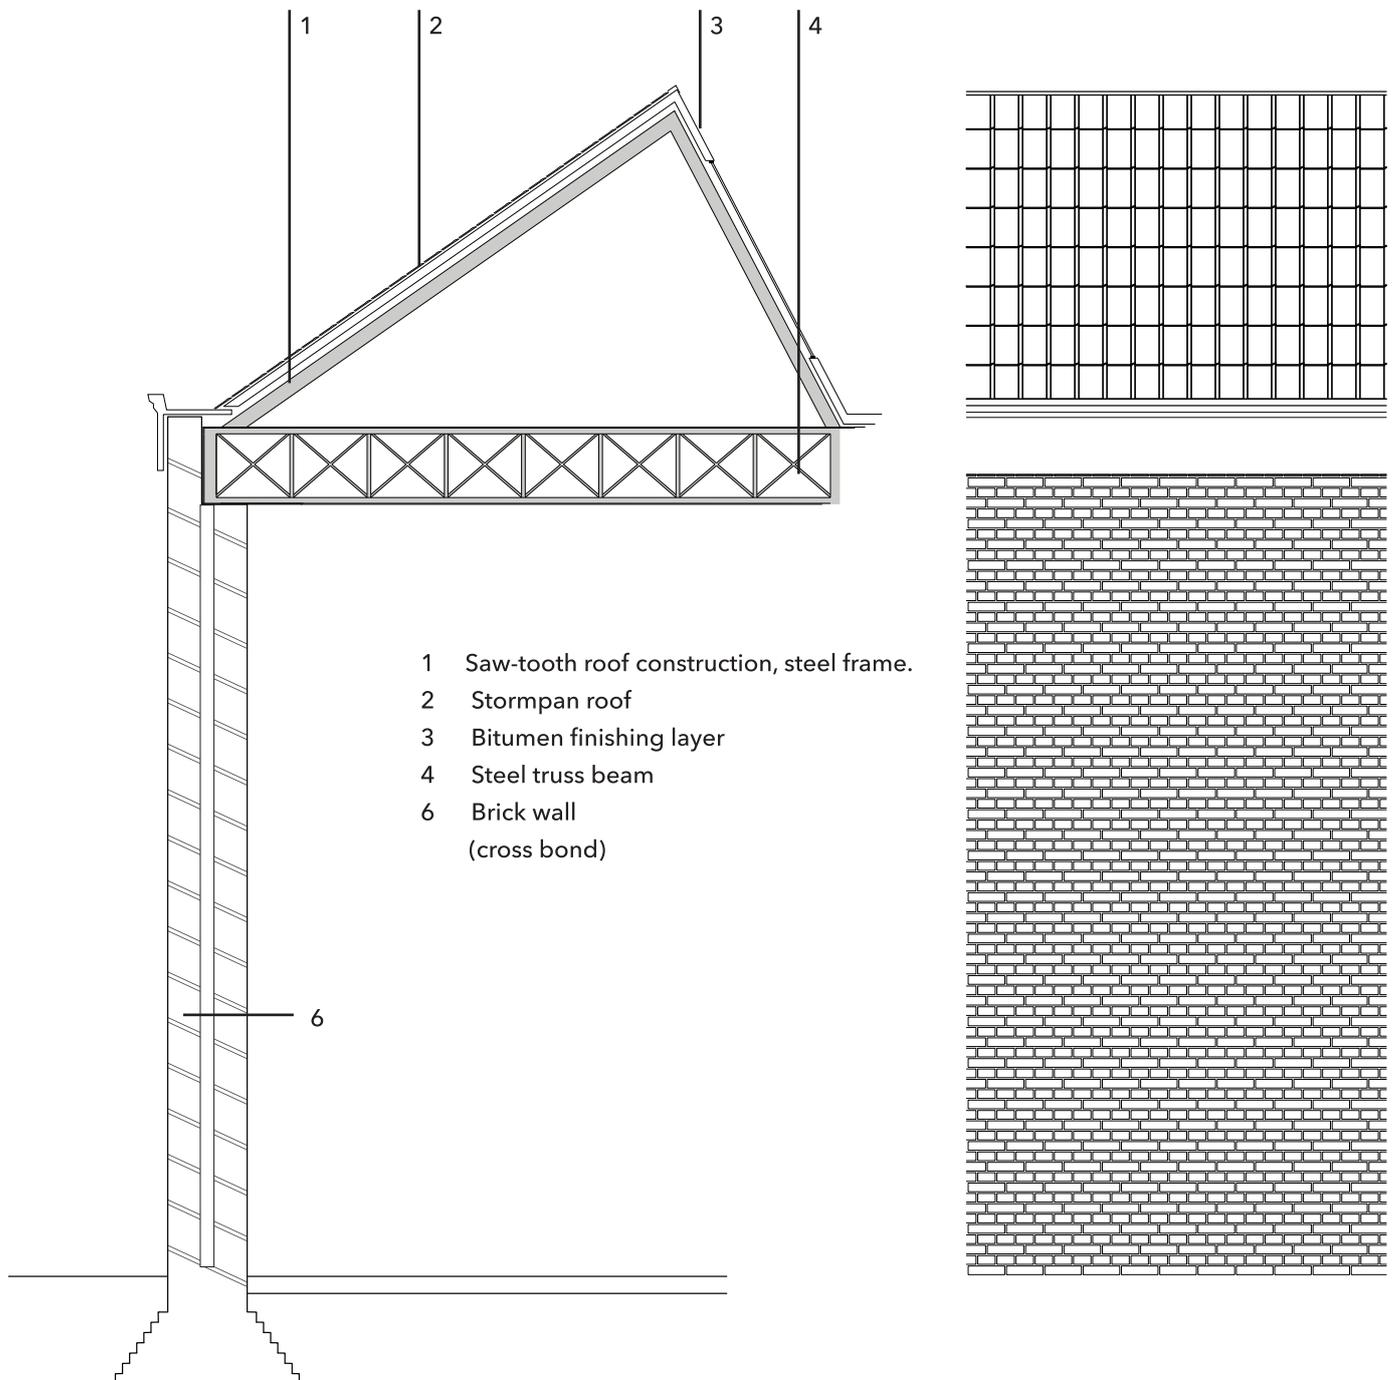
Figure 182 Section and façade fragment (Own images based on Bouwkundig Ingenieurs Bureau Beltman, 1938)

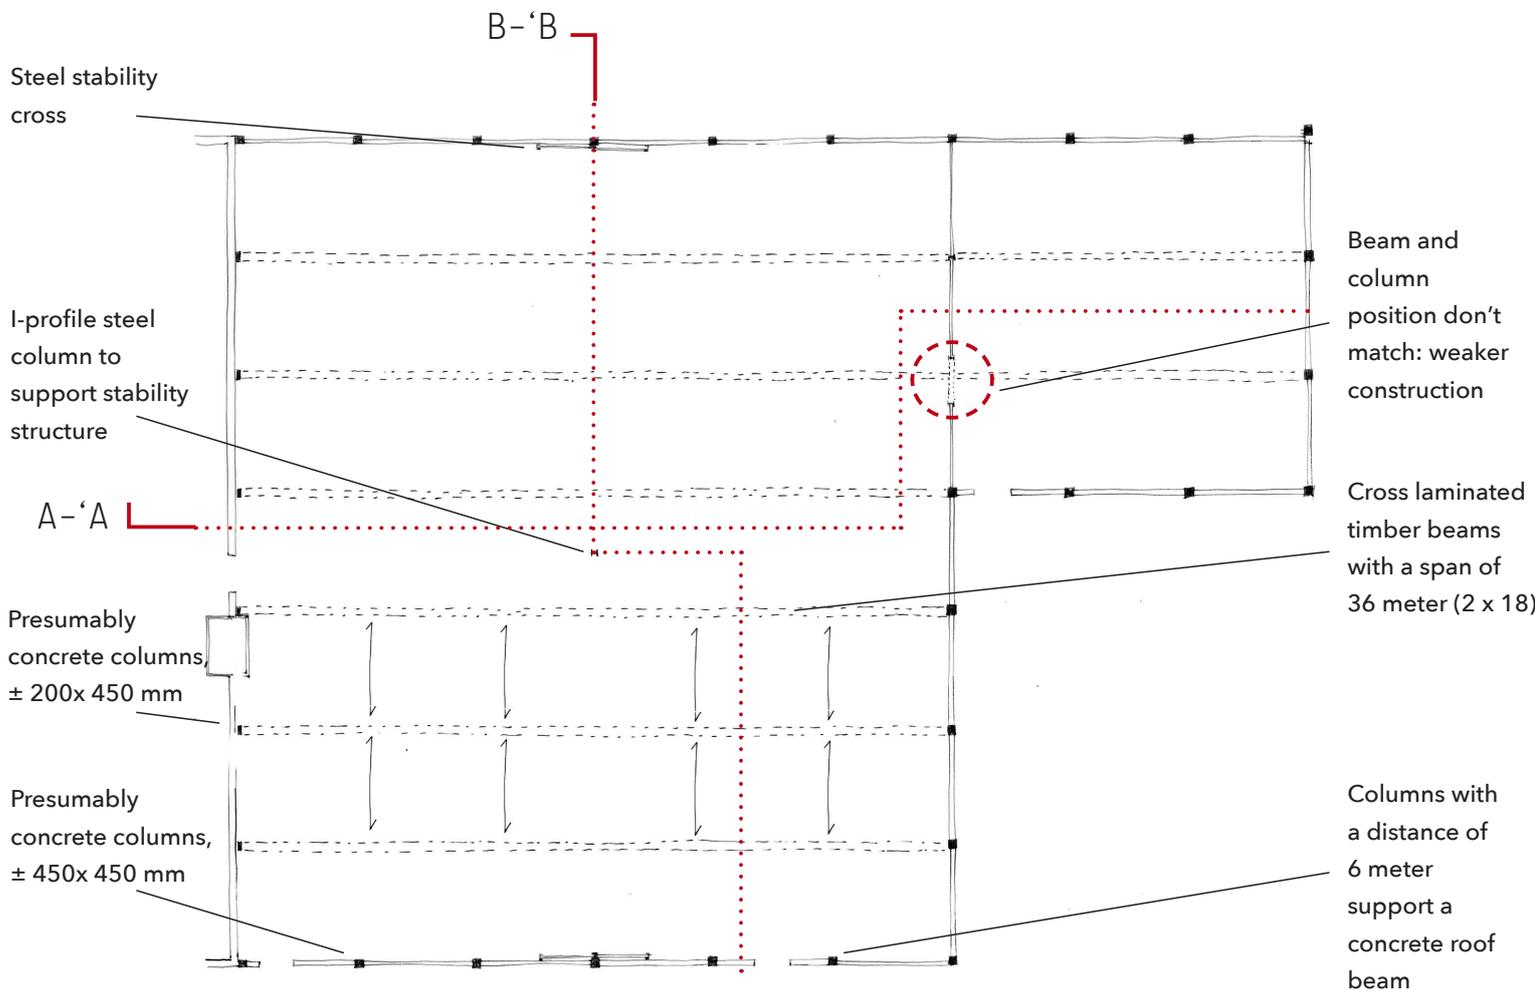
frame which partly supports the beams. The rooflights used to be an important feature of the space. Unfortunately nowadays they are not present anymore.

Figure 183 Structural plan/diagram (Own image based on Bouwkundig Ingenieurs Bureau Beltman, 1955 & N.V. Verbeco Ede, 1955)

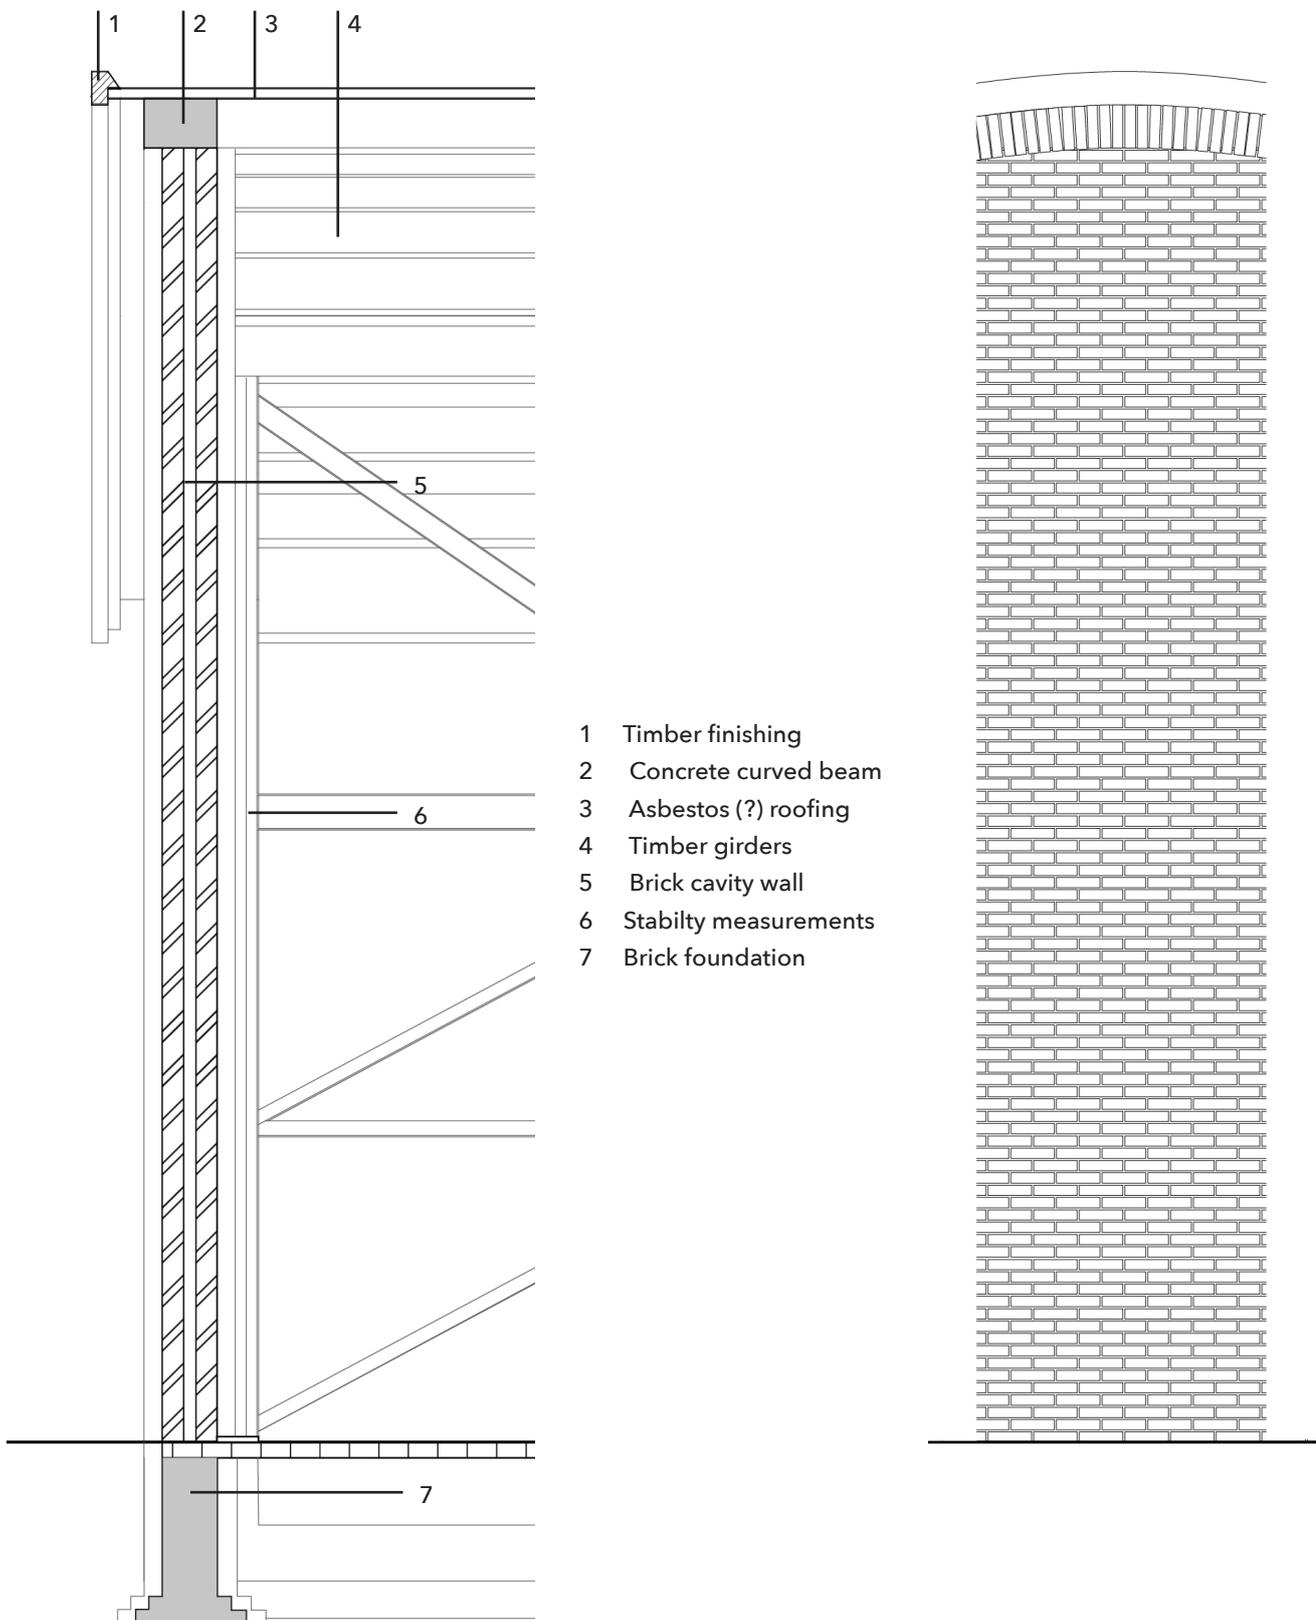
Figure 190 Section and façade fragment (Own images based on Bouwkundig Ingenieurs Bureau Beltman, 1955 & N.V. Verbeco Ede, 1955)

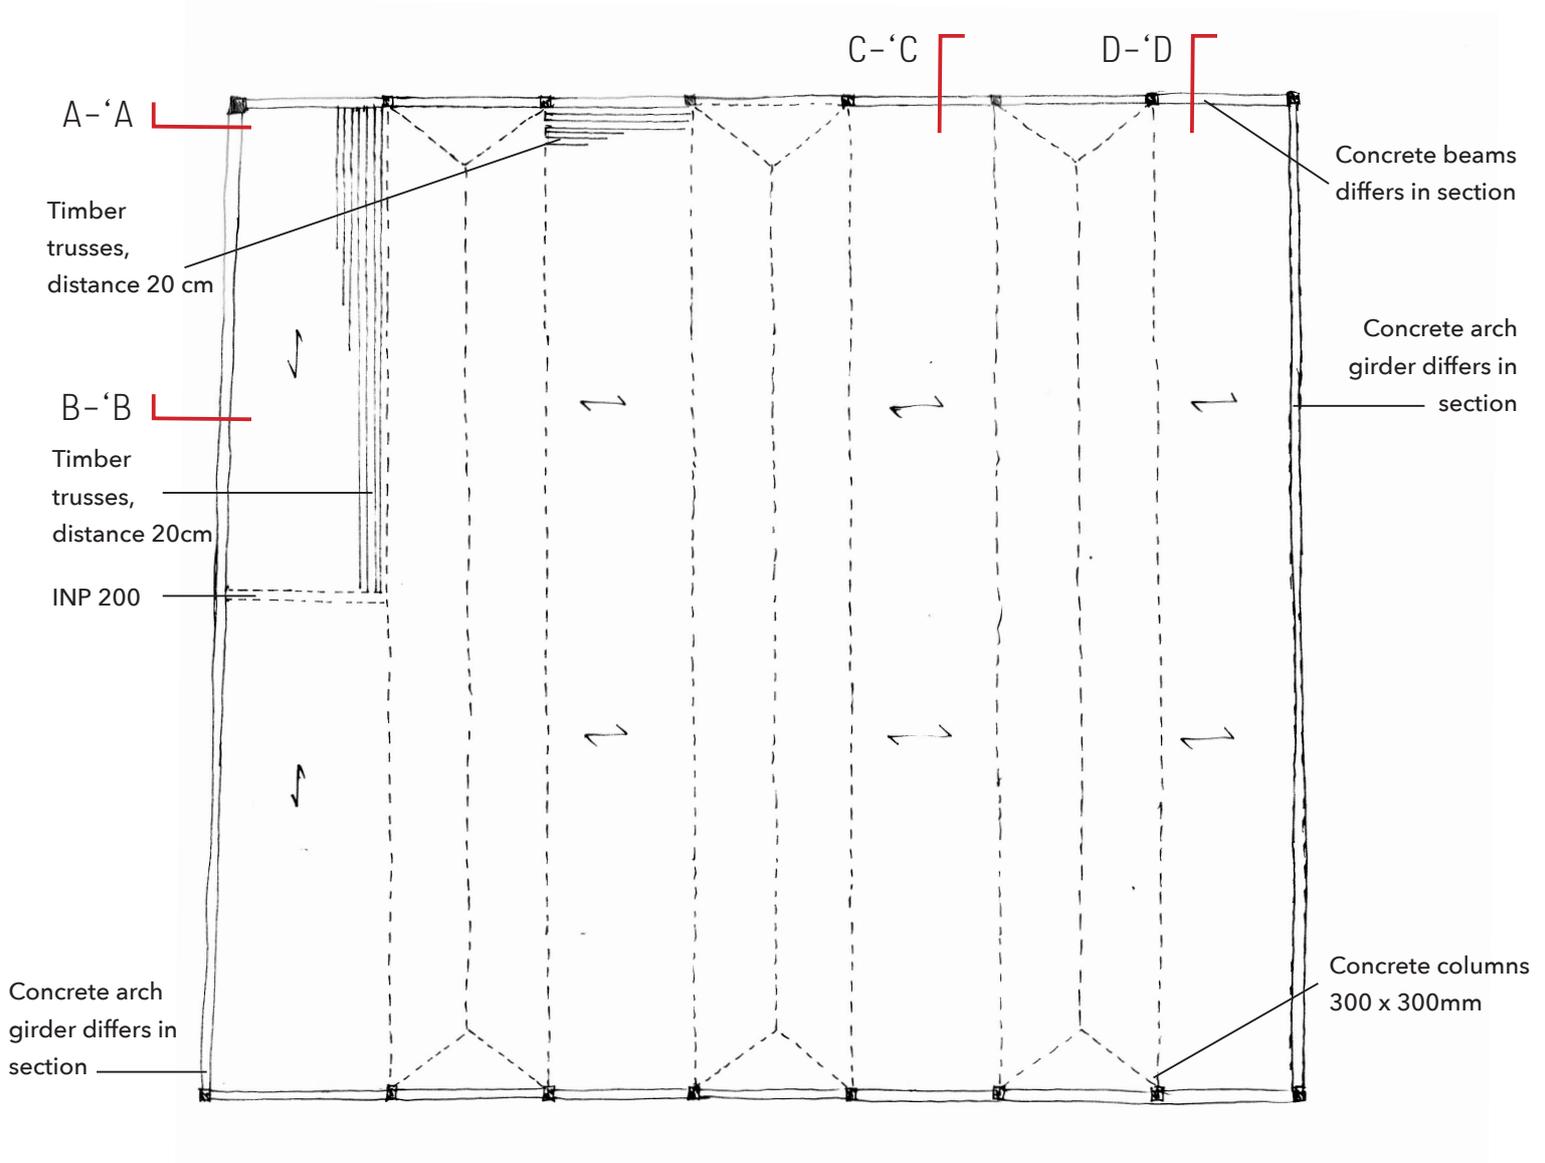
Besides structure, the steel trusses also provided for daylight from the roof. Nowadays these rooflights are covered.

Figure 191 Structural plan/diagram (Own image based on J.C. Pannekoek, 1956/1957)

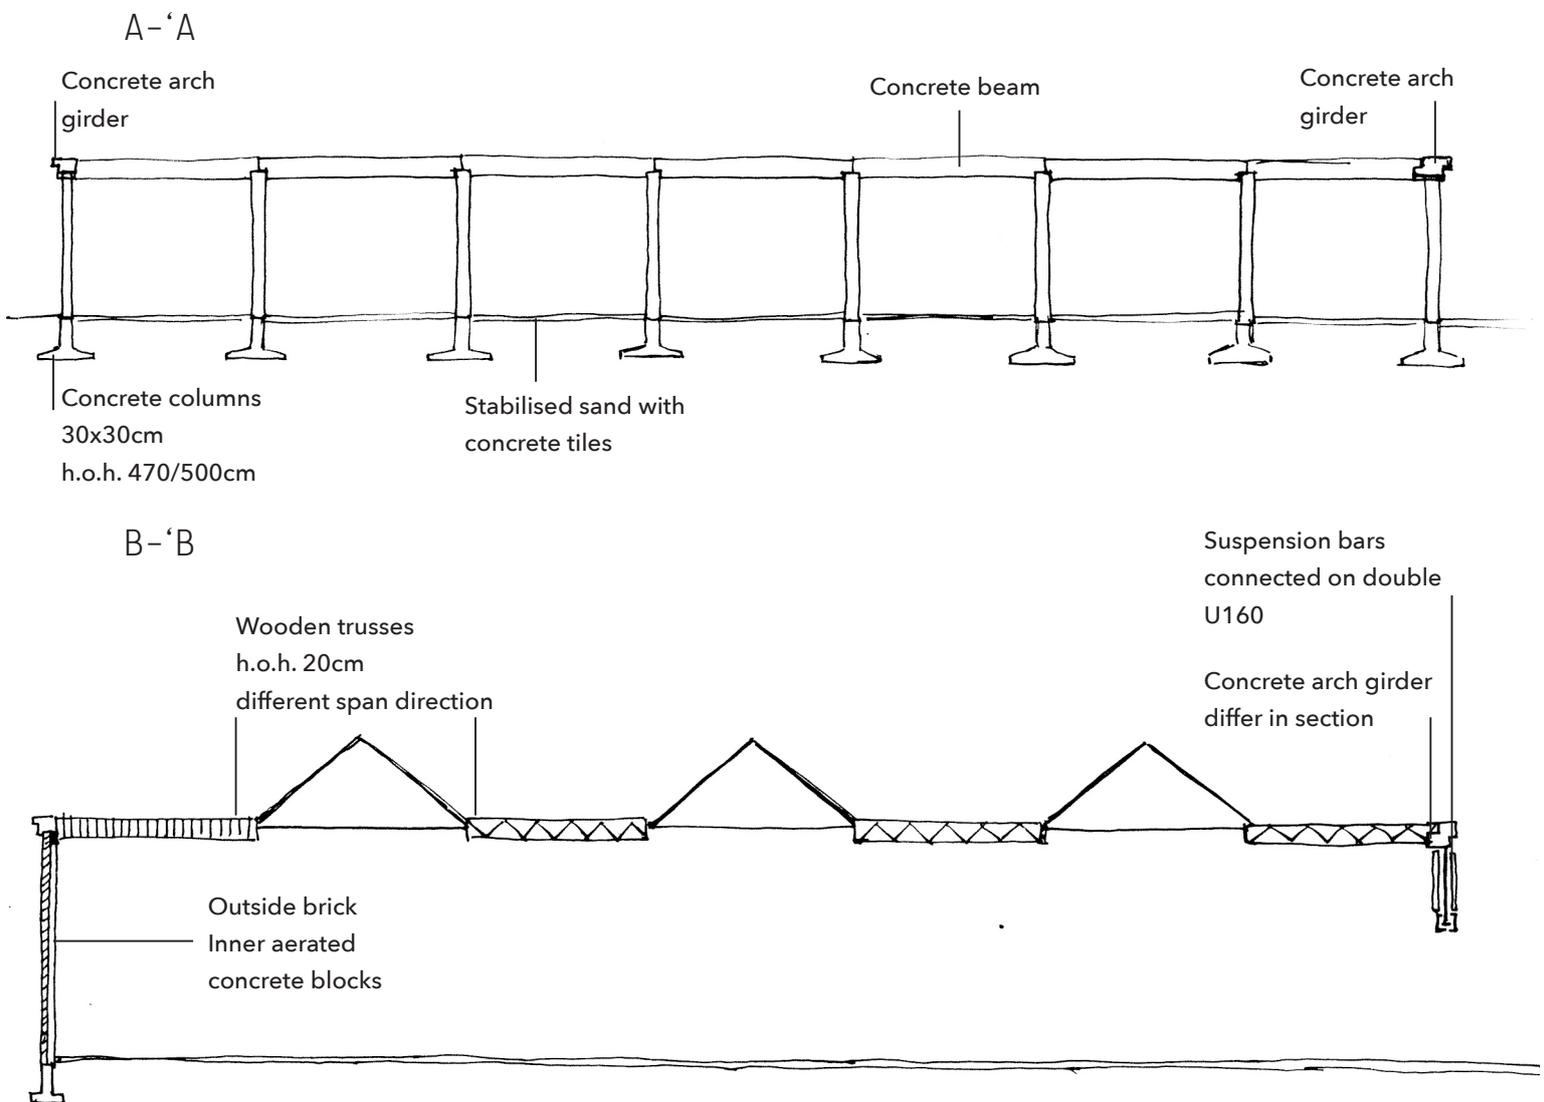
Figure 192 Structural section/diagram (Own image based on J.C. Pannekoek, 1956/1957)

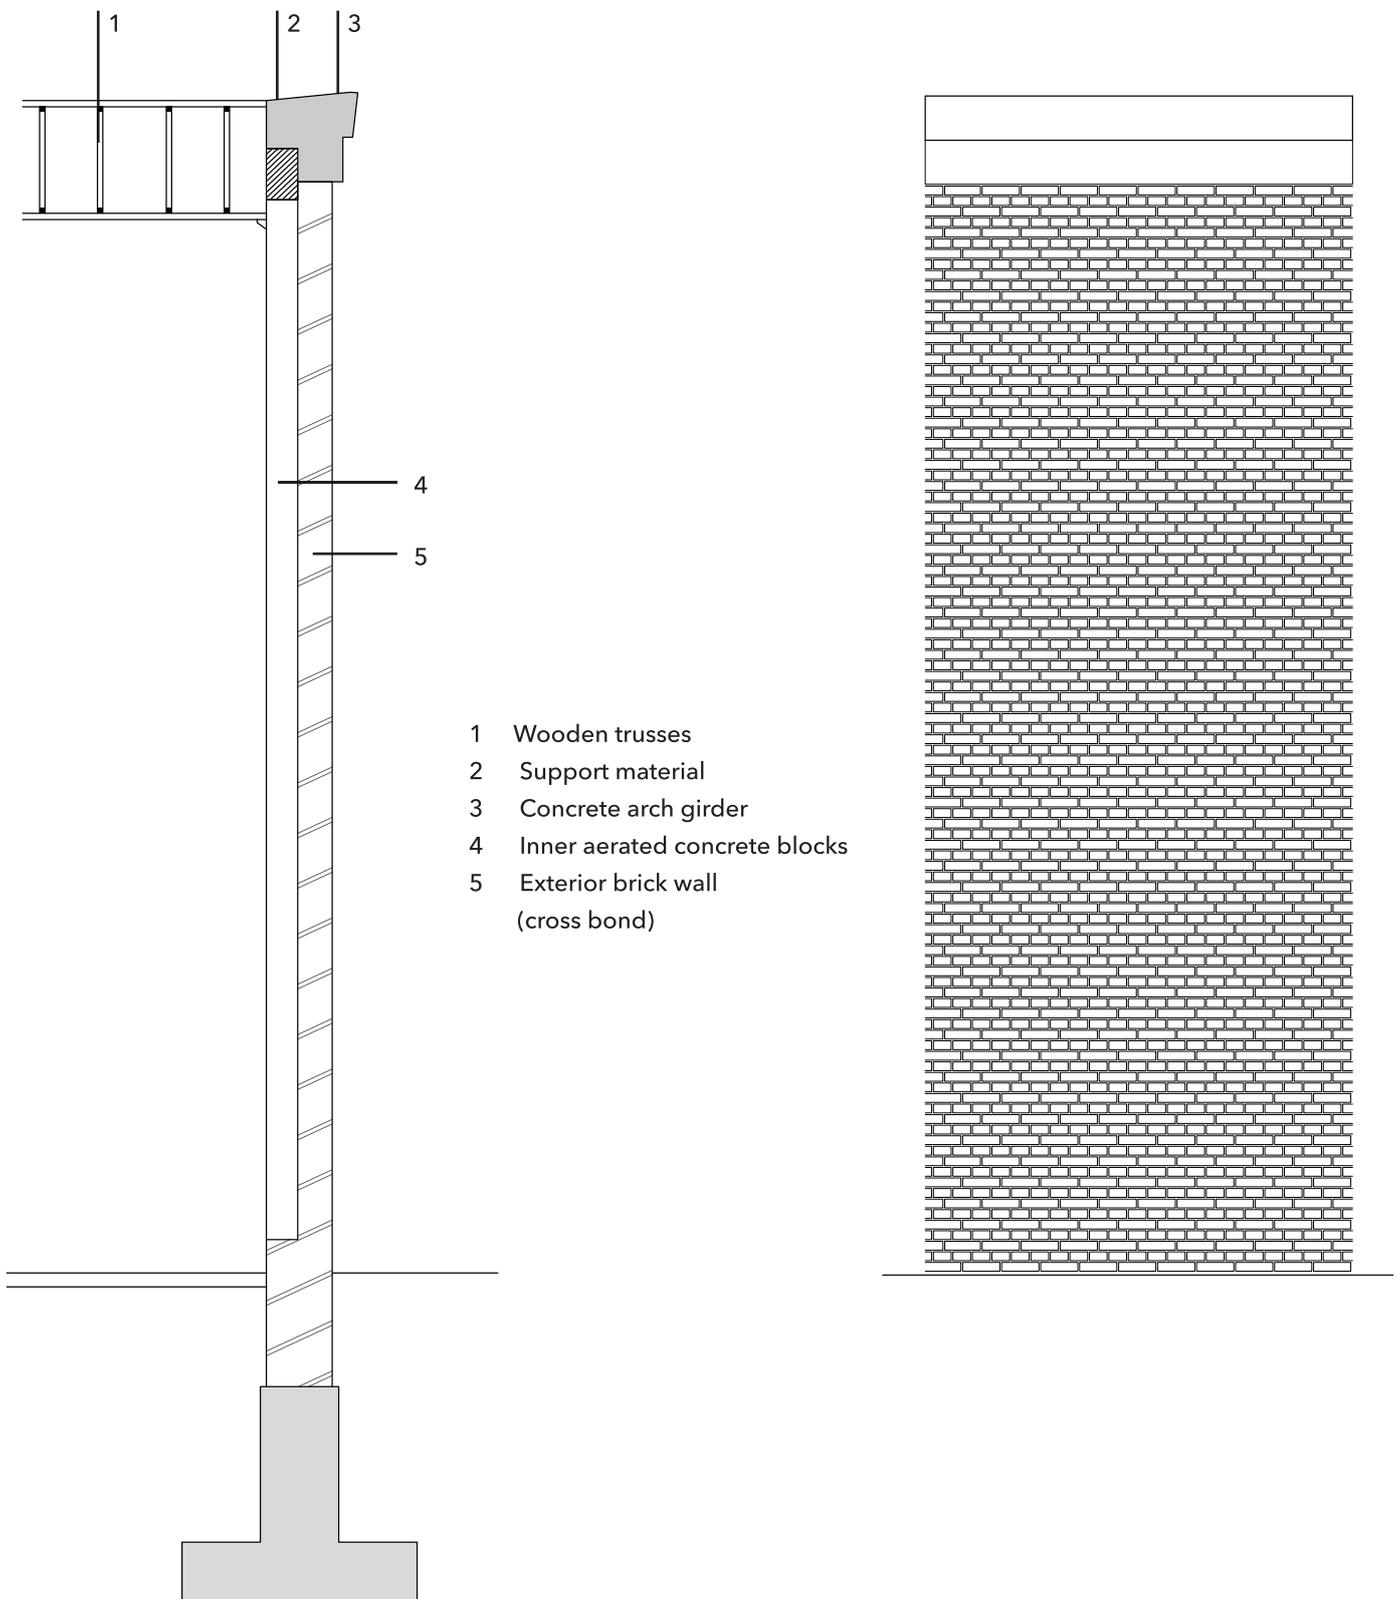
Figure 201 Section and façade fragment (Own image based on J.C. Pannekoek, 1956/1957)

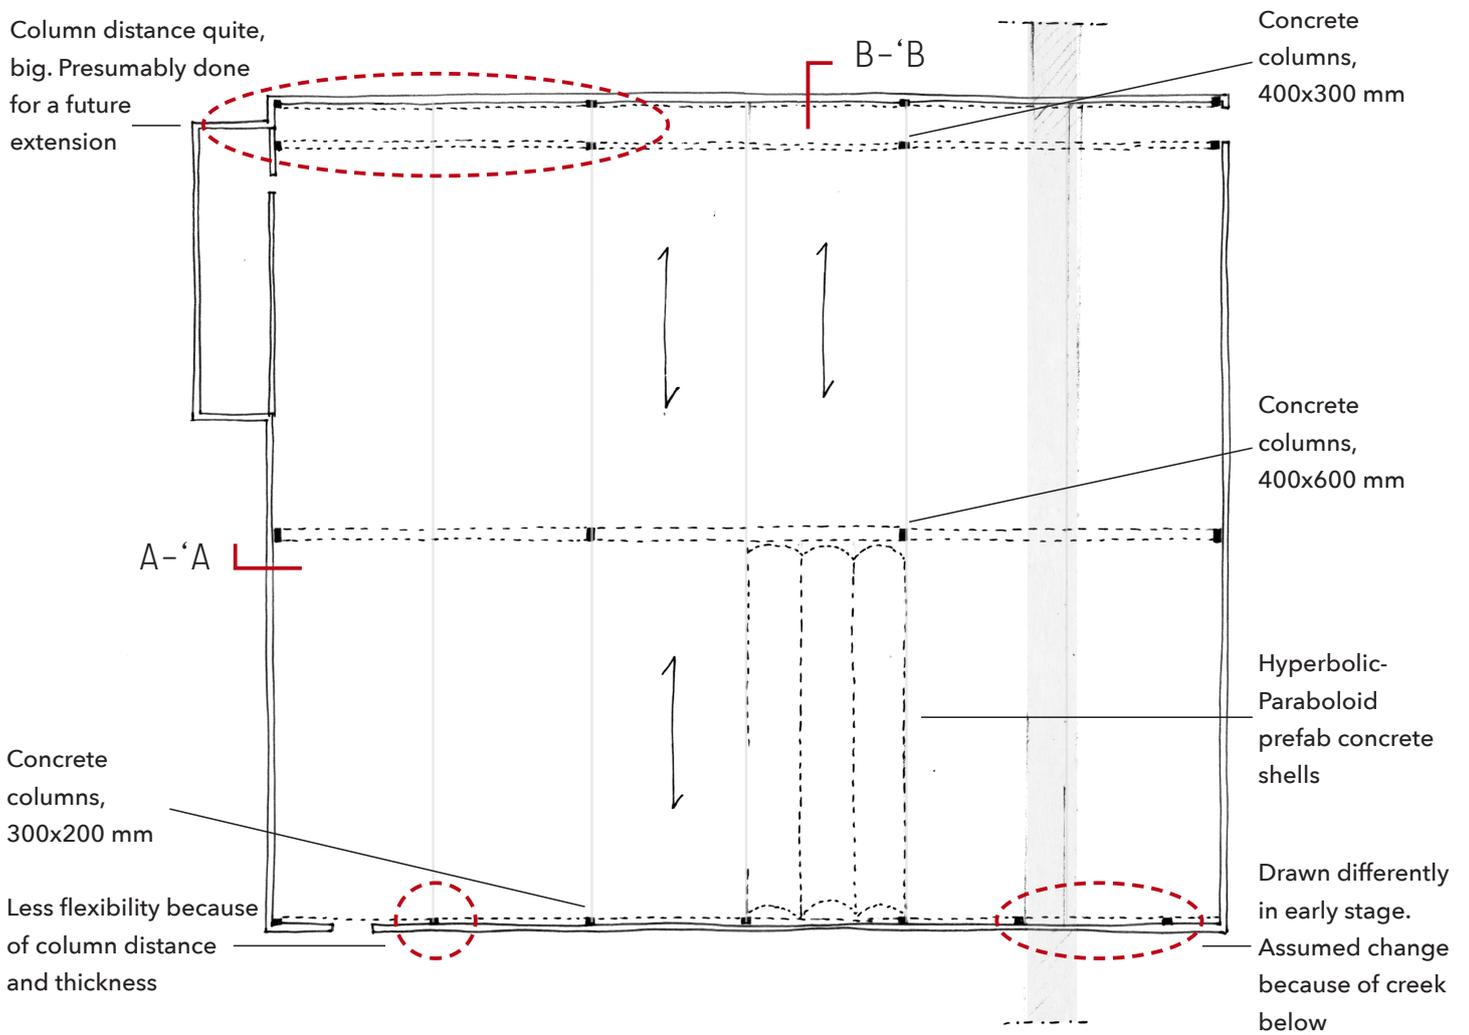
Hyperbolic-Paraboloid (HP) shells. The prestressed beams of the main structure span 15,5 meter.

Figure 202 Structural plan/diagram (Own images based on Architectenbureau van Linge, 1960)
