INDUSTRY

WINTERSWIJK

Analysis Report
Heritage & Architecture

"DEPOL"
1913

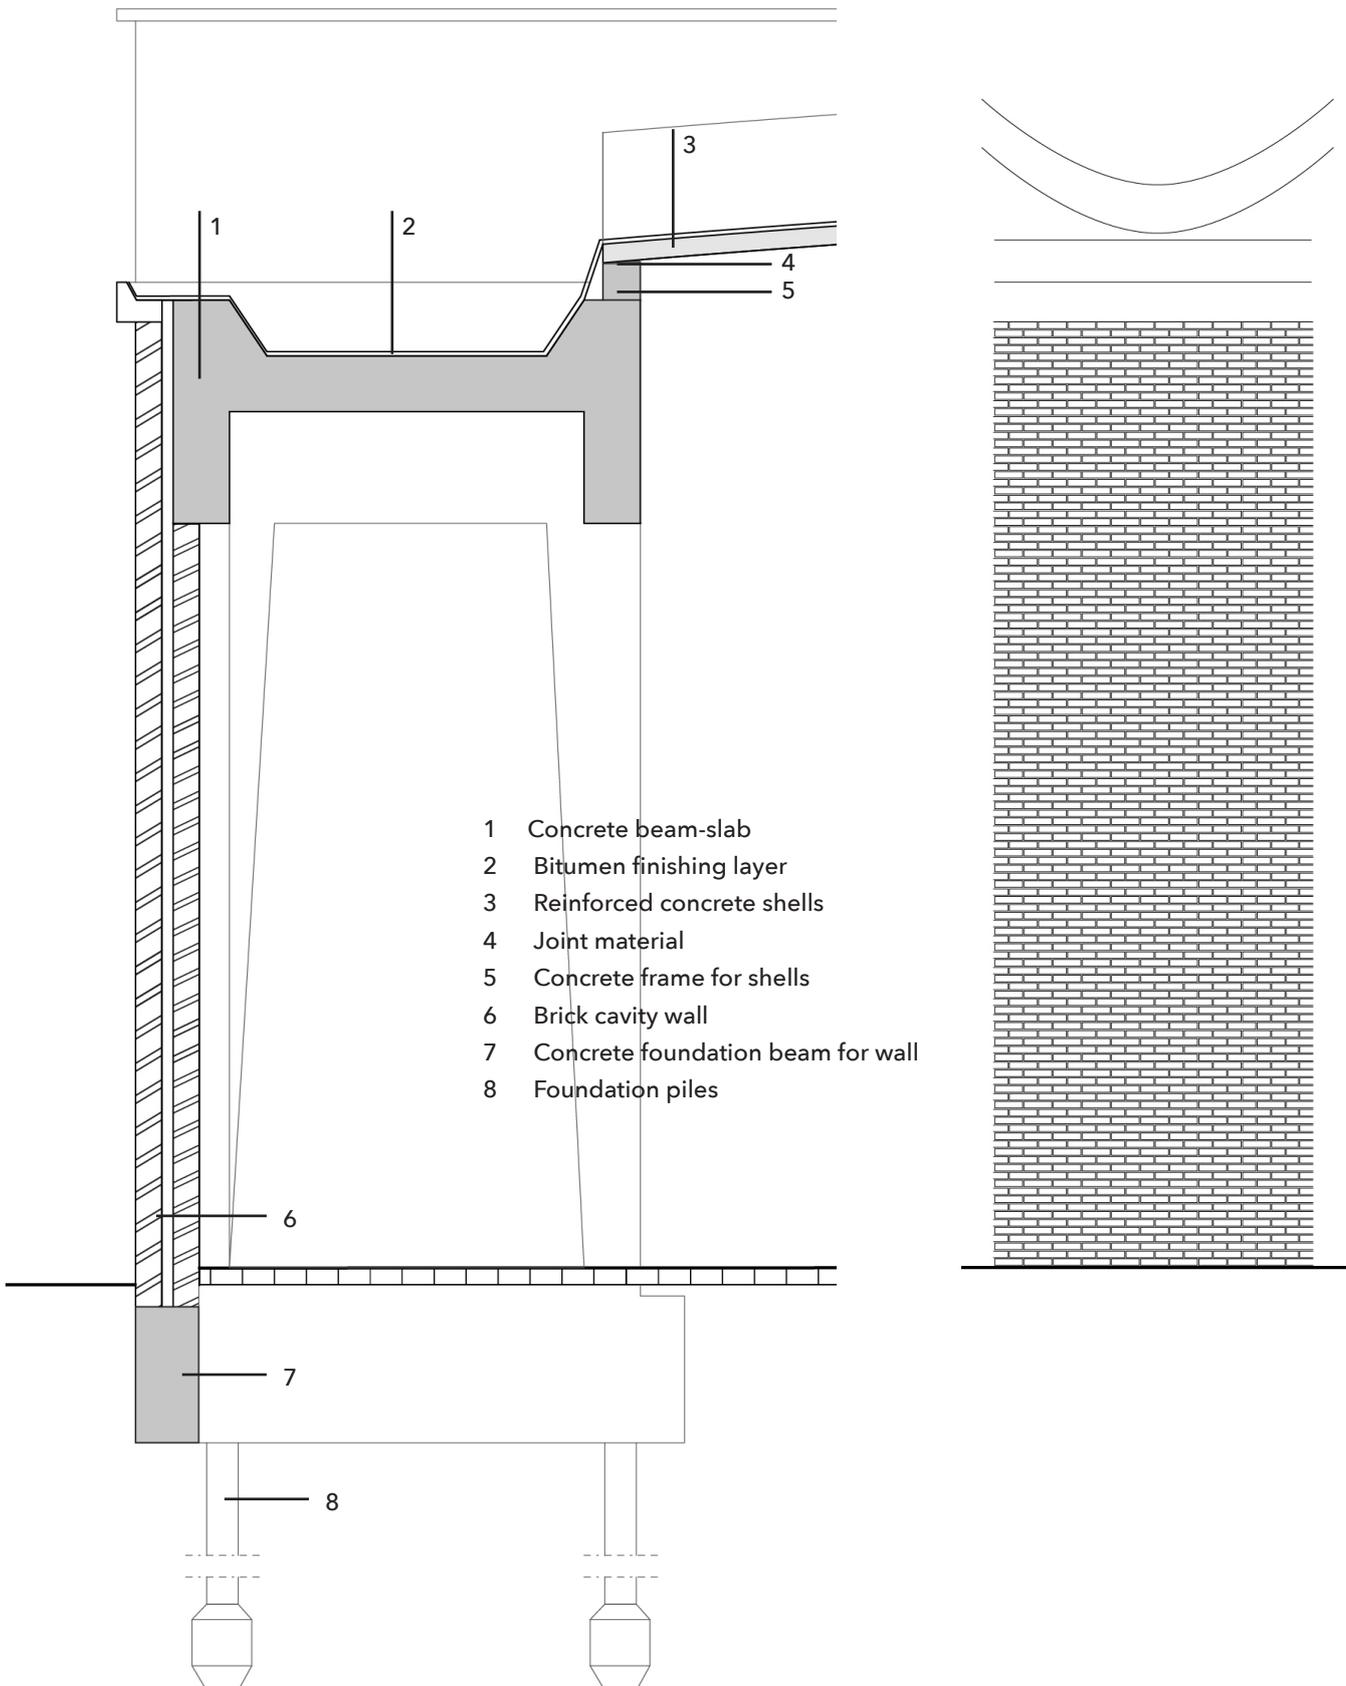
Figure 214 Section and façade fragment (Own images based on Architectenbureau van Linge, 1960)

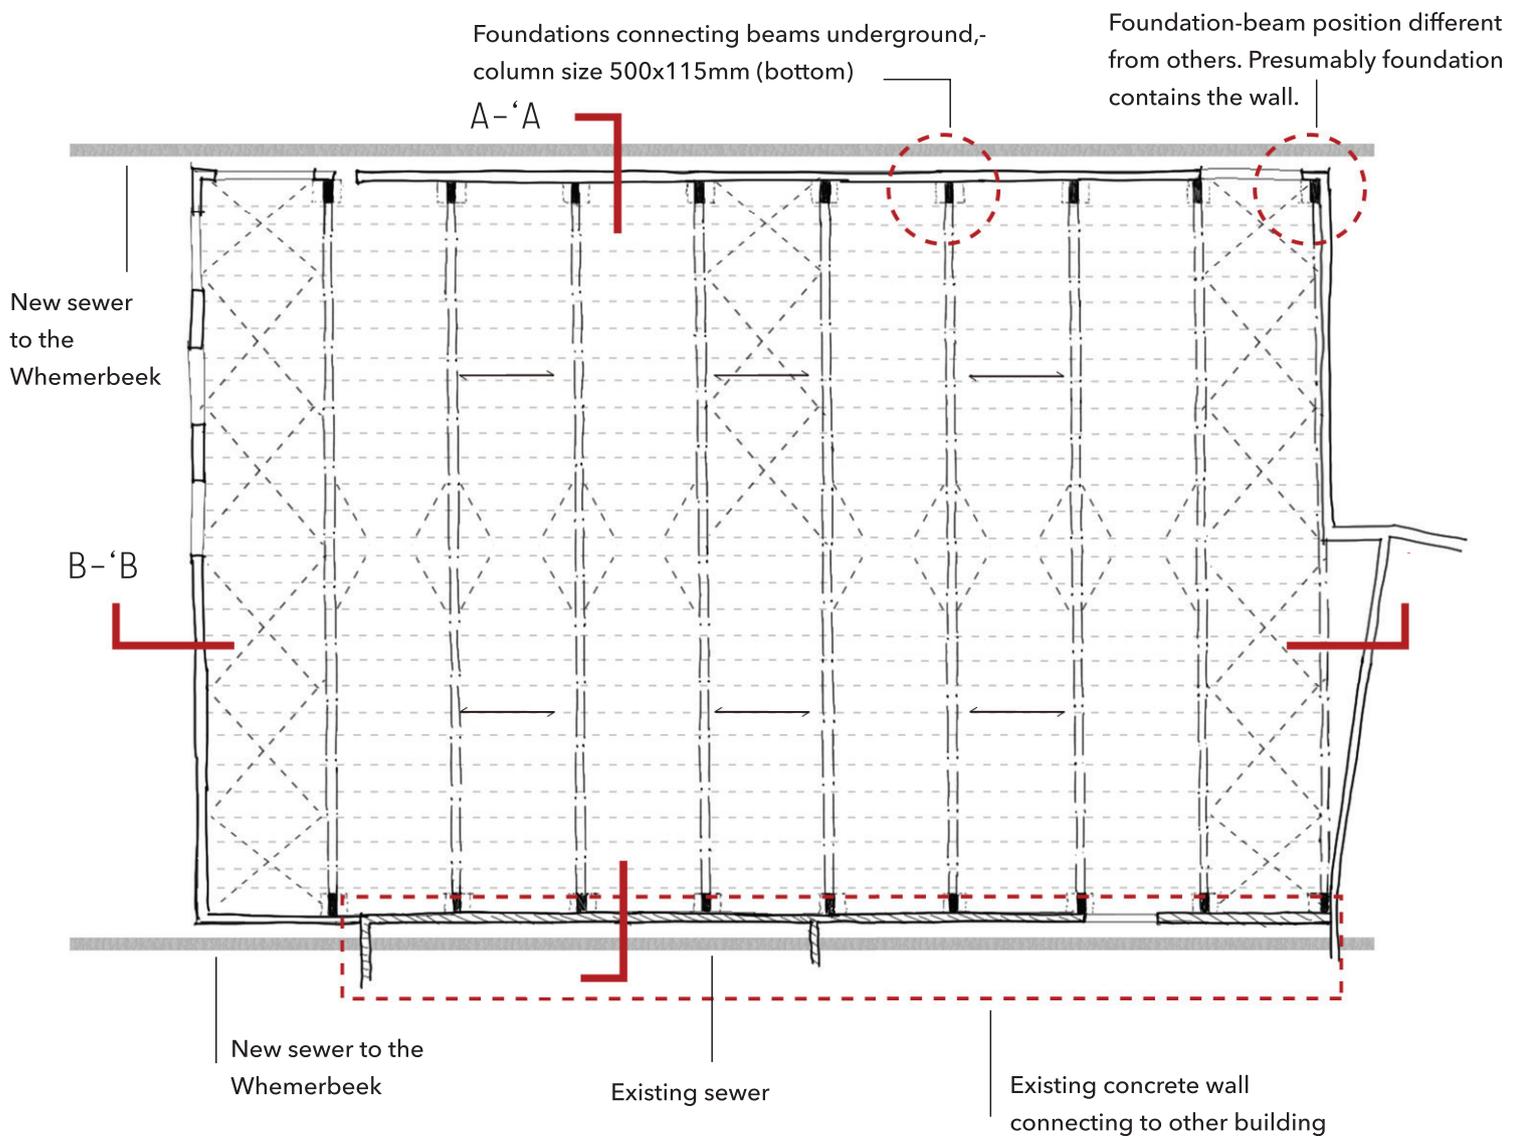
a tension bar under the ground. The span of the beams is 28.51m (West-East) and 4.63m (South-North).

Figure 215 Structural plan/diagram (Own images based on Bouwkundig Ingenieurs en Adviesbureau Sassen, 1960)

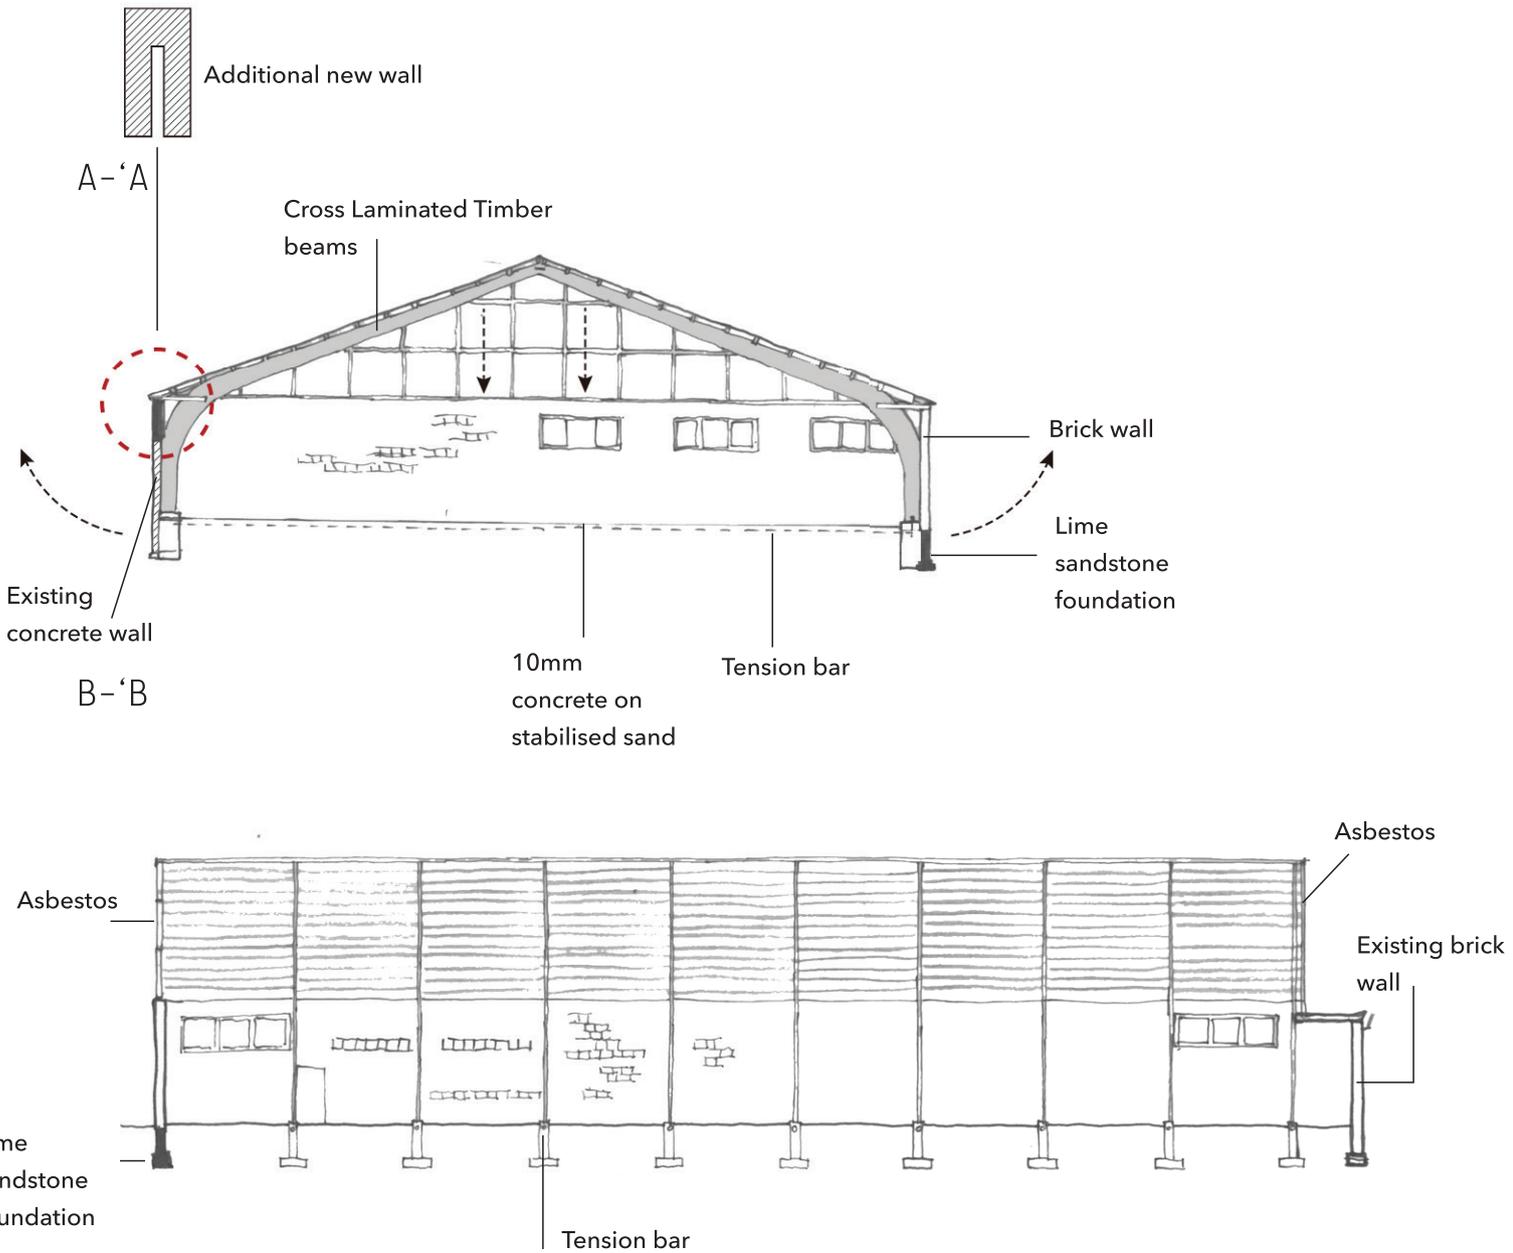
Figure 216 Structural section/diagram (Own images based on Bouwkundig Ingenieurs en Adviesbureau Sassen, 1960)
