## Mechanisms of short pitch rail corrugation

Li, S.

2022

Dissertation  
for the purpose of obtaining the degree of doctor  
at Delft University of Technology  
by the authority of the Rector Magnificus Prof.dr.ir. T.H.J.J. van der Hagen;  
Chair of the Board for Doctorates  
to be defended publicly on  
Wednesday 12 January 2022 at 15:00 o'clock

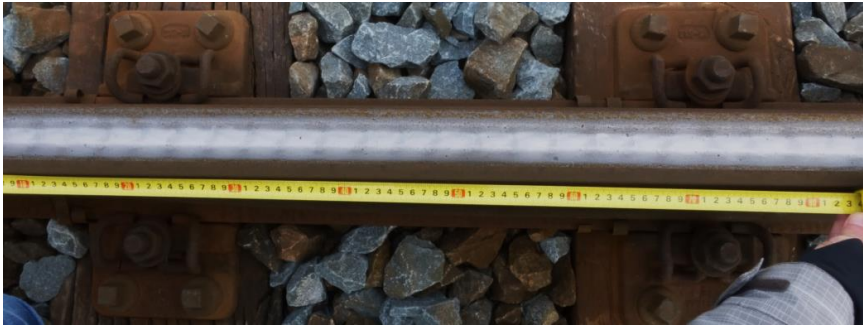
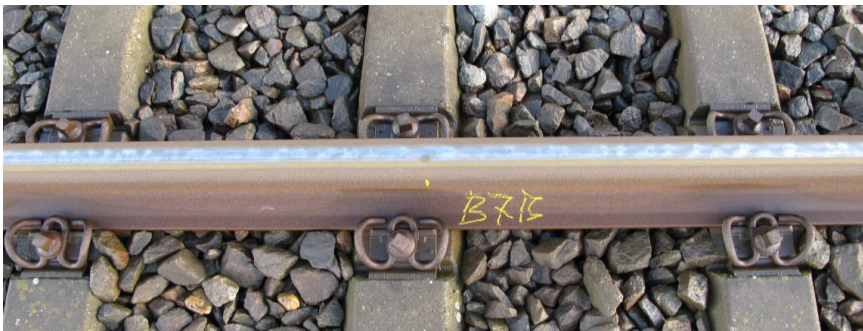
Fig. 1.1 shows an example of the short pitch corrugation (subsequently called corrugation for short) observed from the Dutch railway network. It can be seen from the three subfigures that the corrugation can be uniform in wavelength and distributes evenly along a sleeper span, or its wavelength or amplitude can vary to some extent.

(a) Uniform corrugation.

(b) A non-uniform corrugation of varying amplitudes.

(c) A non-uniform corrugation of varying wavelengths.

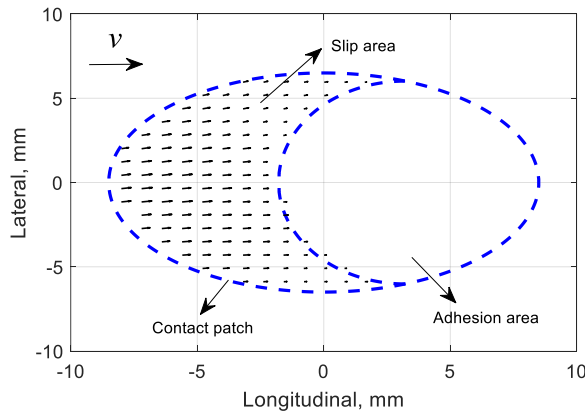
(a) Contact patch and vector of micro-slip within the slip area

(b) Distributions of surface shear stress and adhesion-slip areas.

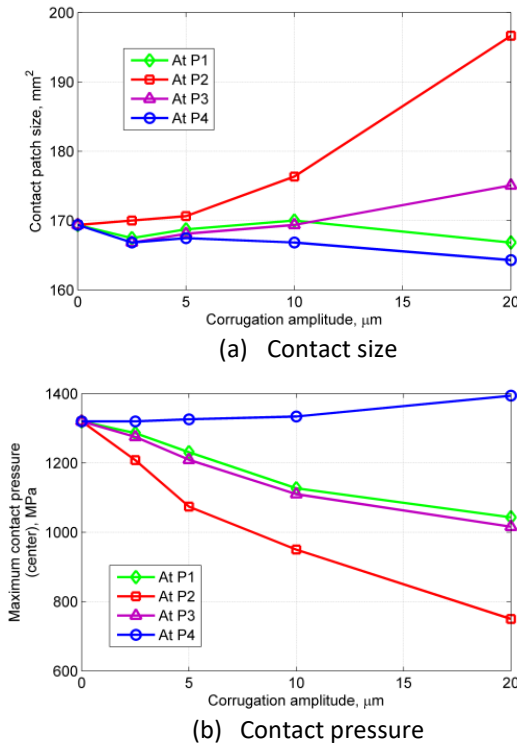
Fig. 2.4a shows the changes in the contact patch size at P1, P2, P3 and P4 with increasing amplitude  $A$ . Compared with  $A = 0 \mu\text{m}$ , an increase in size of up to 16% at P2 is observed in the case of  $A = 20 \mu\text{m}$ , and the increase is approximately 4% at P3. At the other two positions, the changes are minor. The maximum contact patch size is approximately  $200 \text{ mm}^2$  ( $A = 20 \mu\text{m}$ ) at P2, i.e., the corrugation trough, whereas it is approximately  $170 \text{ mm}^2$  when the rail is smooth. Fig. 2.4b displays the maximum contact pressure along the longitudinal axis ( $y = 0 \text{ mm}$ ) for different corrugation amplitudes  $A$ . As the corrugation amplitude increases from  $0 \mu\text{m}$  to  $20 \mu\text{m}$ , the contact pressure at P2 drops significantly to 56% of the original level, i.e., from  $1320 \text{ MPa}$  to  $745 \text{ MPa}$ . This decrease is partly because of the 15% increase in the contact patch size (see Fig. 2.4a). At P1 and P3, the maximum pressure declines slightly to 78% of the original level. An increase in pressure of 6% is observed at P4 for the case of  $A = 20 \mu\text{m}$ .

**Fig. 2.4.** Influence of corrugation amplitude on the size of the contact patch and the maximum contact pressure along the longitudinal axis  $y = 0$  mm.

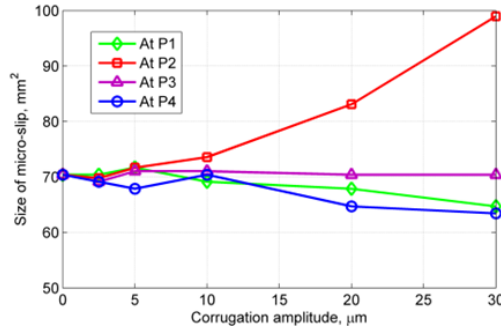
Fig. 2.7b shows the change in the slip distribution along the longitudinal axis  $y = 0 \text{ mm}$ . The maximum slip at P2 is much larger than that of the other cases, which is in agreement with the trend shown in Fig. 2.7a. At P3 and P4, the magnitudes of the slip decrease compared with that of the smooth rail. The increase in the size of the slip zone and the maximum magnitude of the slip at P2 may indicate that large micro-slips in the trough could be a major driver of corrugation development. The distribution of the slip within the contact patch is shown in Figs. 2.6b and 2.6d.

(a) Size of slip zone

(b) Slip along the longitudinal axis y = 0 mm
