**Analysis of local damages effect on mechanical responses of underwater shield tunnel via field testing and numerical simulation**

Applied Sciences (Switzerland)

# Analysis of Local Damages Effect on Mechanical Responses of Underwater Shield Tunnel via Field Testing and Numerical Simulation

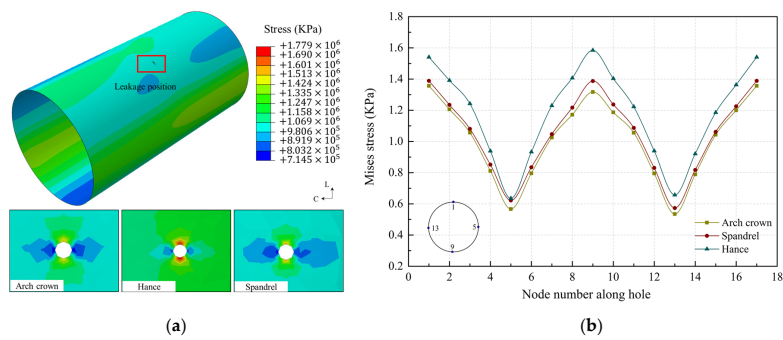
**Figure 13.** The influence of local damage in different positions: (a) Von Mises stress distribution; and (b) Von Mises stress curves.

Similarly, the control variates method was applied to study the stress response under different damage positions. In this section, the mechanical performance is discussed when damage disasters appeared in the spandrel and hance of the tunnel hole. In addition, the effect of hole crown damage on stress distribution is analyzed in the above section. Keeping the water pressure constant, at 487 KPa, the numerical results under different damaged positions were obtained, as shown in Figure 13, where Figure 13a is the stress distribution diagram in different positions and Figure 13b shows the stress curves obtained from different models. The numbering method for nodes along the hole was consistent to the above analysis. These figures indicate that the characteristics of stress distribution in different damaged positions were similar, but the magnitude of stress varied with different positions. The value of stress in the hance of the tunnel hole was the largest, followed by the spandrel, and the arch crown. Thus, it is easier to develop concrete cracks in the hance of the hole than that in other positions, and the most significant influence region is at about 21.8 cm.

The numerical results, shown in Figures 12 and 13, indicate that the tensile stress value is 1.74 MPa when water pressure is 487 KPa. The maximum stress response value longitudinally is 45 KPa in the case of water level changes per meter. Based on this, the maximum stress under the largest water pressure—of which the value is 500 KPa, as determined through field investigation results—can be calculated. Thus, the maximum value of stress distributed around damaged positions is about 1.79 MPa. Subsequently, the maximum tensile stress theory (MTST) was adopted as a criterion to evaluate the state of the concrete structure [27]. Based on MTST, a crack would develop if the tensile stress reached the ultimate strength. The criterion results can be expressed as

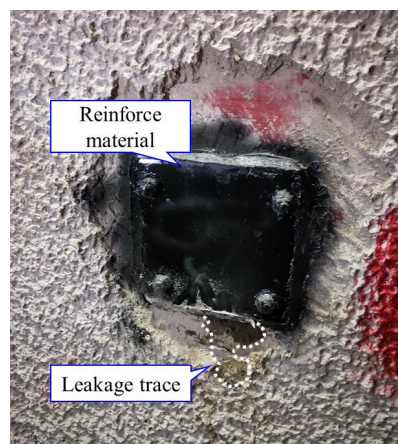
**Figure 14.** Reinforcement measures in the study site.

Thus, the safety factor around damaged positions in the study site is 1.57, which is greater than the critical value. The structure is therefore considered safe. In order to prevent disasters, it is critical to take measures to support and reinforce the influenced region. Considering that steel is a material with high strength and a low price, it was selected to reinforce the damaged positions, as shown in Figure 14. A steel plate was installed for the purpose of anchoring, and the distance from the center of the hole to the side of the steel plate was 25 cm, which is larger than the radius of the influenced area.
