**Bank erosion processes measured with UAV-SfM along complex banklines of a straight mid-sized river reach**

[10.5194/esurf-6-933-2018](https://doi.org/10.5194/esurf-6-933-2018)

Earth Surface Dynamics

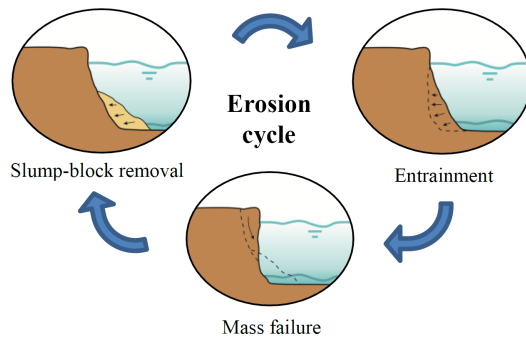
**Figure 1.** Schematic bank erosion phases: slump-block removal (left), entrainment of bare bank (right), and incipient mass failure (centre).

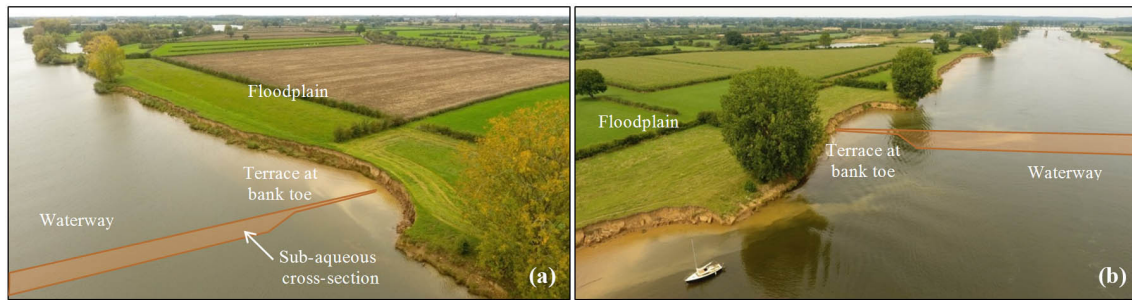
**Figure 2.** Restored bank in the Meuse River: upstream view of first 300 m (a) and downstream view of middle 500 m (b). Bank erosion has caused a series of bays in the 1200 m restored reach. Note eroded bank sediment in suspension.

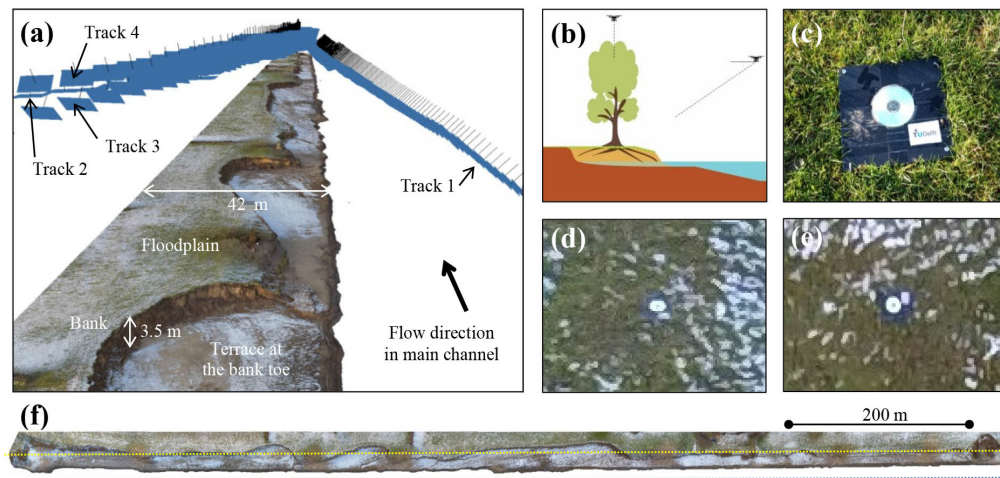
**Figure 3.** (a) Camera positions and orientations in perspective view. The digital surface model shows the low water condition during January 2017, which exposed a terrace at the bank toe. (b) Cross-sectional scheme of UAV paths. (c) Ceramic plaque with CD as ground-control point on the floodplain. (d) GCP in photograph from track 1. (e) Same GCP from track 2. (f) Top view of DSM with UAV track 1 in blue and tracks 2–4 in yellow.

black ceramic tiles (Fig. 3c) fixed to the ground with a circular reflector (12 cm CD) at its centre for their fast recognition in the photographs (Fig. 3d–e show how a GCP is seen from tracks 1 and 2). We measured the GCP coordinates using the Leica GS14 RTK GPS unit, which was also deployed for the cross-profiling.

sion rates naturally depend on each site, after different river sizes, hydraulic conditions, bank materials, etc. In the presented study site, erosion rates varied enormously (Fig. 3), but still the performed eight surveys within a year successfully captured bank processes within a single erosion cycle in areas of fast retreat such as section 4.

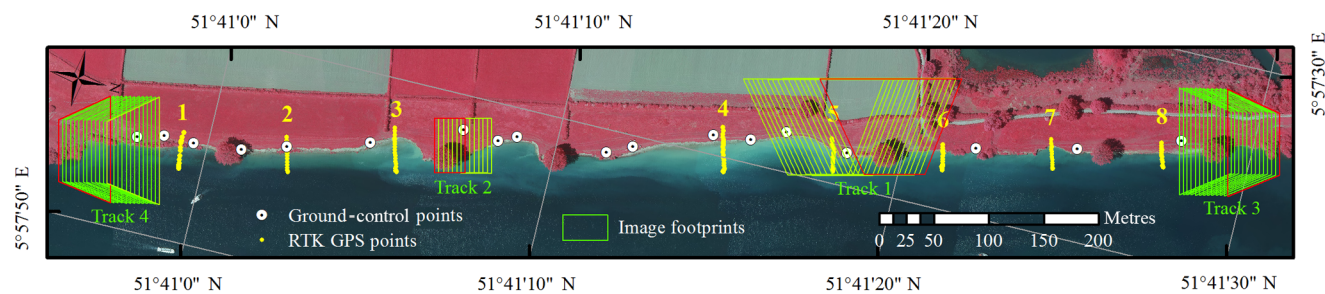
**Figure 4.** Study reach of the Meuse River with GCPs, RTK GPS measurements with cross-section locations and numbers, and some image footprints for all UAV tracks.

For the first step, the analysis of the minimum number of photographs needed to achieve the highest DSM accuracy, we compared the DSMs with RTK GPS measurements to quantify vertical precision. We took 129 points across eight profiles on 18 January 2017 (see Fig. 4) with a Leica

Six bank profiles were selected among those surveyed with GPS on January 2017 (Fig. 4) to compare the bank representation with the different survey techniques. Figure 11 shows the bank profiles at sections 1, 2, 4, 6, 7, and 8. These sections presented distinct erosion magnitudes and features after 7 years of restoration; for example, section 8 (Figs. 4 and 11) appeared close to the original condition, with a mild slope and nearly no erosion, whereas sections 6 and 7 had vertical scarps. The SfM DSM profiles are represented by continuous lines, the ALS profiles with dashed lines, and GPS points with circles. The SfM representation had better prox-

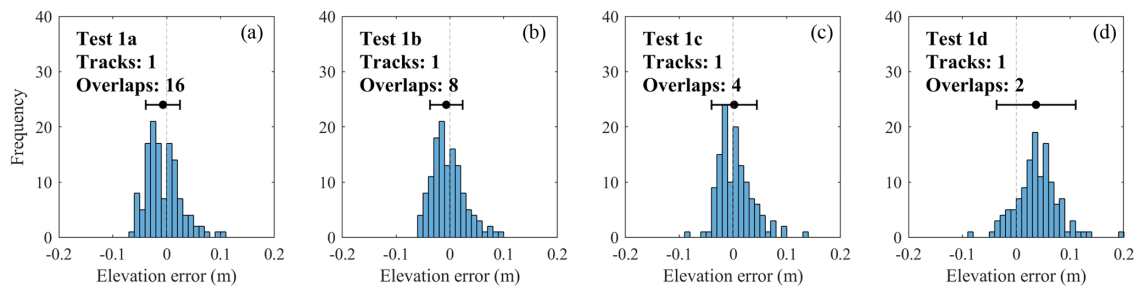
**Figure 5.** Elevation error distributions for SfM tests 1a, 1b, 1c, and 1d, assuming that the RTK points are correct and without error. Indicated overlaps are the minimum.

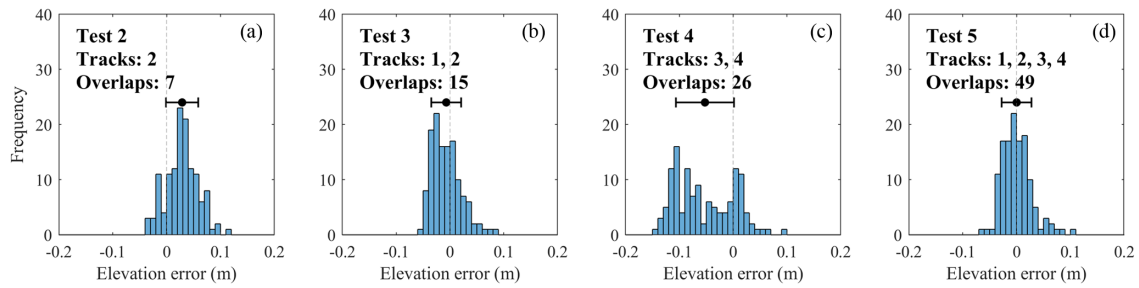
**Figure 6.** Elevation error distribution for tests 2, 3, 4, and 5. Ordinates indicate number of GPS points in each bin.

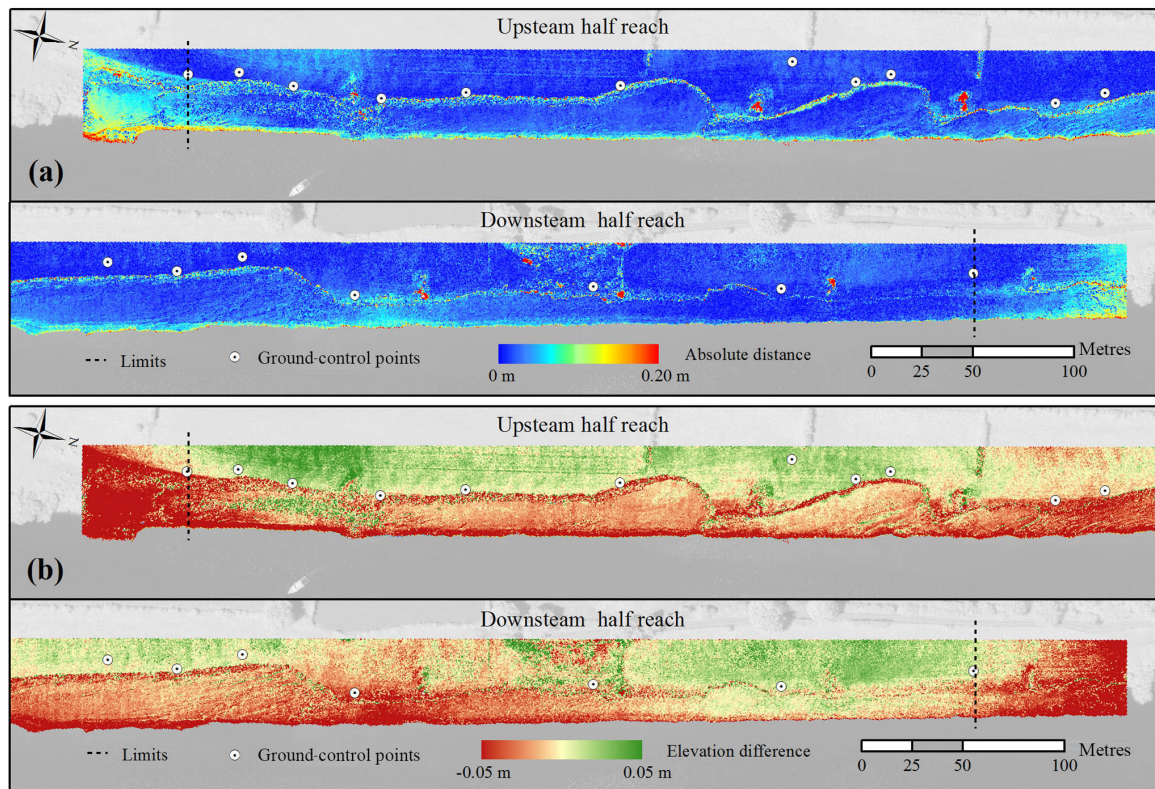
**Figure 7.** (a) Absolute elevation differences between SfM and ALS along the reach. (b) Signed elevation differences between SfM and ALS with a smaller scale range.

Compared to the ALS grid, the test 3 point cloud showed a good agreement over most of the reach. This is observable from Fig. 7a, corresponding to the blue areas that indicate elevation differences lower than 5 cm. However, two notable regions surpassed this difference: the bank and the extremes of the reach. The latter were zones beyond the GCPs, where higher errors in the DSM are expected when using parallel image directions due to inaccurate correction of radial lens distortion (James and Robson, 2014; Smith et al., 2014). Consequently, the results outside the GCP limits were not considered as reliable as those within, where distortions

Figure 7b presents signed elevation differences with a smaller scale range to highlight areas with positive and negative deviations between techniques. Green zones indicate higher ground elevations on the SfM DSM than in the ALS grid, red zones indicate the opposite, and yellow shows elevation matches. The upstream half domain presented a general tendency of SfM to overestimate elevations on the floodplain, and in turn underestimate them on the terrace. This trend is also observed in the upper part of the downstream reach. Nevertheless, these zones showed exceptions, such as a green patch at the terrace close to the dashed limit, and a red patch on the floodplain at the end of the upstream half reach. Despite the described general opposed behaviour between floodplain and terrace, the downstream reach evidenced two zones with consistent trends across the domain, covering both the floodplain and terrace. First, lower SfM elevations at the end of the largest embayment (downstream half reach), and second, SfM higher elevations at the end of the reach, before the dashed limit.

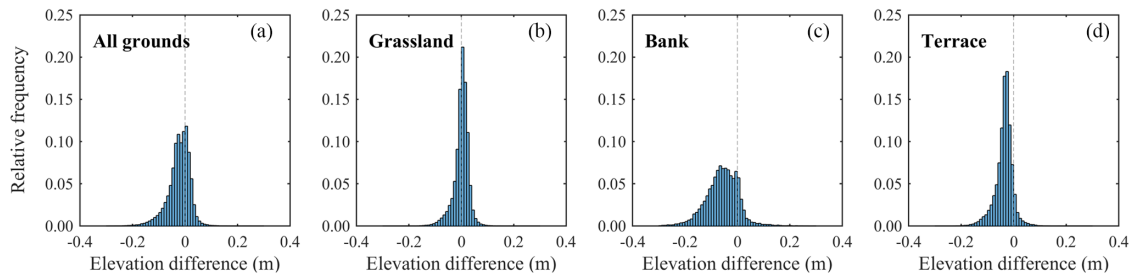
**Figure 8.** Comparison of elevation differences between SfM and ALS for distinct surface types.

Figure 8 presents the relative frequency distributions of the elevation differences divided into three regions: the grassy floodplain, the steep bank, and the bare-ground terrace. Over the grassland, both SfM and ALS had rather similar results (Fig. 8b), with 1 cm mean difference and 2 cm of standard deviation (Table 3). In contrast, the bank had a bias between techniques of 6 cm (Table 3) and a relatively high standard deviation of the same value. Finally, the terrace showed a slightly higher deviation than over the grassland (Fig. 8 and Table 3) but with a bias of  $-4$  cm. The bank area together with the terrace induce an overall small negative bias in the elevation difference distribution (Fig. 8a and Table 3). The former has a small contribution to the total number of measurements and the latter has a greater number but a lower magnitude.

The elevation bias at the bank between the SfM-based DSM and the ALS grid (Fig. 8) was caused by the topographic overestimation of ALS (Table 3 and Fig. 9). This ubiquitous error is ascribed to a known limitation of ALS systems related to the laser beam divergence angle, which locates the closest feature within the laser footprint at the centre of the footprint. This increases the ground elevation at high-slope areas (Bailly et al., 2012), which is the case for riverbanks. Still, the ALS resolution and precision were enough to identify bank slopes, in accordance with other studies (e.g. Tarolli et al., 2012; Ortuño et al., 2017). Furthermore, despite the ALS capability to estimate volume changes of eroded banks (Kessler et al., 2013), the method omits information related to the phases of the erosion cycle by not surveying erosion features smaller than its resolution (in this case, 0.5 m), apparent in contrast with SfM profiles (Fig. 11). Moreover, if finer ALS resolutions are available, for instance, using higher frequency lasers or working with the raw data, more ground details can be captured, but still vertical or undermined profiles would be missed.

The elevation differences between the methods observed for grassland (Fig. 8b) were probably caused by dissimilar ground resolutions, because a larger elevation scatter is expected in the SfM-based DSM when capturing grass with 2 cm resolution, compared to the interpolated ALS samples into a 50 cm grid, even when derived from 0.16 m beam footprints. Nonetheless, the mean difference was zero (Table 3), so that both methods overestimate in the same way the real ground elevation due to grass cover. The effect of this is vis-

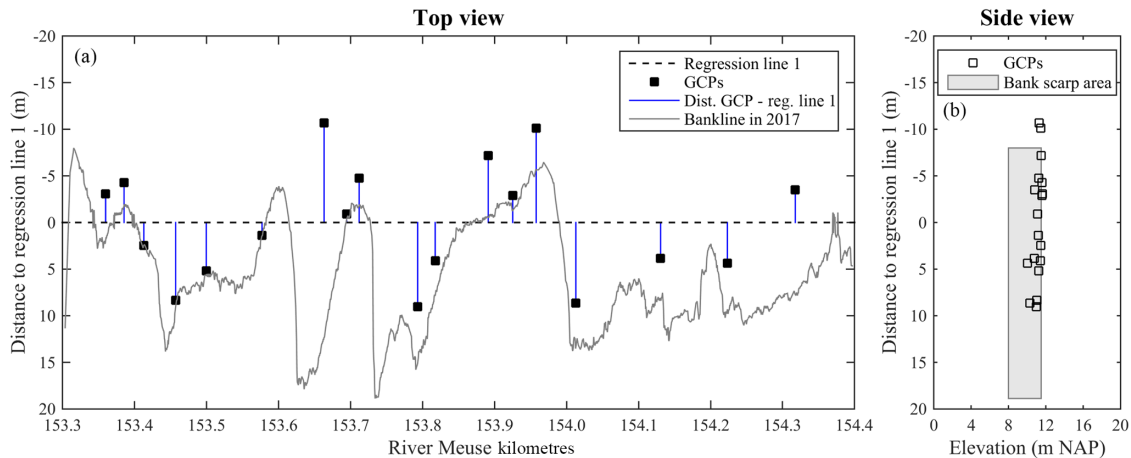
**Figure 9.** GCP horizontal distances to the regression line (a) and respective positions in potential rotation plane from the regression line (b).

tudes of the case study, with maximum bank heights of 3.5 m, indicated with a grey area in Fig. 9b. This side perspective of the domain evidences the potential plane of rotation, whose stability depends on the position of the GCPs.

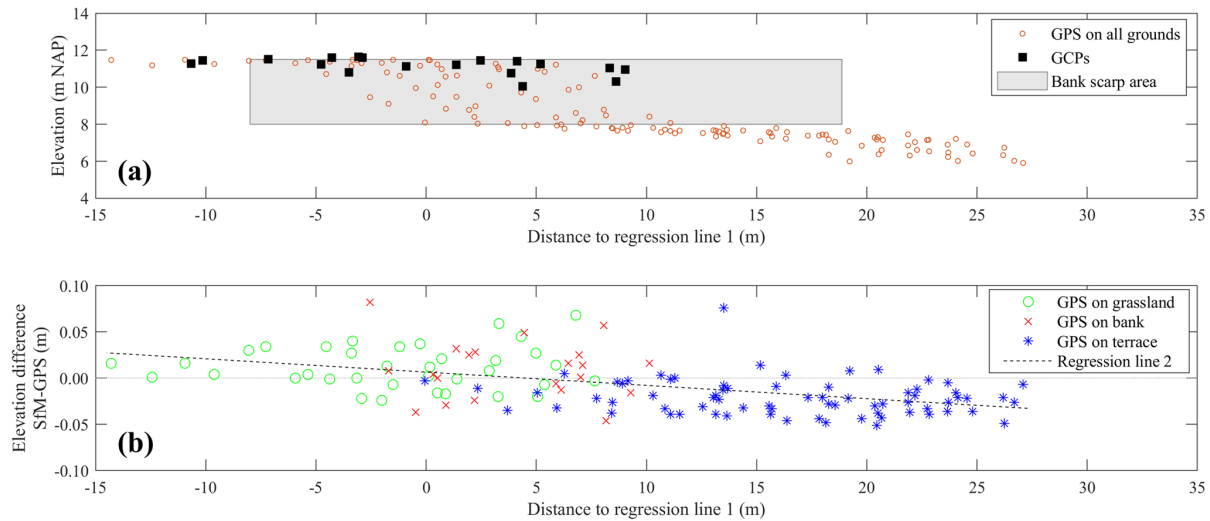
**Figure 10.** (a) Location of GPS measurements in potential rotation plane around regression line 1. (b) SfM DSM elevation errors across regression line 1, distinguished among areas of grassland, bank, and terrace.

The analysis made for test 3 on model rotation evidenced a linear trend with increased surface elevations on the floodplain side of the domain and decreased elevations on the main channel side (Fig. 10b). This tendency was probably caused by a rotation of the DSM around co-linear GCPs that may lead to rotated solutions of the Helmert transformation (Carbonneau and Dietrich, 2017). Yet, the areal SfM-ALS comparison within  $\pm 5$  cm range (Fig. 7b) did not evidence a clear axis along the whole domain that could suggest a rigid rotation of the DSM, since the ALS did have a constant mean accuracy across all surface types (Table 3). The linear rotation tendency, then, might have been obscured by the error range that was larger across the domain (Figs. 6b and 10b) than the mean rotation magnitude, whose elevation difference between the extremes of the cross-sectional domain was 6 cm, and 4 cm within the bank area. Thus, other sources of error were also present that resulted in the obtained error range.

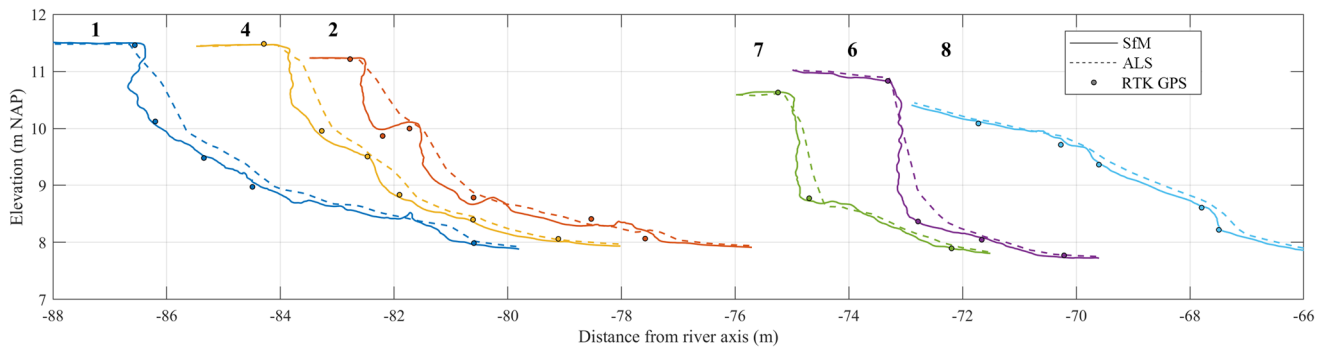
**Figure 11.** Banks measured with SfM (continuous lines), ALS (dashed lines), and GPS (circles) on 17–18 January 2017. Cross-sections are located, from left to right, at river kilometres 153.4, 153.9, 153.5, 154.2, 154.1, and 154.3 (see Fig. 4 for locations).

imity to the GPS points than the ALS in almost all cases. What is more, ALS generally overestimated the elevation corresponding to the GPS points, which confirms the bias observed in the comparison of bank elevations shown in Figs. 7 and 8.

SfM profiles showed detailed bank features, such as a collapsed upper bank laying at the toe (section 2), an overhang at the bank top (section 1), small-scale roughness on scarps (sections 6 and 7), and slump-block deposits (section 4). These features appeared as simple shapes in the profiles but they were confirmed with field observations. The ALS depicted simpler profiles, smoothed by coarser resolution, which made it difficult to identify characteristic features of the erosion cycle in them. Yet, ALS profiles had enough point spacing to capture gentle bank slopes with reasonable precision (section 8), but for steeper ones (sections 1, 2, and 4) and especially at scarps (sections 6 and 7), this technique provided lower accuracies.

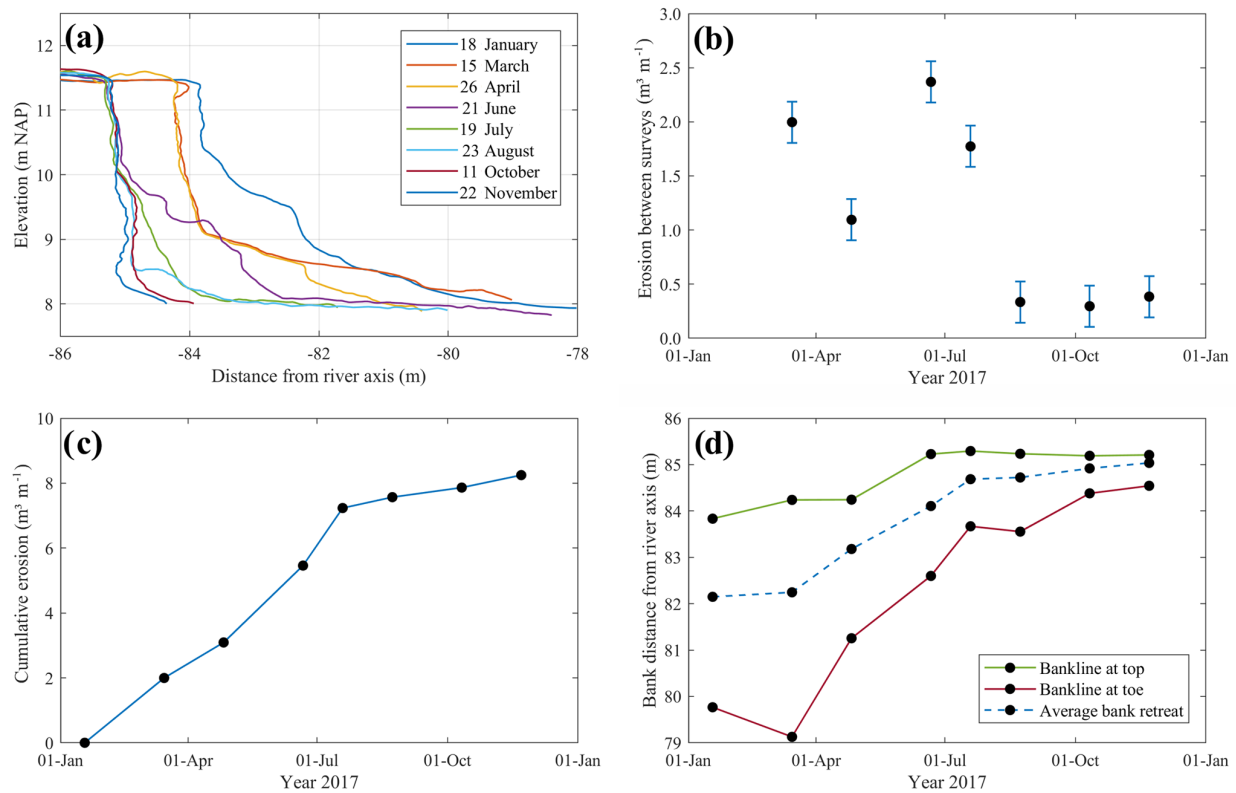
**Figure 12.** Sequential surveys at cross-section 4, Meuse River kilometre 153.9, over 2017. **(a)** Bank profiles from DSMs; **(b)** eroded volume per unit width between consecutive surveys; **(c)** cumulative erosion along surveys; **(d)** bankline locations at the top and toe of the bank.

The temporal development of section 4 (Figs. 4 and 11) is illustrated in Fig. 12a by a sequence of SfM-UAV surveys. The initial stage corresponds to the survey of Fig. 11 on 18 January 2017. The consecutive surveys showed the evolution of the vertical bank profile through which different processes can be inferred. The bank profile, initially characterized by a top short scarp and slump blocks along the bank face, experienced a mass failure and a further removal of blocks between 18 January and 15 March 2017. Between 15 March and 26 April, only toe erosion occurred. By 21 June, another mass failure happened, which left slump blocks along the lower half of the bank. On 19 July, these blocks were removed, leaving a steep bank face. Then, further toe erosion caused a small soil failure at the lower bank whose remains laid at the toe. On 11 October, this wasted material was removed. Then, until the last survey on 22 November, entrainment occurred at the lower half of the bank profile, further steepening the bank. In light of the results, the

bitrarily defined for this case at 11.1 and 8.1 m, respectively. The top bankline showed a major jump between April and June and a smaller one between the first two surveys, corresponding to mass failure events. The bank toe presented a more gradual retreat, with events of slumping and temporal accretion that were timely captured along the surveys. This alternative bank retreat representation provides evidence of the development of bank erosion at every survey. The contrast of bankline retreat at the top and toe of the bank illustrates how different processes on their own represent dissimilar erosion evolutions, since they constitute different phases of the erosion cycle, i.e. at the top mass failures and the toe slump-block removal and entrainment. Finally, the average bankline between bank toe and top would best represent the real retreat (dashed line in Fig. 12d), despite not necessarily indicating an actual bank location for a specific elevation. This approach logically considers all erosion phases and follows a similar trend to the cumulative erosion of Fig. 12c.
