## Experimental investigation of cavitation-induced erosion around a surface-mounted bluff body

Jahangir, Saad; Ghahramani, Ebrahim; Neuhauser, Magdalena; Bourgeois, Sébastien; Bensow, Rickard E.; Poelma, Christian

Wear

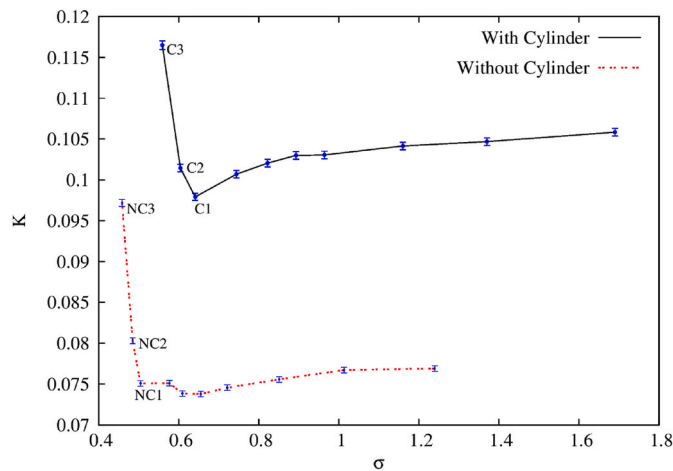
**Fig. 5.** Pressure loss coefficient ( $K$ ) versus cavitation number for different test cases with and without the bluff body.

The experiments are designed so that the pressure drop is as similar as possible (with and without cylinder), as this has the largest effect on the cavitation number. Due to flow blockage effects, this means that the volume rate can not be the same as well. To investigate the cylinder blockage effect and compare it with the cavity blockage effect, the pressure loss coefficient,  $K$ , for the two sets are plotted against the cavitation number in Fig. 5. Here, the pressure loss coefficient is defined as

In the figure, the three leftmost points on each line represent the reported cases in Table 1. The plot lines simply connect the measured points to demonstrate the trend and the error bars show the measurement uncertainty. The errors are estimated based on the measurement uncertainties of the flowmeter and pressure transducers. When we remove the bluff body, the flow is almost cavitation free (assessed by flow visualization) until very low cavitation numbers ( $\sigma < 0.6$ ). However, with the cylinder, the flow cavitates even at relatively high cavitation numbers ( $\sigma = 1.16$ ), as also reported earlier by Ghahramani et al. [37]. In Fig. 5, it is observed that for the bluff body cases (solid black line), by decreasing the cavitation number (increasing the Reynolds number), the pressure loss has a slight reduction at first as the boundary layer momentum thickness decreases. Then there is a sharp drop with a minimum value at  $\sigma = 0.64$  (corresponding to case C1), which is due to the lubrication effect of the vapor: in this area, the generation and shedding of cavitating vortices reduce the effective fluid viscosity and friction loads on the body (see Ref. [37] for a detailed description of cavity dynamics). By further decreasing the cavitation number below  $\sigma = 0.64$ , the pressure drop increases substantially. For such cases, the cavity structures in the cylinder wake are large enough to significantly narrow the effective channel cross-section, and the pressure loss over the channel increases. For the test series without the cylinder (red dashed line), in the cavitation free regime, by decreasing the cavitation number (increasing the Reynolds number), the pressure loss has a slight reduction, similar to the bluff body case. After  $\sigma = 0.6$ , we first have a slight increase in pressure drop. At  $\sigma = 0.575$  (not listed in Table 1), only a sheet cavity with a length of about 7 mm (1.4D) is observed on the lower wall, which does not have a considerable volume as compared to the other cases. Then by further decreasing the cavitation number below 0.504, there is a sharp increase in pressure drop similar to the bluff body case. By comparing the two plots and the vertical distance between them (which shows the cylinder blockage effect), we can conclude that the cavitation blockage effect is significant. If we compare the vertical distance between points NC1 and NC3 (or C1 and C3), with the vertical distance between the two plots, it can be stated that for the lowest cavitation number, the blockage effect is about 80% of the blockage effect for the rigid bluff body. However, this is the sum of 'true' blockage (reduced channel cross-section) and cavitation-induced reduction of cross-section.

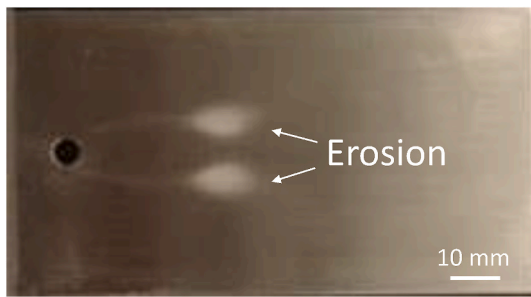
**Fig. 16.** (Top view of the sample plate) Mass loss (erosion) pattern on stainless steel at a flow velocity of 50 m/s ( $Re = 2.5 \times 10^5$ ).

Fig. 16 shows the result of an earlier test at ANDRITZ Hydro to measure the mass loss using the stainless steel and in the current test-rig. The test was performed at a flow velocity of 50 m/s ( $Re = 2.5 \times 10^5$ ). In

the old test, the cylinder was placed on the sample plate (hole in Fig. 16), while in the current experiments, the cylinder was placed before the sample plate. The figure shows the erosion pattern after 30 h of operation. After this time, 26 mg loss of mass was found, where the total mass of the sample plate was 615.788 mg. The global material loss pattern looks qualitatively similar to the paint removal of case C1, with two erosion spots downstream and two thin lines connecting the cylinder with the main erosion spots. These thin lines follow the cavity contour. However, these lines are not present in case C2. The difference can be associated with surface alteration in the metallic surface compared to the painted surface. Also, metallic structures are quite sensitive to

In summary, Figs. 15 and 16 provide qualitative verification of the paint removal tests for cases C1 and C2, while Fig. 13 is a summary of the various erosion patterns for the cases with and without cylinder and for various cavitation numbers.
