Numerical modelling of a masonry farmhouse retrofitted with bed joint reinforced repointing

in partial fulfilment of the requirements for the degree of

in Civil Engineering

at the Delft University of Technology,

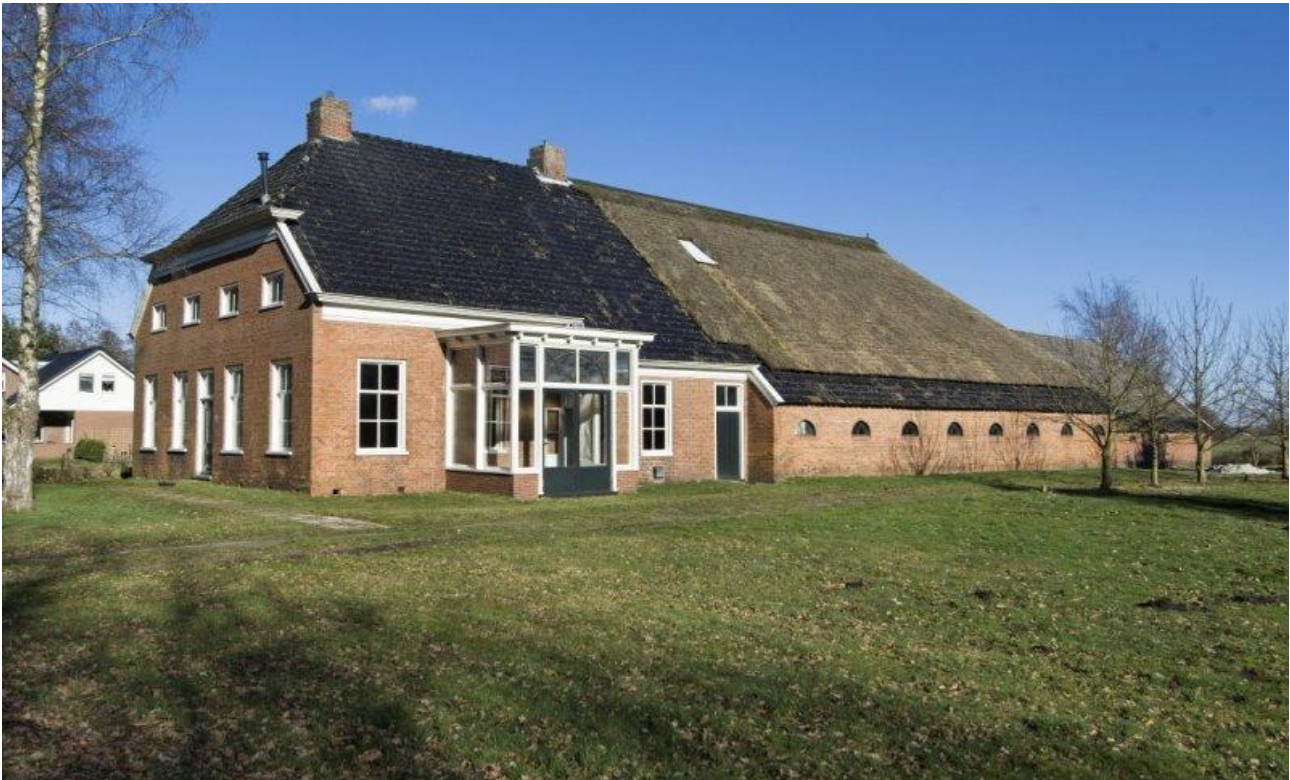
Figure 1.2 typical farmhouse in Groningen (van Galen, 2008)

In this research, the effectiveness of the bed joint reinforced repointing strengthening method will be studied at building level by means of nonlinear finite element analysis, since not much research is available on this. With reference to application in practice, the case study of a farmhouse will be considered. The combined effect of settlement and earthquake loading will be studied. Furthermore, a partially reinforced masonry façade will be studied to assess the added benefit of this strengthening technique during the construction stage of the building. In Figure 1.2 an image of a typical farmhouse in the Groningen region is shown.

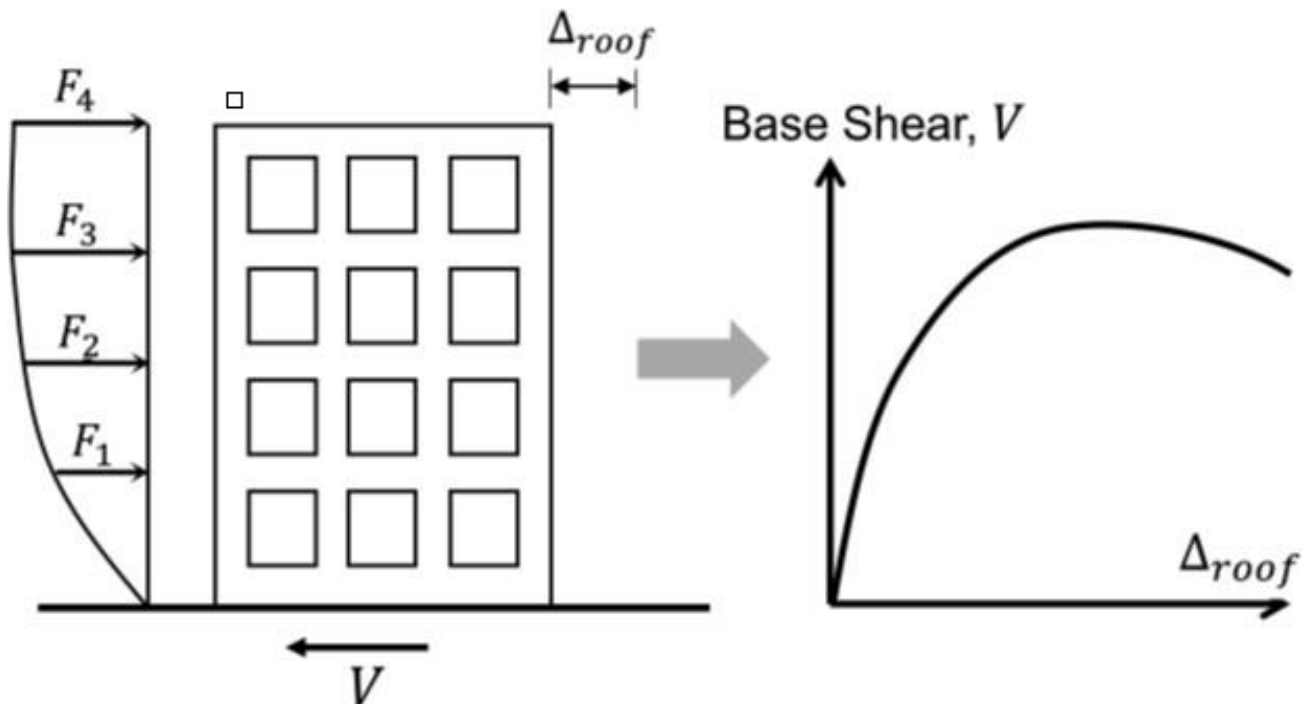
Figure 2.10 modal pushover analysis (Najam, 2017)

- In the modal pushover analysis an equivalent lateral force distribution, that is approximately equivalent to the first modal shape, is introduced (DIANA 10.4 user's manual). The load is incrementally increased in steps. In this way the structure can be loaded up to failure and a base shear-displacement curve can be constructed, giving information about the seismic capacity of the structure (Najam, 2017).

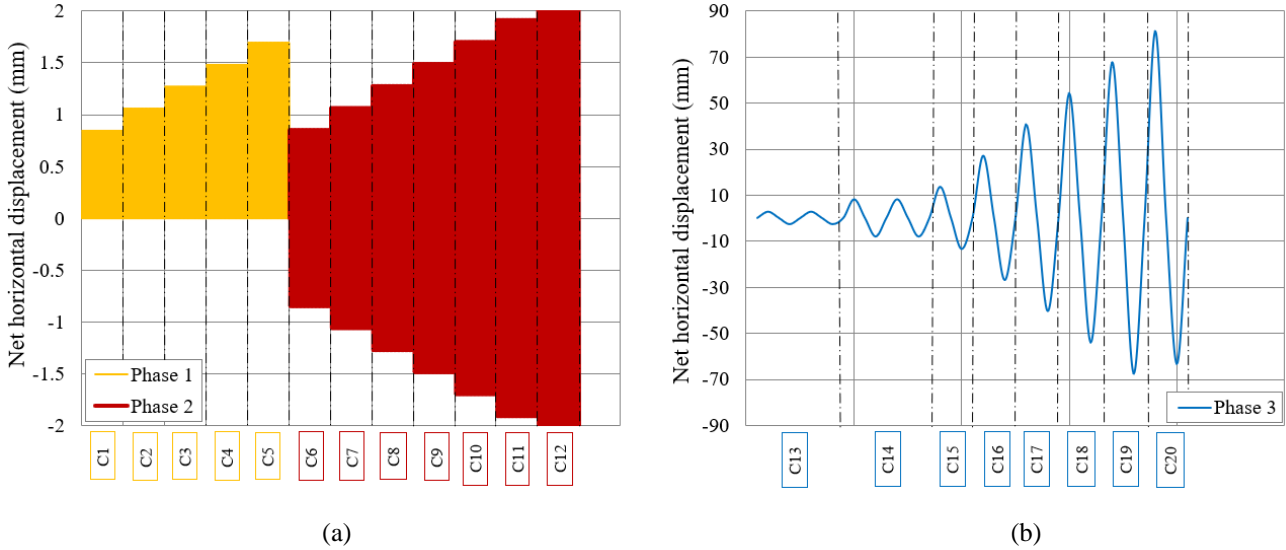
Figure 3.2 loading scheme for (a) phase 1 and 2 and (b) phase 3

Both TUD-COMP 41 and TUD-COMP 45 were tested up to light damage (phase 1 and 2) in multiple cycles, each consisting of 30 runs. After this the wall named TUD-COMP 45 was strengthened using bed joint reinforced repointing and was tested under phase 1 and 2 again, after which both walls were tested up to near collapse (phase 3) in multiple cycles, each consisting of varying amounts of runs. The loading schemes of phases 1, 2 and 3 are shown in Figure 3.2.

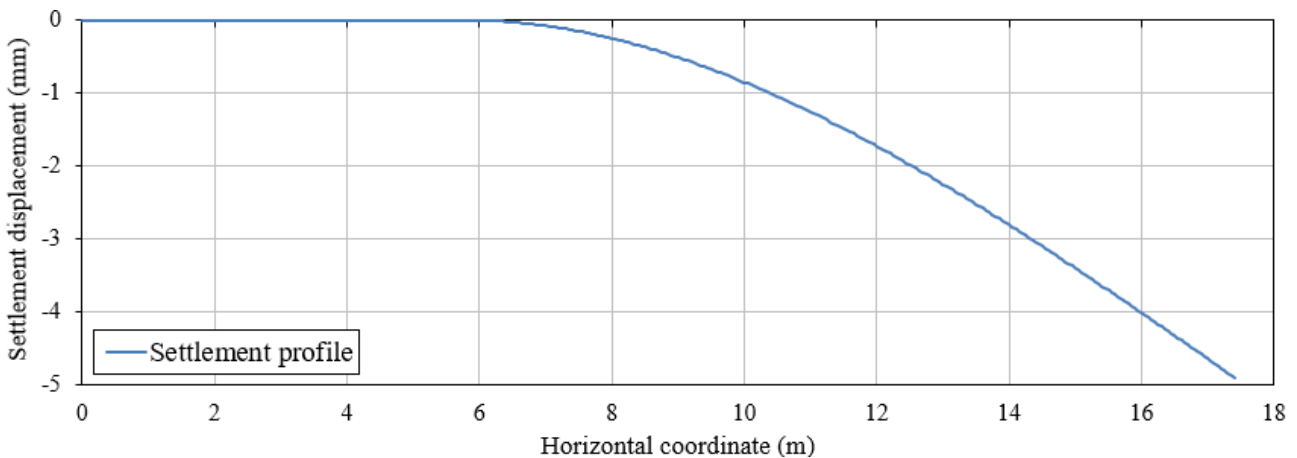
Figure 3.6 settlement profile along the foundation

A settlement load was introduced to simulate pre-existing masonry damage. This was implemented by applying a settlement, with a certain shape and amplitude, along the foundation of the façade (with length 17.4m). The settlement shape considered is depicted in Figure 3.6. The maximum amplitude of the settlement was set to -4.90mm.

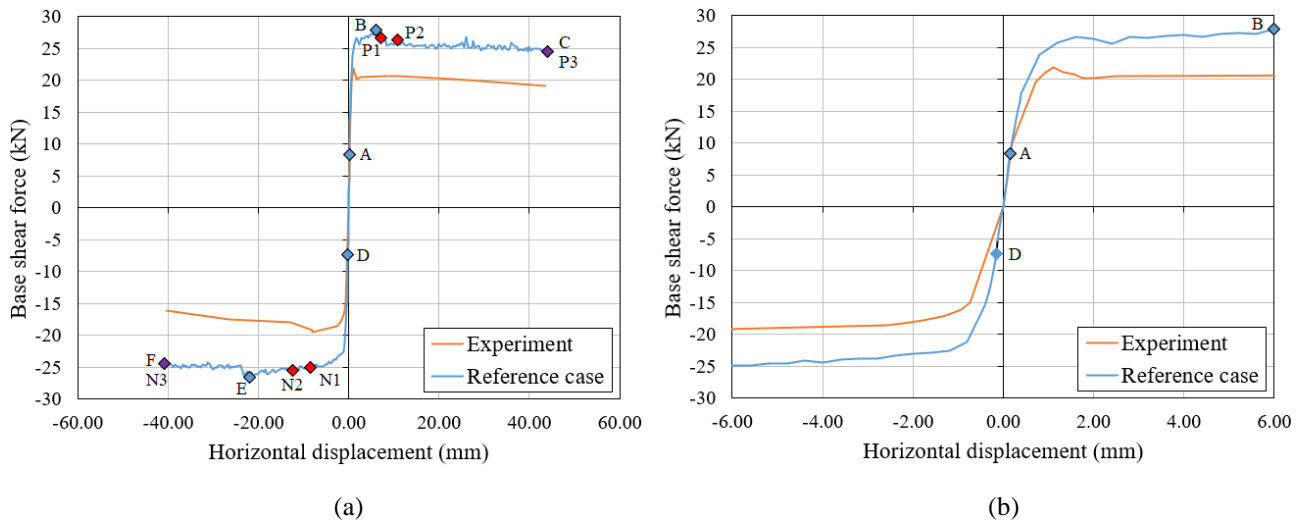
Figure 4.1 capacity curves of the experiment and reference case for (a) -60mm to 60mm and (b) -6mm to 6mm

Figure 4.1 shows the capacity curves of the experiment and reference case for the unstrengthened masonry wall. Convergence was found in every load step; the displacement norm is the one that usually converges over the force norm. More information regarding the convergence can be found in section 4.2.3.

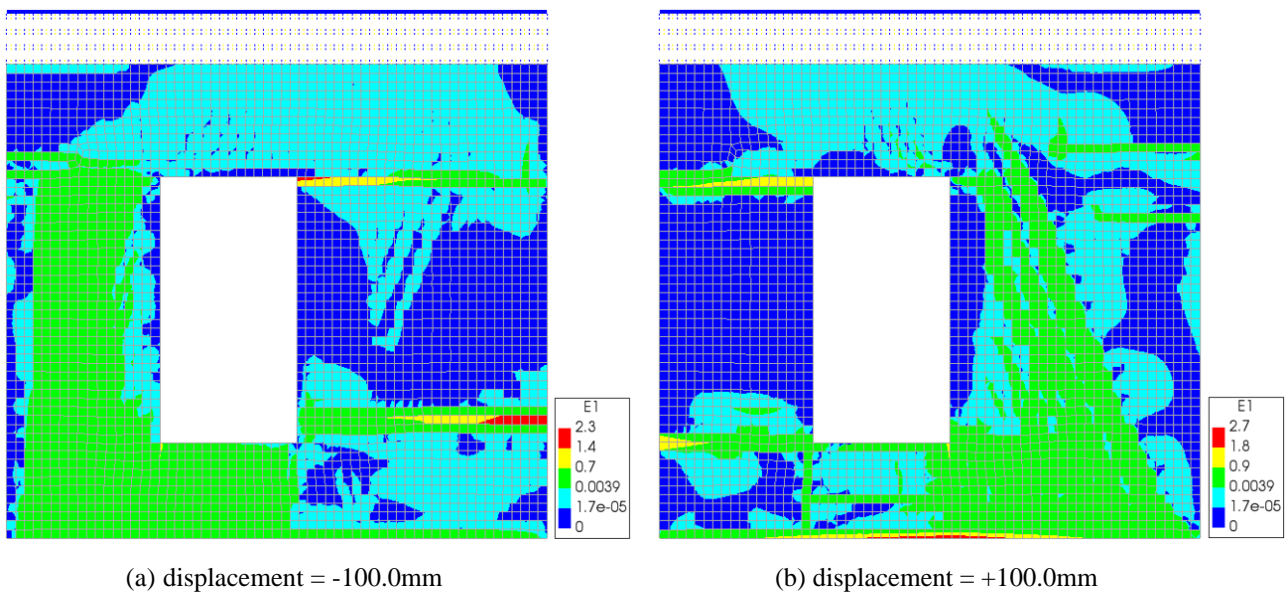
Figure 4.2 crack patterns of the numerical model at $\pm 100.0\text{mm}$

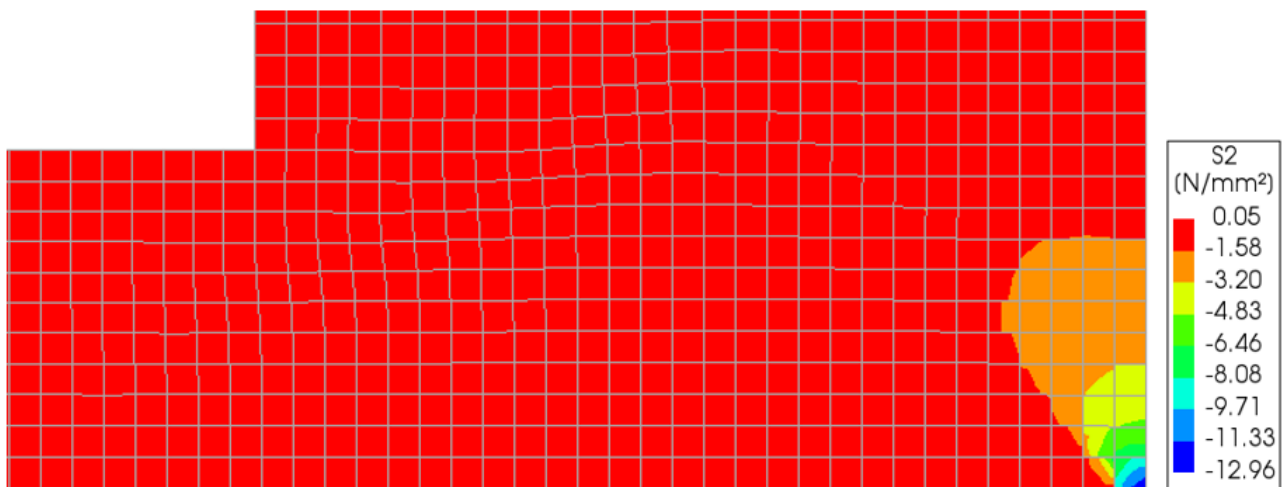
Figure 4.7 toe crushing in the positive loading direction at a displacement = +15.20mm

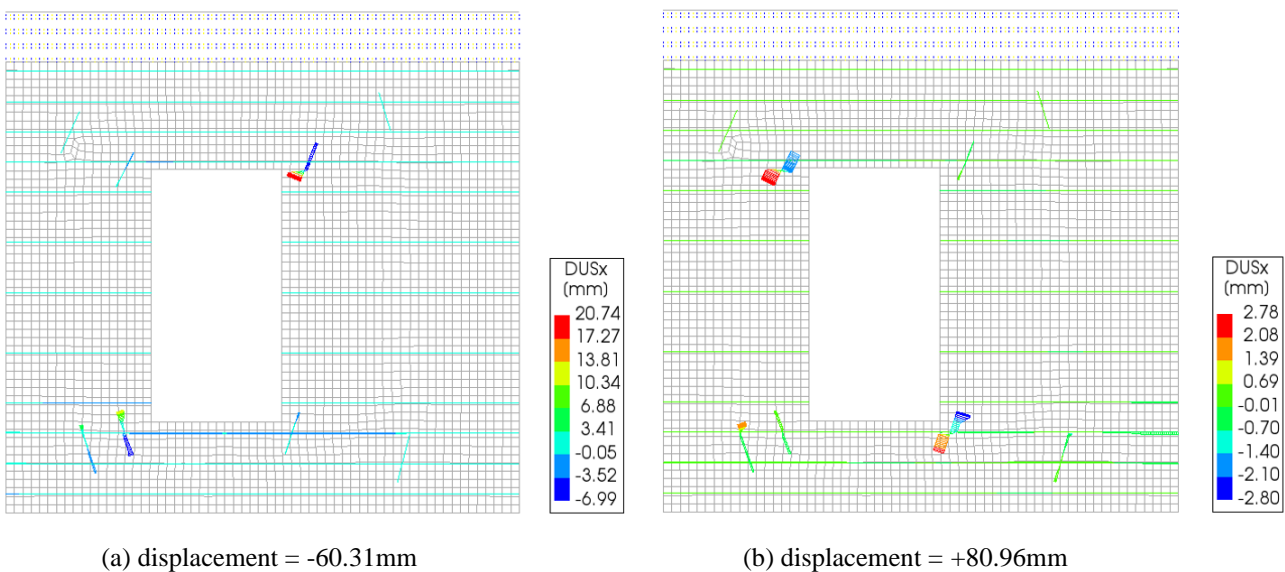
Figure 4.19 amount of slip in the reinforcement in (a) negative direction and (b) positive direction

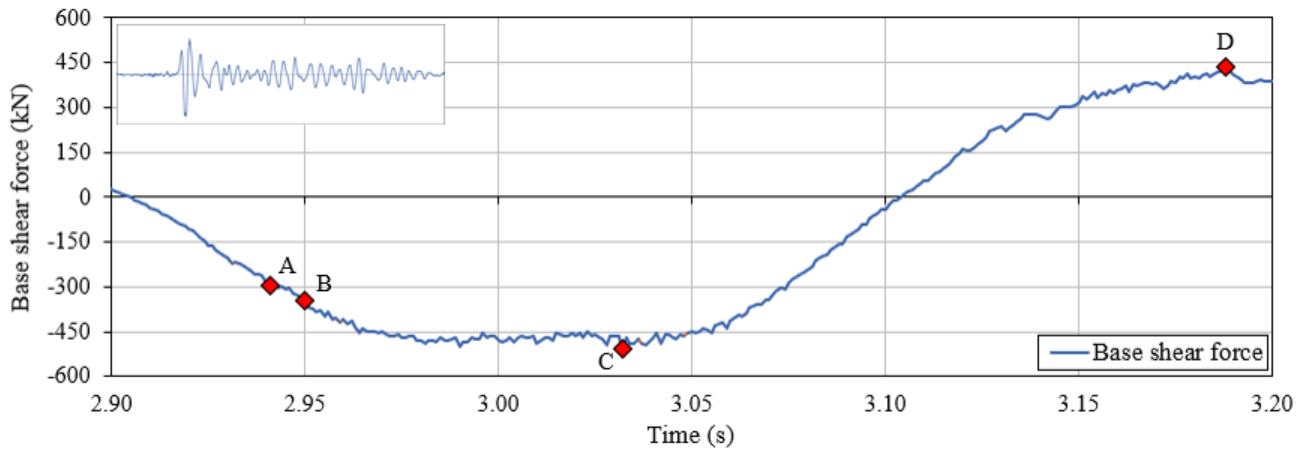
Figure 5.33 enlargement of the base shear over time of the (before settlement) strengthened wall, with the points of interest (A-D)
