## Dealing with Heritage Assessment and Conservation

Lubelli, B.; Pottgiesser, U.; Quist, W.J.; Rexroth, Susanne

Lubelli, B., Pottgiesser, U., Quist, W. J., & Rexroth, S. (Eds.) (2025). *Dealing with Heritage: Assessment and Conservation*. TU Delft OPEN Publishing. <https://doi.org/10.59490/mg.130>

Assessment and Conservation

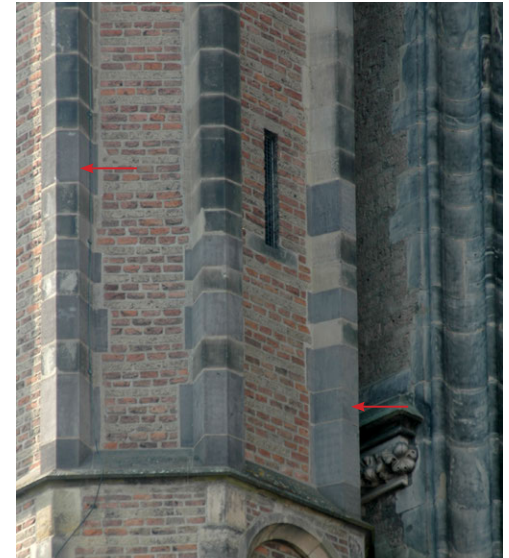
FIG. 2.9 Volvic basalt on the stair tower of the south transept of the Dom Church in Utrecht, as a replacement for Bentheim sandstone / Photo: W.J. Quist

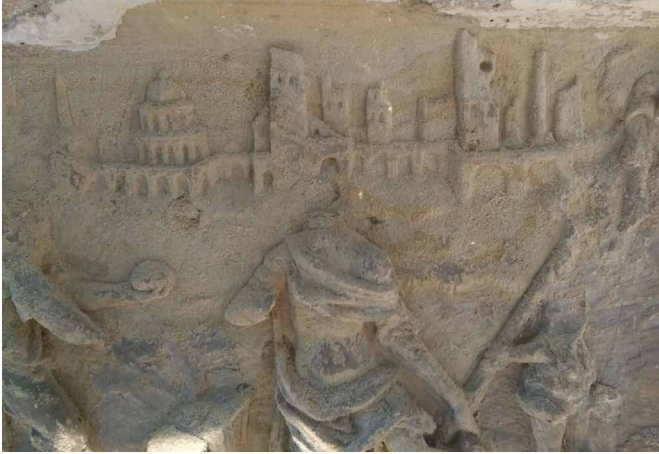
FIG. 4.4 Powdering of the stone: a consolidation treatment may be effective in this case / Photo: B. Lubelli

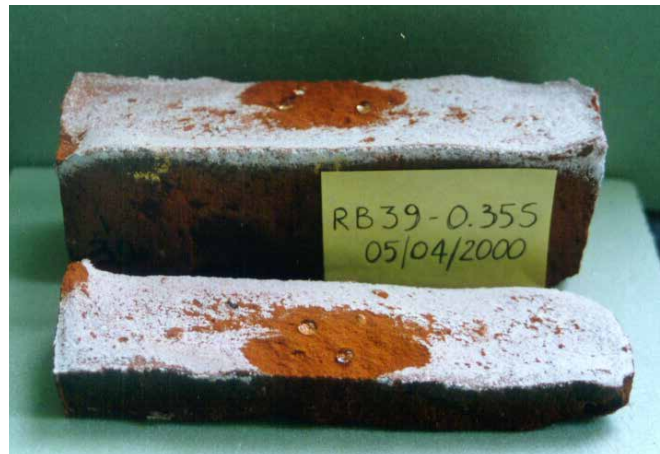
FIGS. 4.12/4.13 Salt accumulation beneath the layer treated with a water repellent (left) and subsequent spalling of the treated part (right) during a laboratory test / Photos: B. Lubelli

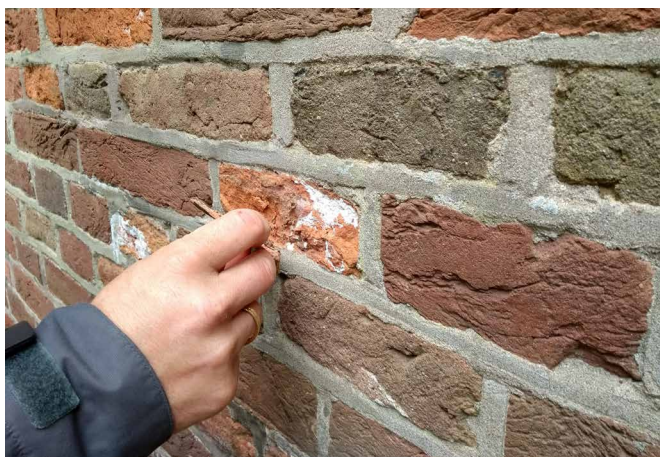
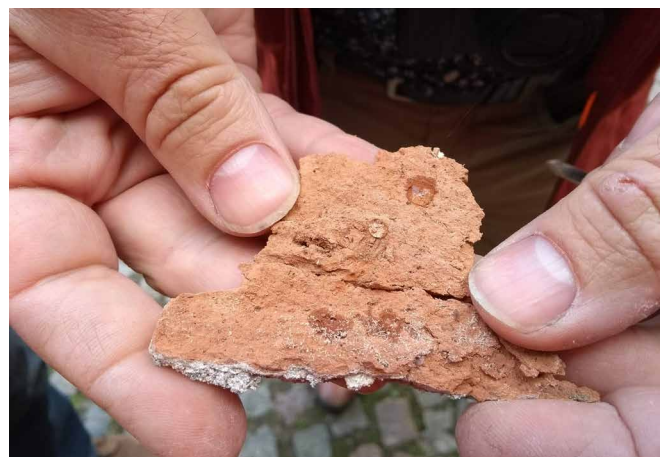
FIGS. 4.14/4.15 Spalling due to salt accumulation beneath the treated layer; the water repellent is still effective several years after the application / Photos: M. van Hunen

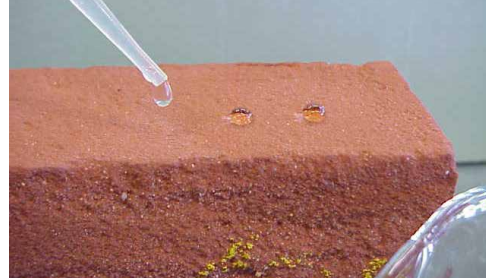
FIG. 4.19 Method for the assessment of effectiveness of water repellent treatment: beading effect / Photo: B. Lubelli

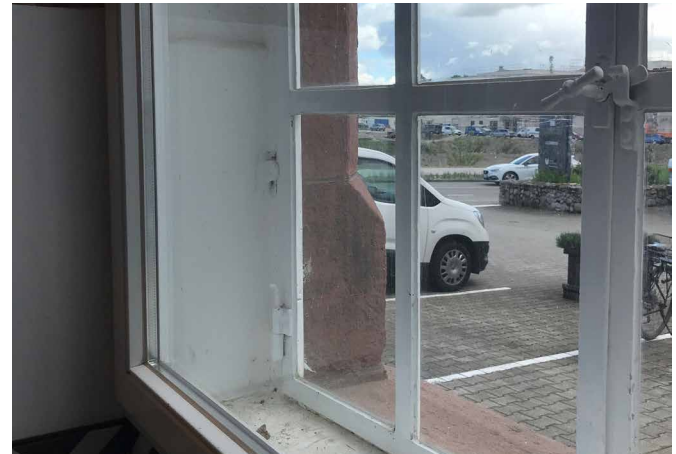
FIG. 5.37 a) Single steel windows with new secondary wood-framed glazing at the interior and b) scheme / Photo: S. Rexroth
