5.2 Material properties

Method

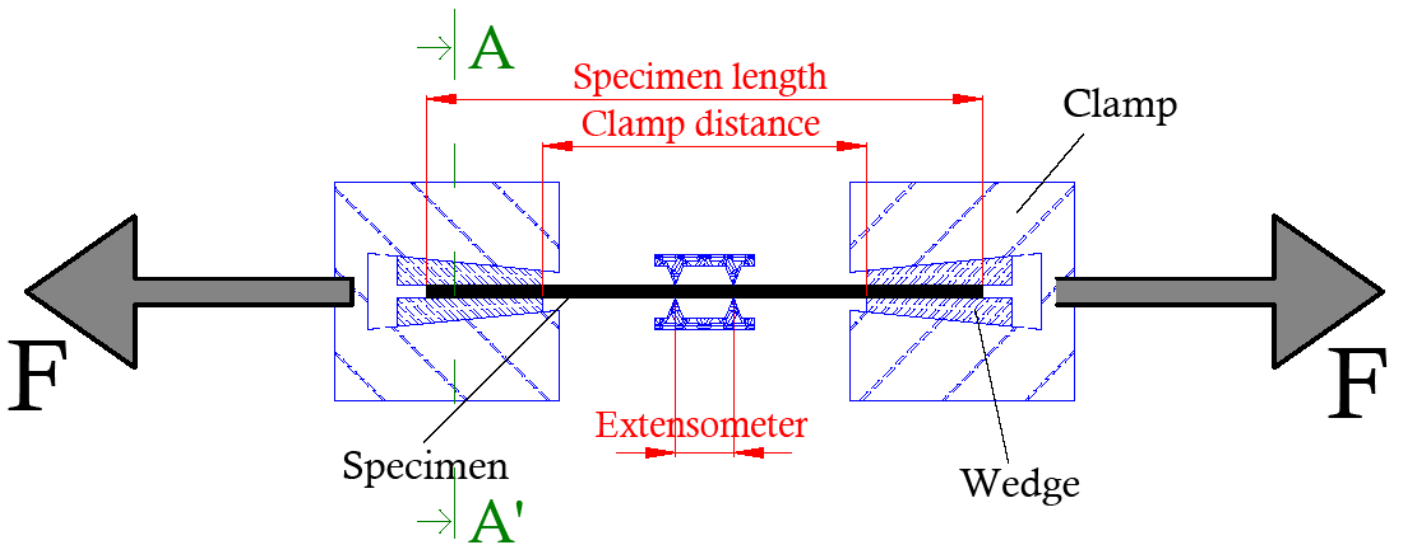
Figure 2, Test set-up schematic representation (not to scale)

Figure 1, Cross section AA' for a round and a rectangular specimen (not to scale)

The specimens are tested in a displacement controlled tensile test. The set-up is presented schematically in *Figure 2*. The specimens are fixed by wedges that are able to slide in the clamps as the force increases.

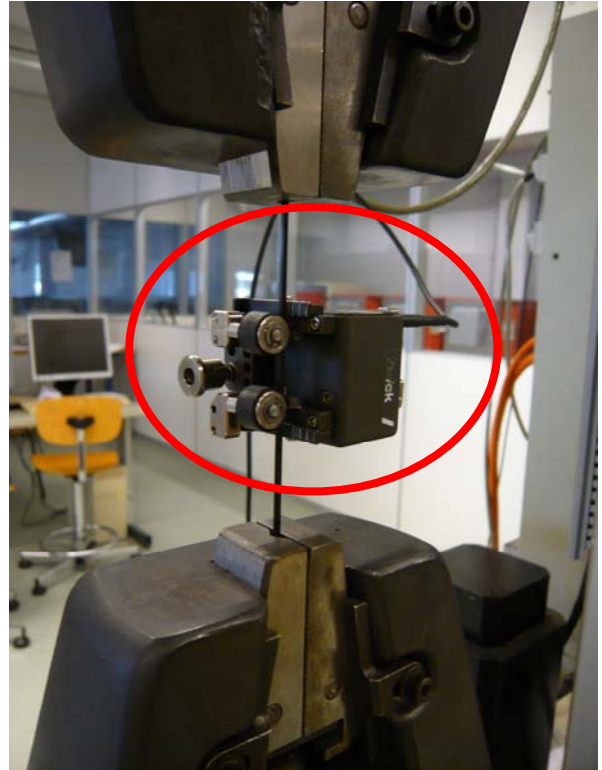
Figure 3, Photo of test set-up with round carbon fiber specimen. The device in the middle of the picture (circled in red) is the Zwick extensometer

The specimen is mounted by a Zwick Extensometer. This device measures the extension of the specimen over a length of 20,31 mm.

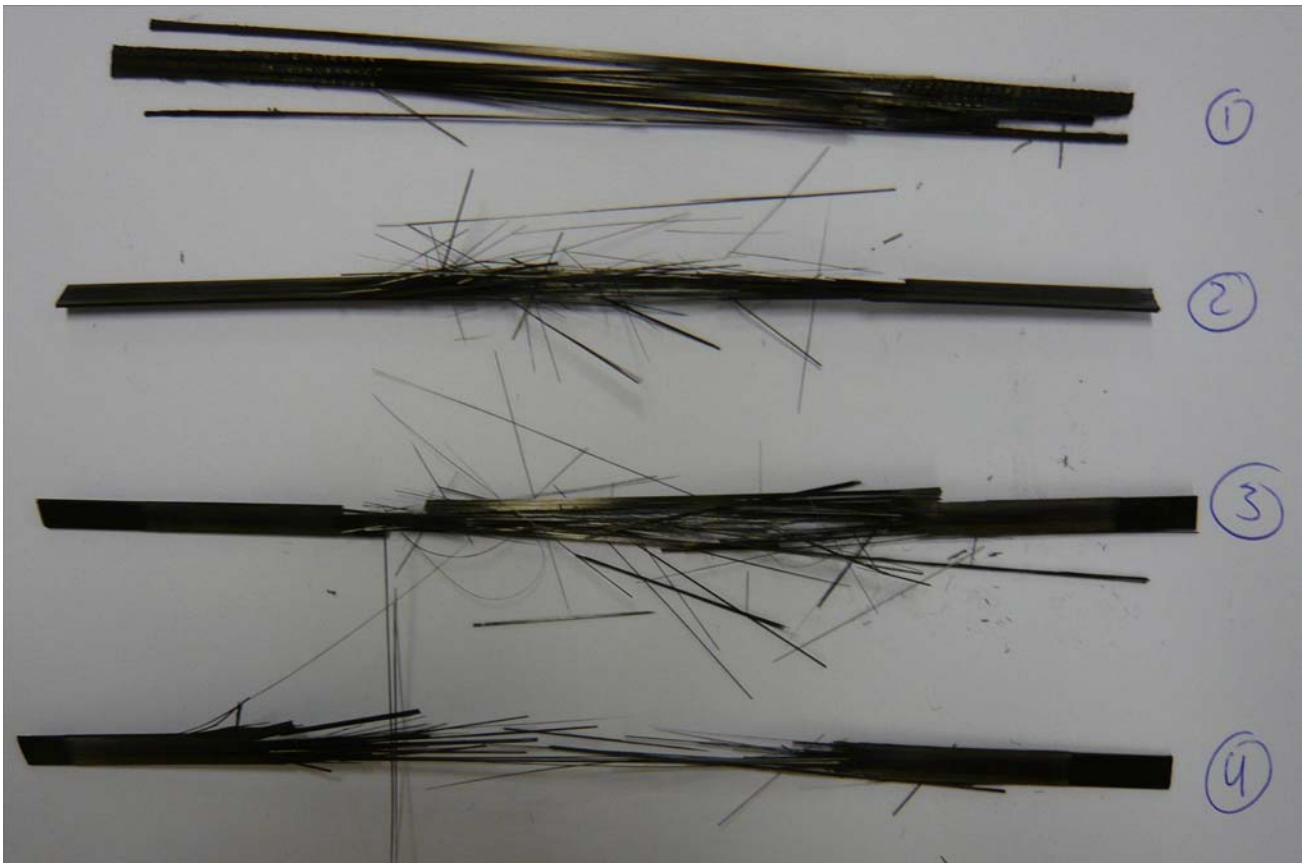
Figure 5, Flat specimens 1 to 4. Specimen 1 failed due to clamping force. The tests of specimens 2 to 4 resulted in higher ultimate tensile stresses

The first flat specimen that is tested is a strip of 0,6x8mm. First attempt was done with two rough wedges. The strip failed at the wedge clamp due to a combination of tensile stress and clamping force

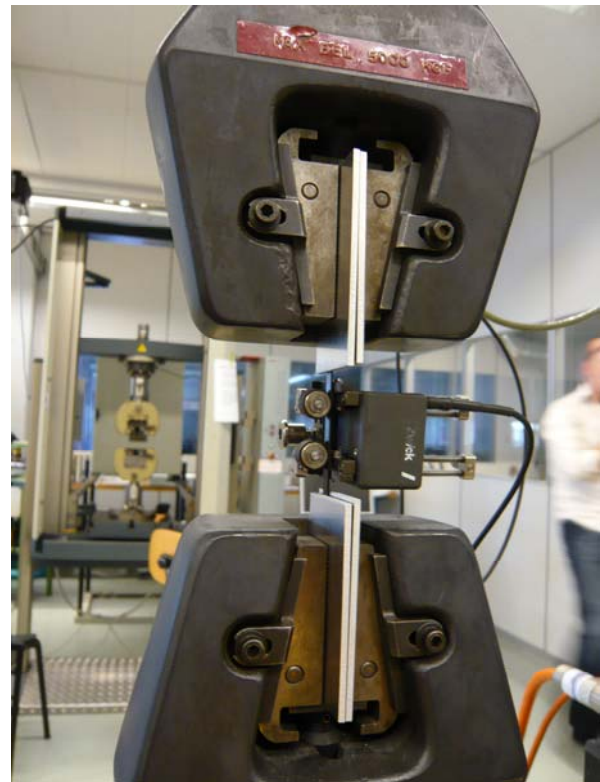
Figure 6, Picture take before testing of specimen 2

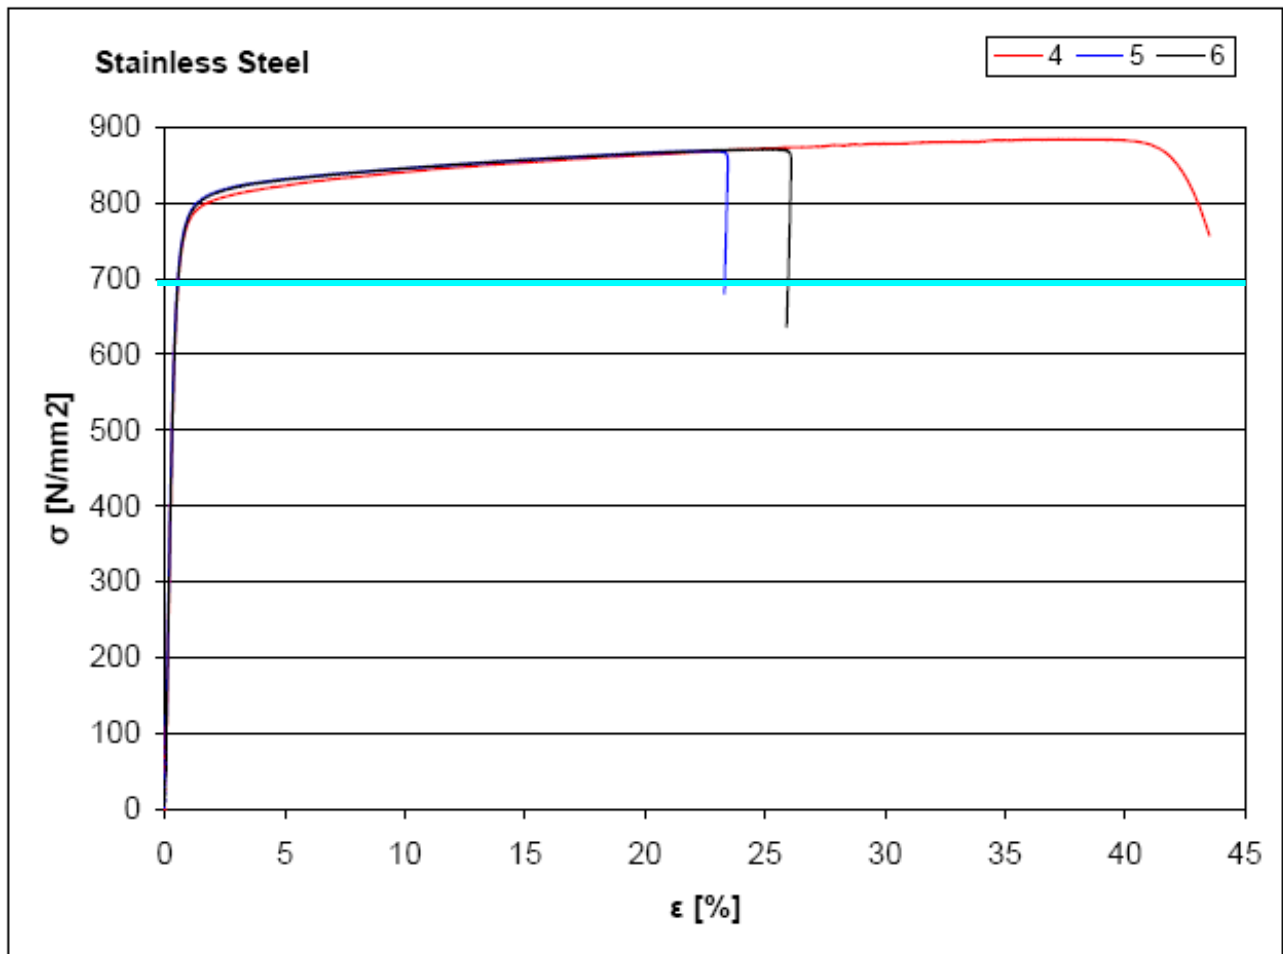
Figure 7, Stress-strain diagram of stainless steel specimens. The presumed yield strength is presented by the light blue line

The average ultimate tensile strength is 875 N/mm^2 . This value is however not acceptable for permanent loading. This material should not be loaded beyond the yield strength, which is assumed 700 N/mm^2 (see horizontal line in *Figure 7*).

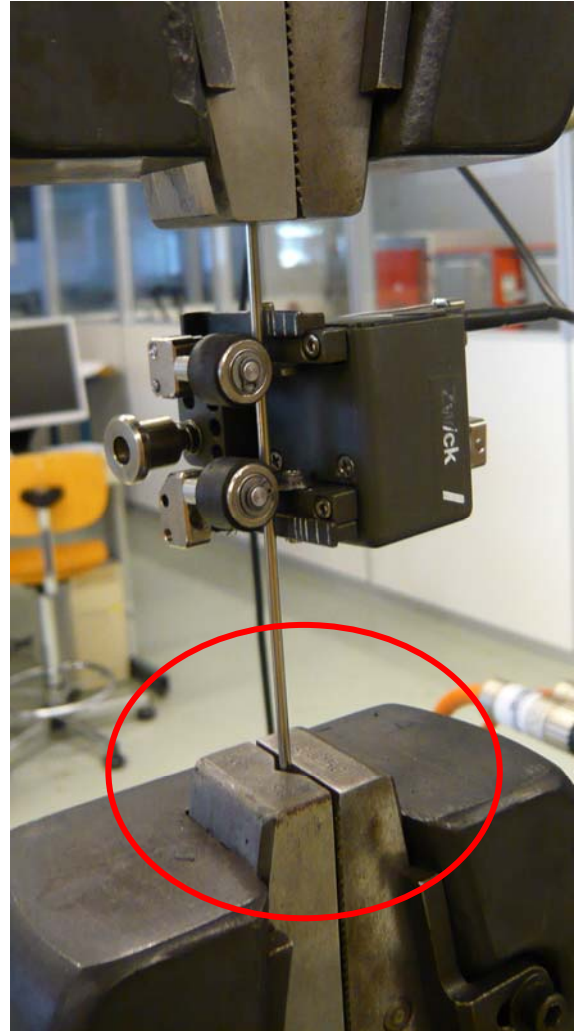
Figure 8, Stainless steel specimen in tensile test set-up prior to testing. Notice the two different wedges denoted by the red circle.

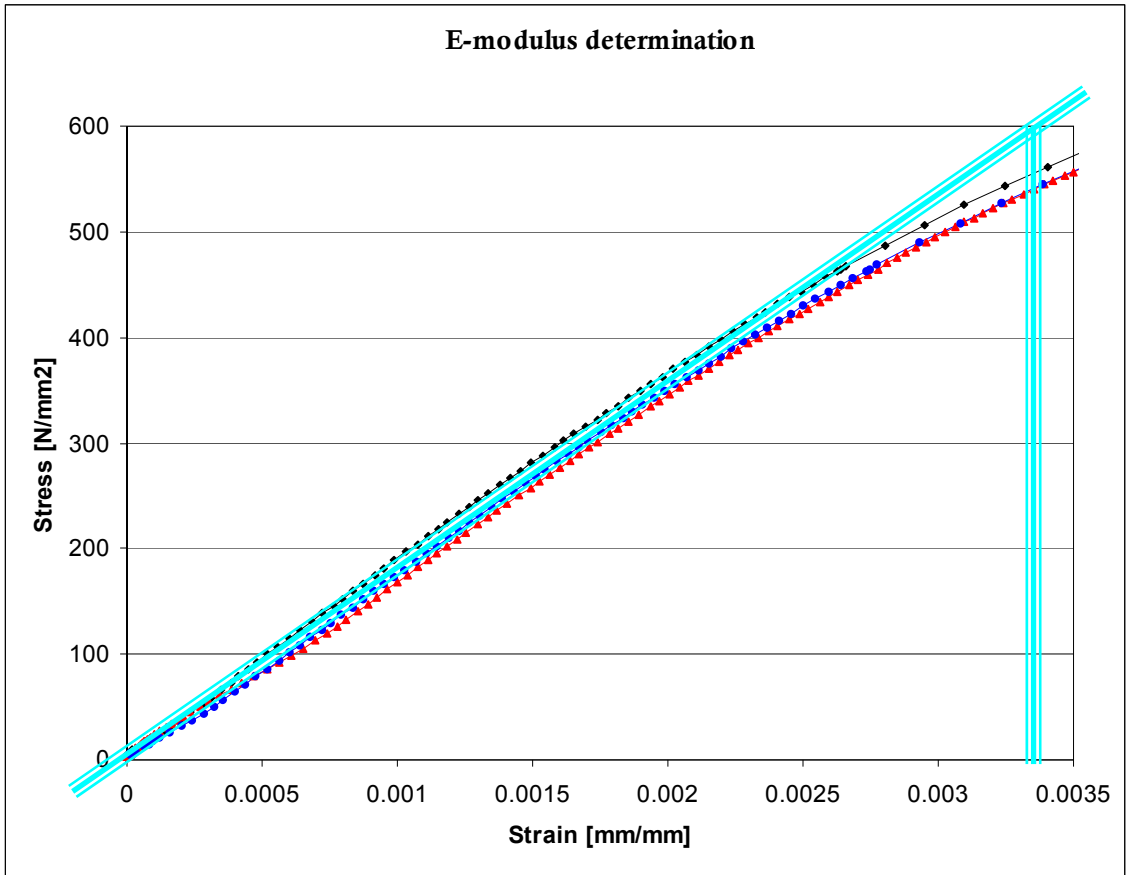
Figure 10, E-modulus determination

The ultimate tensile strength of stainless steel that was given in *Table 2* is a minimum value for the strength up to yielding (0.2% yielding strength). It can be seen in *Figure 10* and *Figure 10* that the stiffness starts to degrade above 515 MPa.

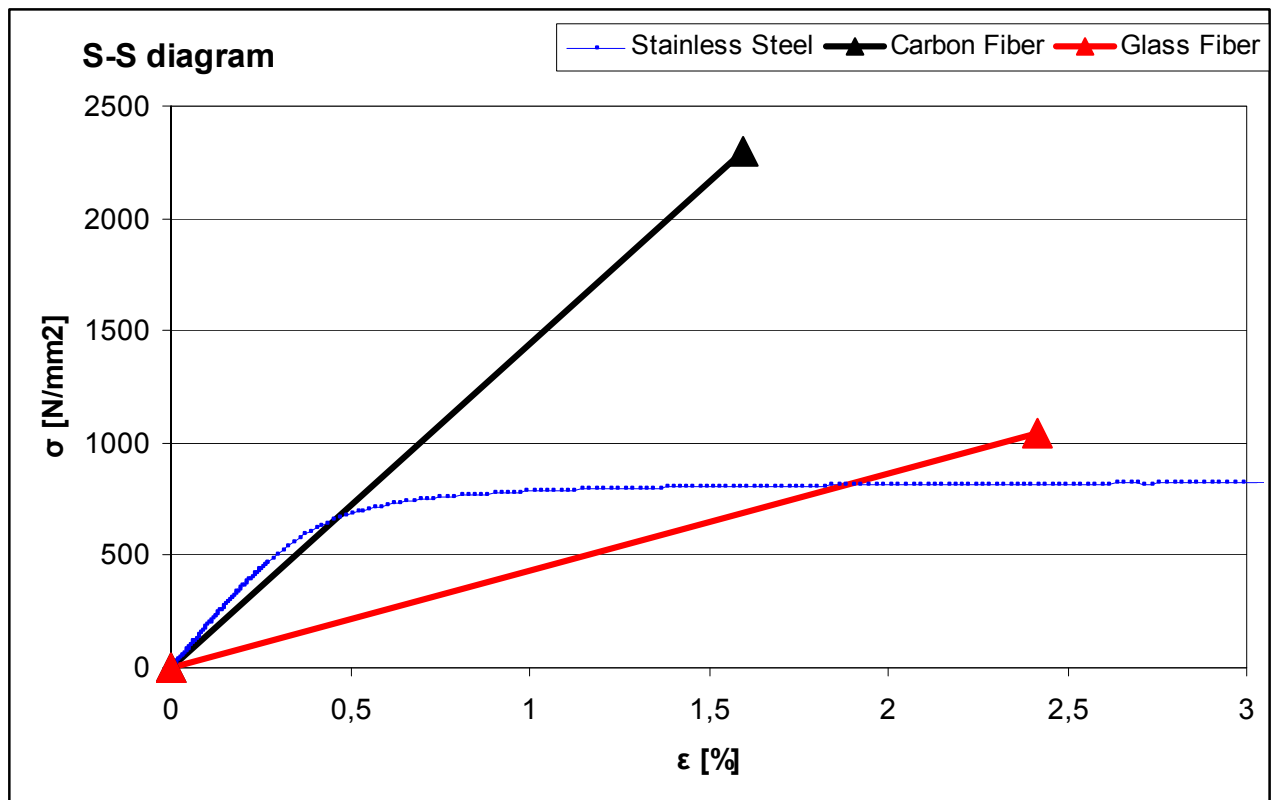
Figure 15, σ - ϵ curves of stainless steel, carbon fiber and glass fiber

Concluded structural properties can be found in *Figure 15* and *Table 7*.

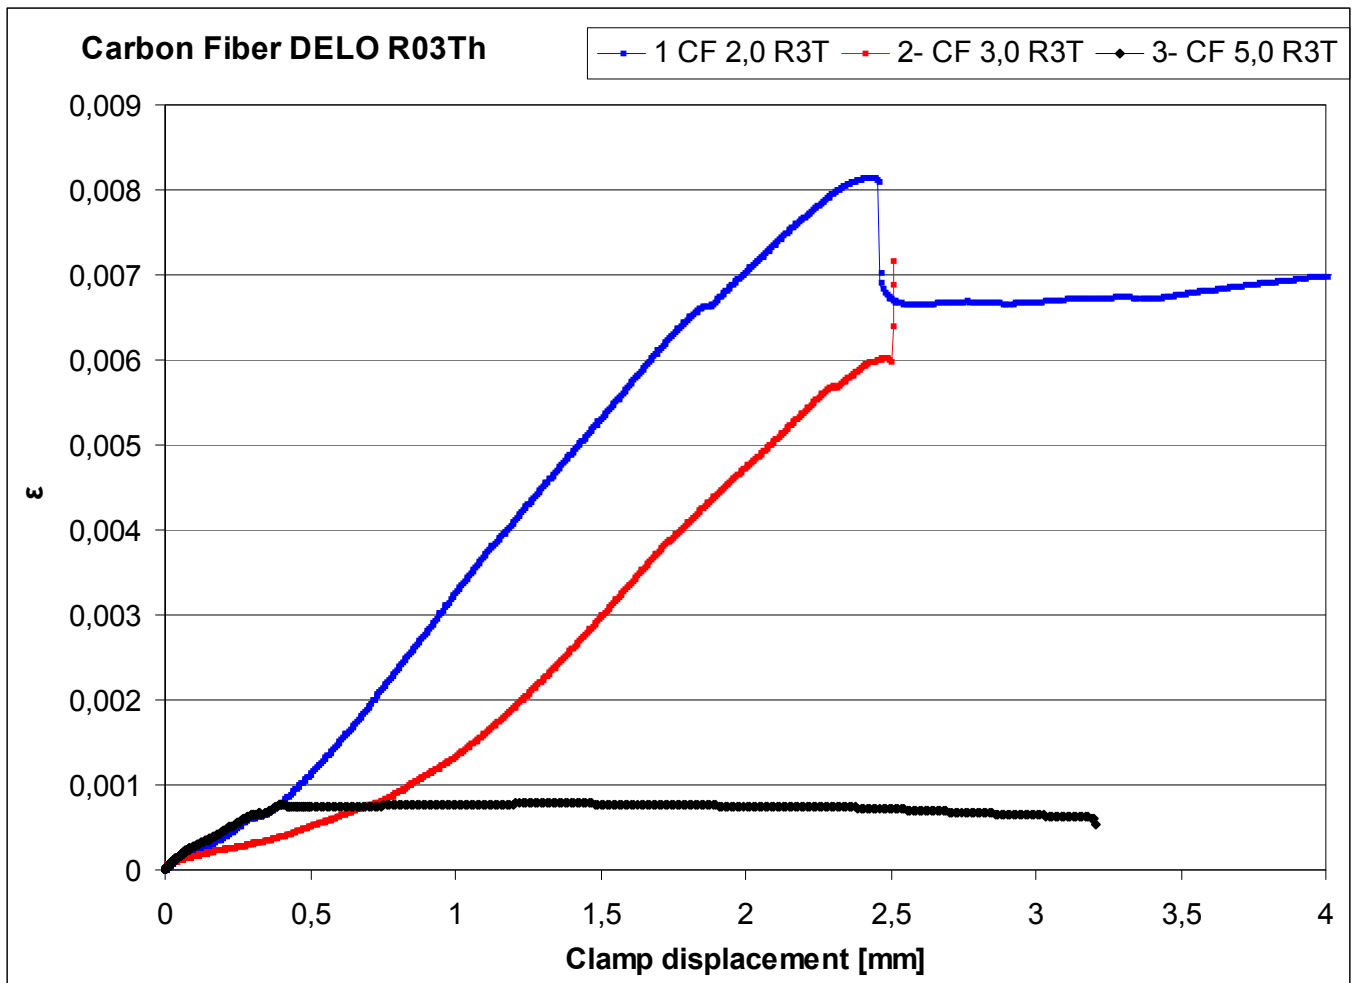
Figure 20, Strain-displacement curve of carbon fiber staff in combination with DELO Rapid 03 Thix

None of the specimens failed due to breaking of the carbon fiber strip

Specimen 3 failed at a tensile force of 333N. This is much less than expected.

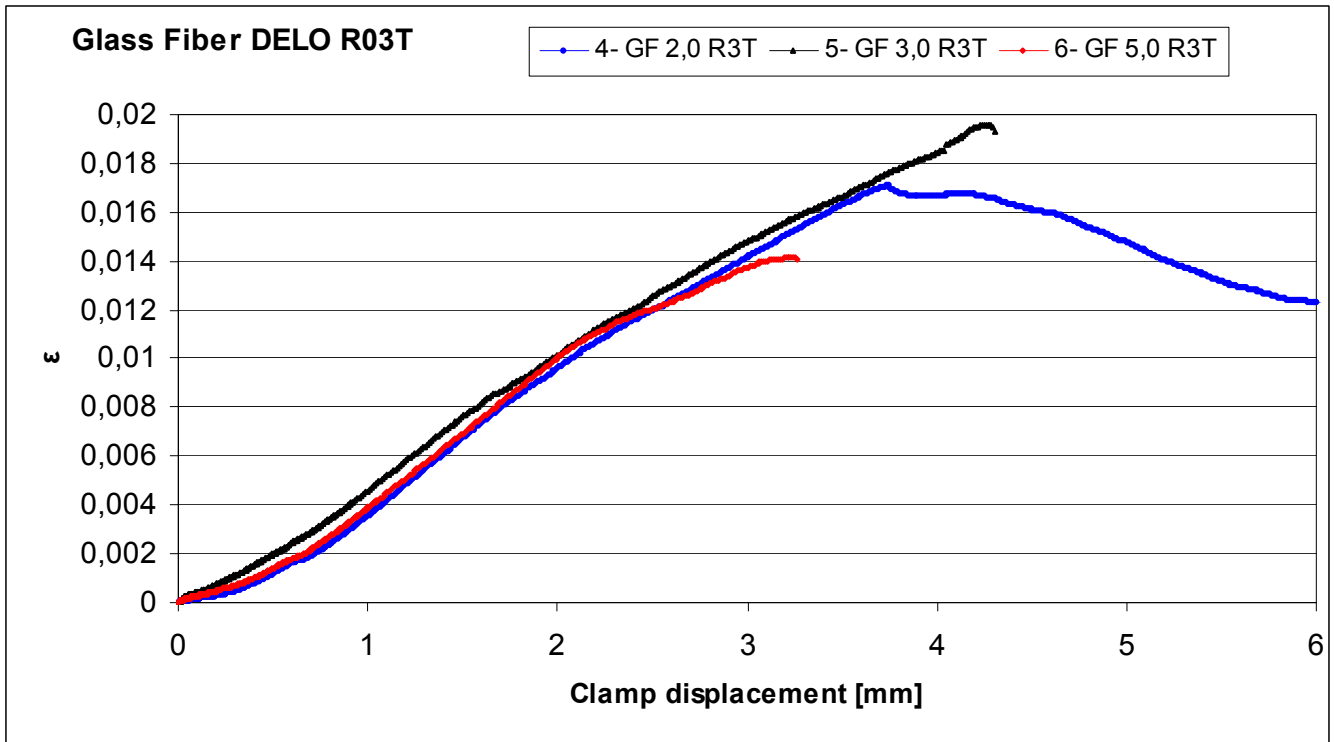
Figure 21, Strain-displacement diagram for specimens 4 to 6

The glass fiber staff has not broken for specimens 4 to 6.

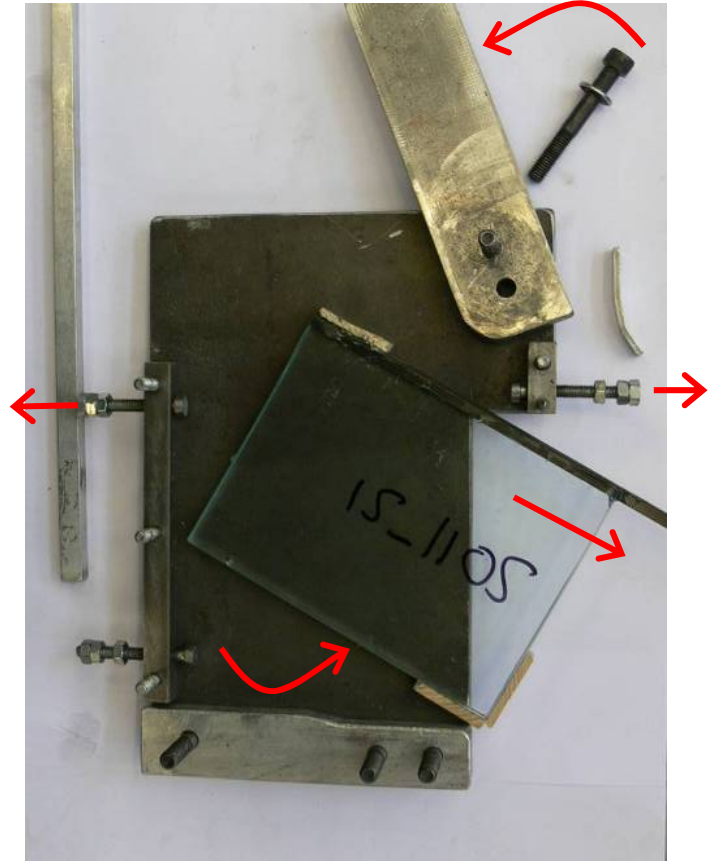
Figure 29, Replacing specimens; 1 bolt and 2 supports are removed to allow turning.

After each test the specimen has to be replaced. This is possible without removing it from the bank draft or opening the whole element. Specimen can be taken out by removing one bolt from the handle and then turning the rest of the element (*Figure 29*).

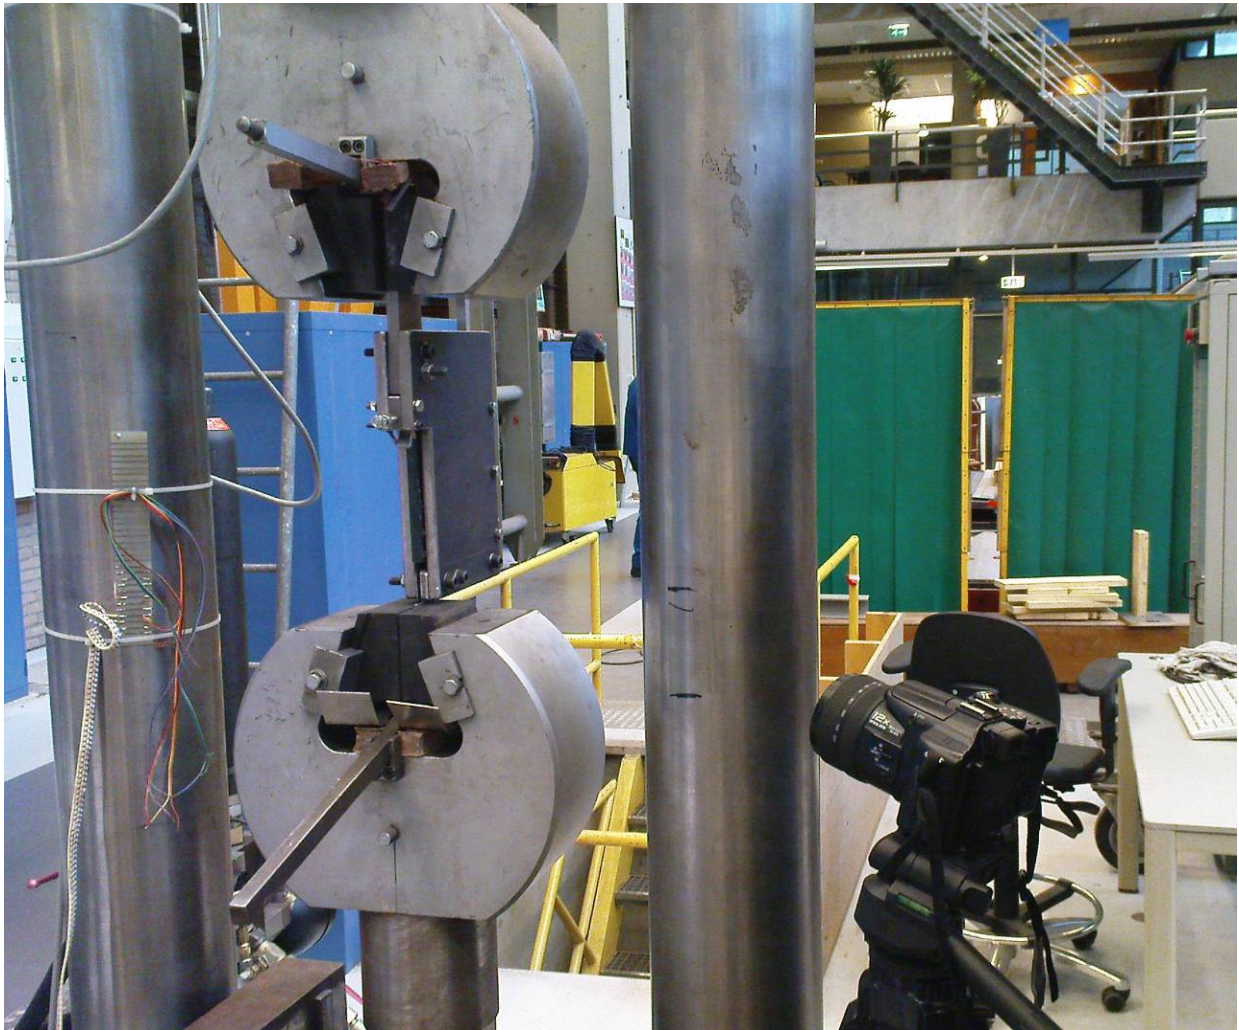
Figure 30, Overview of test setup with camera position

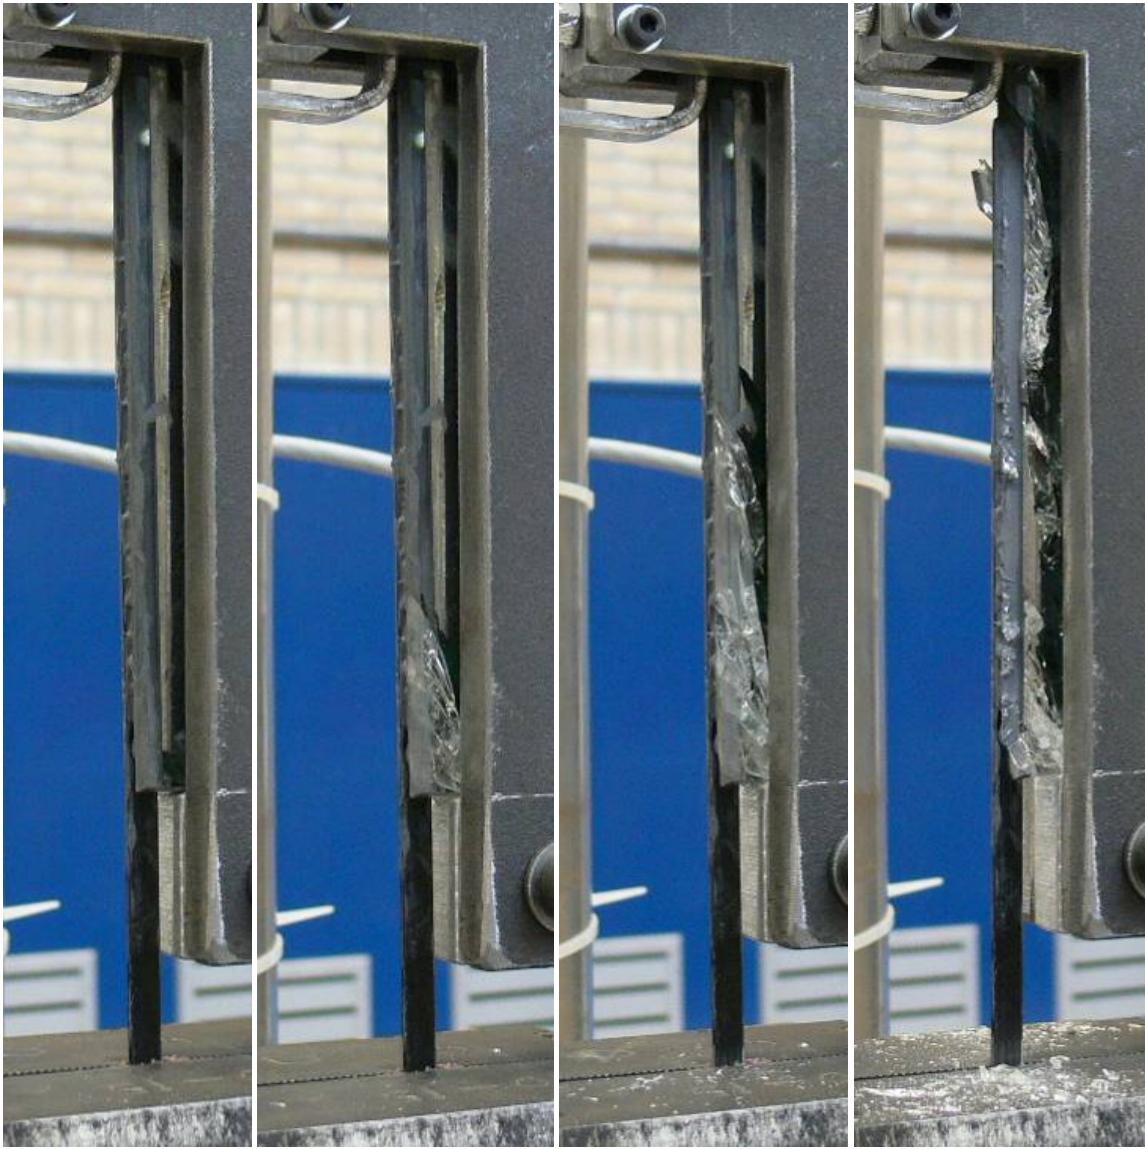
Figure 34, Specimen 2013_01 at different moments during the test.

The first observable failure of the specimen was the failure of the glass pane. After the first crack in the glass pane, more cracks occurred. Failure of the adhesive layer is not noticed before the glass fractured and the

force dropped back to 0. The adhesive eventually failed on 100% adhesive failure with the glass pane; the whole adhesive layer is stuck to the carbon fiber, not to the glass fractures.

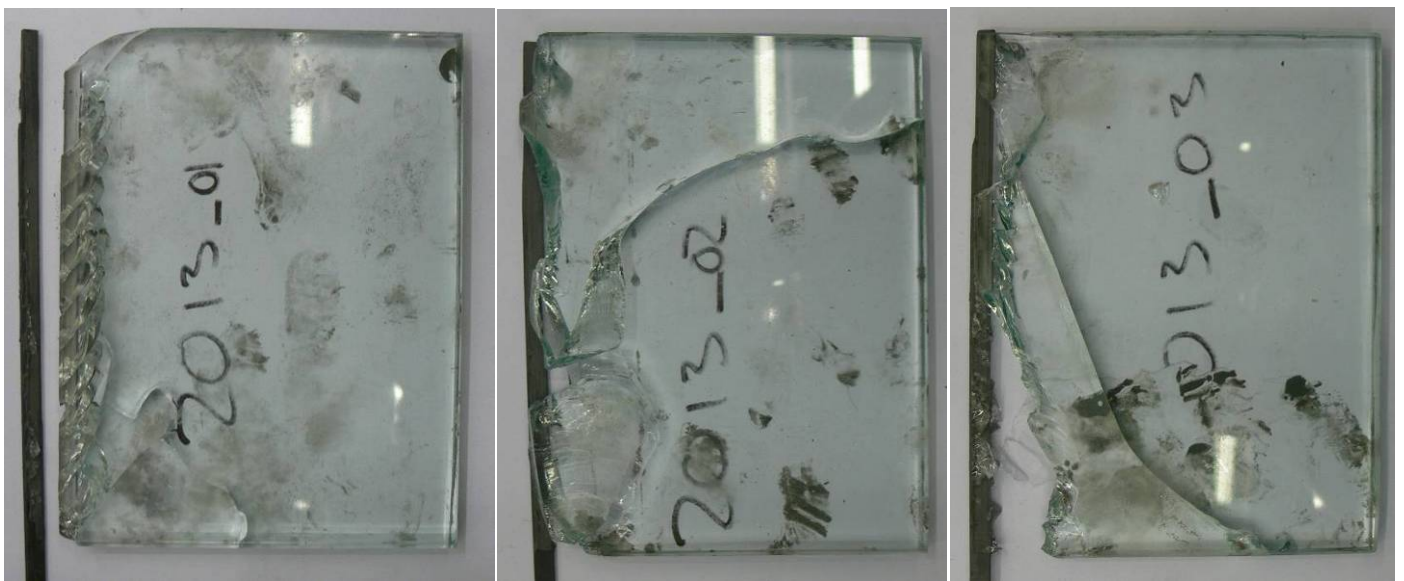
Figure 33, Specimens 2013_01, 2013_02 and 2013_03 after the test

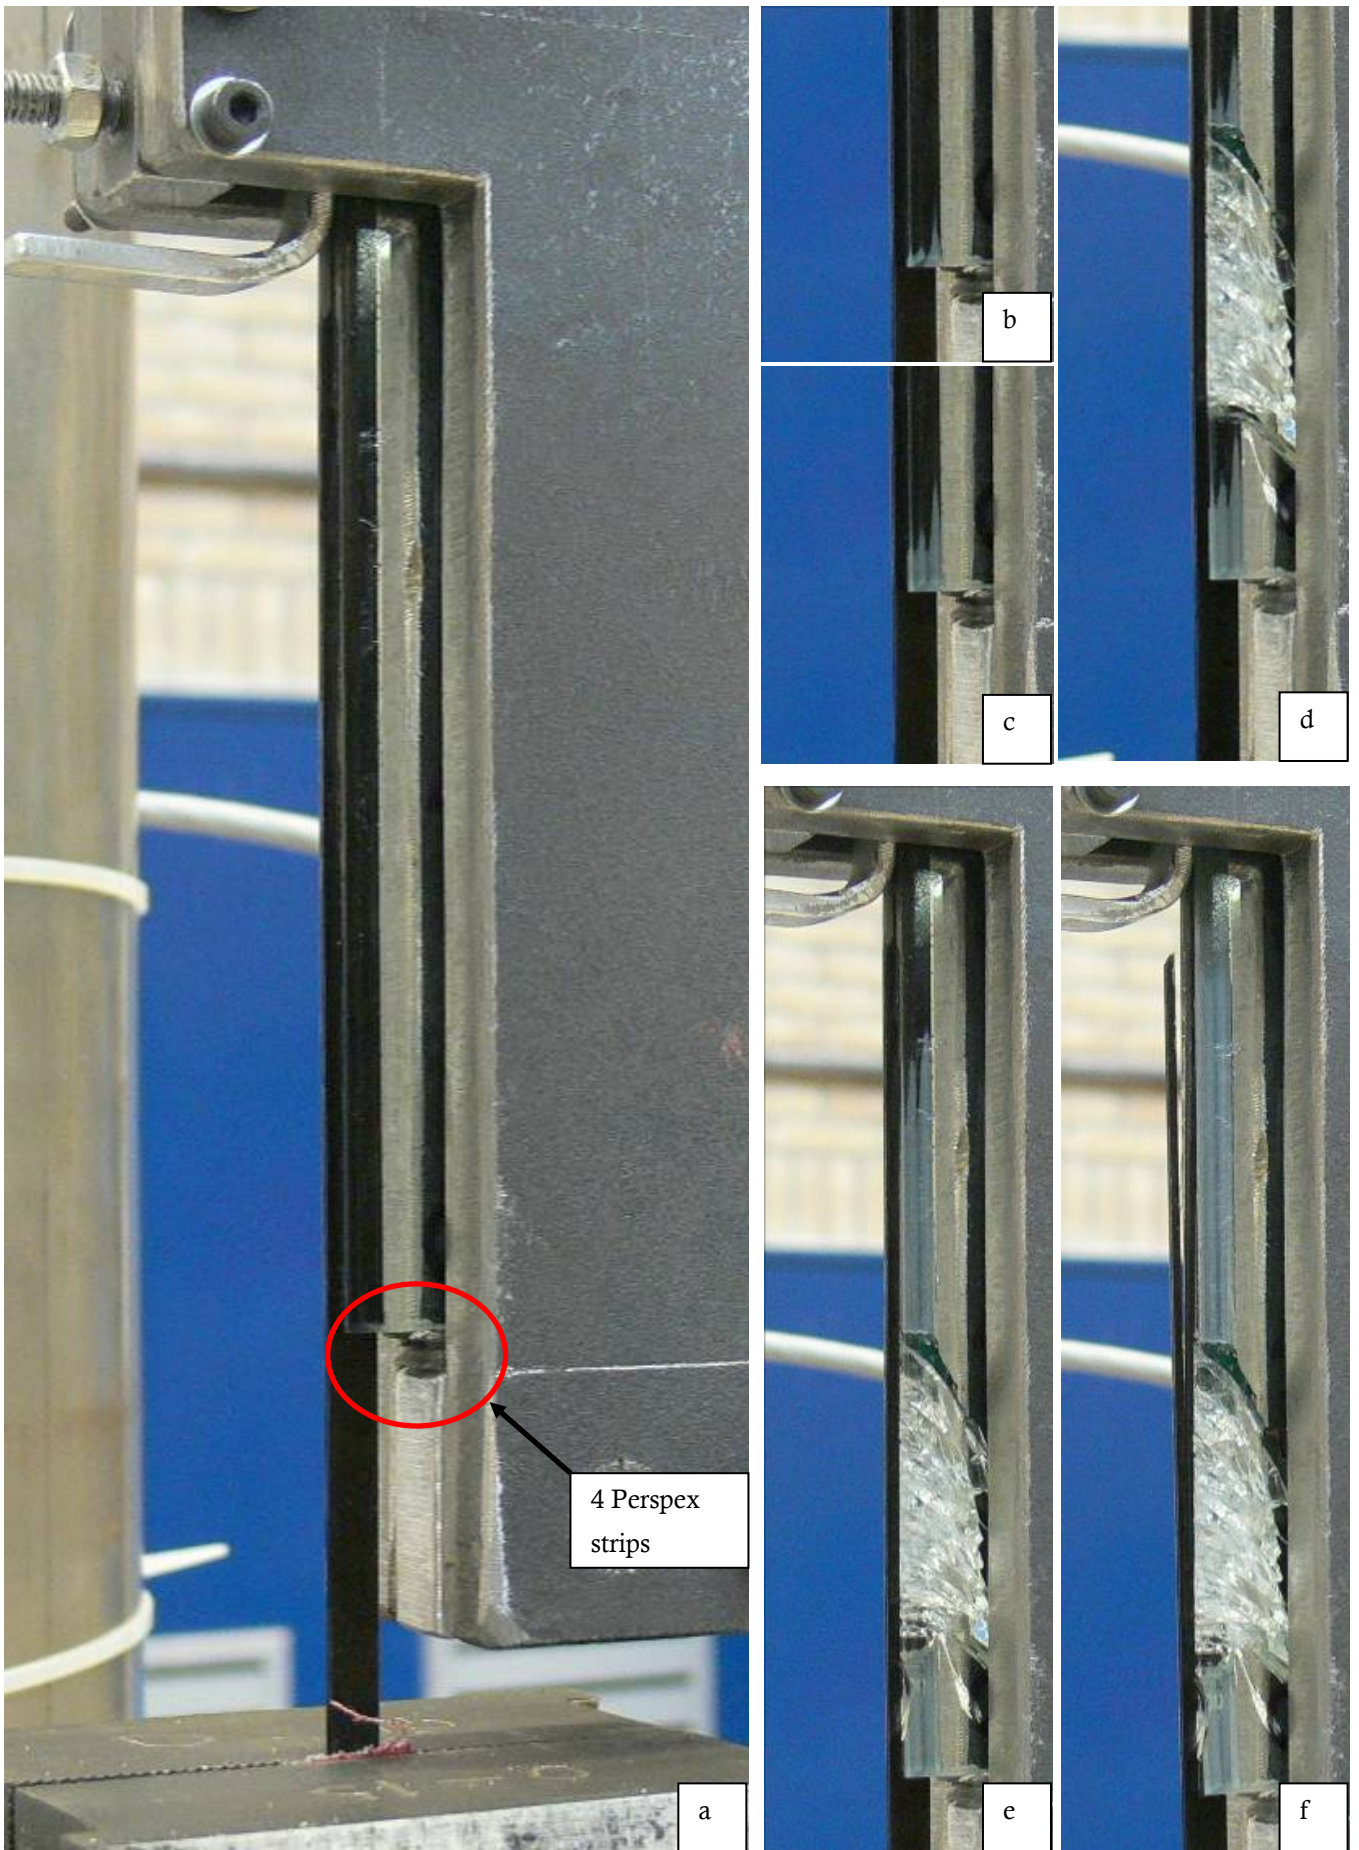
Figure 39 a-f, Test 2011_02 in chronological order from a (begin) to f (total failure)

The first failure occurred by adhesive failure at the glass (Figure 39b+c). Then the glass failed (Figure 39d) probably from the heart of the compressive zone to the carbon fiber strip (see crack Figure 41). Then the adhesive progressed again (Figure 39d-f).

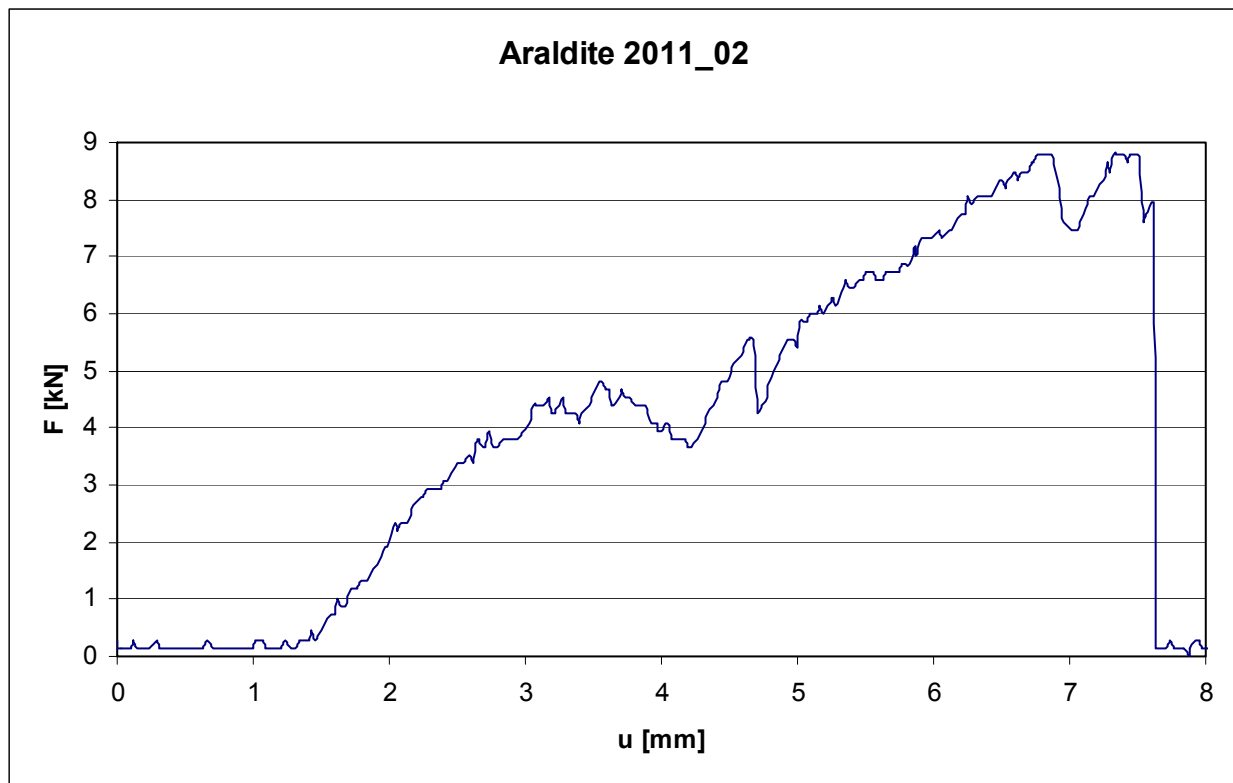
Figure 40, Force-displacement diagram of specimen 2011_02

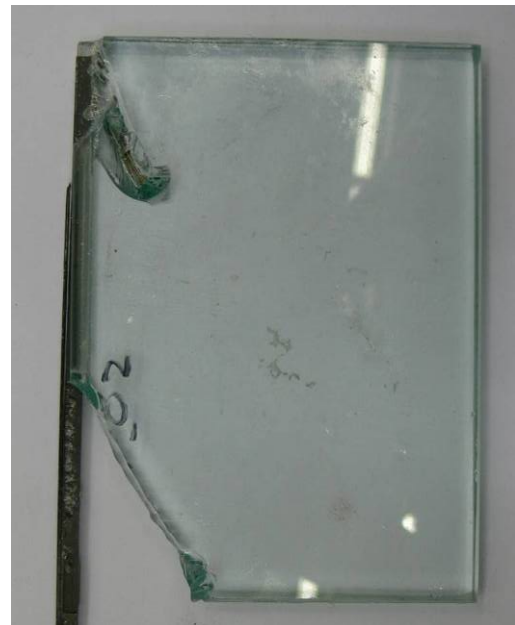
Figure 41, 2011_02 after the test

Figure 41 shows the specimen after the test.

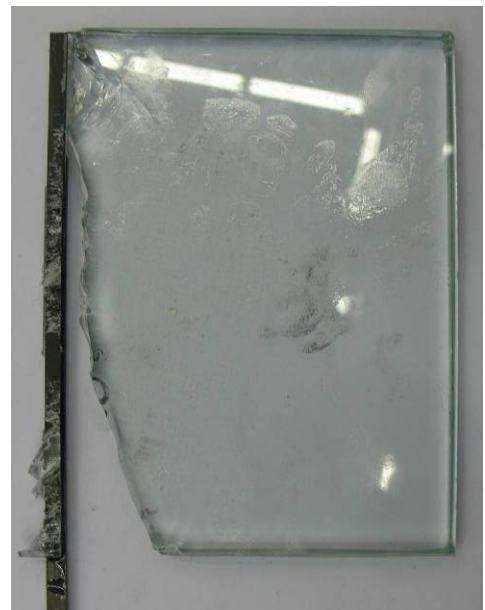
Figure 44, Specimen 2011_03 after the test

The failure behavior is comparable to that of 2011_01; progressive glass fracturing, no adhesive failure was observed.

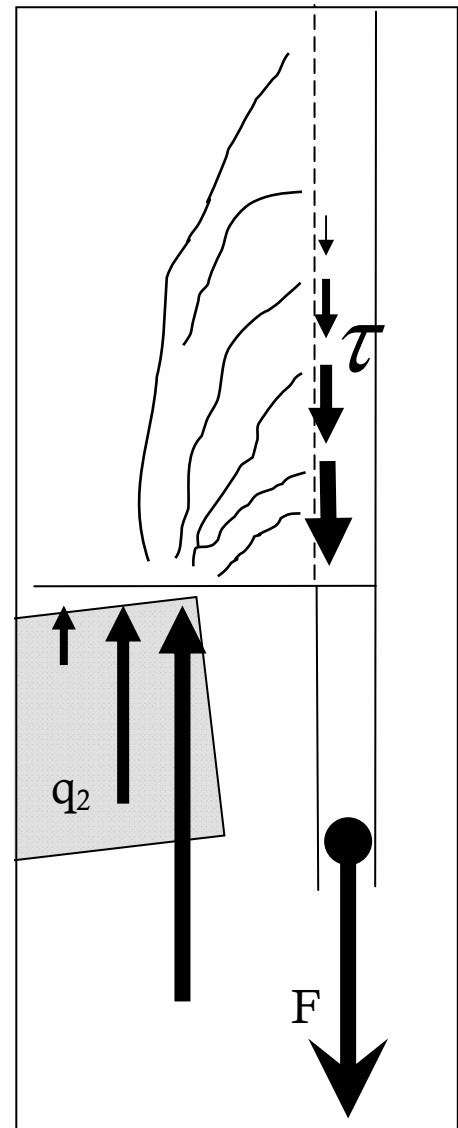
Figure 45, Close-up of fractured glass pane with stress introduction.

The force applied by the bank draft is equal to the divided load q_2 ($\Sigma F_x=0$). When force is applied to the carbon strip, the glass pane tends to rotate a little bit due to the moment that is generated by the lever between F and q_2 (Figure 46). This will cause q_2 to concentrate at the tip of the aluminum block, near the reinforcement, introducing the supporting force more or less as point load into the glass. The shear stress introduced into the glass by the carbon fiber (τ in Figure 45) has a peak in the beginning of the joint. These two are near to each other.

In the first 3 tests the glass pane fractured due to the combination of these. As the fracturing of the glass progresses, τ and q_2 progress as well respectively to the left and bottom (in Figure 45), creating more and longer fractures.

The fractures are caused indirectly by compressive stress. Tensile stress in the glass arises square to the compressive stress from q_2 to τ , this is what causes the cracks.

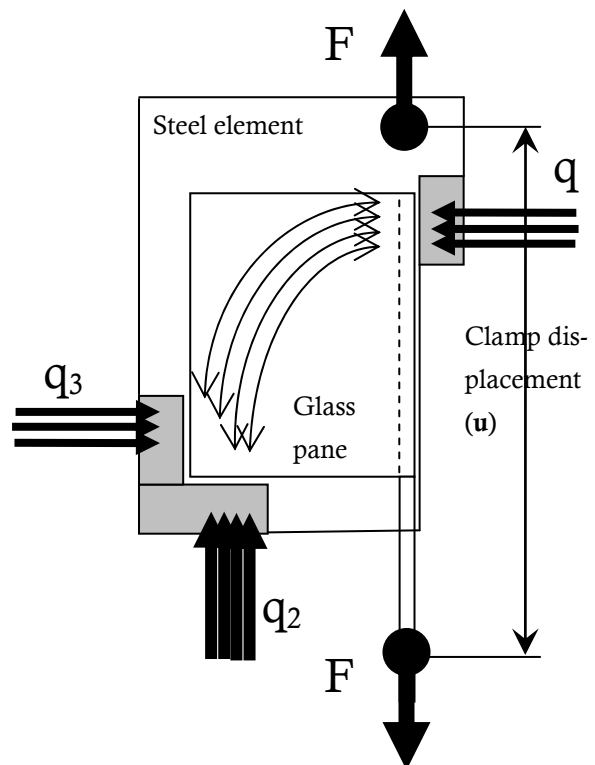
Figure 47, Schematic representation of recommended setup. Notice the change of the aluminum support, shifting of q_2 and increase of q_1 and q_3 . The new compressive zone is denoted by the bent arrows.

It is recommended to disperse the stress concentration discussed above. This can be done by moving away the

support from the top-right corner of the glass pane (as in Figure 46) to the middle- or bottom-right corner of the glass pane. This will increase the lever between q_2 and F severely, creating a large moment that has to be absorbed by q_1 and q_3 . This will create a new compressive stress zone as denoted in Figure 47. This compressive zone will not interfere with the shear stress zone due to the carbon fiber until failure of the adhesive connection has progressed a great deal.

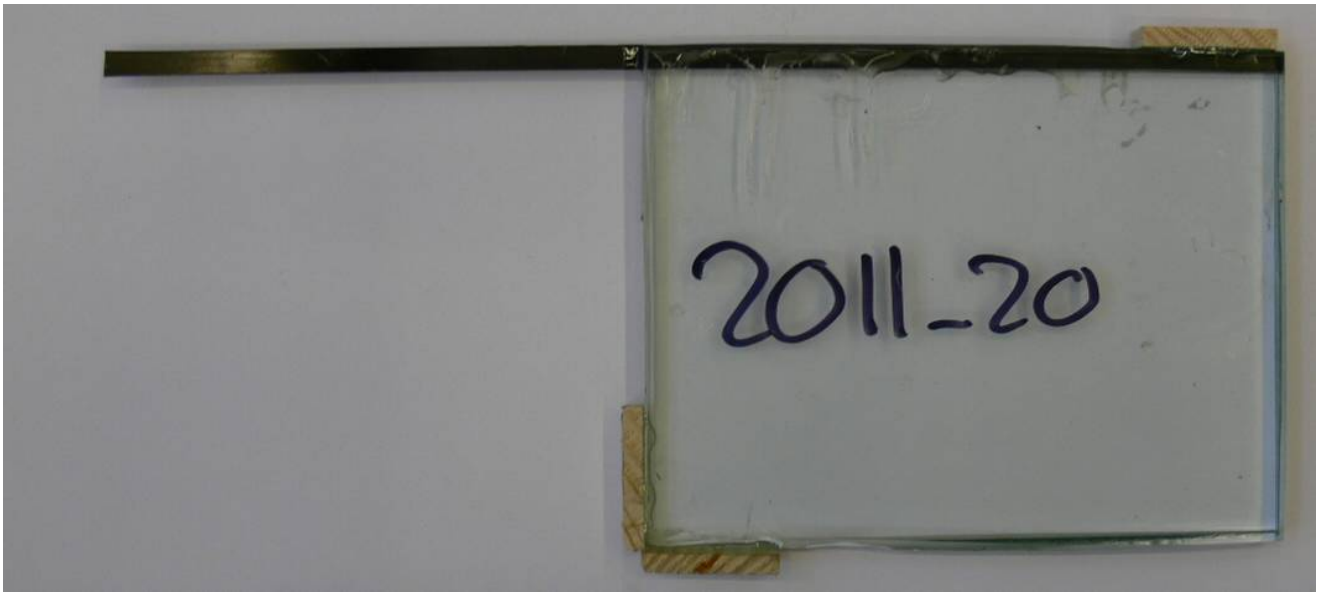
Figure 48

Above: Specimen mounted with wooden blocks.

The specimens in sequence 2 are mounted by small wooden blocks with a thickness of 5 mm, in the corners of the glass (see *Figure 48*).

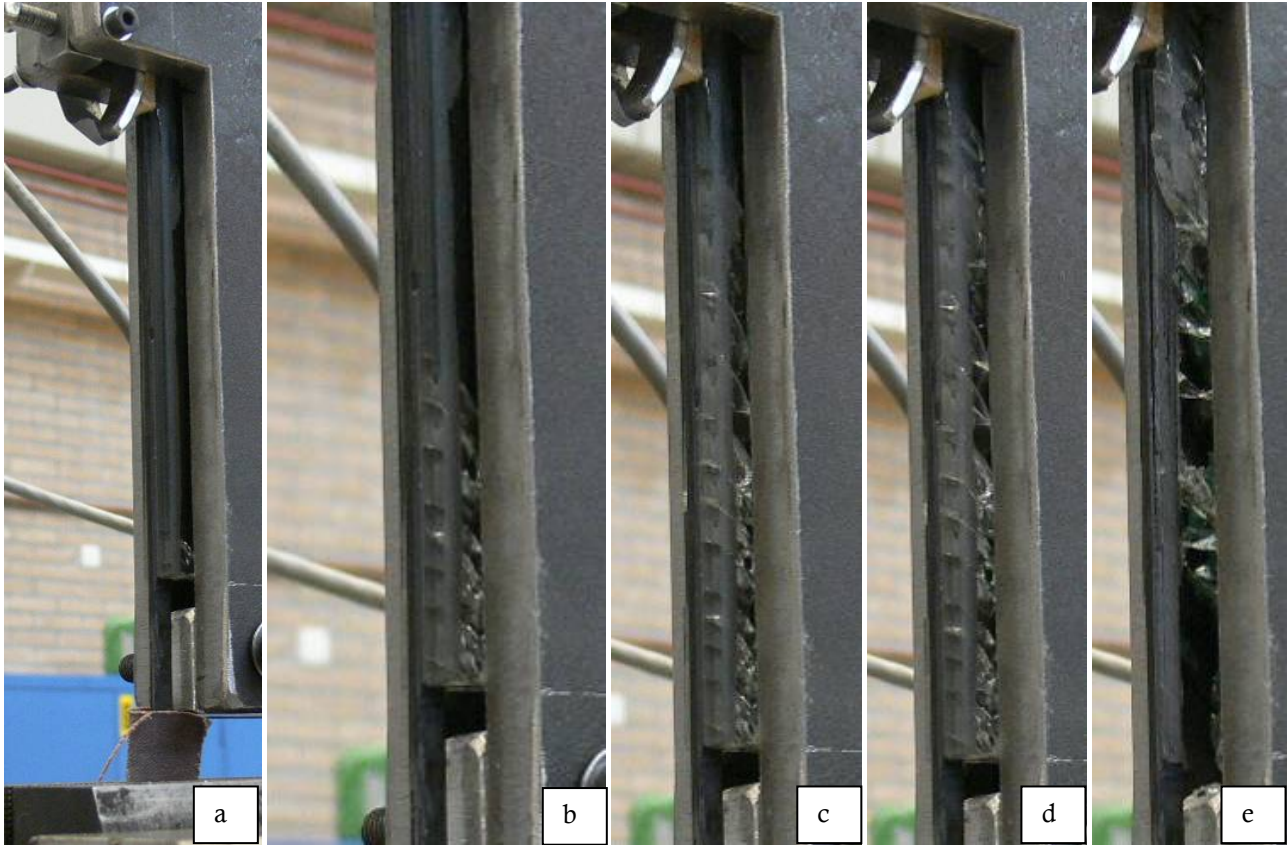
Figure 49

Above: Specimen 2013_05 at different moments during the test. The letters correspond with the letters in the curve.

specimen 2013_05 in Figure 49.

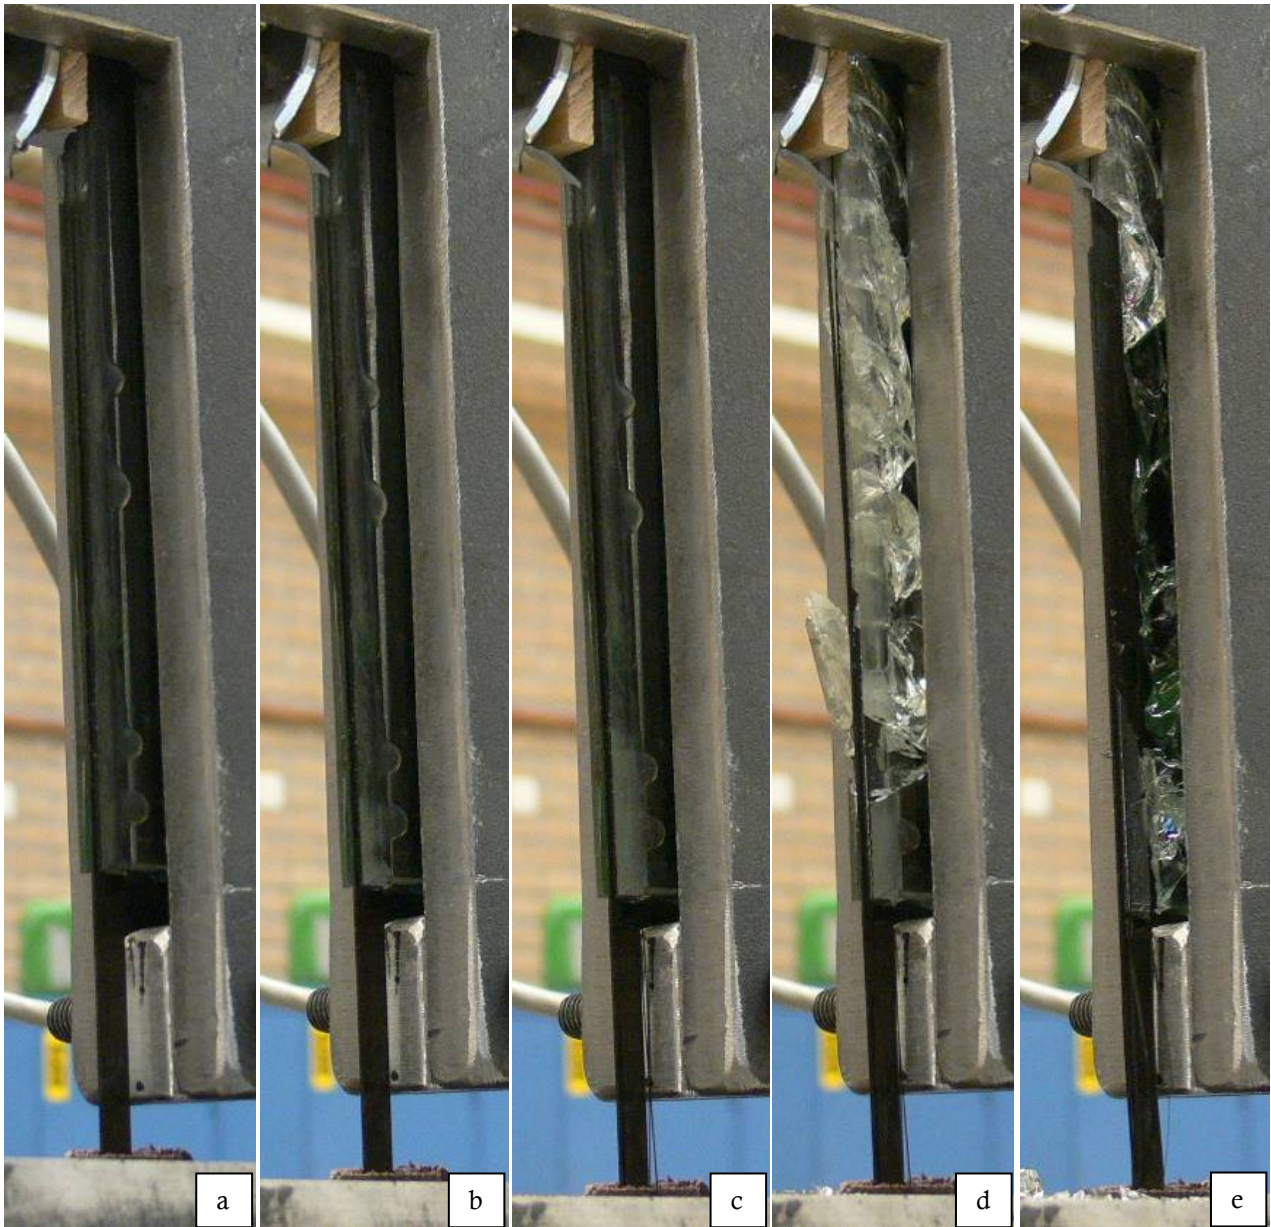
Figure 51, Above: 2011_09 at different moments during the test. Below: Specimens after the test.
