5.2 Material properties

Method

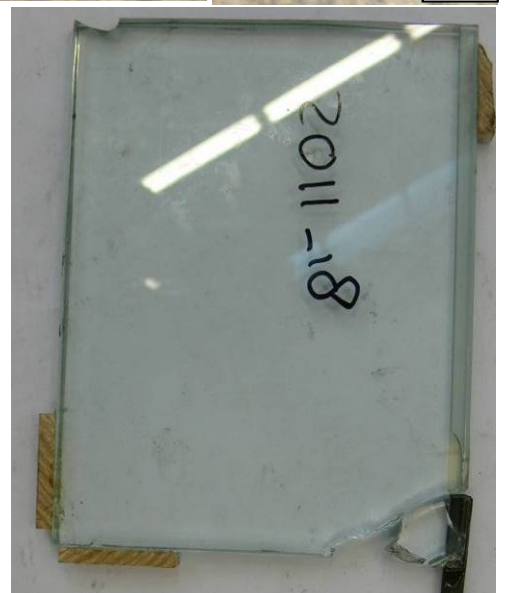
Above: specimen 2011_18 at different moments during the test.

Right: specimen 2011_18 after the test. Fracture pattern is comparable for all three specimens. The small missing piece at the top left corner was already broken of when testing started.

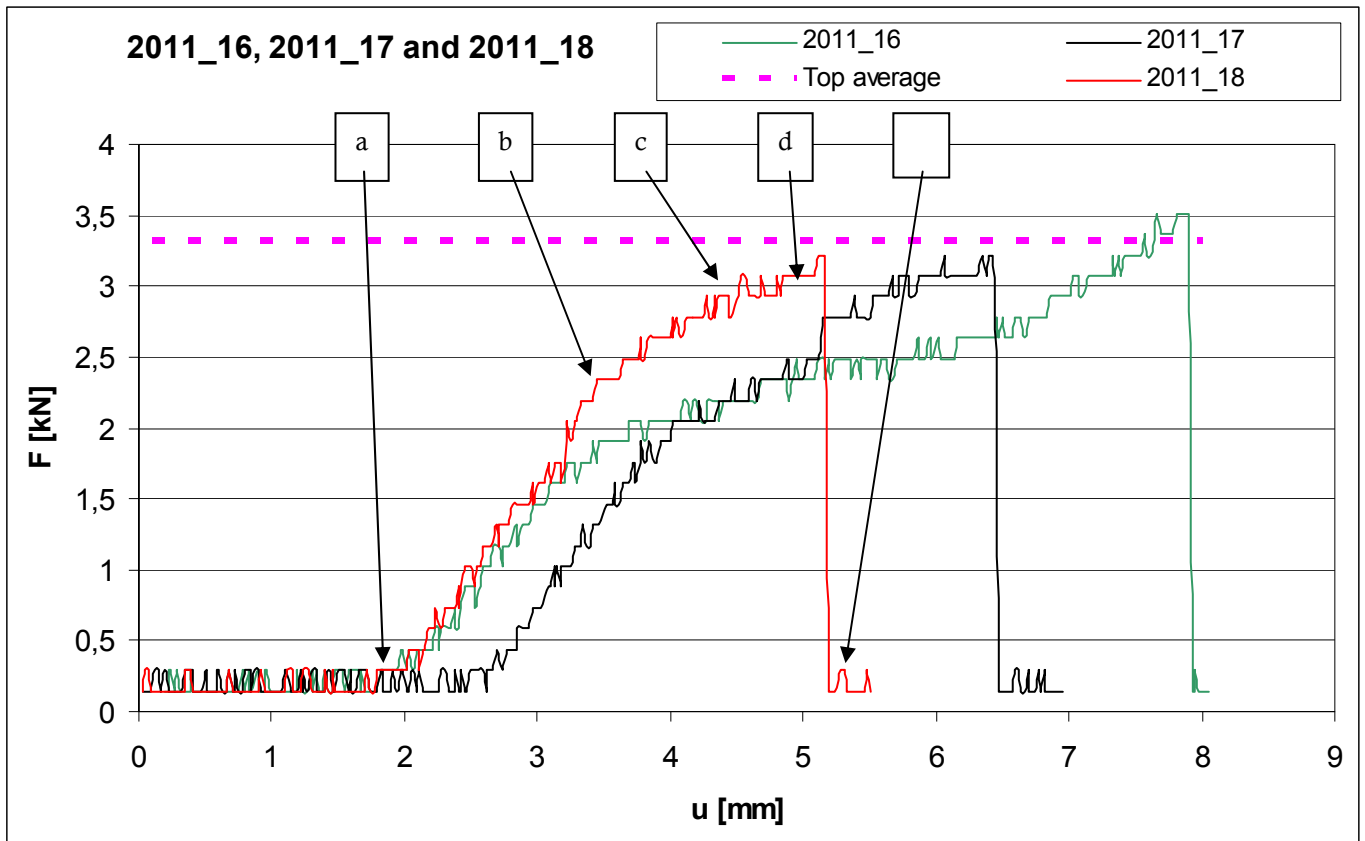
Figure 58, force-displacement diagram of specimens 2011_16 to 2011_18

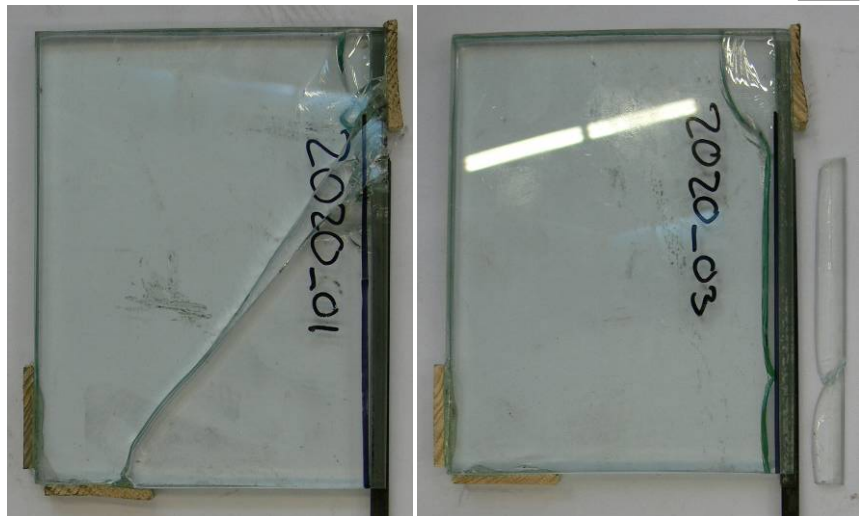
Above: Specimen 2020_03 at different moments during the test.

Right: Specimen 2020_01 and 2020_03 after the test. Fracturing of 2020_02 is comparable to 2020_03

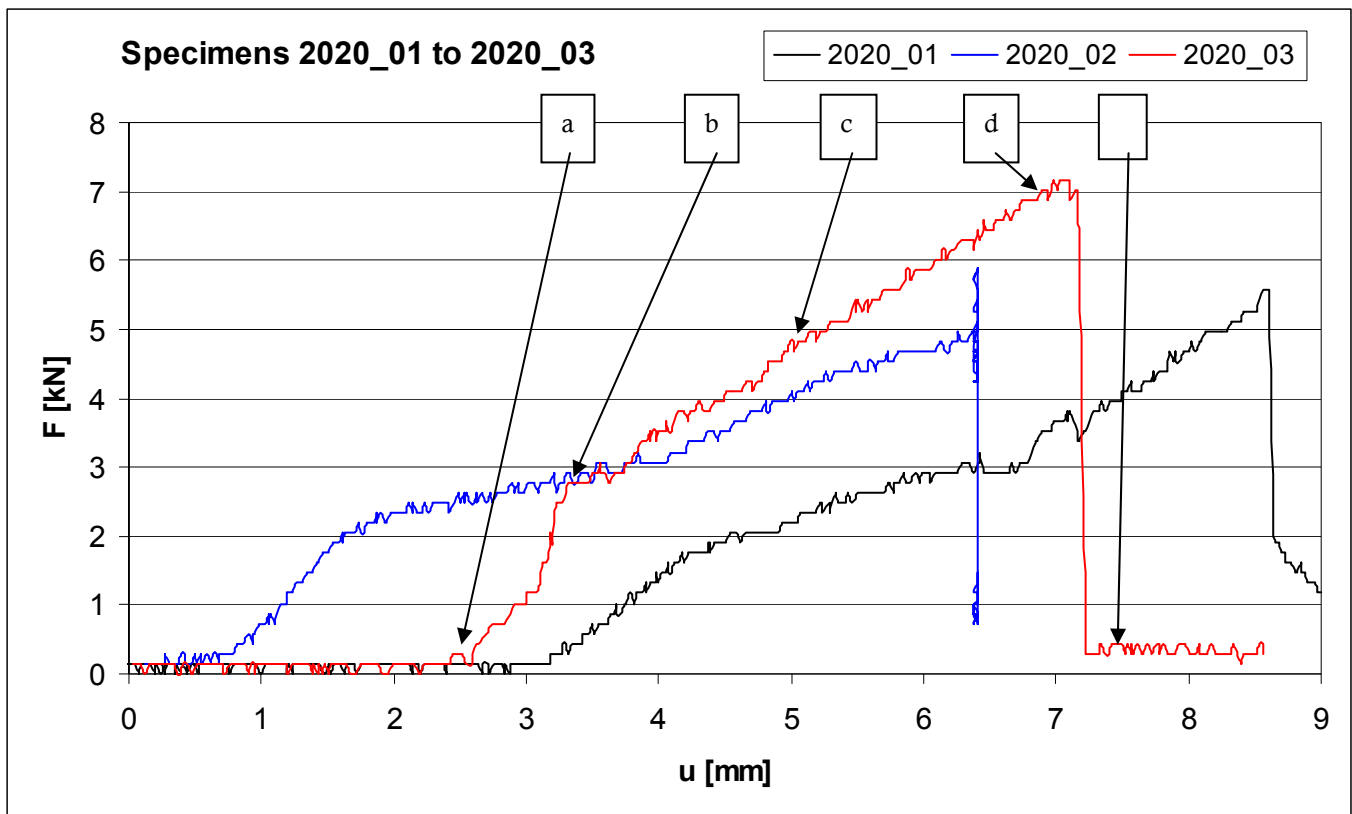
Figure 60, Force-displacement curve of specimens 2020_01, 2020_02 and 2020_03.

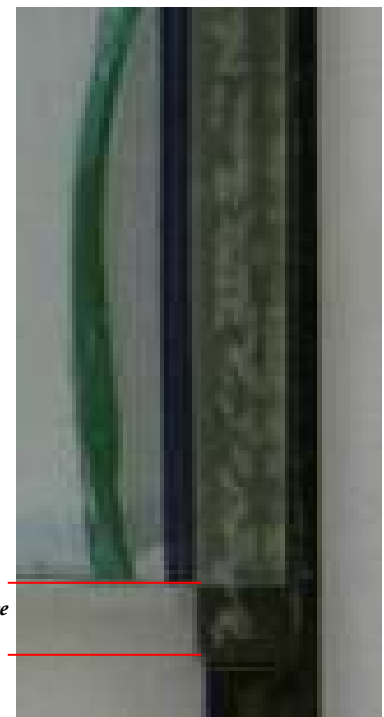
Figure 61, Close-up of specimen 2020_03 after the test. The carbon strip is dislocated (marked by red lines) and the adhesive is visible in white.

The adhesive fails before the glass does. The failure mechanism is cohesive failure, which is visible in Figure 61.

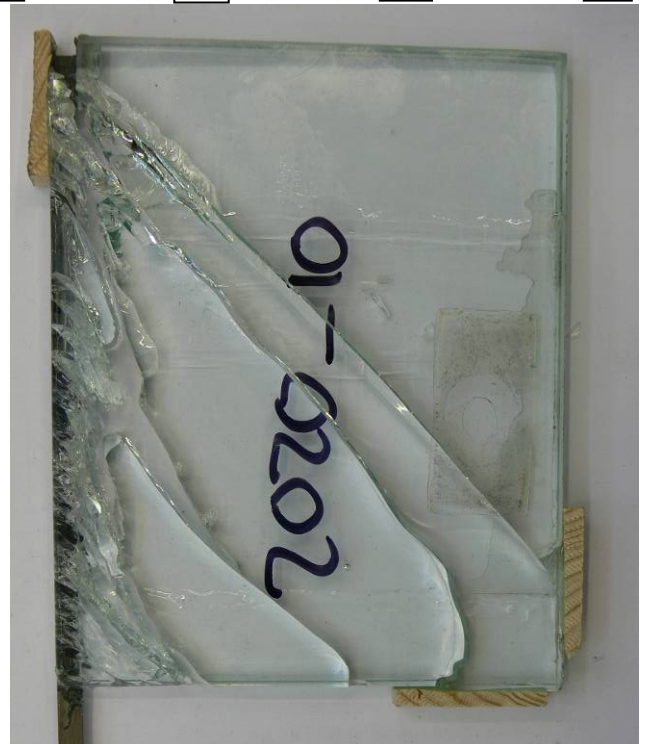
Above: specimen 2020_10 at different moments during the test.

Right: 2020_10 after the test.

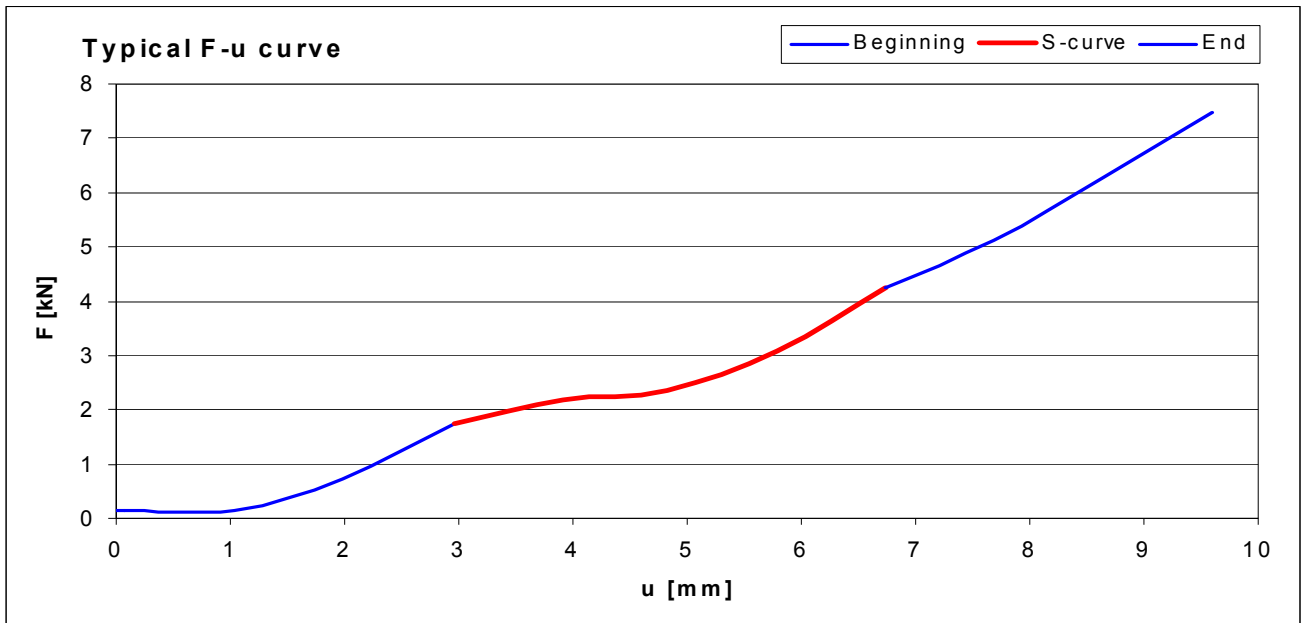
Figure 67, Typical force-displacement curve of tests in sequence 2

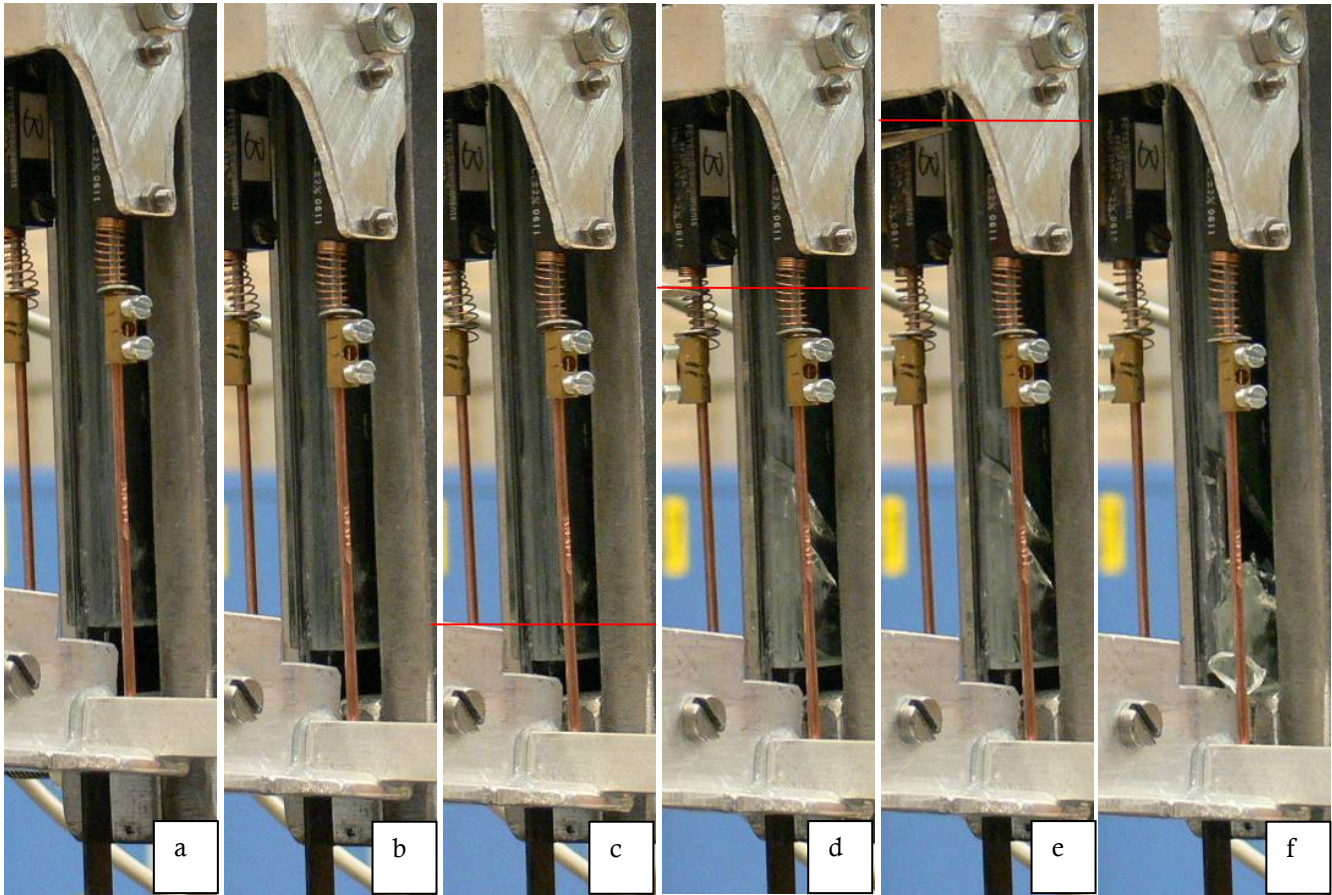
Figure 76, Above: specimen 2013_10 at different moments during the test. The letters correspond to the moments marked in Error! Reference source not found.. Below: Specimens 2013_10 and 2013_11 after the test.

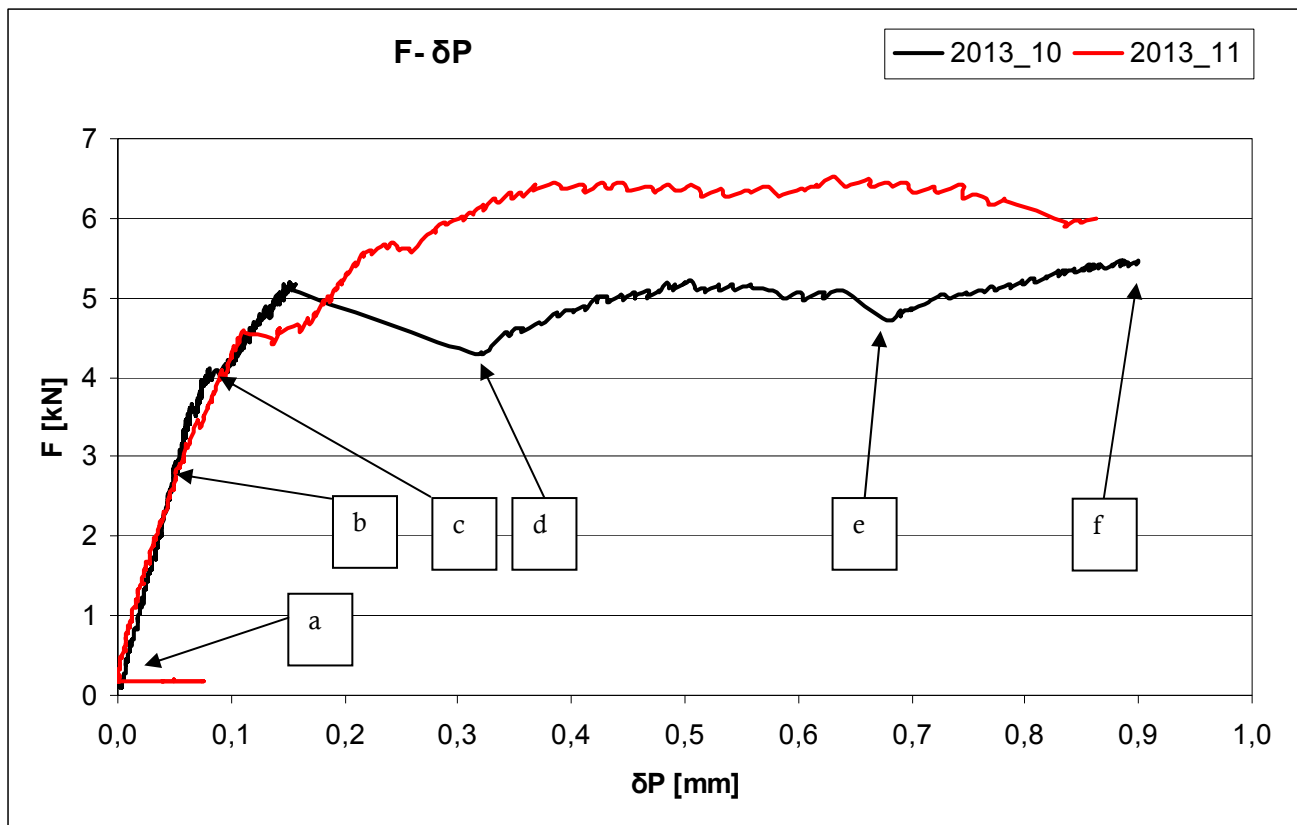
Figure 77, Force-displacement diagram for point P of specimens 2013_10 and 2013_11.

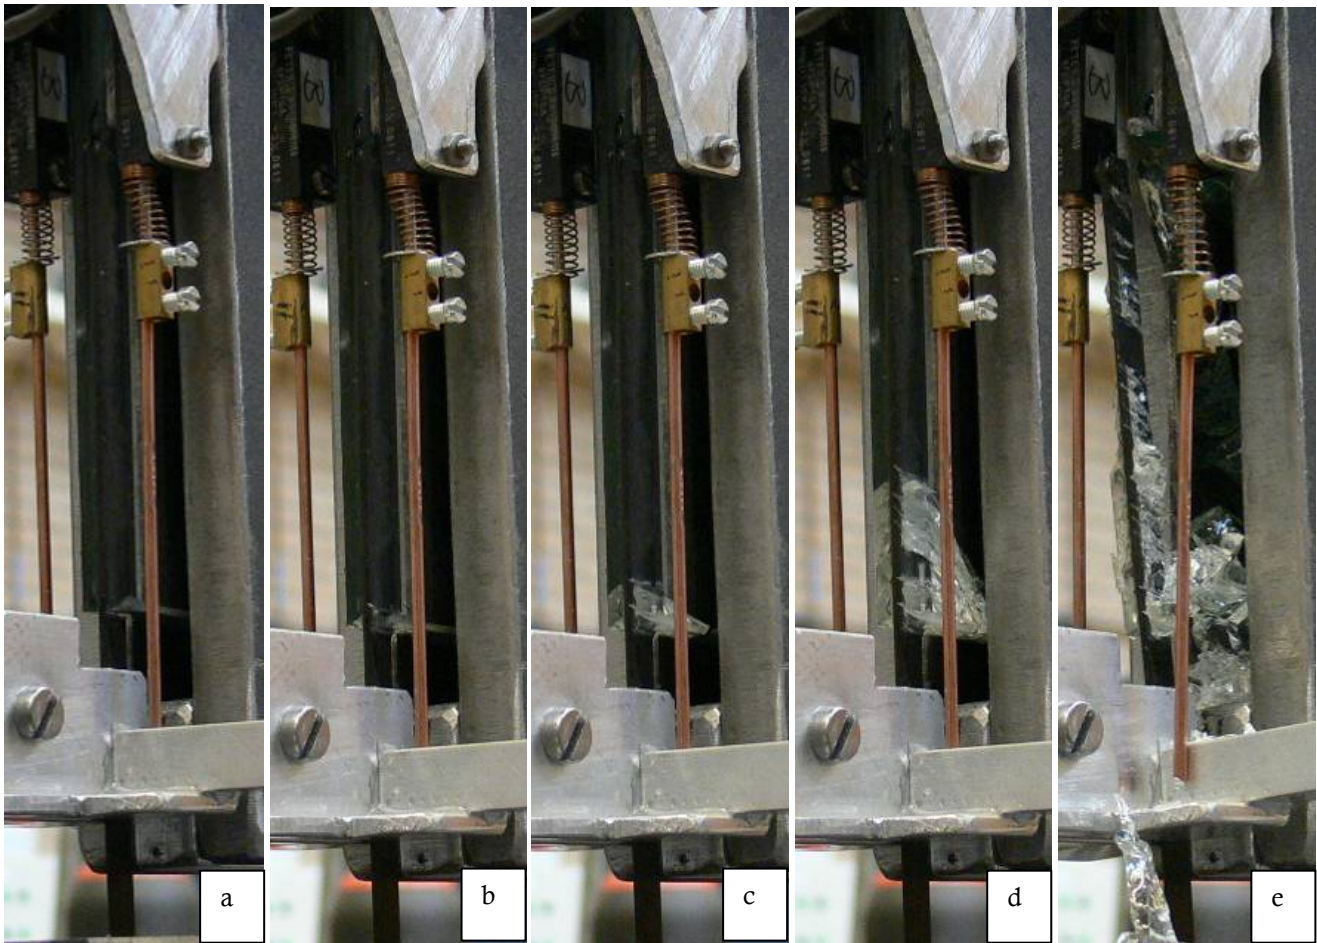
Figure 78, Above: specimen 2011_23 at different moment during the test. The letters correspond to the moments marked in Figure 79. Below: Specimens 2011_23 and 2011_24 after the test.

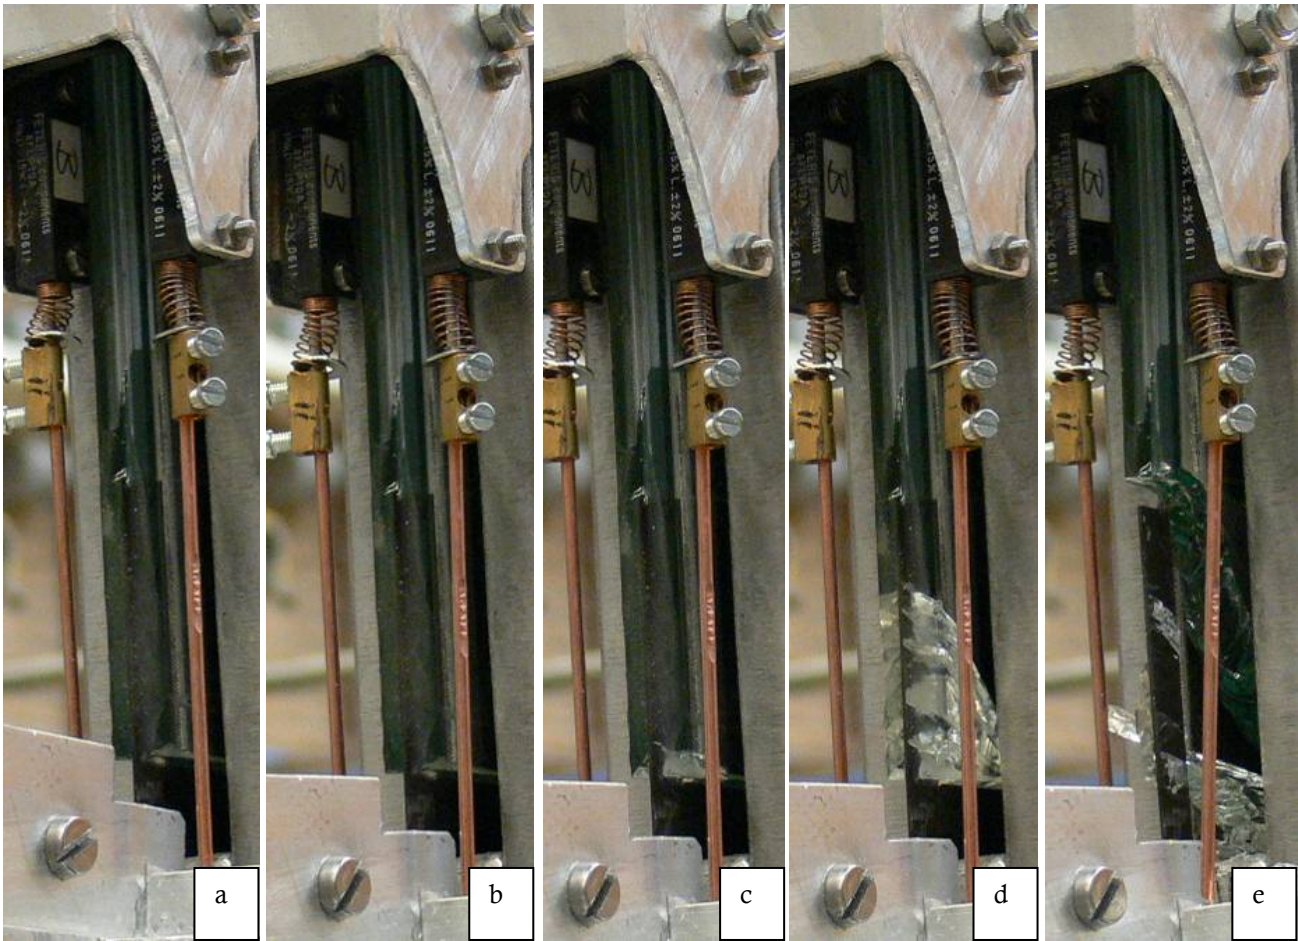
Figure 80, Above: Specimen 2011_26 at different moments during the test. Below: 2011_26 and 2011_27 after the test.

The support force q_1 (see *Figure 47*) at the perspex support block is suddenly released when the reinforcement bursts out of the glass pane. The impressed perspex block functions as a spring and releases all its stored energy at once. The specimen is launched back with the edge against the steel element.

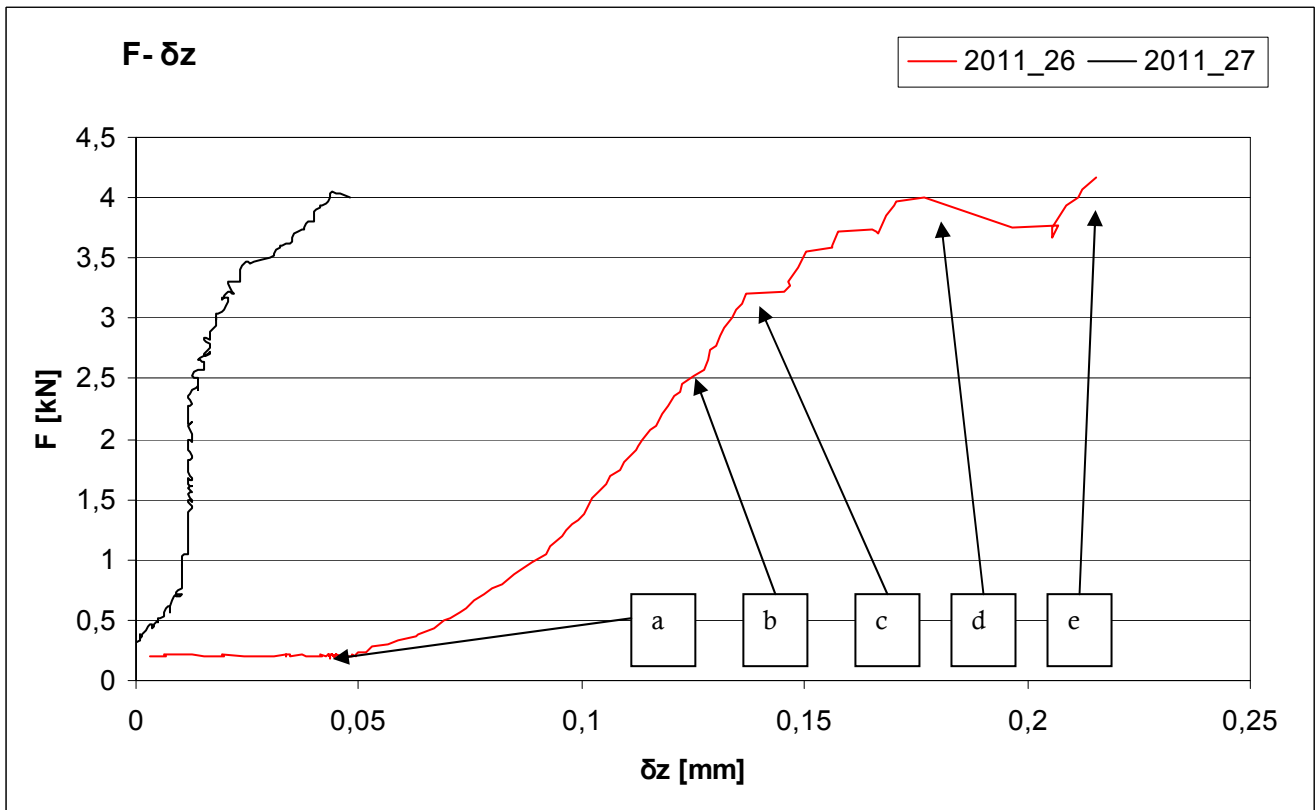
Figure 82, Above (a): F-z diagram for specimen 2011_26 and 2011_27.

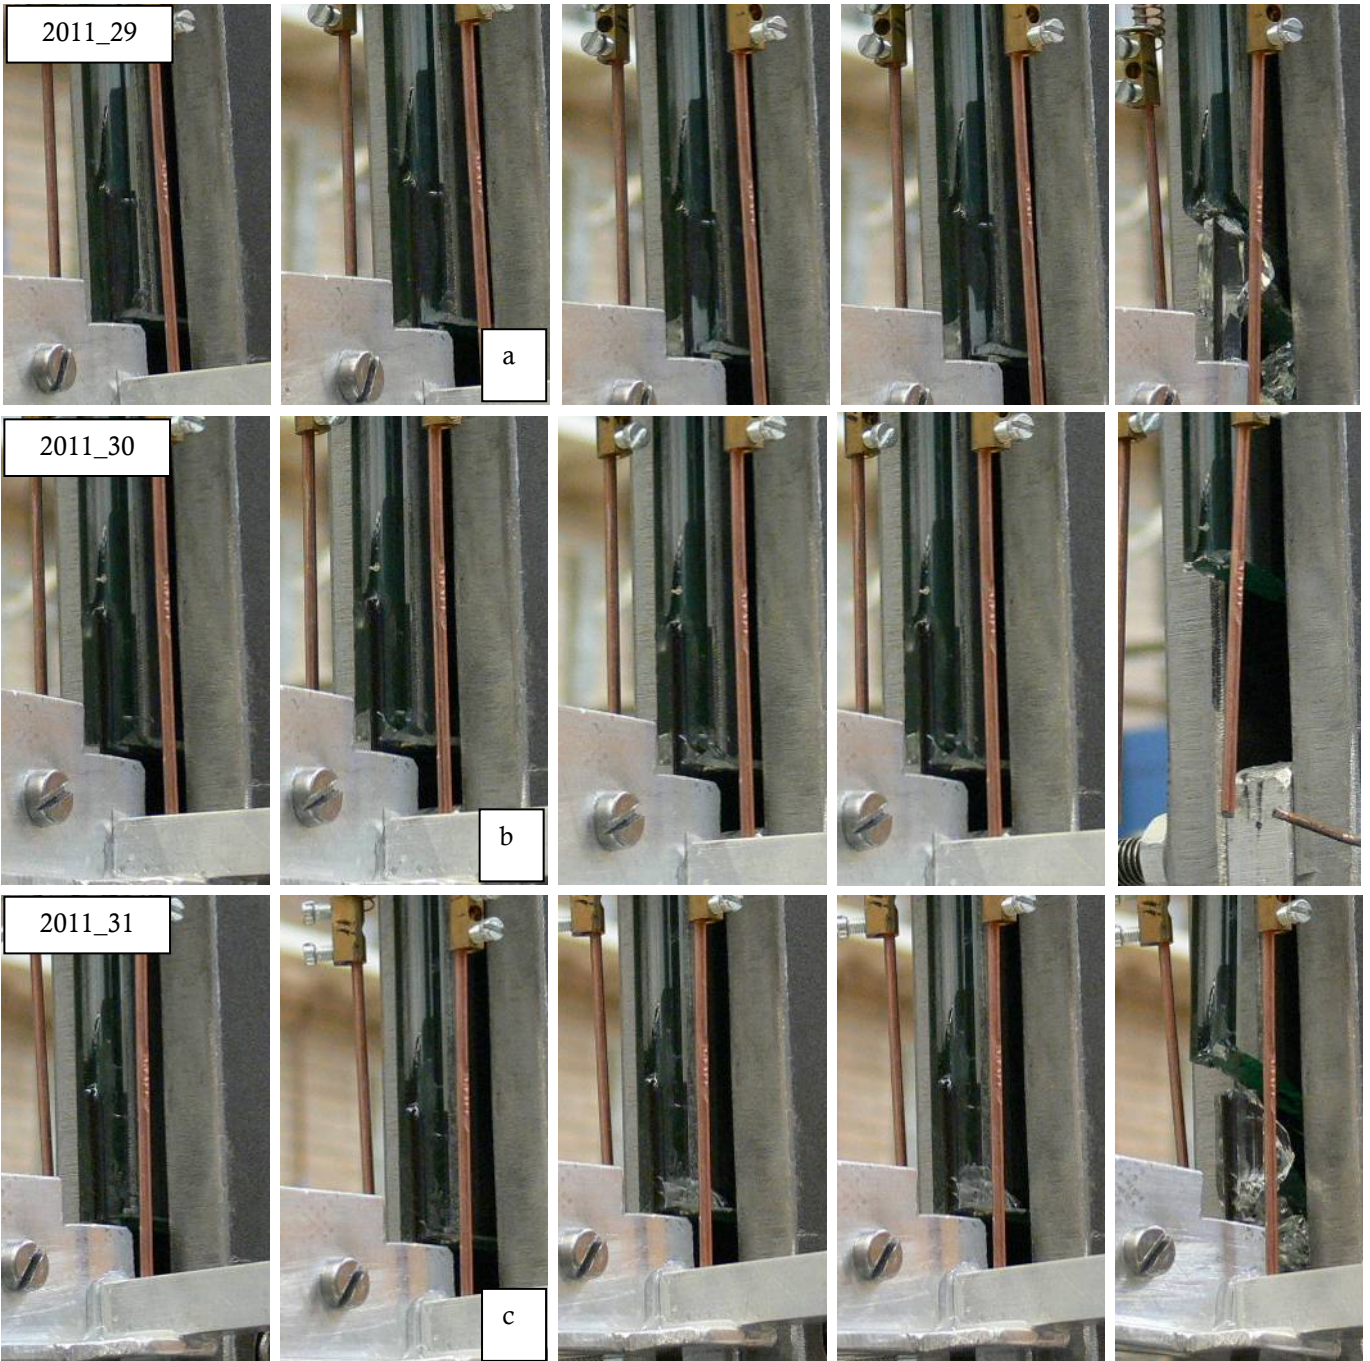
Figure 84, Above: Specimens 2011_29 (top row), 2011_30 (middle row) and 2011_31 (bottom row) at different moment during the tests. Below: close-up of specimen 2011_29 after the test.

Similar crossing tangents could be drawn for 2011_29 (crossing in point 'a') and 2011_30 (crossing in point 'b').

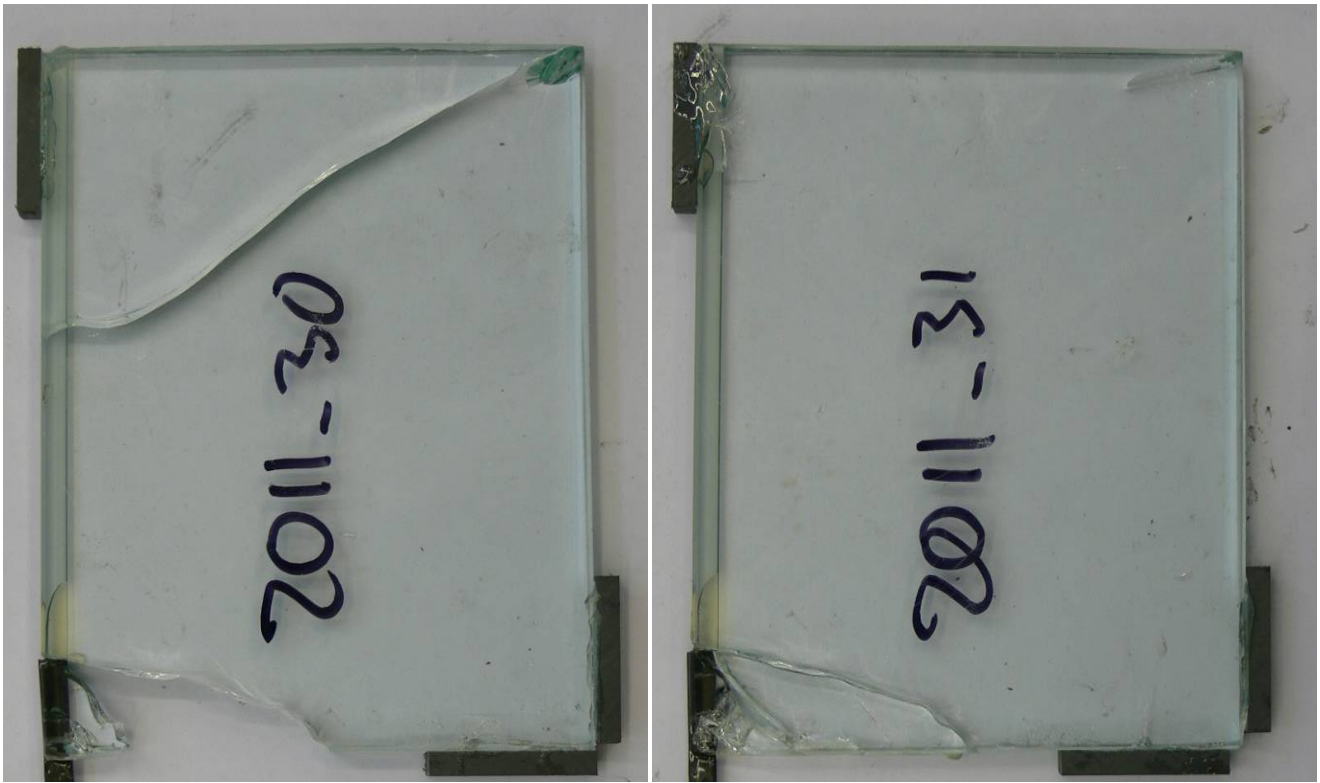
Figure 86, Specimens 2011_30 and 2011_31 after the test.

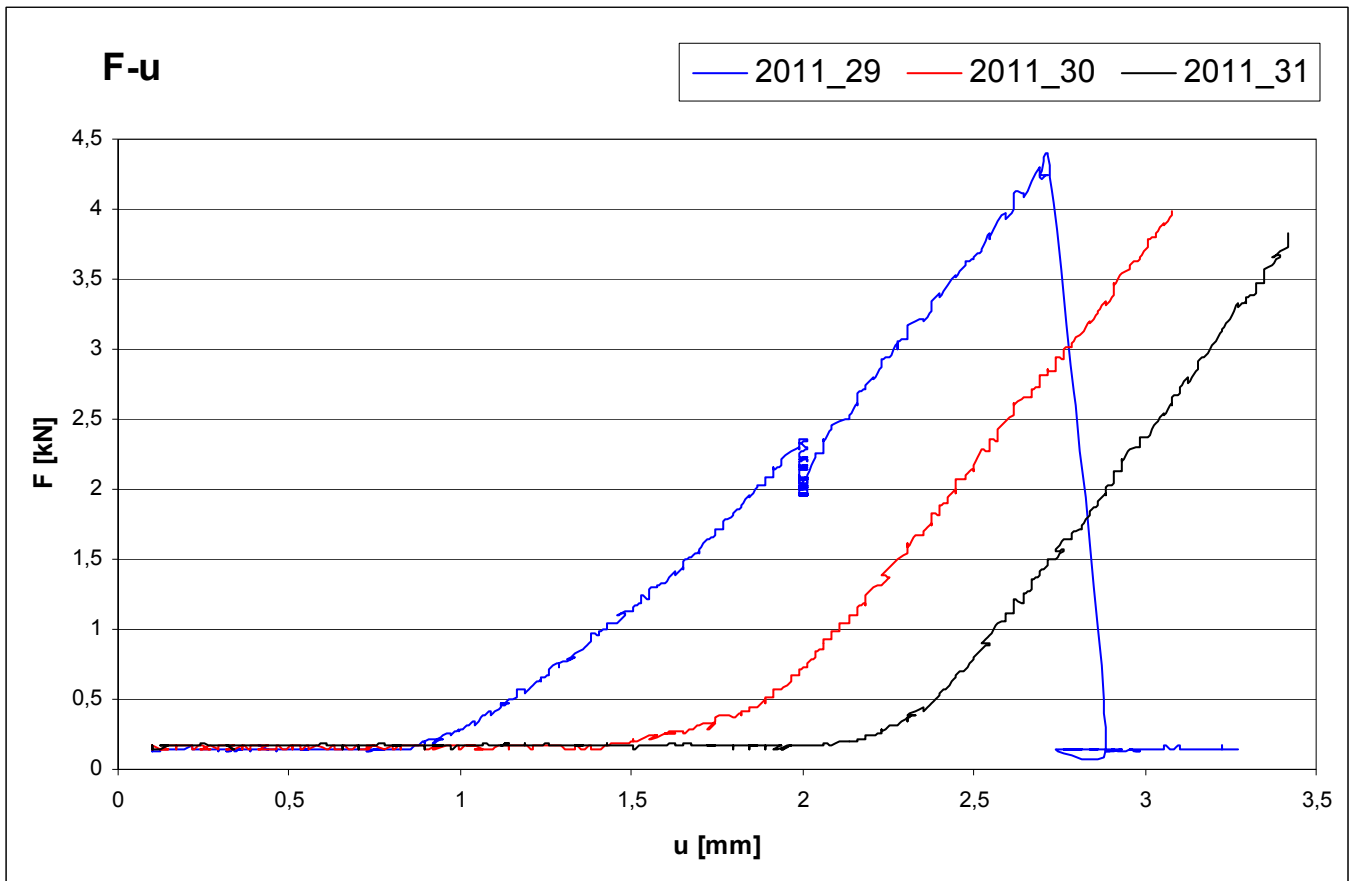
Figure 87, Force-displacement diagram for specimens 2011_29 to 2011_31.

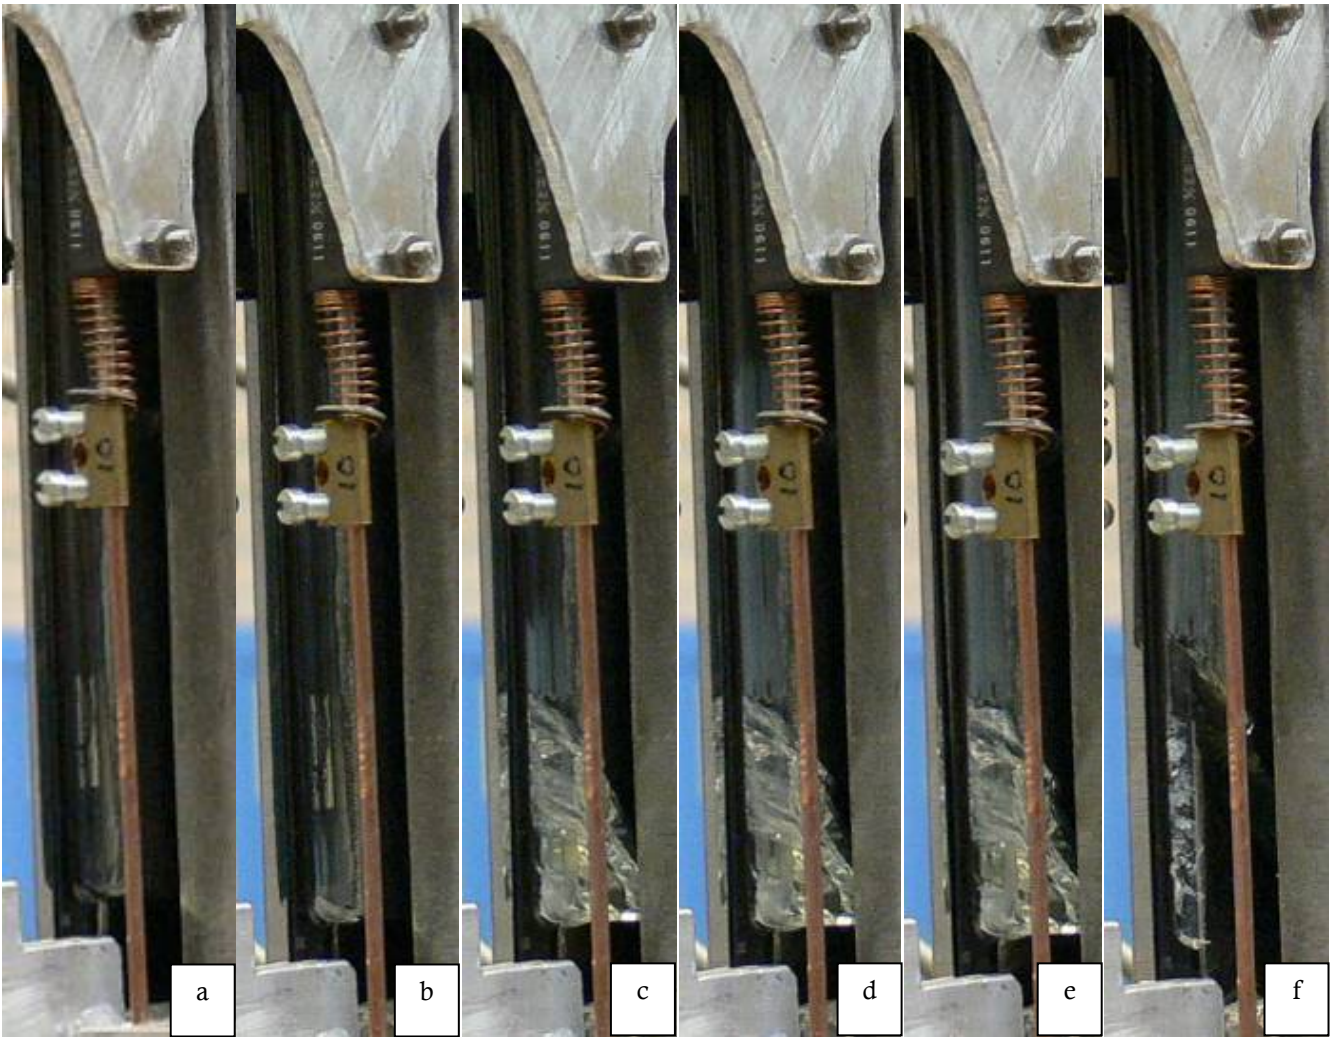
Figure 88, Above: specimen 2011_32 at different moments during the test, corresponding to the moments in Error! Reference source not found.. Picture 'f' was taken after total failure. Below: Specimen 2011_32 and 2011_34 after the test.

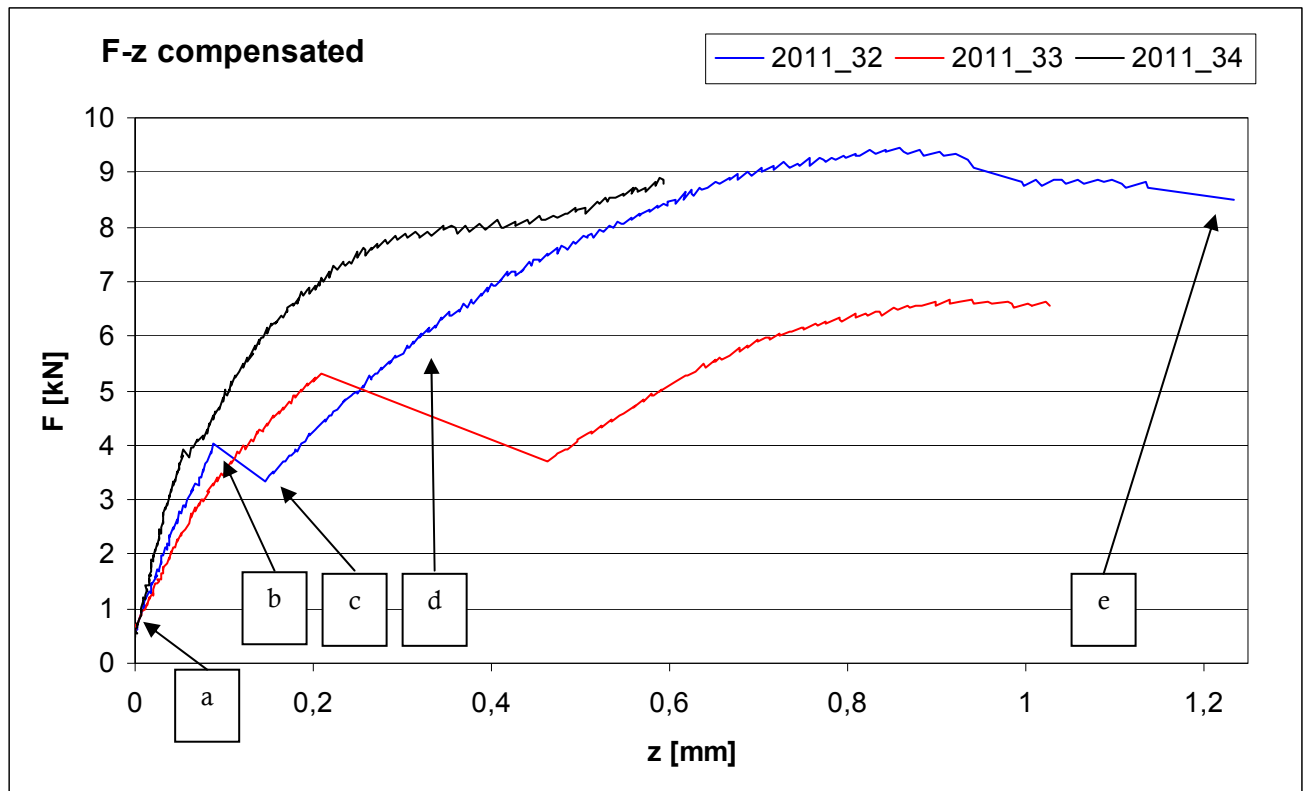
Figure 89, Force-displacement diagram for point 'P' of specimens 2011_32 to 2011_34. Moment 'P' is after total failure.

From *Figure 89* it is clear that stiffness decreases as force increases. The specimens have a certain maximum force to which they level out. This maximum force is different for each specimen. Anticipation is that the maximum force would not rise if the specimen was larger and had a longer carbon strip.

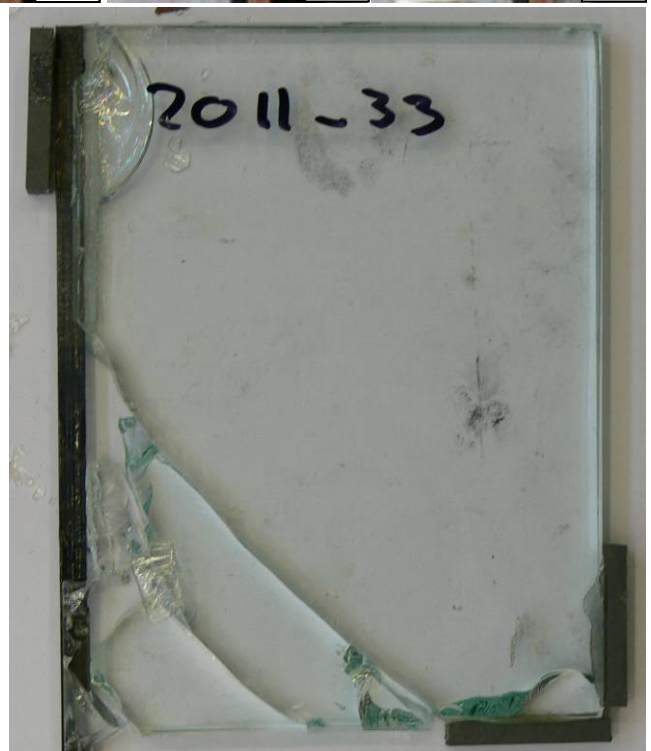
Above: Specimen 2011_33 at different moments during the test. Moment correspond to Figure 91. Note that pictures 'g' and 'h' are referring the beginning of the test, approximately the same point as 'a' in Figure 88.

Right: after the test.

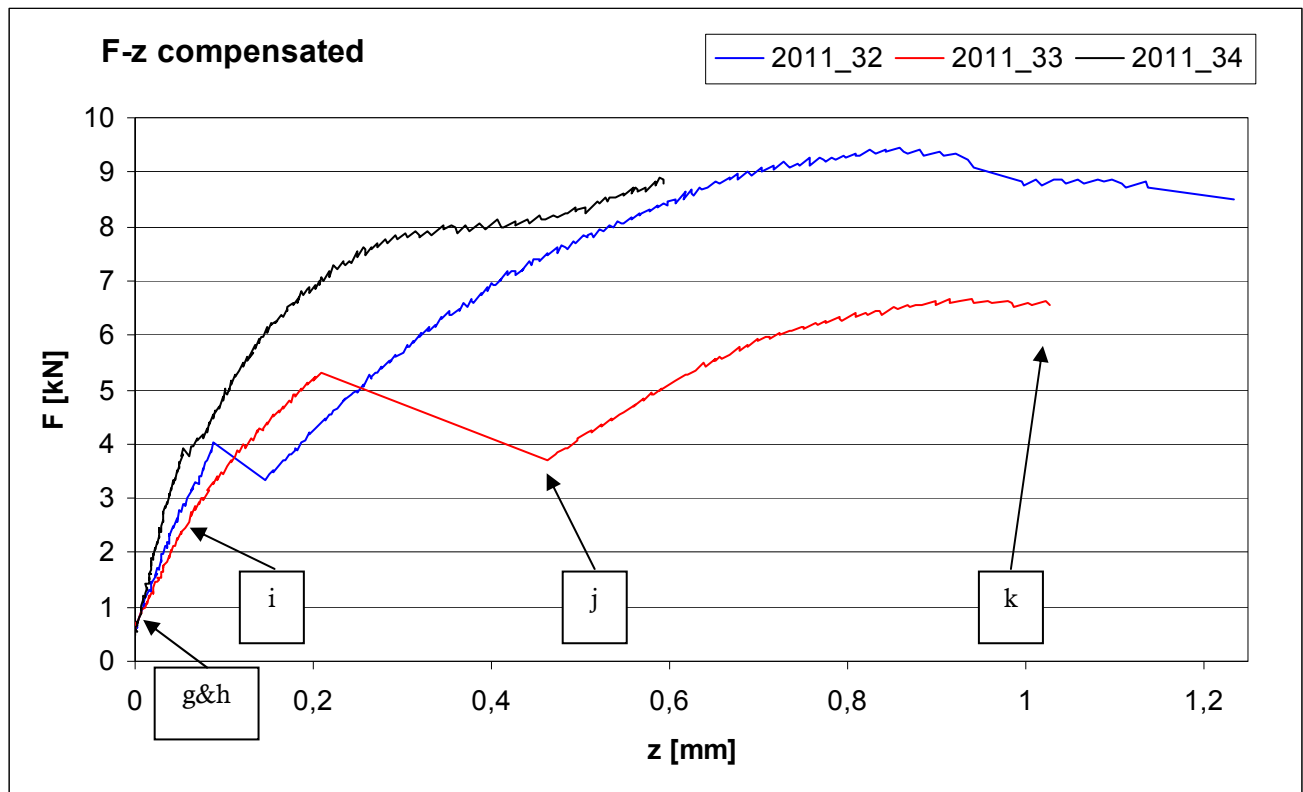
Figure 91, Force-displacement diagram for point 'P' of specimens 2011_32 to 2011_34. Moment 'k' is after total failure.

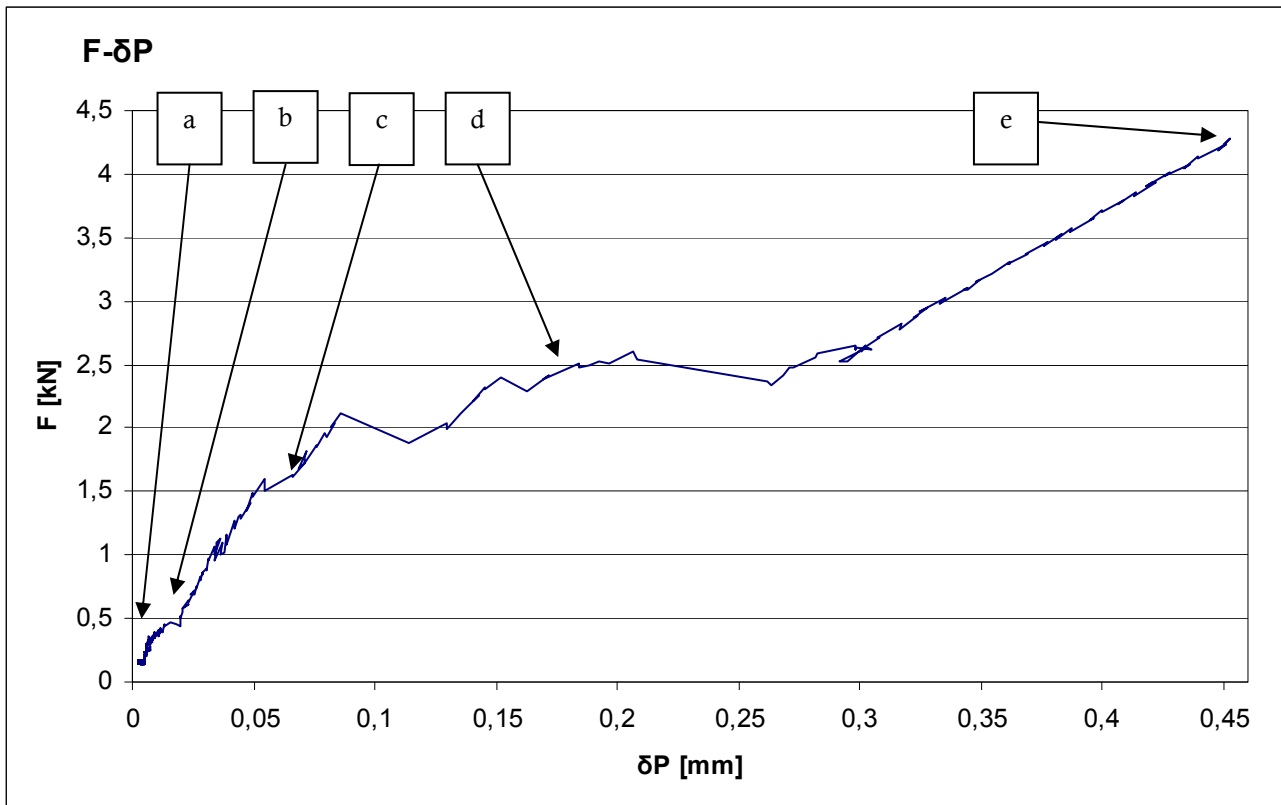
Figure 94, Force-displacement diagram for point P for specimen 2011_35.

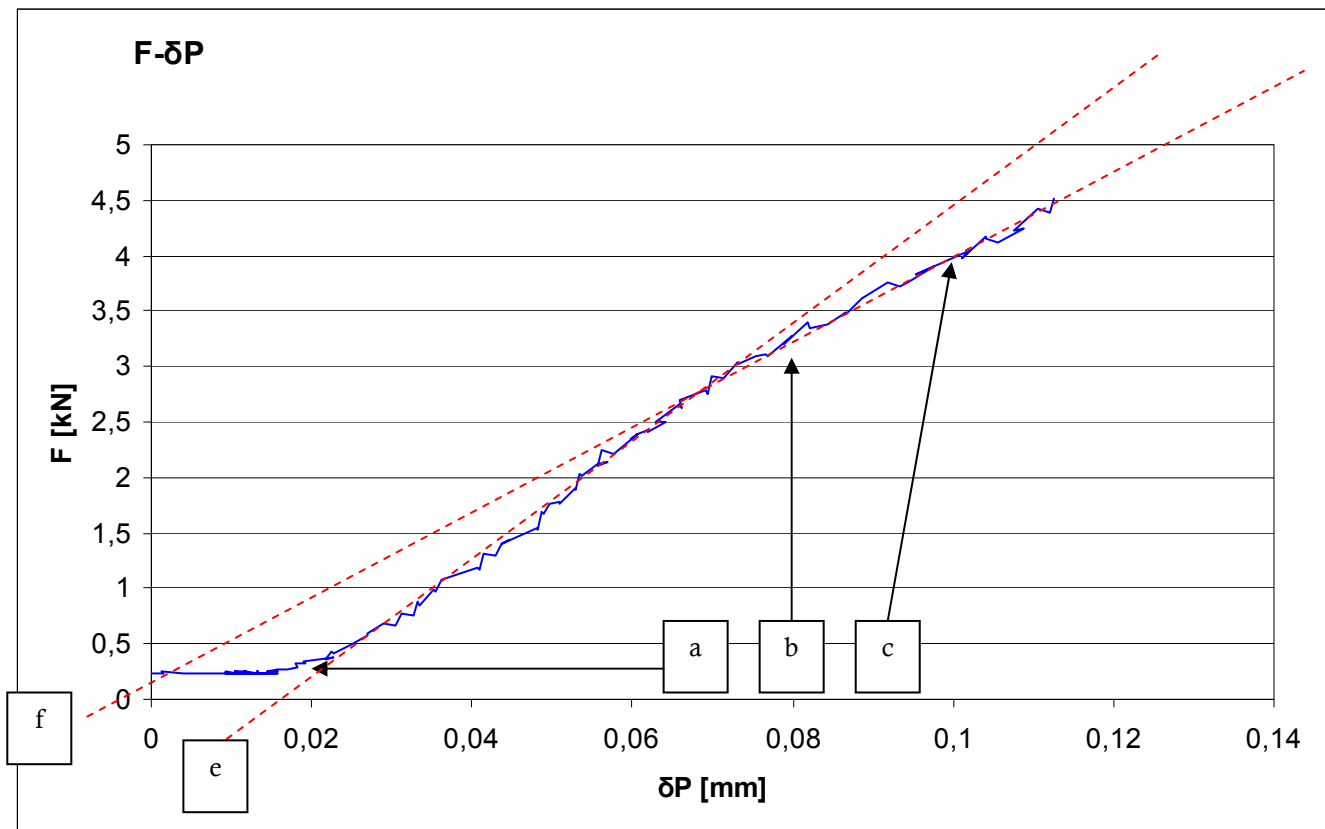
Figure 96, Force displacement diagram for point P for specimen 2011_37.

At this same moment the adhesive started progressive failure and the specimen reduced in stiffness. This is emphasized by lines 'e' and 'f' (*Figure 96*).

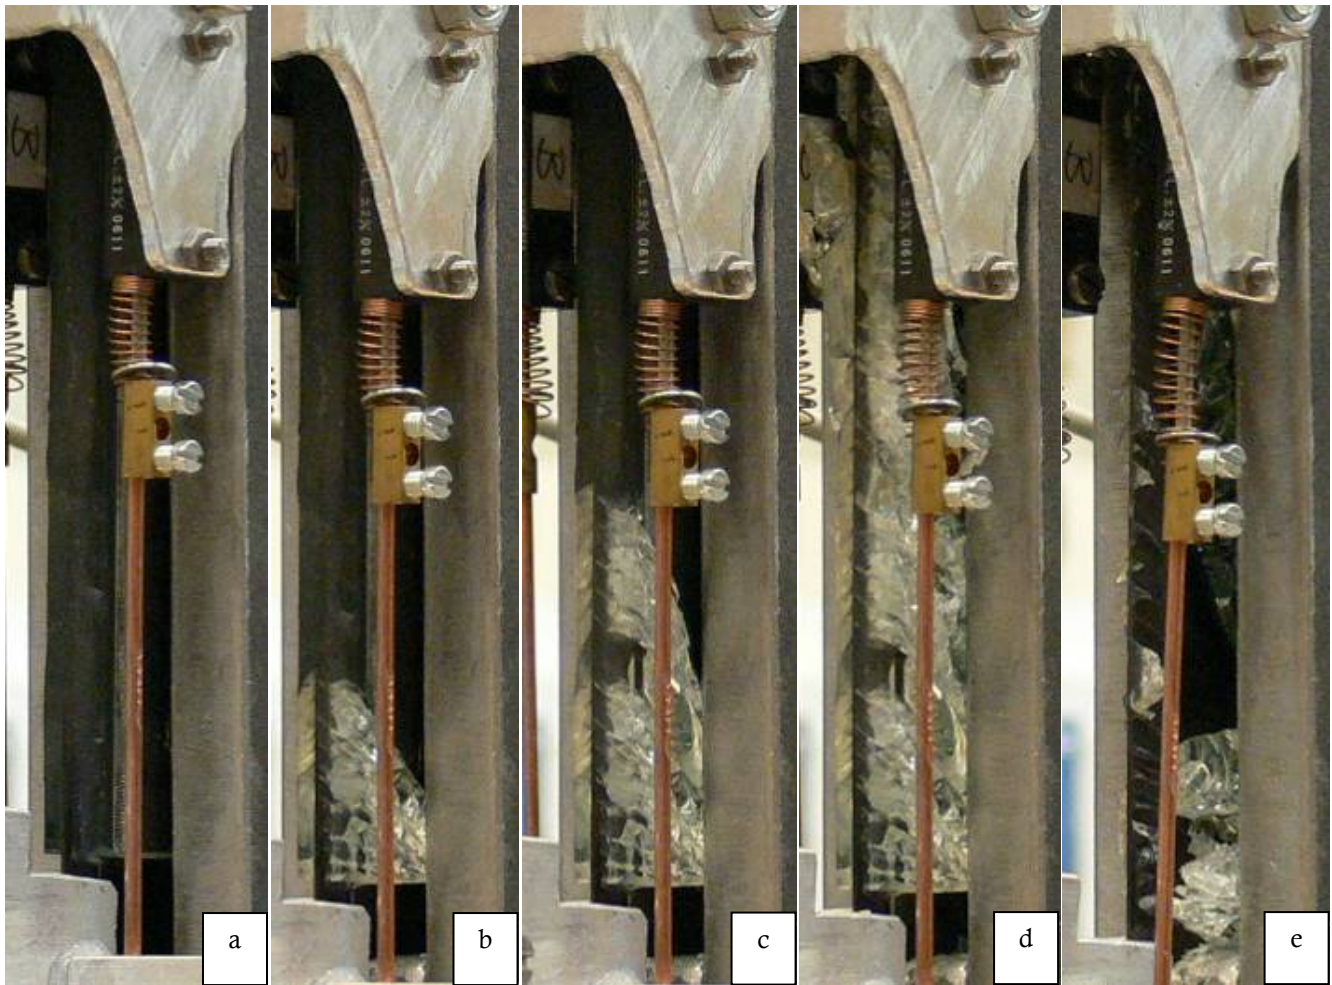
Figure 97, Above: specimen 2011_40 at different moment during the test. Below left: obliqueness of carbon strip, denoted by red lines. Middle: after the test.

Below right: specimen 2011_41 before the test. The red arrows indicate the beginning and end of the fissure.
