5.2 Material properties

Method

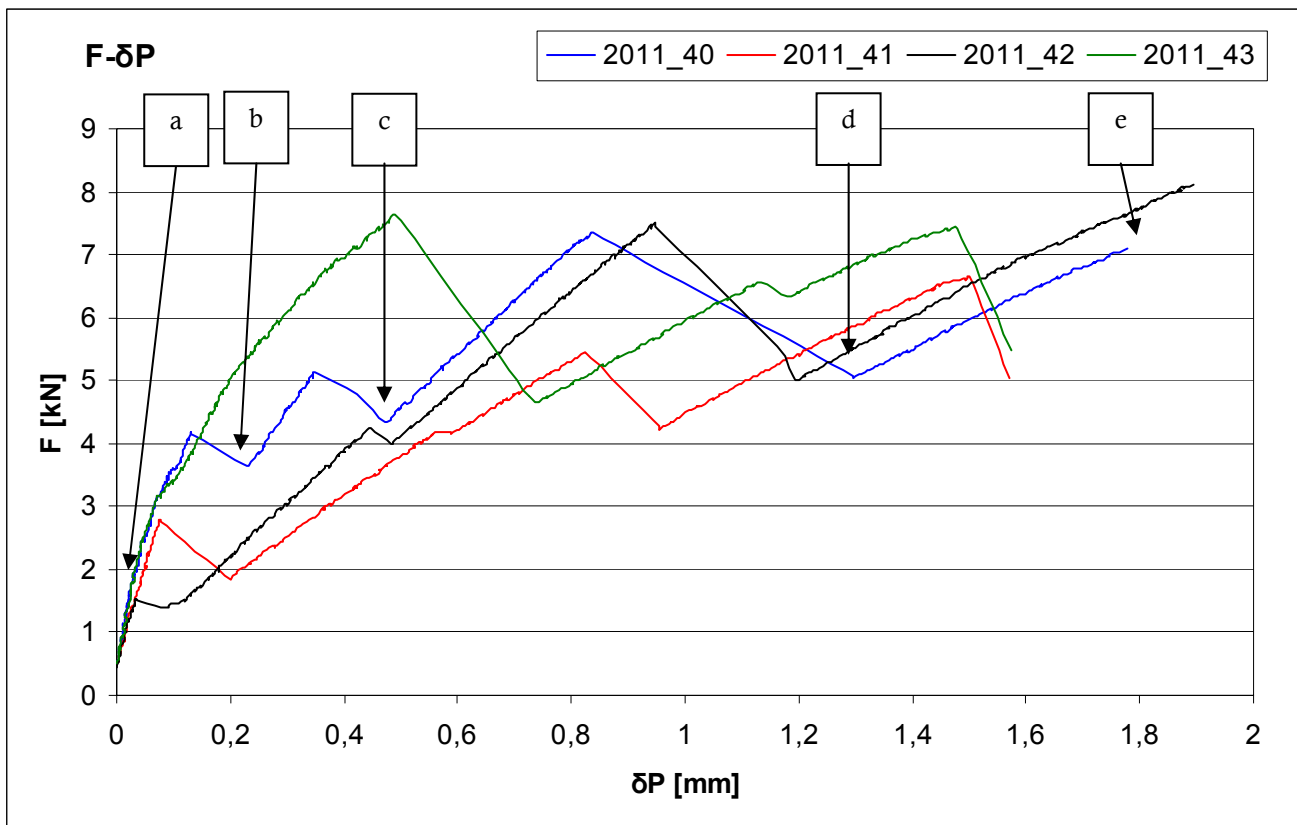
Figure 98, Force-displacement diagram for point P for specimens 2011_40 to 2011_43.

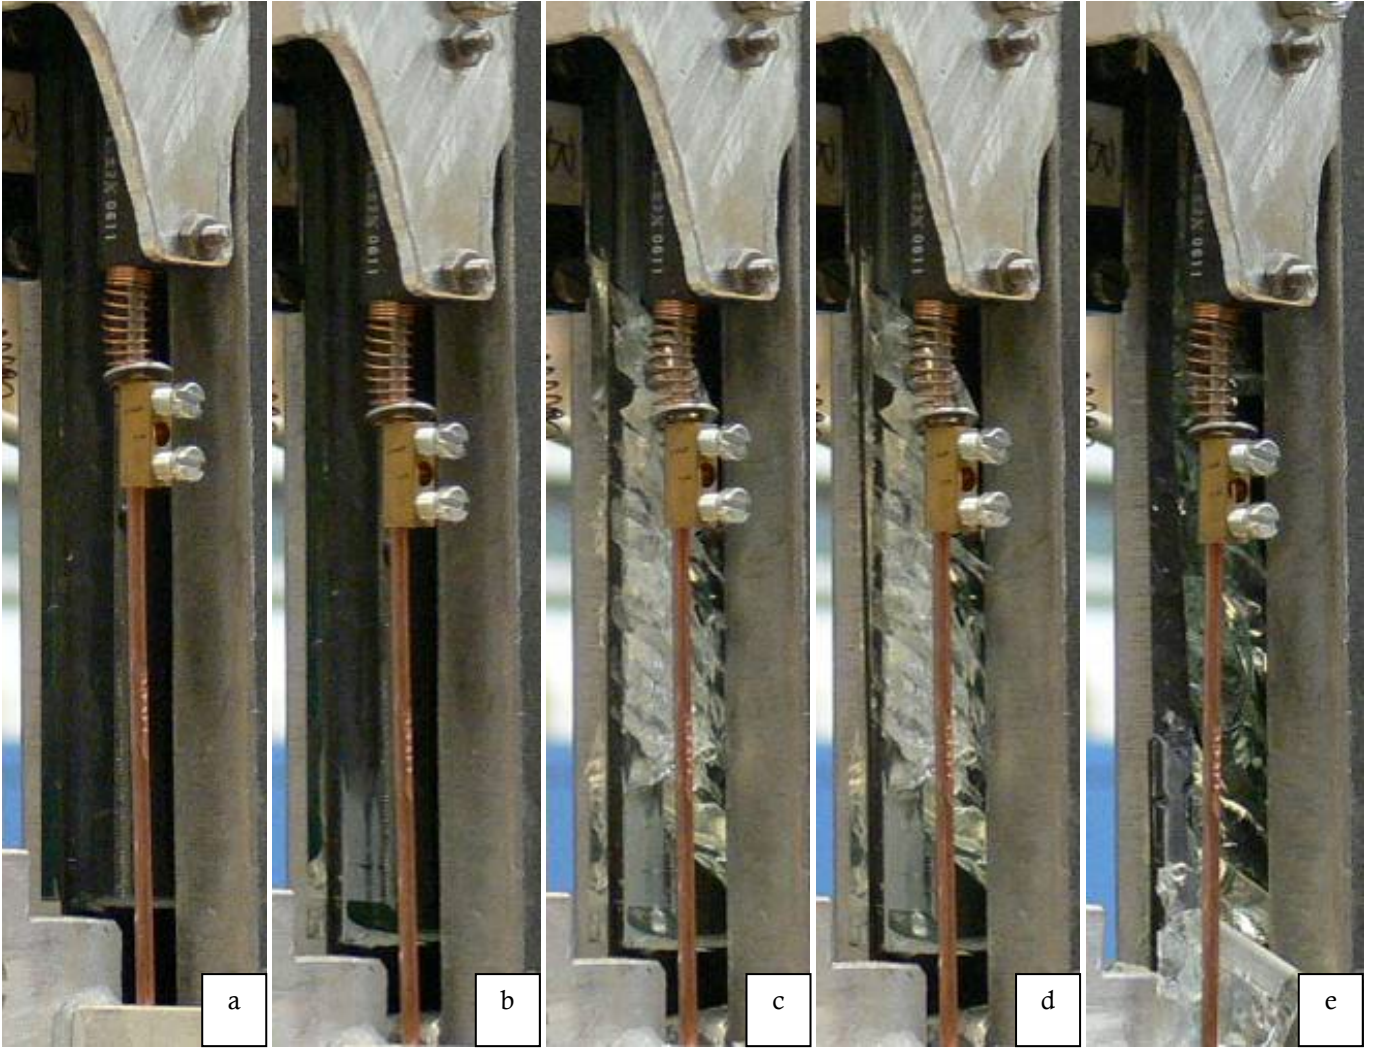
Figure 99, Above: specimen 2011_43 at different moments during the test. Below: specimens after the test.

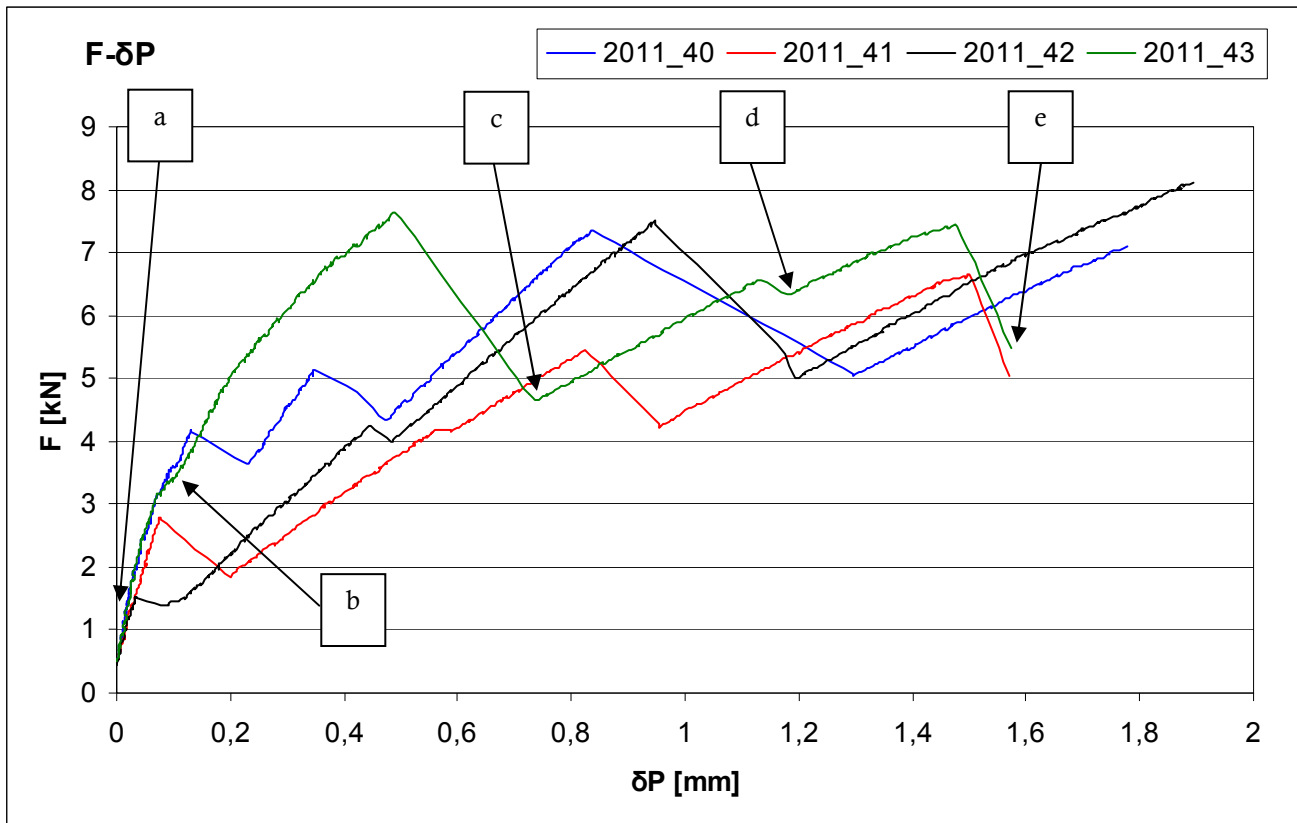
Figure 100, Force-displacement diagram for point P for specimens 2011_40 to 2011_43.

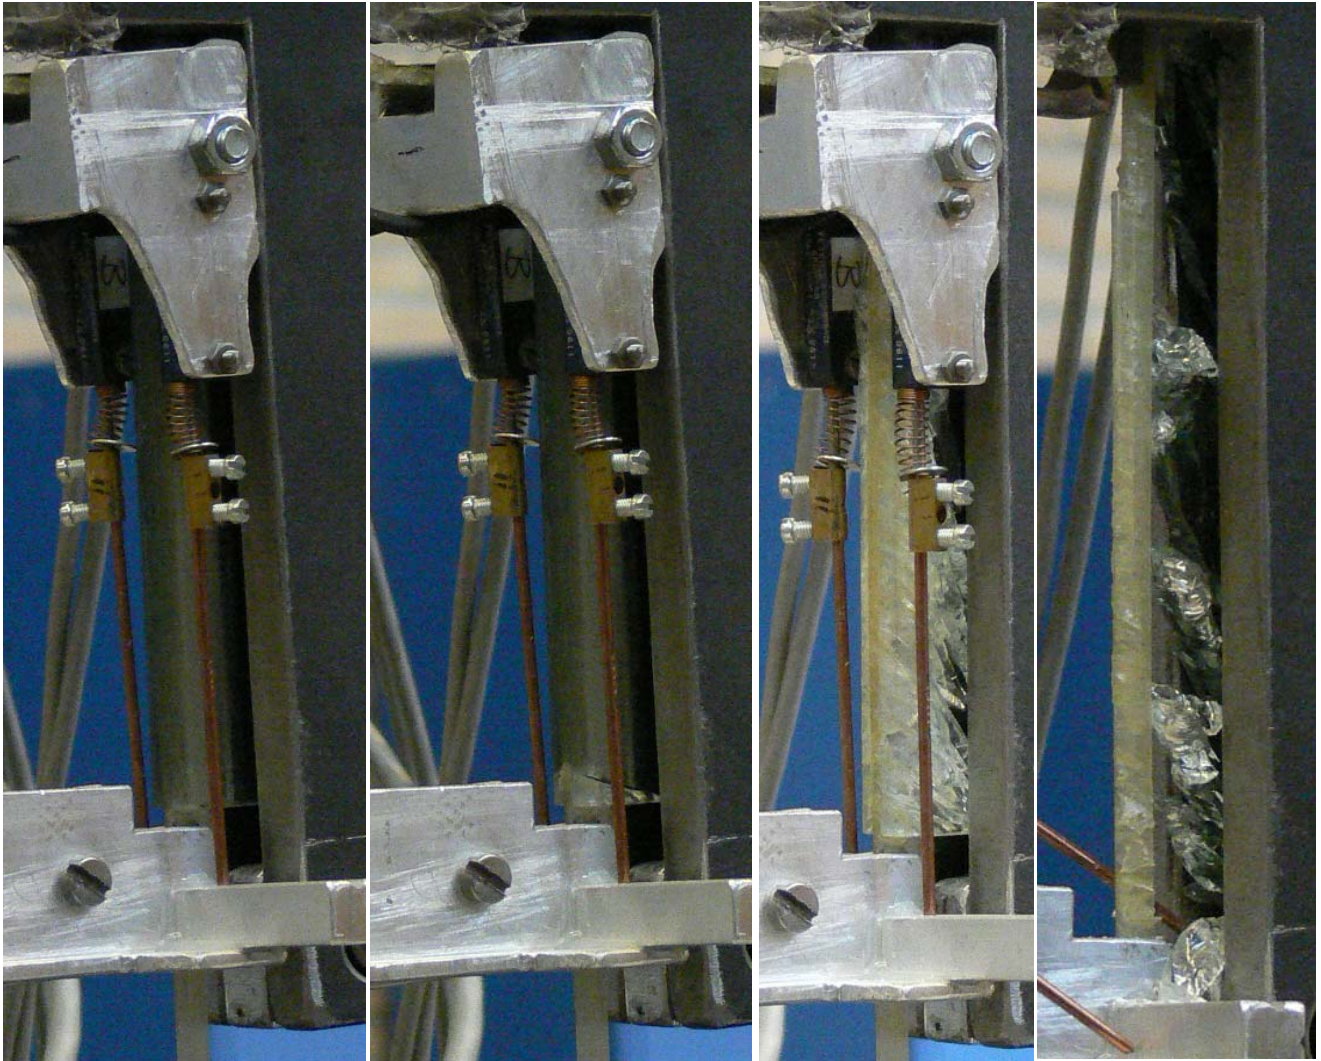
Figure 101, Above: specimen 2011_GF1 at different moments during the test. Below: specimens after the test.

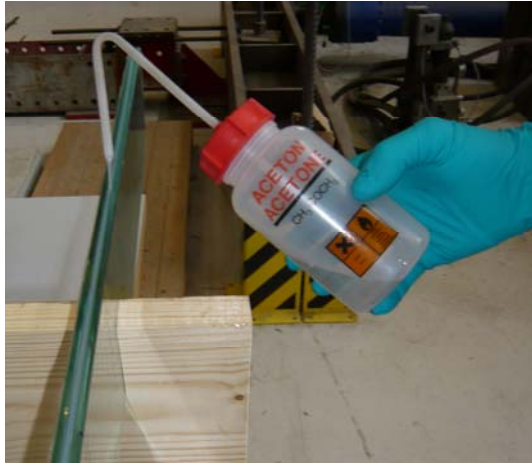
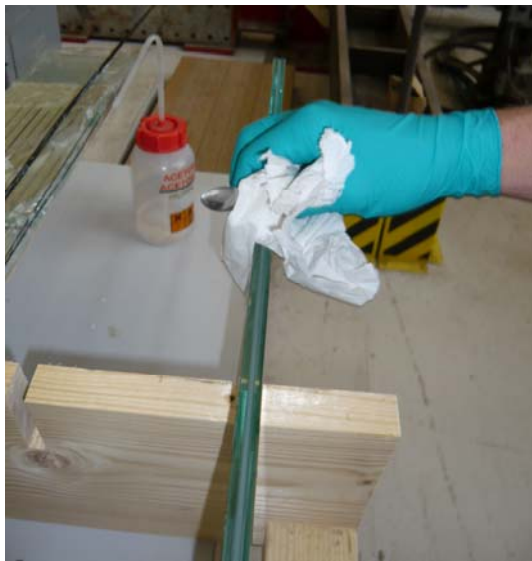
a: Cleaning procedure of glass specimen.

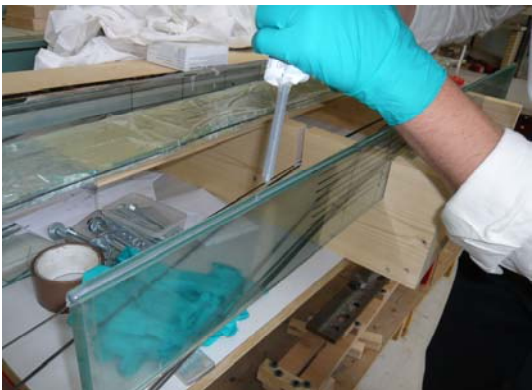
b: Application of adhesive at specimen 3

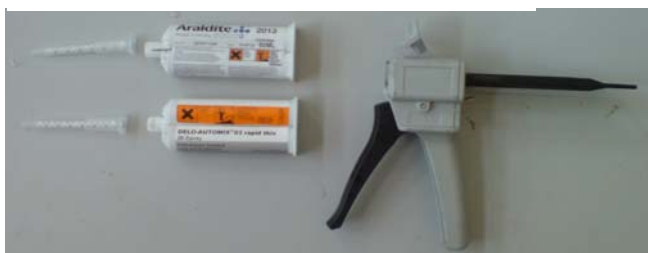
e: Ready-mix nozzle, adhesive cartridges of both adhesives and glue squirt.

Araldite can also be applied as ready-mix.

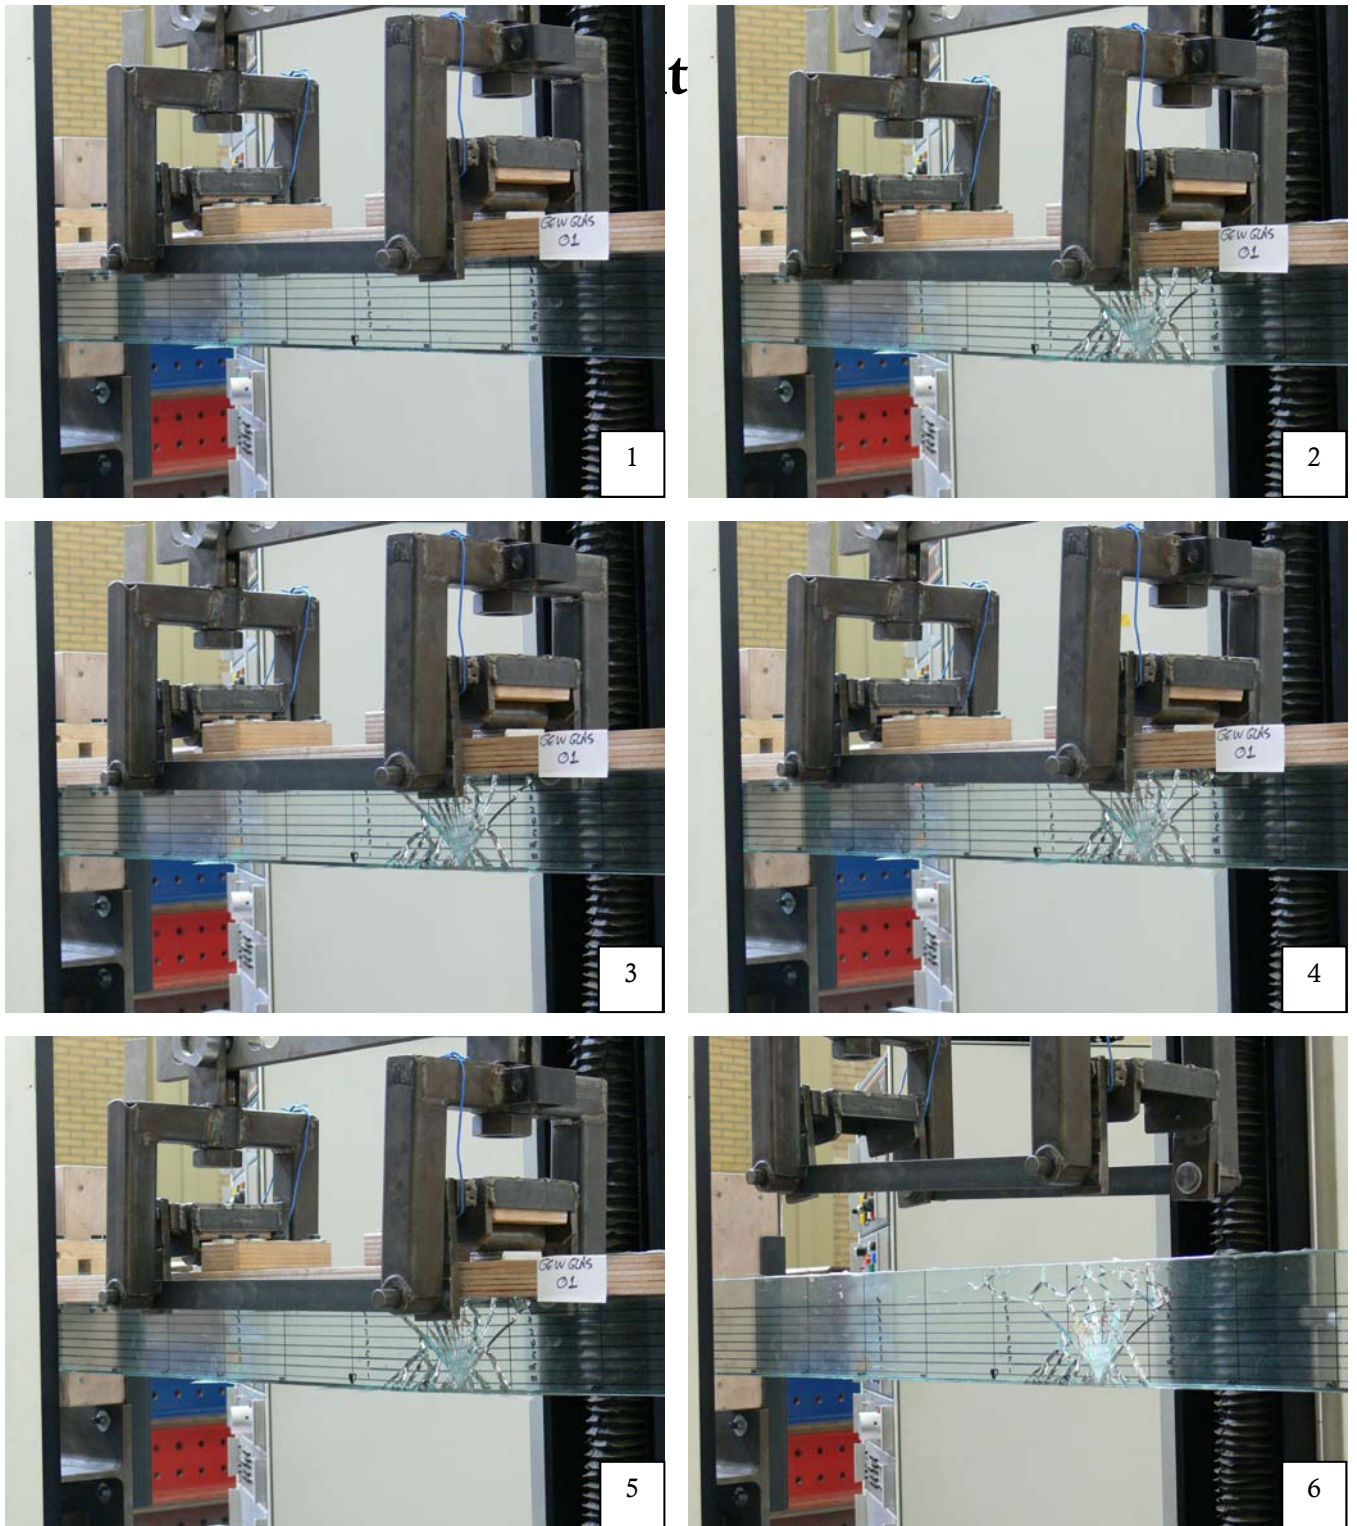
Figure 105, Test 1 on 6 different stages of the test. First crack is visible on picture 2. When examined closely the sliding of the upper support is visible on photos 3, 4 and 5. Photo 6 is taken when the test was complete.

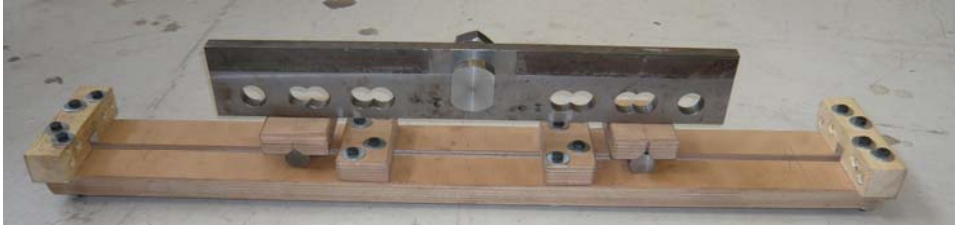
Figure 108, Altered upper support flange.

To prevent the rolling of the supports after the first crack, the hinged steel construction is simplified (see *Figure 108*).

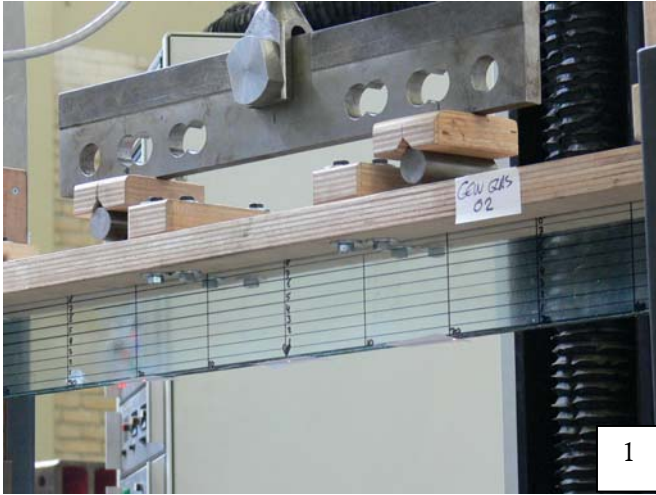
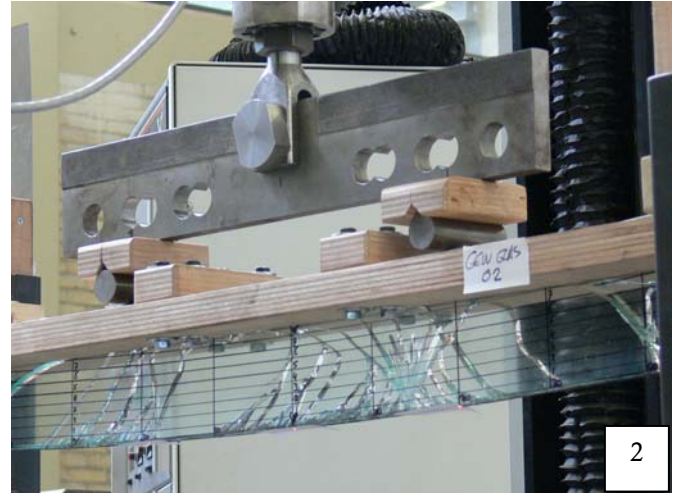
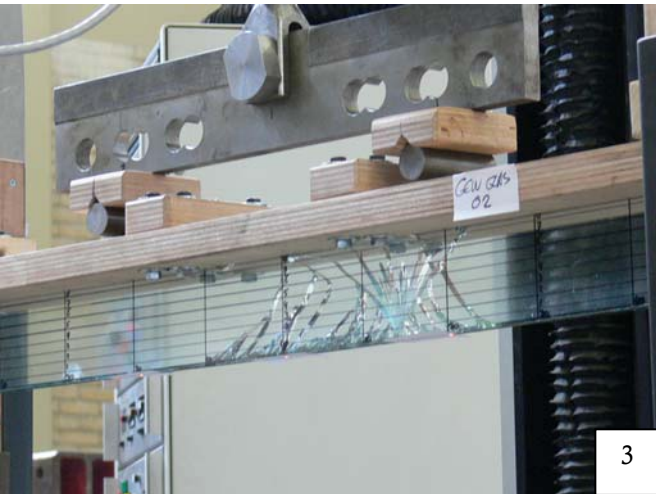
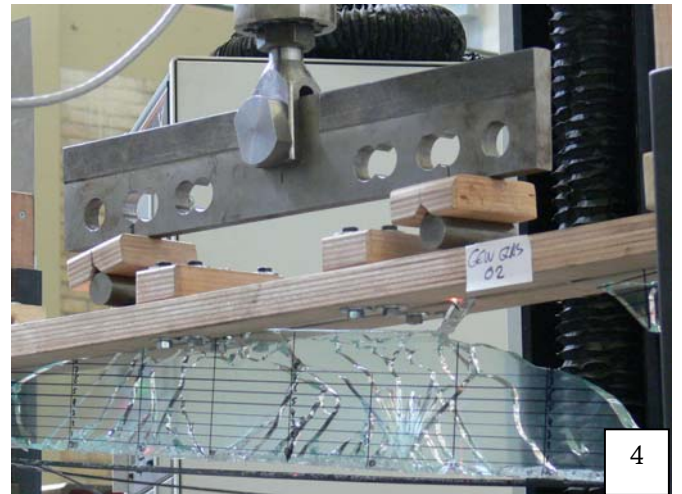
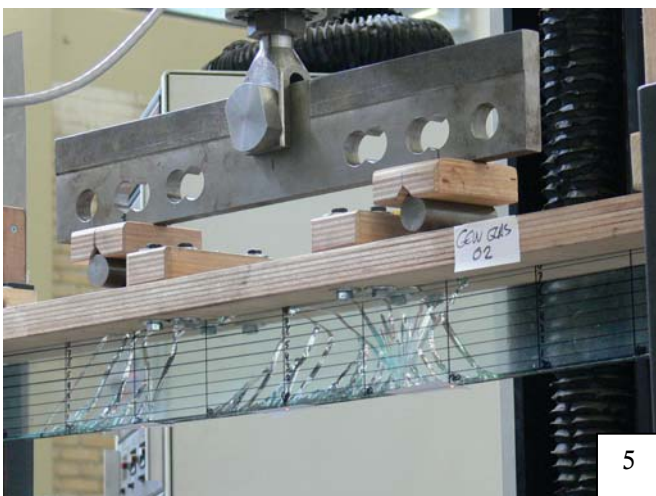
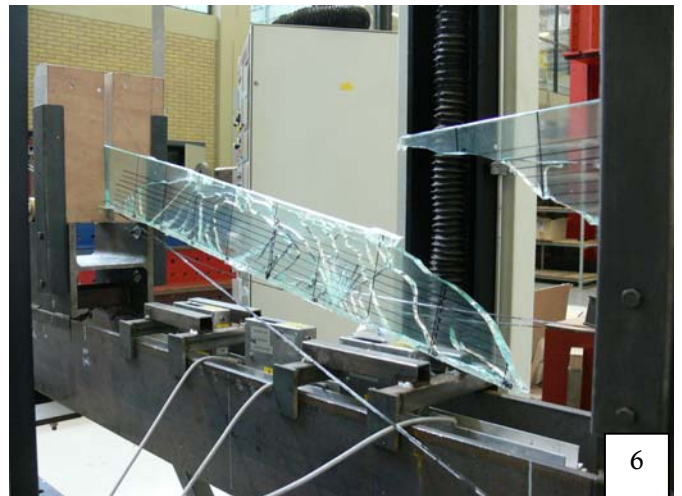
Figure 110, Test 2 on 6 different stages of the test. First crack is visible on picture 2. Further cracks are visible on photos 3 and 4. Total failure has occurred on photo 5. The final result of test 2 is visible on photo 6.

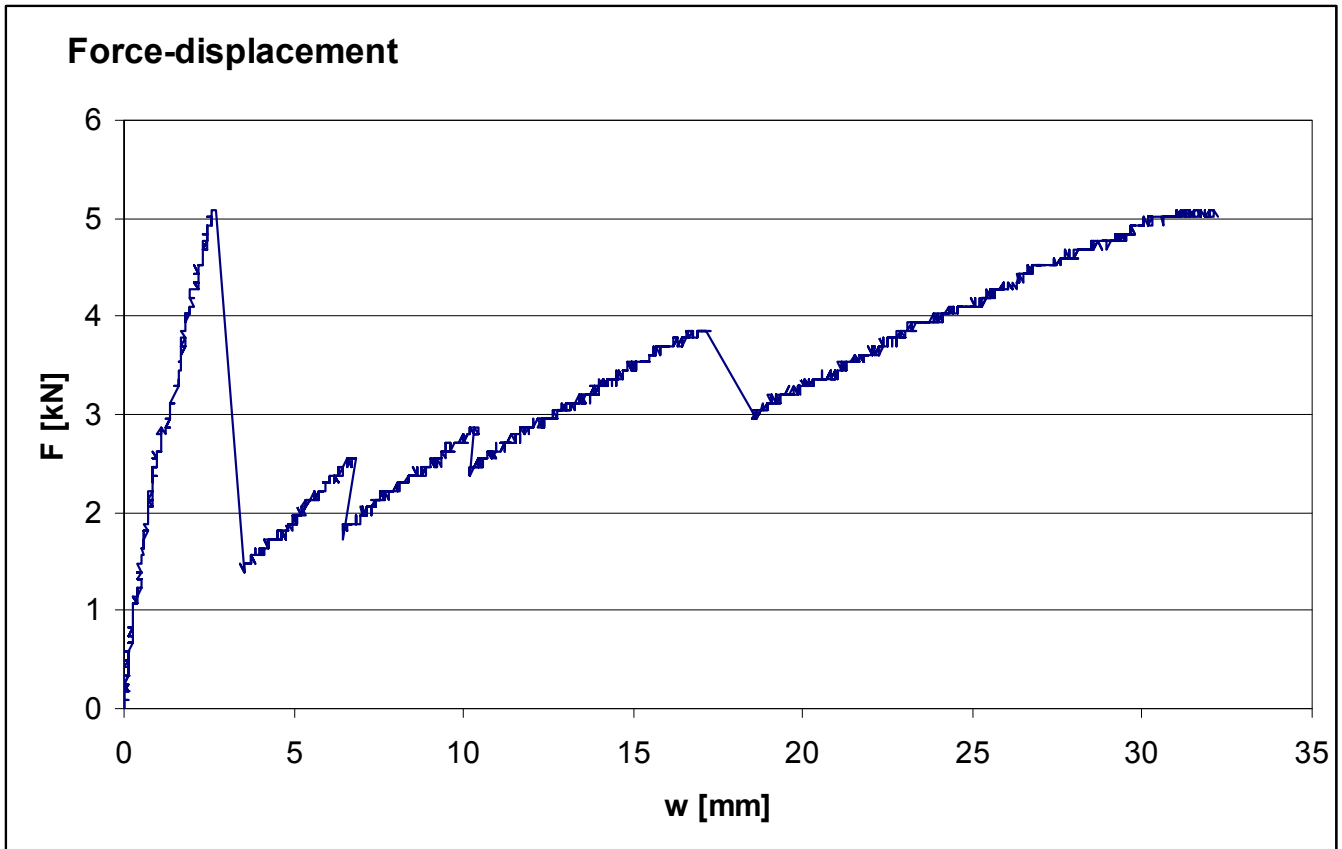
Figure 111, Force- displacement diagram. Each fallback in applied force represents a new crack in the glass.

The stiffness of the beam is greatly reduced after the first crack.

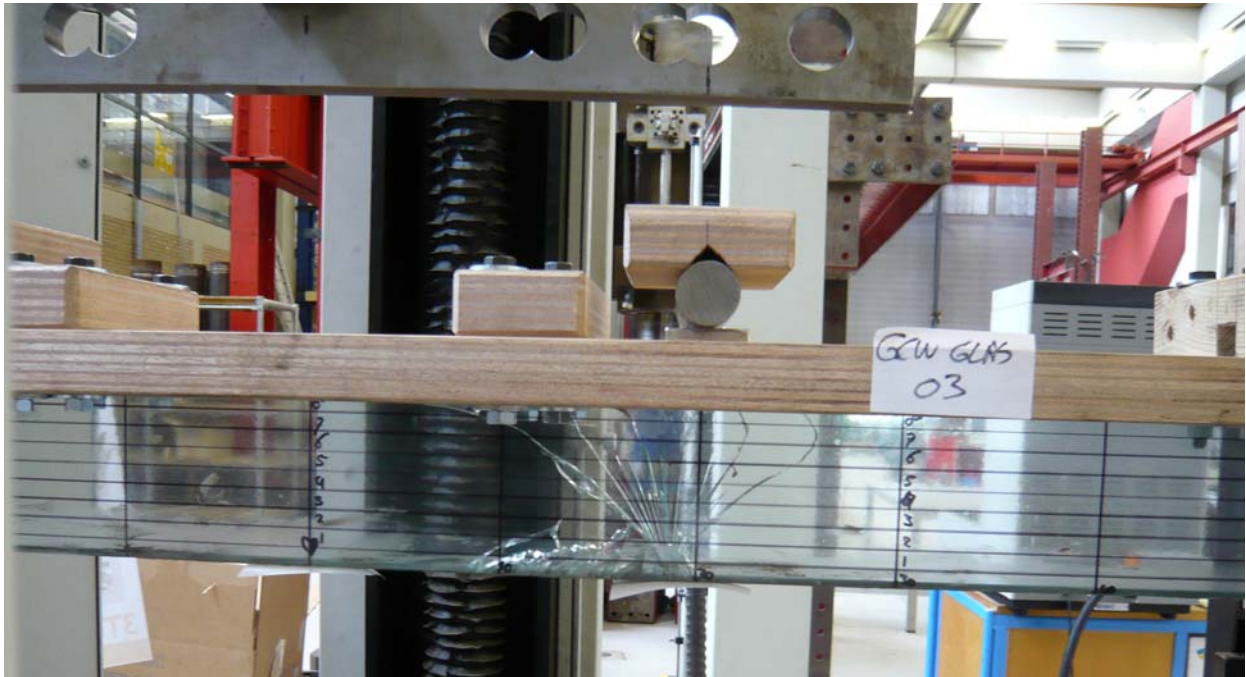
Figure 113, Test 3 at begin.

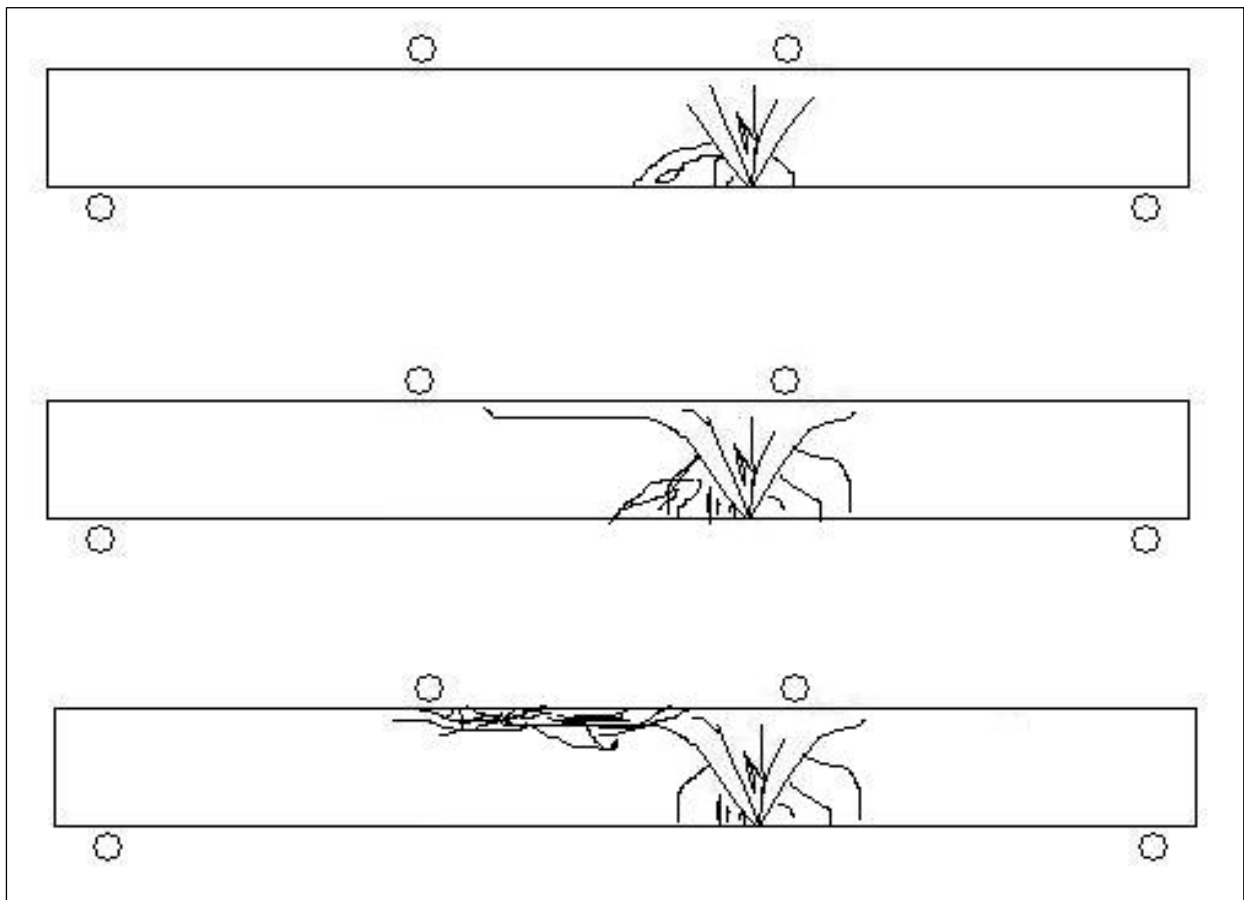
Figure 112, Crack growth during test 3.

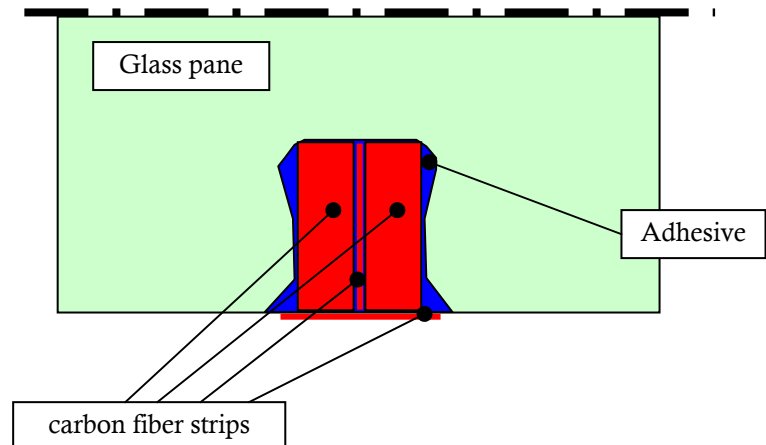
Figure 114, Close-up of bottom of girder cross-section with reinforcement geometry for specimen 2.

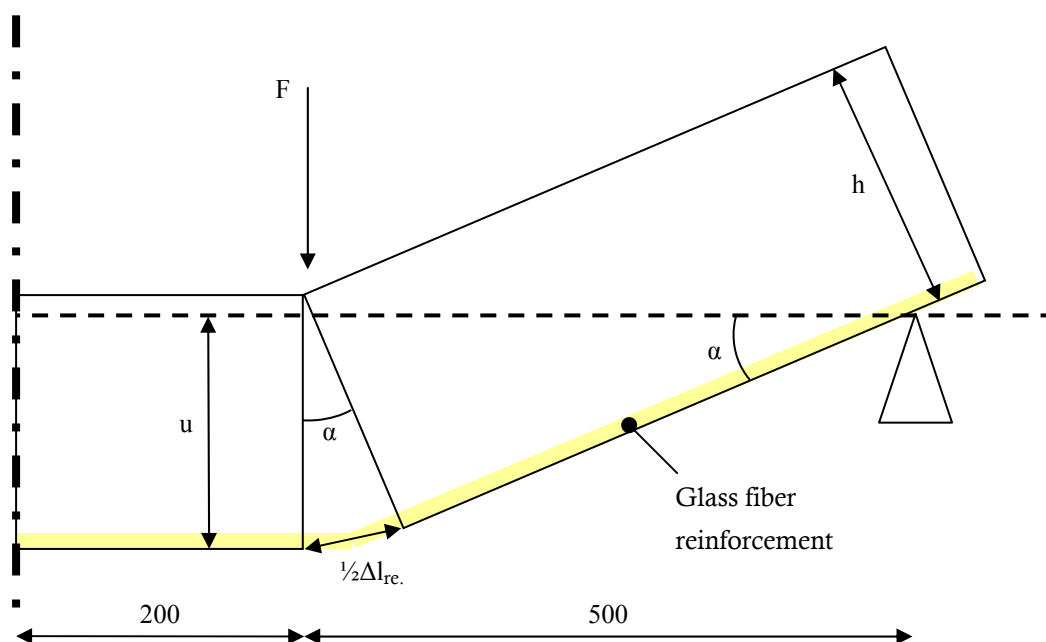
Figure 117, Schematic representation of half of girder in U.L.S.
