Mobile Water Monitoring Phetchaburi

Testing mobile app based data gathering in the Phetchaburi River Basin and possible applications

February 2018 – April 2018

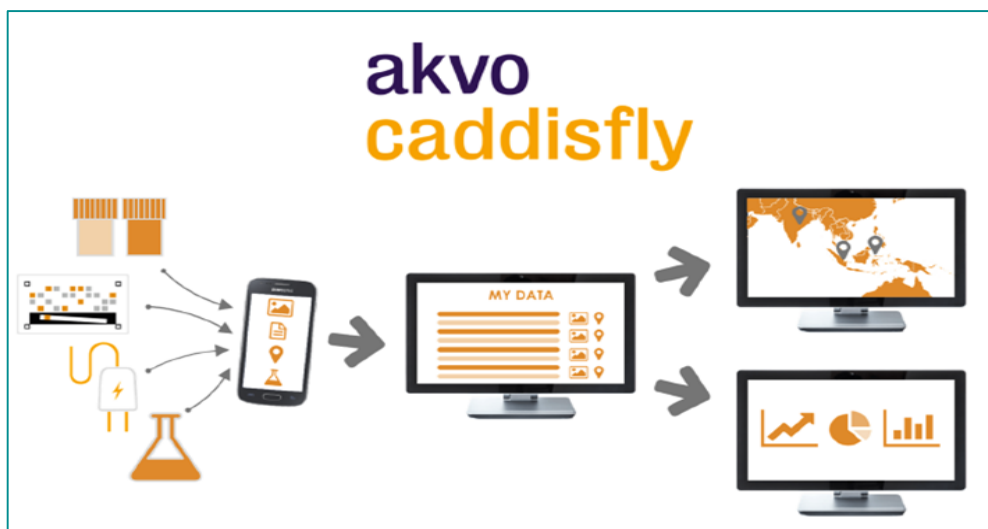
Fig. 2.3: Principles of Akvo Caddisfly (Akvo, 2017)

The mobile app itself can use four different measuring techniques: colorimetric, test strips, sensors and microbiology. Depending on measured parameter, the available budget, desired accuracy and measuring range, a measuring technique can be selected and used as input for the Akvo Caddisfly app. An overview of water quality parameters that can be measured with the Akvo app can be seen in Fig. 2.4. All the materials are relatively affordable and available to use in the field.

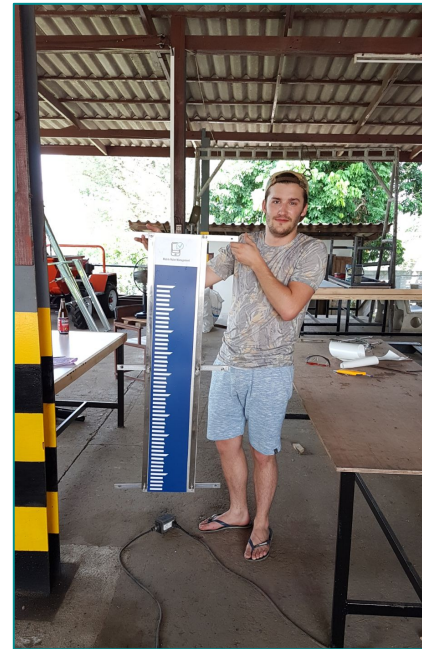
Fig. 2.6: Finalized MWM staff gauge

The materials used to build the design were all bought in stores in nearby villages. Knowing that the river has a low water quality and when nearing the river mouth, a higher salinity, a durable and less erodible material was needed. In addition, the staff gauges would heat up in the sun and cool down during the night, so the material should also have a low thermal expansion. The materials that were decided on are aluminium and stainless steel. Figure 2.6 shows a staff gauge ready to be used. Photos of the installed staff gauges and their final design can be found in Appendix B.

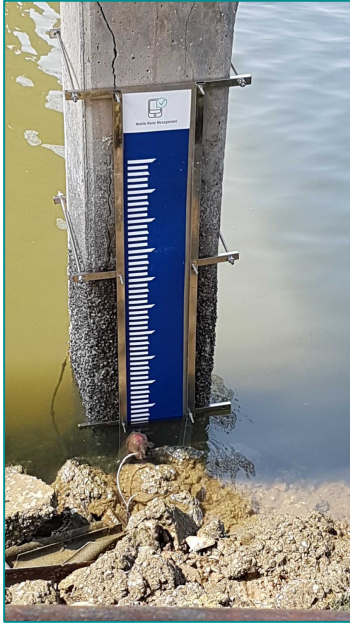
Fig. 3.3: Staff gauge at Location 1

Based on the criteria, 9 locations for the staff gauges were considered a match. These 9 locations are all easily accessible and it was easy to mount the staff gauges on either bridge pillars, or existing concrete staff gauges of the RID. Fig. 3.2 shows the locations of the staff gauges. In Appendix B pictures of the staff gauges on location can be found. Fig. 3.3 shows an example of the staff gauge at the river mouth. The numbering of the locations for water level and water quality are different. The numbering of the water level locations starts downstream at the river mouth and goes upstream towards the Kaeng Krachan dam, whereas the water quality is only measured downstream of the Phetchaburi diversion dam. The numbering for water quality starts at the Phetchaburi diversion dam, since the RID office is located there. Table 3.1 shows the names of the water quality and water level locations and the differences they may have.

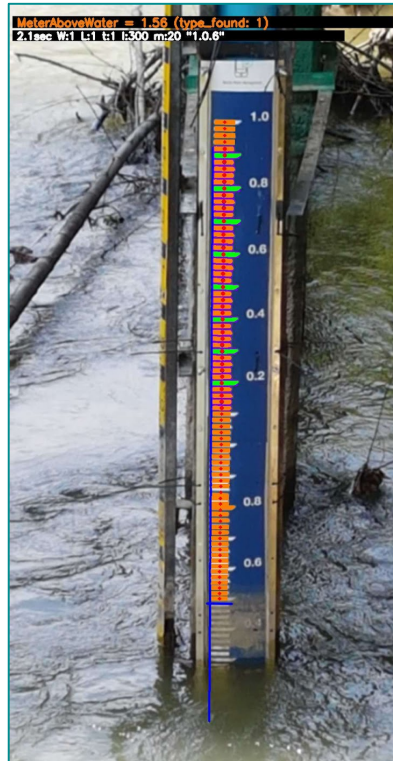
Fig. 4.1: Sedimentation on staff gauge (Location 3)

Fig. 4.2: Sedimentation on staff gauge (Location 3)

Sedimentation on the staff gauge sticker causes problems for reading the water level, especially if the sedimentation is still wet, see Fig. 4.1 and Fig. 4.2. How will the staff gauges perform when the amount of sediment on the sticker increases? This is not particularly important for the Netherlands, where surface waters are generally cleaner, but in countries like Thailand where rivers can carry a large amount of sediment this should be taken into account.

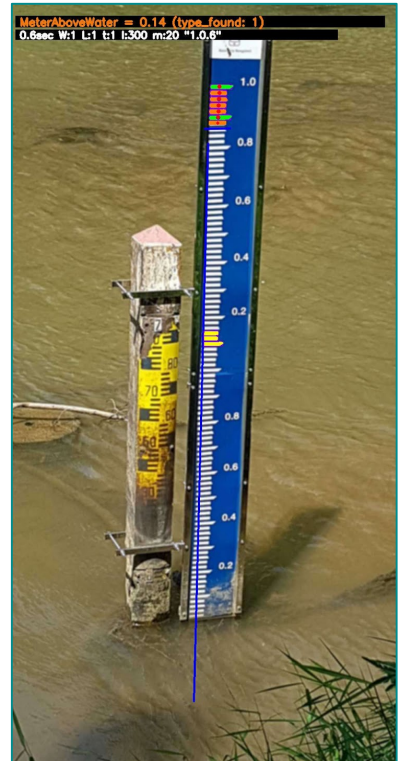
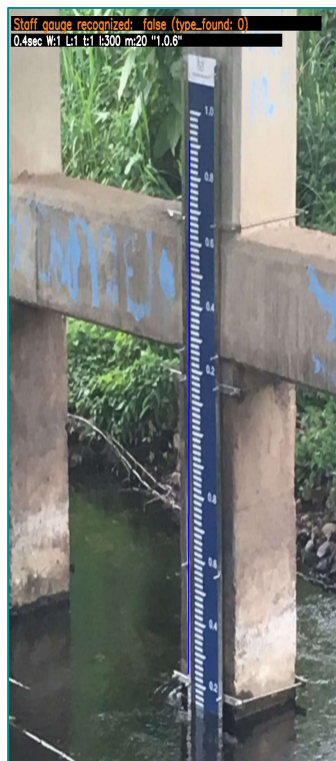
Fig. 4.3: Incorrect sticker alignment (Location 4)

Fig. 4.4: Incorrect sticker alignment (Location 9)

When the stickers weren't perfectly straight on the staff gauge, the app sometimes saw the water-boundary too high on the staff gauge. Cutting it off mid-way. We suspect this is because the algorithm wants to put a straight (blue) line on the left side of the stripes. When the blue line intercepts one of the stripes, or the metal bar on the left, it often recognized this as water-boundary, see Fig. 5.2. There were also cases that the app could not recognize a staff gauge at all if the space between the metal bar and the stripes was not big enough. This prevented the app from properly putting a straight line next to the stripes in the blue part of the sticker, making it impossible to recognize a staff gauge, see Fig. 5.3.

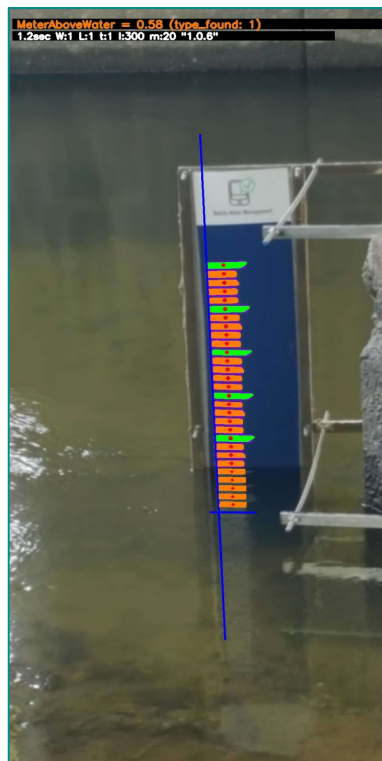
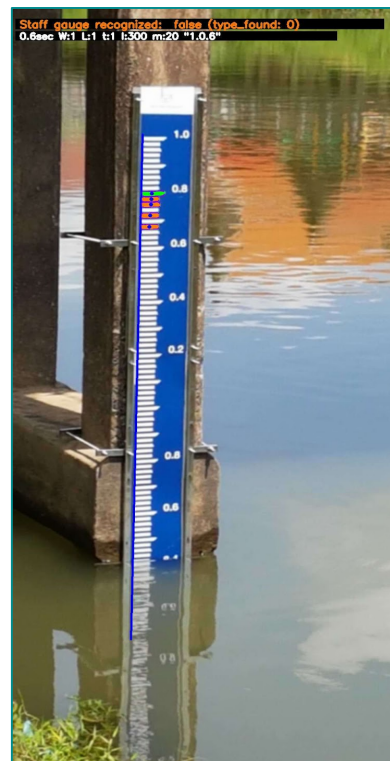
Fig. 4.5: Staff gauge water reflection (Location 6)

Fig. 4.6: Staff gauge water reflection (Location 2)

In some cases, the algorithm failed to account for the reflection of the water level, see Fig. 4.5 and Fig. 4.6. As a result, the measured water level was determined below the actual water level. While in general, the algorithm seems to do a good job accounting for water reflection, there is still room for improvement.

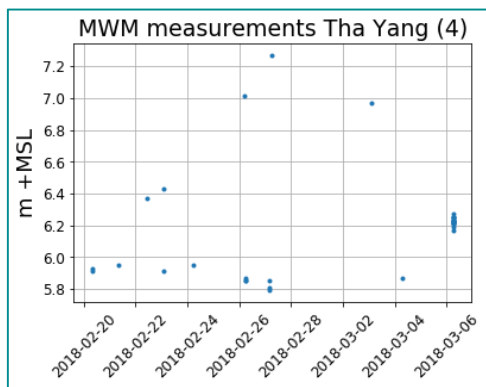
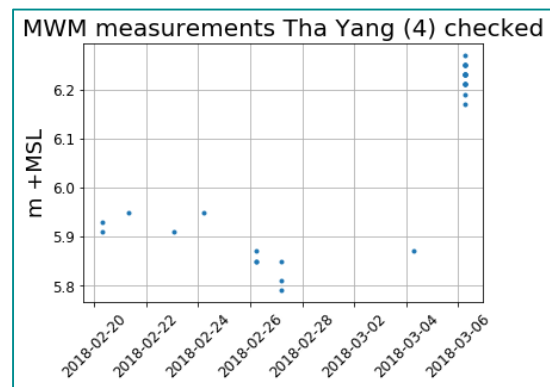
Fig. 4.7: Unchecked data (Location 4)

Fig. 4.8: Checked data (Location 4)

The Buddhist monk gathered interesting data to analyse, see Fig. 4.7. He took and accepted pictures without checking the quality of the measurement. This resulted in some questionable data points. Here you can see the need to check the measurements done through the app. After taking away the faulty data, the data seen in Fig. 4.8 resulted.

The figures also show a 5 cm spread sometimes, of measurements performed simultaneously. This spread might be due to waves and/or reflection of the staff gauge in the water. This will be elaborated upon further in section 5.

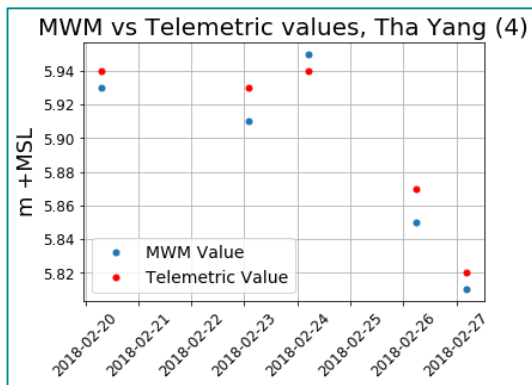
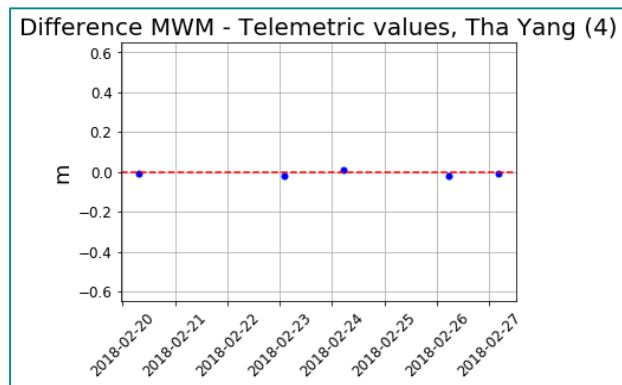
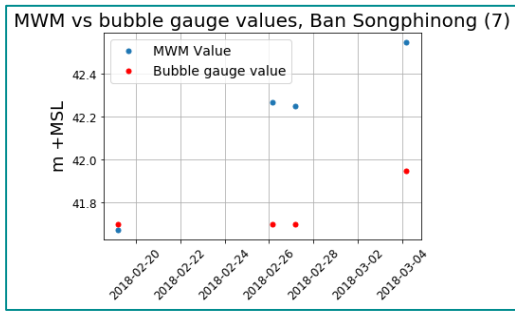
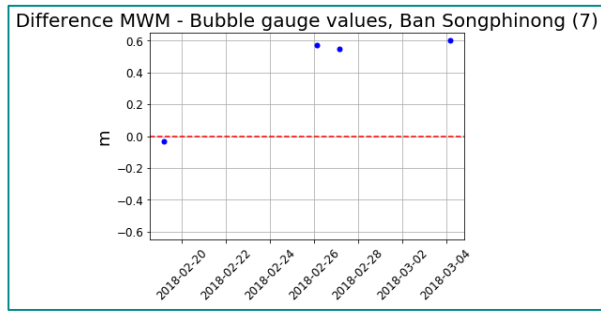
Fig. 4.9: Comparison with RID data (Location 4)

Fig. 4.10: Comparison with RID data, difference (Location 4)

Fig. 4.11: Comparison with RID data (Location 7)

Fig. 4.12: Comparison with RID data, difference (Location 7)

The data from the MWM app was compared to the data provided by the RID. The RID data was recorded with a telemetric system. The data from both these sources is plotted in one graph. Difference graphs are added for clarity. All graphs can be found in Appendix D2. In Fig. 4.9 – Fig 4.12 the graphs for Tha Yang (station 4) and Ban Songphinong (station 7) are shown.

The figures show that at most locations, there is a discrepancy between the MWM staff gauges and the existing telemetric system. The power of the MWM app is that it can be proven that the measurements taken through the app were done correctly by examining the pictures. The consistent errors can be explained with a difference in set-point level in the reference system. However, in most cases the differences increase and decrease in size, which could be explained by irregularities in the telemetering system. We summarized the functioning of the existing system in Table 4.1. The stations marked in green are ok, according to the verification with our data. The stations marked in yellow we suggest to check, because of some (small) irregularities. The stations marked in red show large unknown differences and require a more in-depth check of the collected data.

At Ban Songphinong (location 7), the difference is small at first. However, it seems that the automatic system is not recording smaller (up to 50 cm) changes in the water level. The station indicates a constant level, where the staff gauge shows an increase in water level. When the MWM data shows a water-level increase of almost 100 cm, the automatic system shows an increase of about 20 cm. It is recommended to investigate these differences in the data.

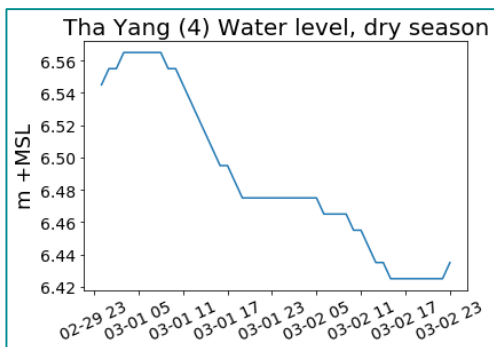
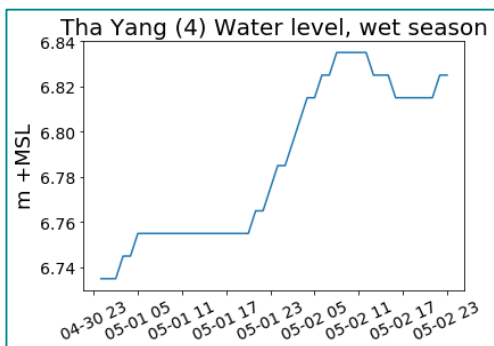
Fig. 4.13: Water level, dry season (Location 4)

Fig. 4.14: Water level, wet season (Location 4)

Even though station 4 only shows small differences in measured water level, when checking the data, it appears that the station doesn't gradually increase or decrease as expected, but there are jumps to different levels, giving a stepped graph (see Fig. 4.13 and 4.14). That is why it is advised to check whether the device is working correctly.

The Tha Yang (location 4) station shows the least difference in water level with our measurements. This would suggest the station is working fine. However, when looking at the raw data of the RID, the shape seems to be off. It shows a stepwise measurement of the water level, which is different from the data given by the other stations in Phetchaburi. This could be because it is an older measuring device with a lower resolution. This could not be checked at this point during the study. It is recommended that this station is inspected by either the RID or KU for possible signs of malfunctioning or damage.

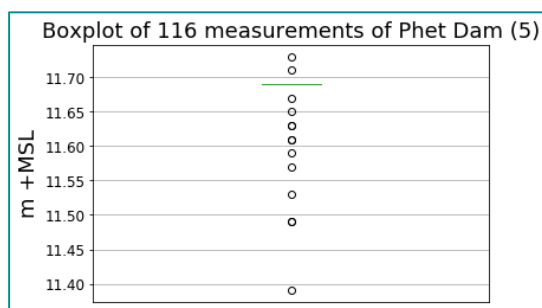
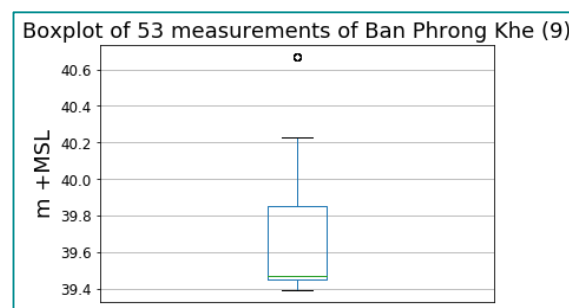
Fig. 4.15: Accuracy of measurements (Location 5)

Fig. 4.16: Accuracy of measurements (Location 9)

In Fig. 4.15 and Fig. 4.16, the boxplots of the measurements for both sites can be found. The following data was recorded:

These results show that the need for human verification of the measurement done by the MWM app is necessary for a reliable dataset. The standard deviation of 4.4 cm in ideal conditions is acceptable, however the 48 cm is unacceptable to have present in your dataset.

When performing the error analysis at Phet Dam, a spread was found in the measurements. These were mostly caused by the reflection of the staff gauge in the water. This only occurred when the picture was taken right in front of the staff gauge, perfectly aligning the staff gauge with its reflection. In general, the results here are good, with a standard deviation of 4.4 cm. But the highest outlier showed a difference of 30 cm, confirming the need for human verification of the measurement.

The error analysis at Ban Phrong Khe was less successful. A standard deviation of 48 cm was found, which is unacceptable. This again shows the need for human verification of the measurement. This would make sure that these faulty measurements would never be accepted in the dataset. The Ban Phrong Khe staff gauge was the least ideal staff gauge of this project, with the most deviation in the sticker that was placed on the staff gauge. The staff gauge was 2m tall and was made with 2 stickers of 1 m. This made it extra hard to perfectly align the sticker. The lack of reception at this location also makes it hard for human verification of the measurement, since the photo could only be sent to MWM when reception was restored. This would also be the moment when one could see if the algorithm had made a mistake. A solution to this would be to have the algorithm be available on the apps offline, and not only on the server of MWM.

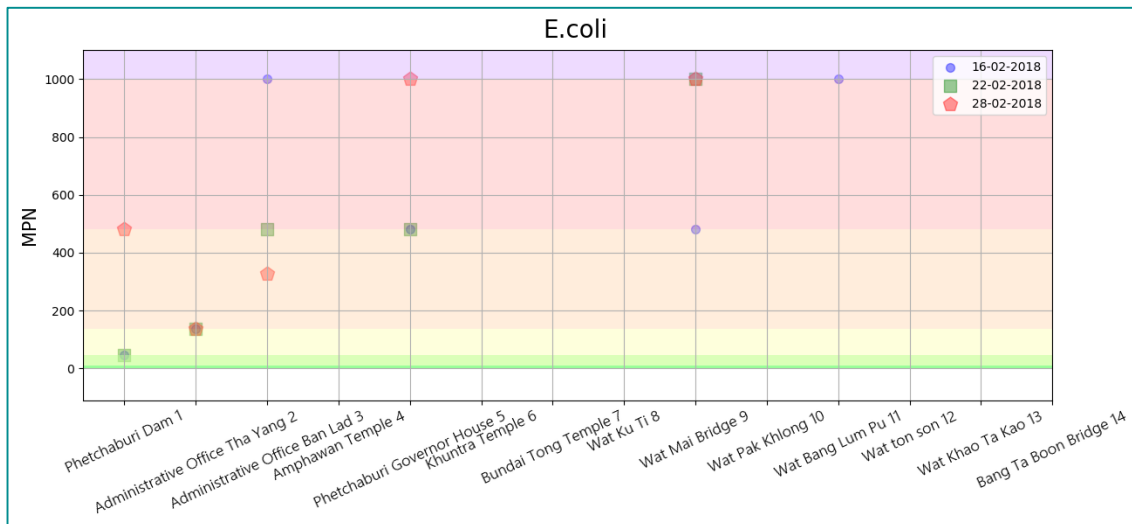
Fig. 4.17: E. coli measurements

In Fig. 4.17 the measured E. coli is shown. The present E. coli has been measured at Phet Dam (location 1), Tha Yang (location 2), Ban Lat (location 3), Phetchaburi Provincial Governor's house (location 5), Wat Mai Bridge (location 9) and Wat Bang Lum Pu (location 11). The measurements were taken for three weeks.

It can be seen that as you go downstream, the amount of E. coli present in the water increases. This coincides with the present settlements that are along the river. The graph has six colour bands which indicate the safety for human use whether for recreation water or application for irrigation. The colours are explained in the table here below. Recreation water risk is based on EPA Recreational Water Quality Criteria and for irrigation it is based on US FDA Regulation. Compliant means the water quality is within the standard and can be used for irrigation ("Compartment Test Bag", n.d.).

The measured E. coli shows an increase when going downstream. When looking at the land-use map (Appendix C) it can be seen that after human settlements, the E. coli present in the water increases. This can be explained with the fact that untreated wastewater is being discharged in the rivers. After every human settlement, the total amount discharged increases, making the river more polluted. At location 2 Administrative Office Tha Yang, the E. coli MPN value is consistently in the orange range. It means it has a high risk when it is used for recreation water and it is also not recommended to use for irrigation. This whole test seems to suggest that water after location 2 shouldn't be used for recreation or irrigation (non-compliant). Location 1 at the Phetch Dam is the cleanest of all location. Though, there is one moment in which the E. coli MPN value reached the "High risk" category and it is non-Compliant. This may be concerning as this water is used for irrigation. To get an understanding if this value is an outlier or not, more E. coli test should be done.

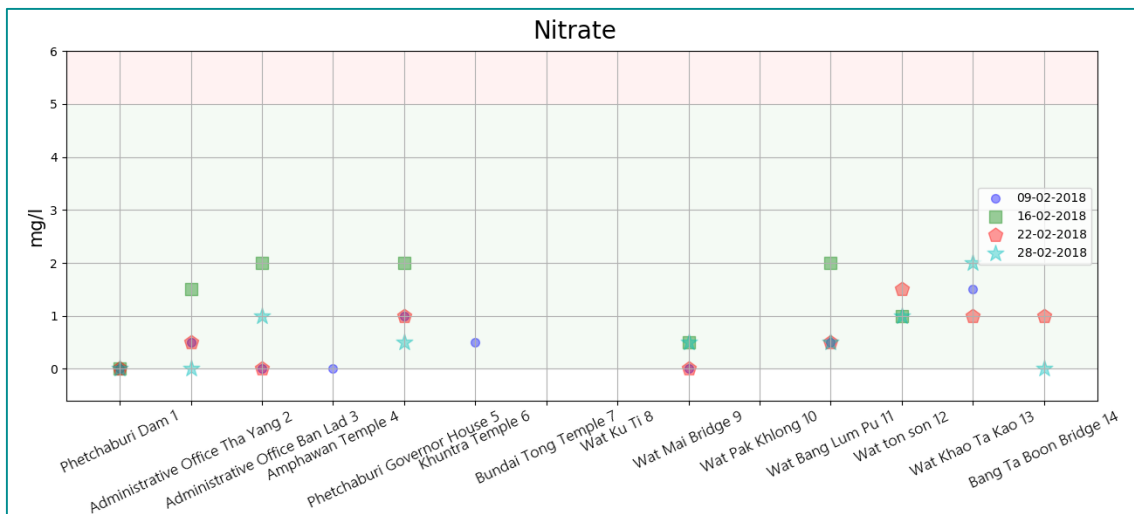
Fig. 4.18: Nitrate measurements

Fig. 4.18 shows the taken nitrate measurements. Generally, nitrate is of no issue in the river. The concentration stays within an acceptable level throughout the river. It is within the Thai standard (Notification of the National Environment Board, 1994) of 5 mg/l Nitrate.

Nitrate levels show an acceptable level throughout the river. This indicates that the farmers among the river do not use an excessive amount of fertiliser for their crops and that the total amount of nitrates discharged by wastewater is still acceptable during the period of measurement. However, the measurements for this research are only done in a specific period of the year. Previous research shows that high nitrate concentrations can occur in dry periods during extreme dry years or during the first flush after a long dry period (Voravong et al., 2014). This pollution is likely caused by the runoff of pig farms and fish/shrimp farms and takes place mainly in the coastal zones near Bang Ta Boon and Baan Laem. Monitoring of nitrate concentration in these areas in different seasons can still be useful for example with a monthly interval. High nitrate concentrations can have negative consequences for human health, the environment, biodiversity of the area and even the agricultural production itself.

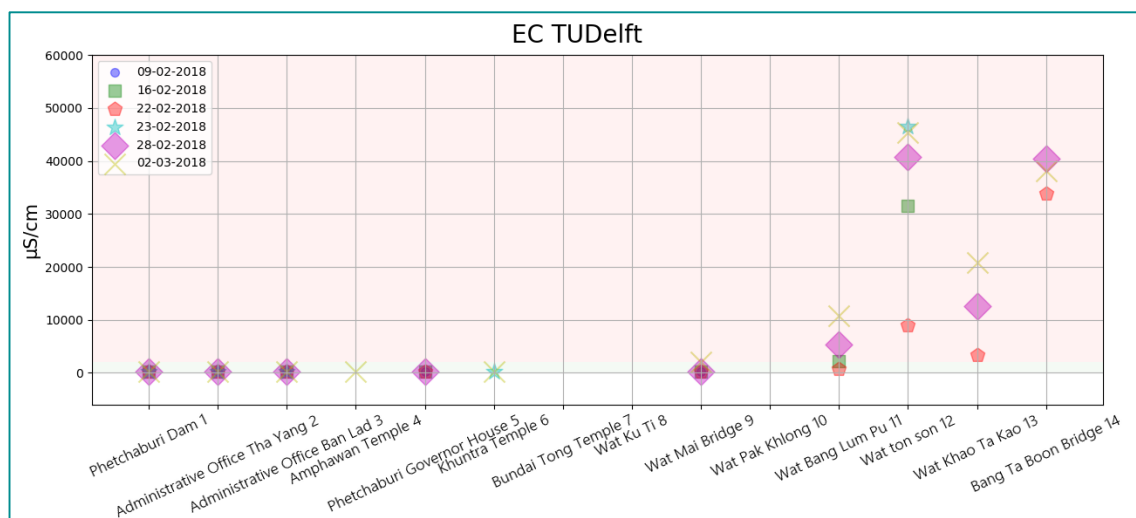
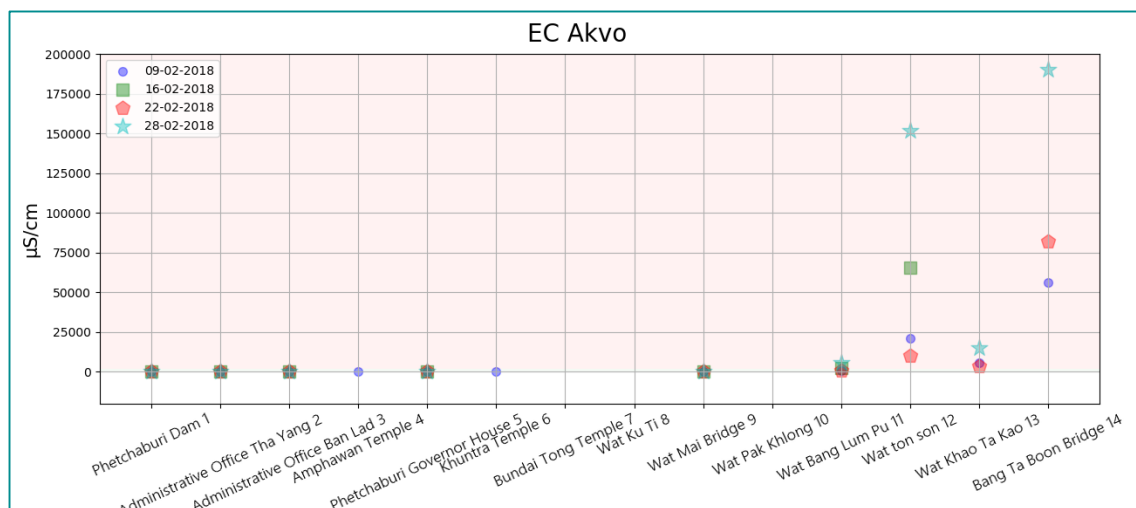
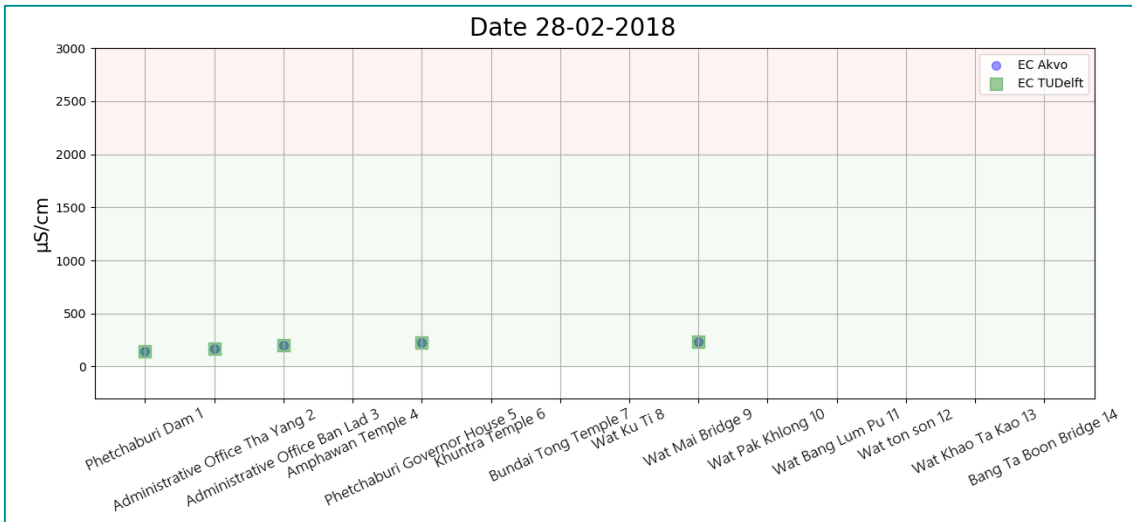
Fig. 4.20: EC measurements, TU Delft equipment

Fig. 4.21: EC measurements, Akvo equipment

Fig. 4.22: EC measurements, comparison between TU Delft and Akvo equipment

In general, the results of the conductivity measurements show increasing values in the downstream direction of the Phetch river, as can be seen in the graphs below. One can also see that downstream of point 9 (Wat Mai bridge) EC values fluctuate significantly between different measuring days. In all the EC graphs the RID EC standard of 2000 $\mu\text{S}/\text{cm}$ is indicated to use as a reference and to if the water still can be used for irrigation.

The conductivity measured with Akvo device shows similar results to EC TU Delft, see Fig. 4.20. A tremendously high EC is measured at Wat Bang Lum Pu (location 11) and Bang Ta Boon Bridge (location 14). This is due to the fact that the Akvo EC meter range goes up to 12500 $\mu\text{S}/\text{cm}$. Exceeding this value will yield inaccurate results. However, the Akvo EC meter results are nearly identical to those from EC TU Delft below 12500 $\mu\text{S}/\text{cm}$. It is so identical that it doesn't give additional information. Fig. 4.22 shows how similar the results of both measurement devices are. For this reason, only the TU Delft EC meter is utilized for RID measurement comparison, as it also has a greater range to measure high EC. More detailed comparison between the Akvo EC meter and TU Delft EC meter can be found in Appendix F.

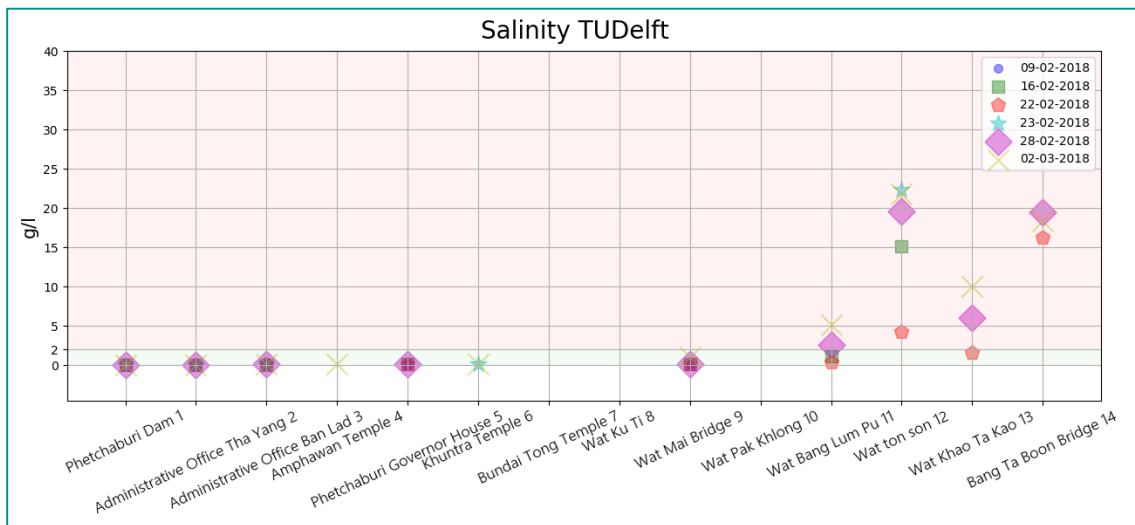
Fig. 4.23: Salinity measurements, TU Delft equipment

Besides the standards for EC, the RID also utilizes standards for salinity. To check whether the performed measurements in this research also meet the RID salinity standards, the EC values are converted to salinity using a conversion factor that the RID uses as well. Fig. 4.23 shows the salinity derived from the EC TU Delft measurements. A more zoomed in version of this graph can be found in appendix F.

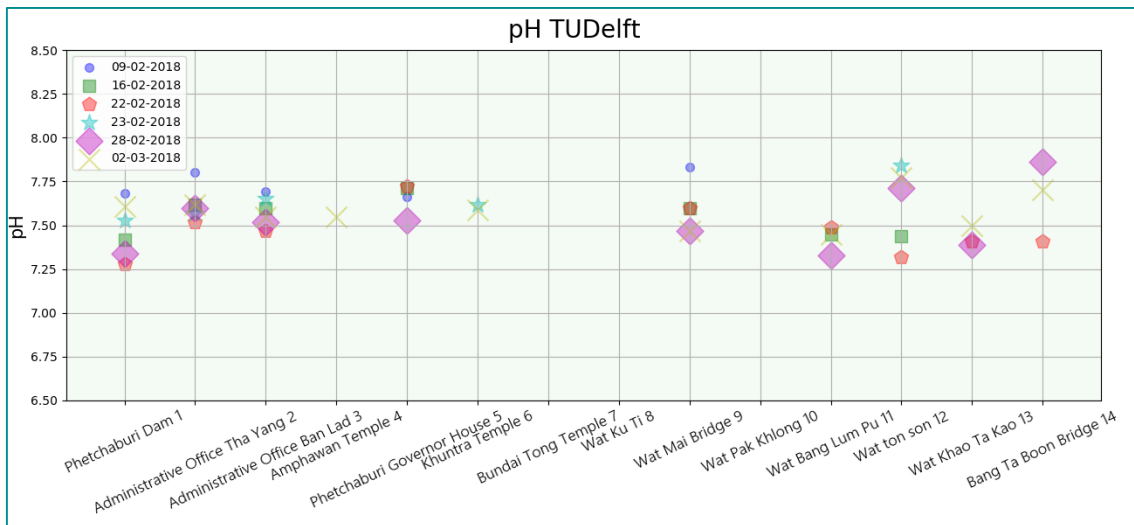
Fig. 4.24: pH measurements, TU Delft equipment

The pH measurements done with the TU Delft device are shown in Fig. 4.24. The pH of the river water stays within acceptable limits all throughout the river.

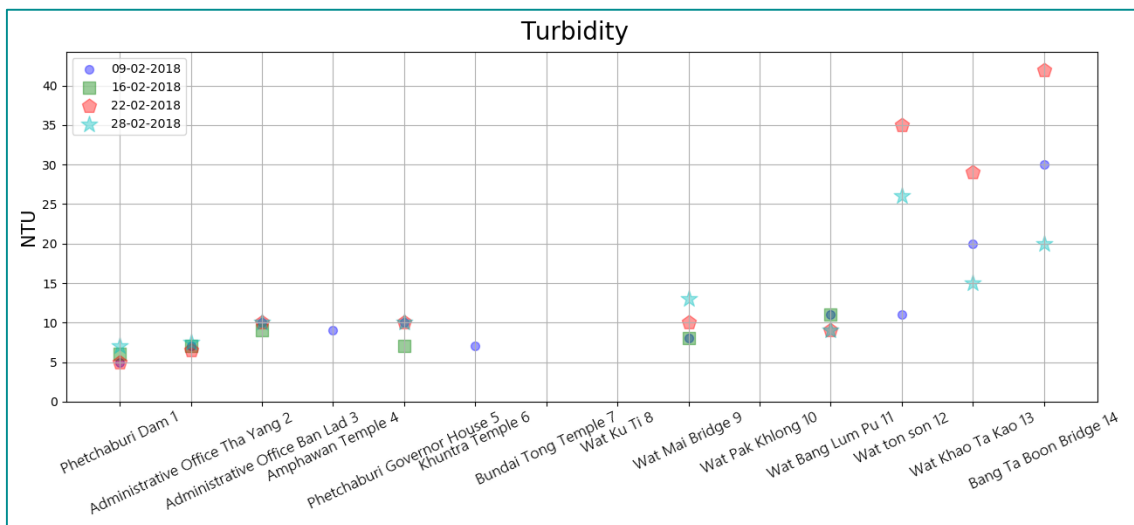
Fig. 4.25: Turbidity measurements, Akvo equipment

The turbidity measurements taken with the AKVO app can be seen in Fig. 4.25. Turbidity increases as you go downstream of the river.

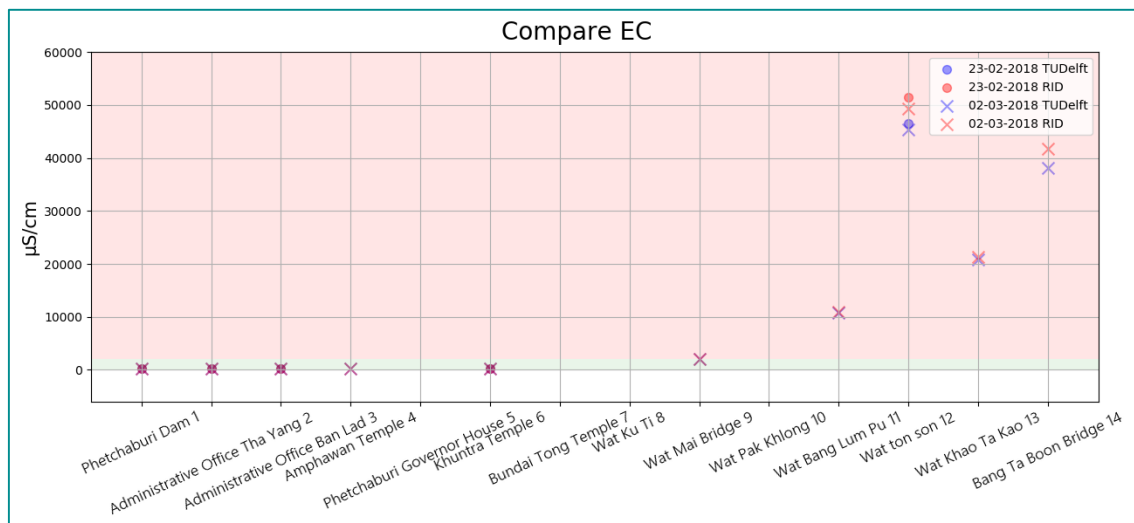
Fig. 4.26: EC measurements, comparison between TU Delft and Akvo equipment

Looking at Fig. 4.26, when comparing the EC data to the data gathered by the RID it is clear that both are similar. Only with higher EC values the difference starts to show.

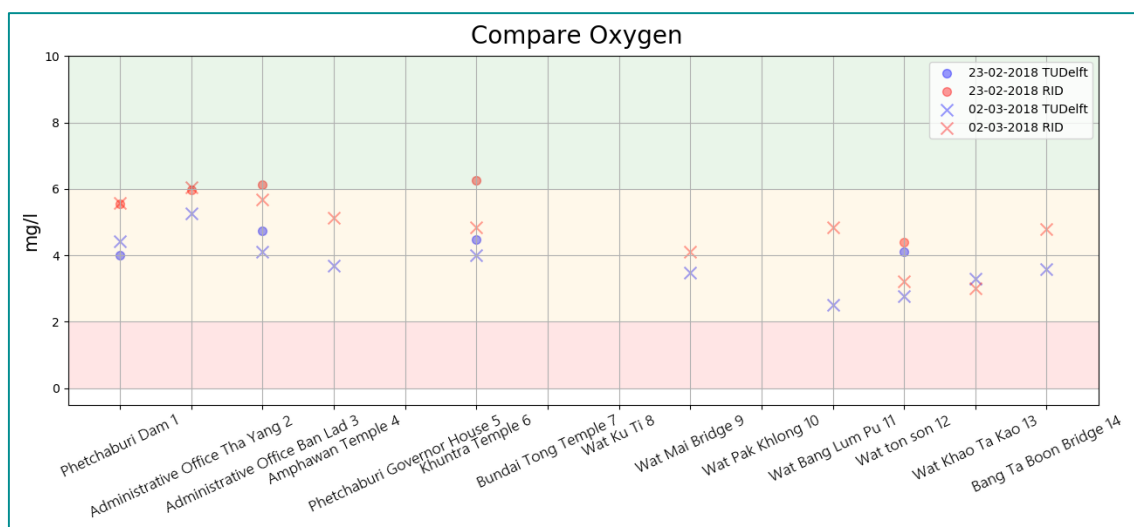
Fig. 4.27: Oxygen measurements, comparison between TU Delft and Akvo equipment

As can be seen in Fig. 4.27 the measurements done by the RID's oxygen meter are consistently about 1 mg/l higher. It is likely that the values of the RID data for dissolved oxygen over 2 years as shown in Appendix E1 contain the same error.

The dissolved oxygen concentration measured by the TU Delft equipment is consistently 1 mg/l lower than the DO measured by the RID. This offset is quite significant and should be reason to re-calibrate both sensors. It was mentioned that the RID had replaced their old DO sensors with a new model, which unfortunately broke and they were forced to switch back to the old model. As mentioned in 5.1.1, the Thai DO-standard for surface water is 4 mg/l for irrigation and drinking water. Downstream from the Phet dam these standards are not always met. When going further downstream, the RID measured DO concentration nearly reduces to 2 mg/l. This is still above the RID standard of 2 mg/l. However, if the offset between the TU Delft equipment and the RID equipment is caused due to calibration issues of the RID sensor, this could mean that in fact the DO concentrations are less than 2 mg/l.

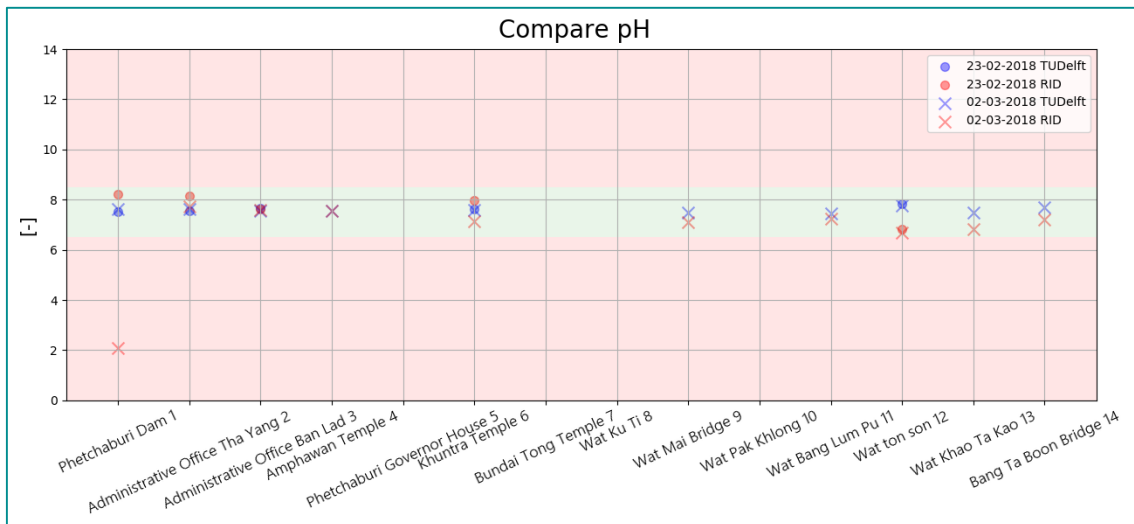
Fig. 4.28: pH measurements, comparison between TU Delft and Akvo equipment

In general, the gathered pH data corresponds well with the data gathered by the RID. There was one instance where pH determined by the RID was significantly lower; this measurement was done at location 1 on 02-03-2018. It turned out that this measurement is incorrect due to a typing error. Otherwise, the measured pH is within acceptable limits throughout all measurement locations.

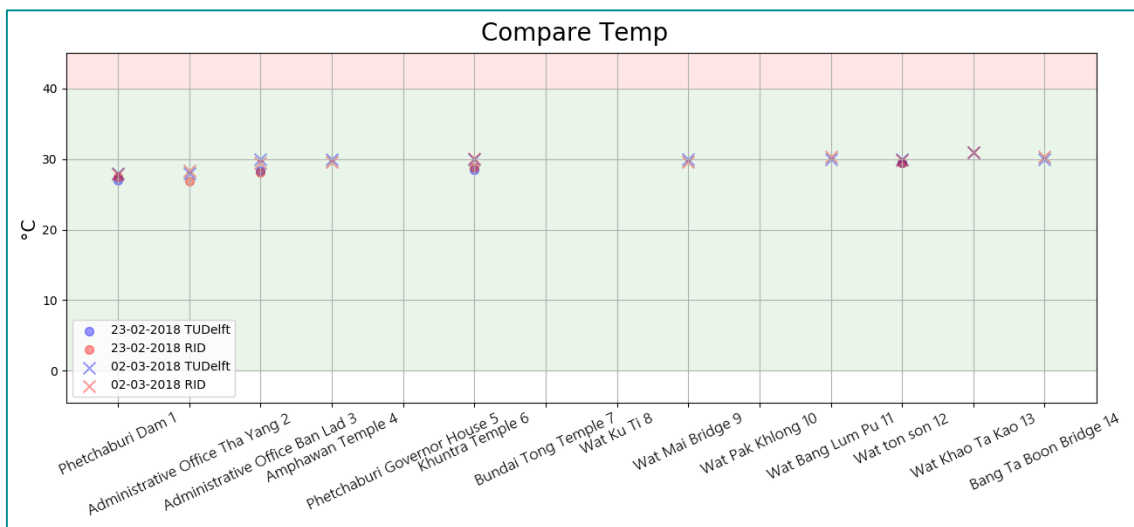
Fig. 4.29: Temperature measurements, comparison between TU Delft and Akvo equipment

The temperature data collected by the RID corresponds well with our collected data, and shows acceptable values for all the measurement stations.

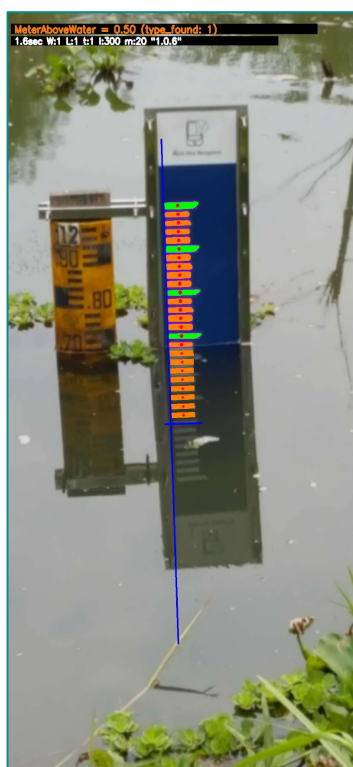
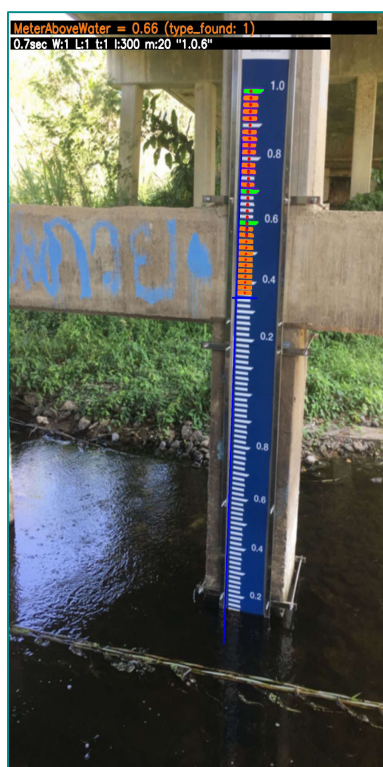
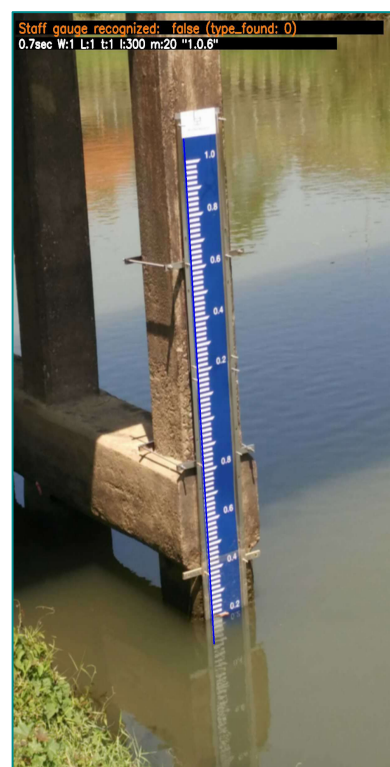
Fig. 5.1: Water reflection

Fig. 5.2: Incorrect sticker alignment

Fig. 5.3: Staff gauge not recognized
