## Dealing with Heritage Assessment and Conservation

Lubelli, B.; Pottgiesser, U.; Quist, W.J.; Rexroth, Susanne

Assessment and Conservation

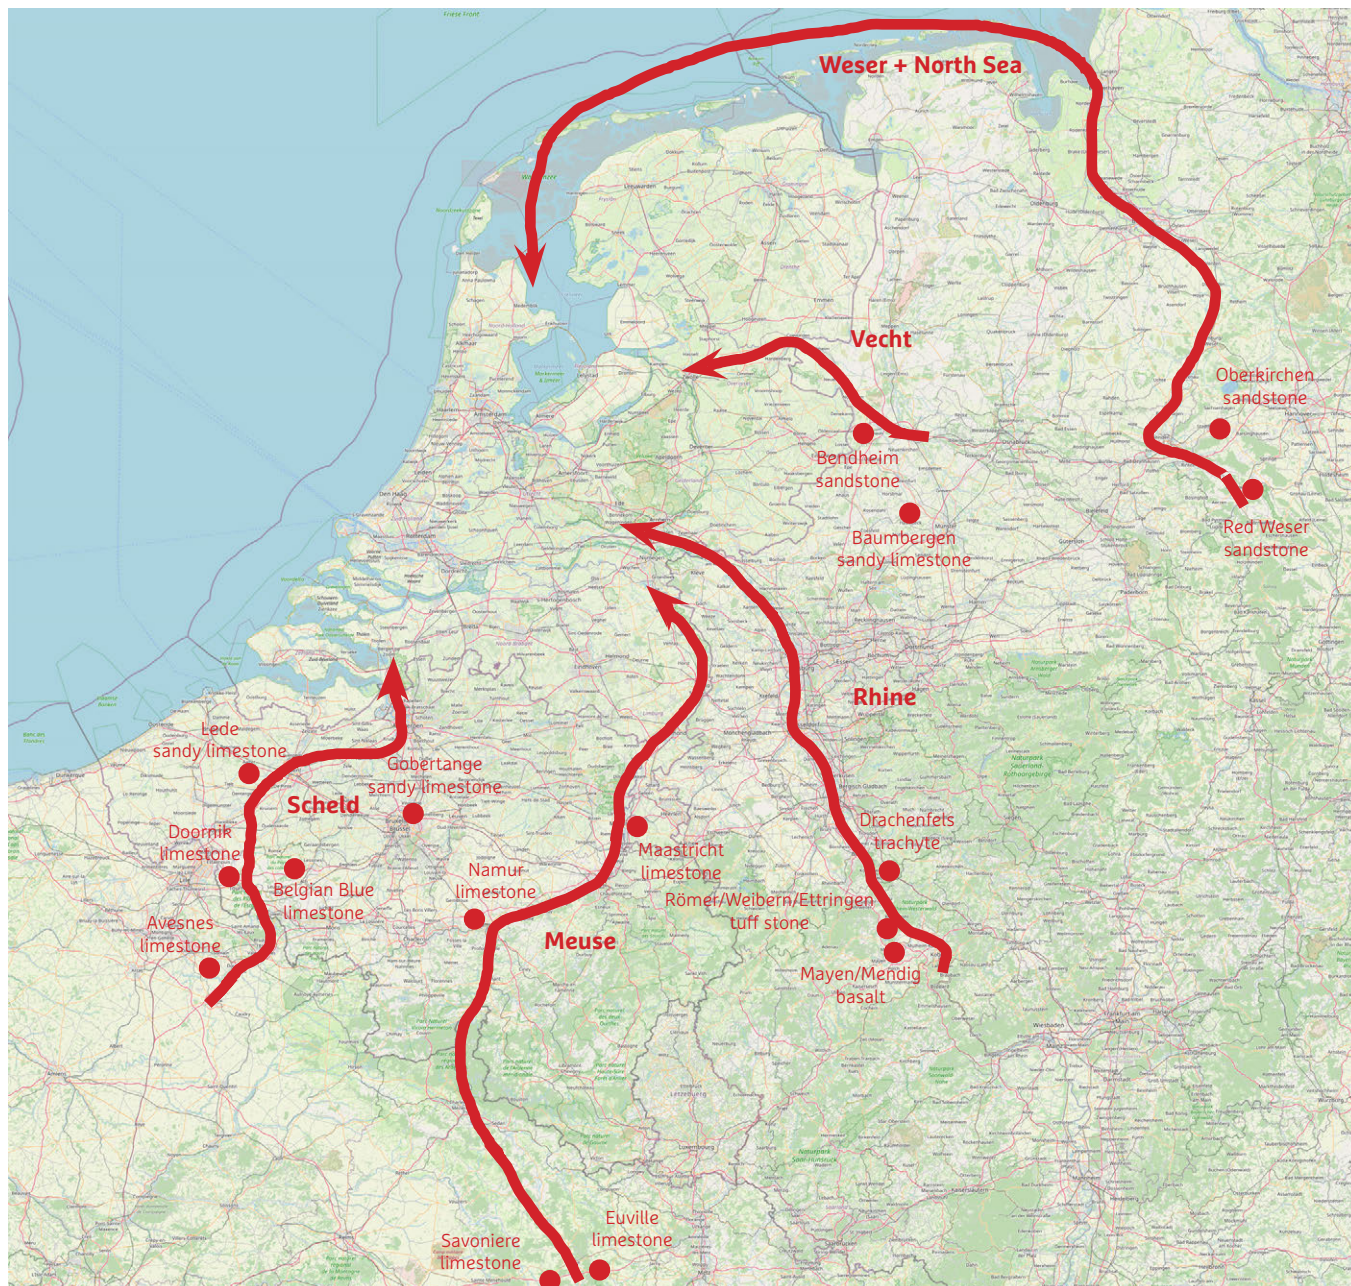
FIG. 2.2 Areas of origin of natural stone types used in historic buildings in the Netherlands with their direction of distribution (base map: openstreetmap)

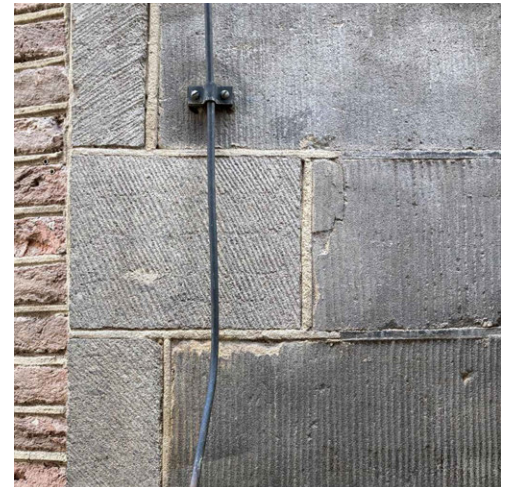
FIG. 2.7 Peperino Duro (left) used to replace Bentheim sandstone (right) in the Nieuwe Kerk in Amsterdam / Photo: W.J. Quist

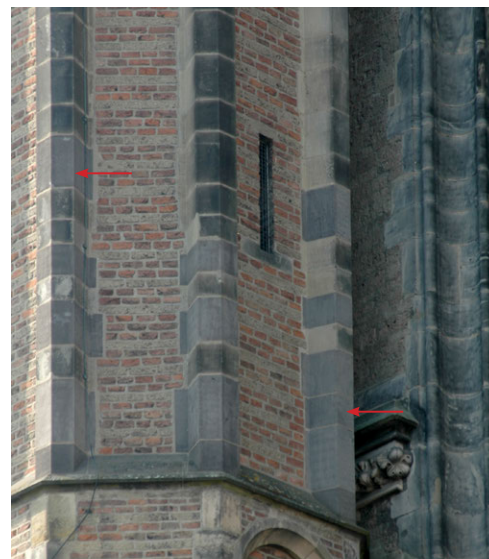
FIG. 2.9 Volvic basalt on the stair tower of the south transept of the Dom Church in Utrecht, as a replacement for Bentheim sandstone / Photo: W.J. Quist

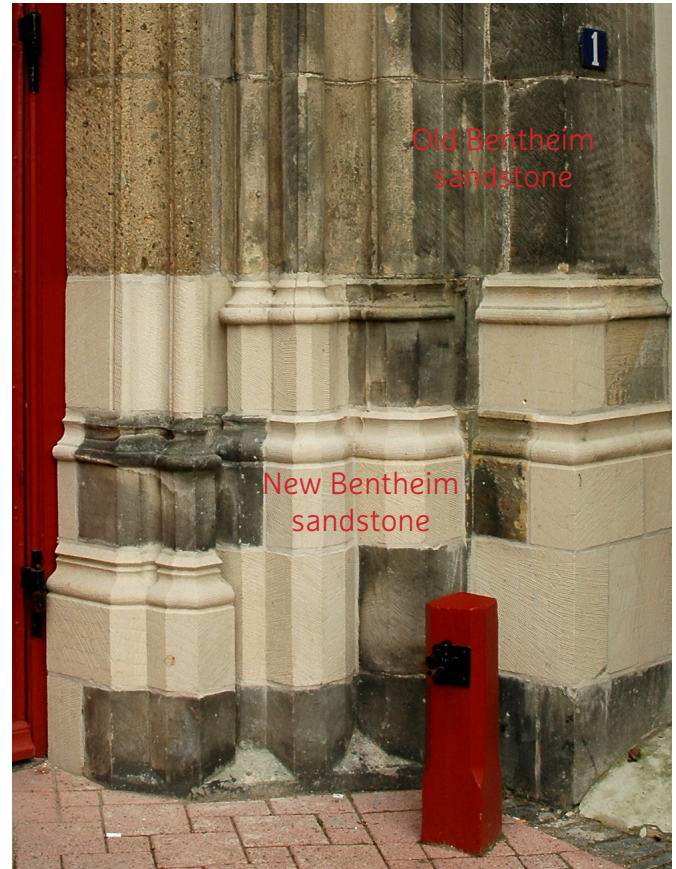
FIG. 2.11 Bentheim sandstone at the south portal of the Sint-Joriskerk Amersfoort / Photo: W.J. Quist

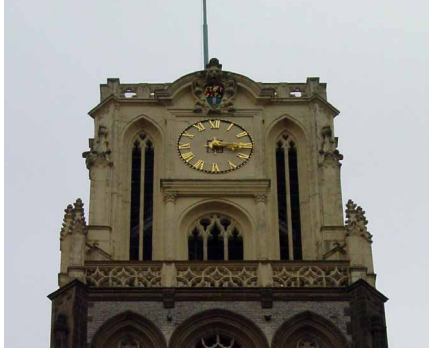
FIG. 2.12 The painted lantern of the Laurens Church tower in Rotterdam before conservation / Photo: W. Quist

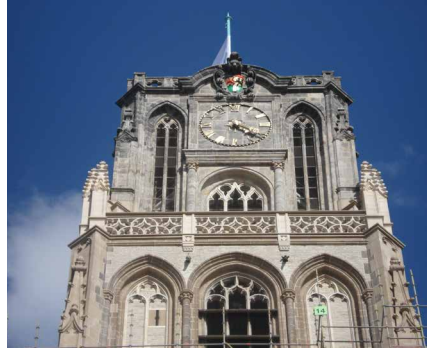
FIG. 2.13 The lantern of the Laurens Church tower in Rotterdam after conservation / Photo: W. Quist

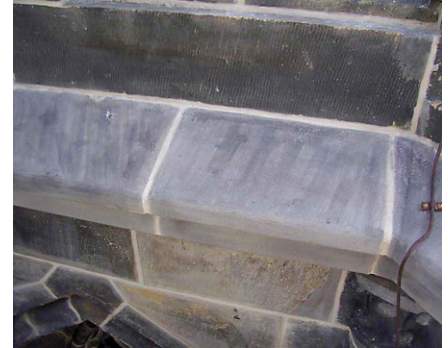
FIG. 2.14 Artificially patinated Bentheim sandstone on the lantern of the Laurens Church tower in Rotterdam / Photo: T.G. Nijland

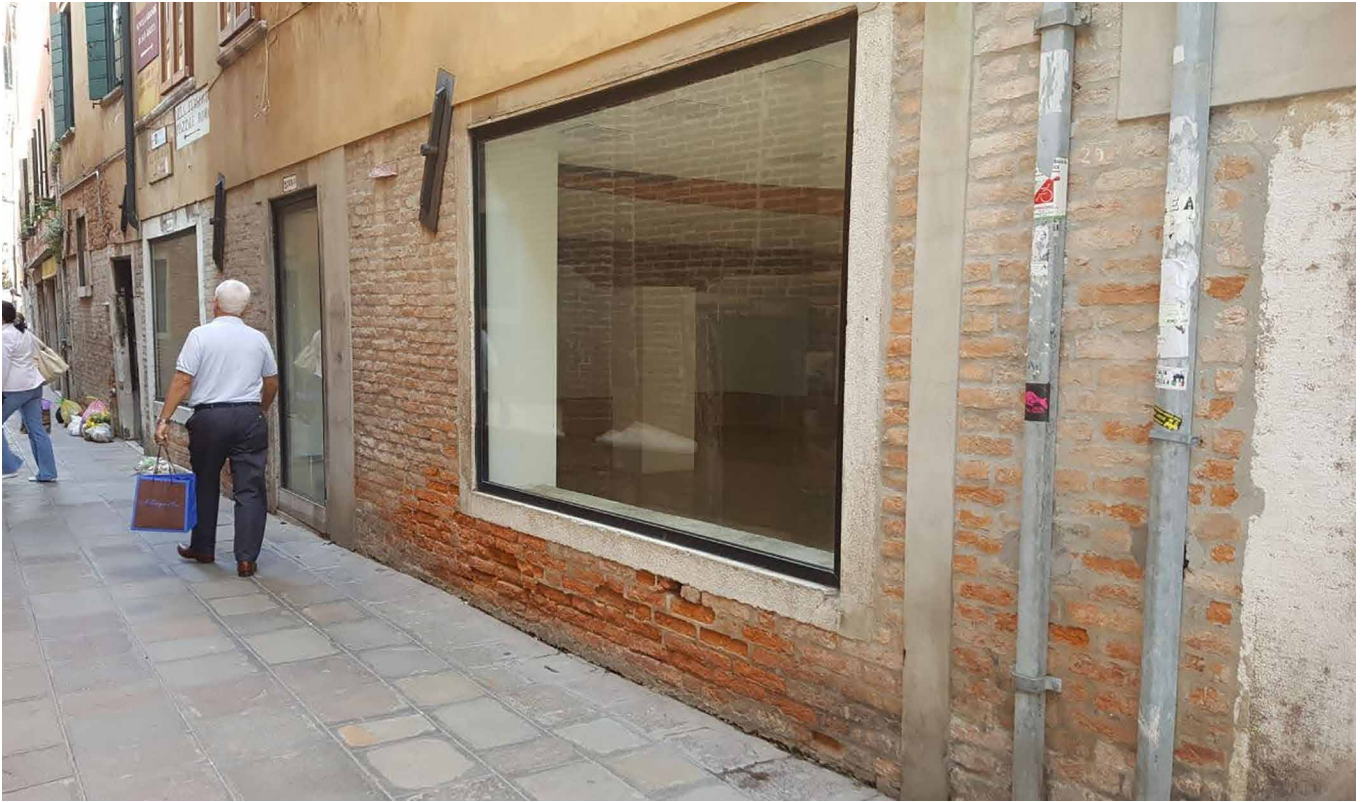
FIG. 3.1 Salt crystallization damage due to the presence of salts and rising damp, Venice, Italy / Photo: B. Lubelli

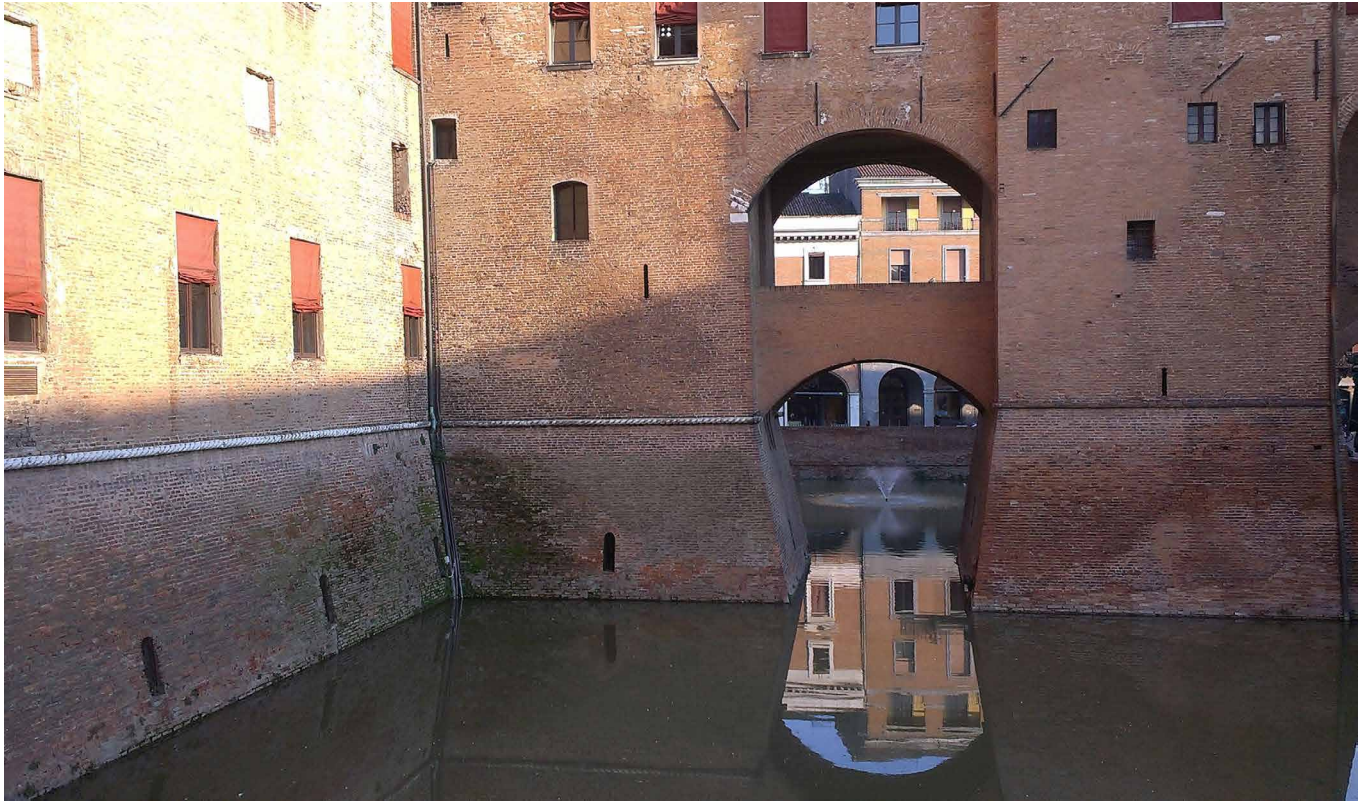
FIG. 3.2 The height of rising damp is generally limited to 1,5-2 meters, Ferrara, Italy / Photo: B. Lubelli

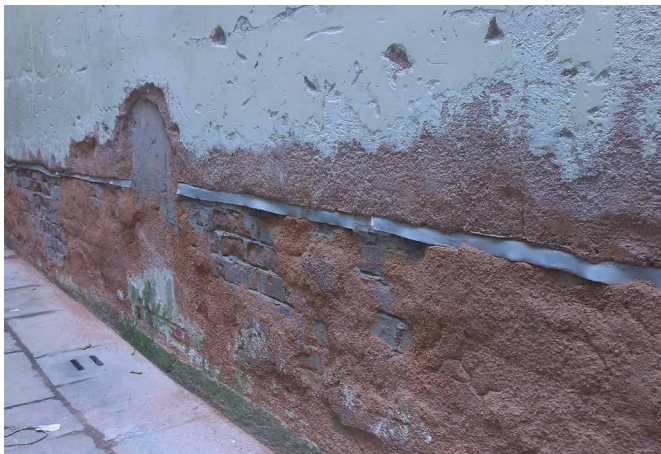
FIG. 3.3 Mechanical interruption of the wall by the use of plastic sheet, Venice, Italy / Photo: B. Lubelli

- *Mechanical interruption:* a layer of impermeable material, e.g. a lead slab, is inserted in the wall, generally after removing of a joint or of a course of masonry (see e.g. Massari and Massari, 1985) [FIGS. 3.3/3.4];

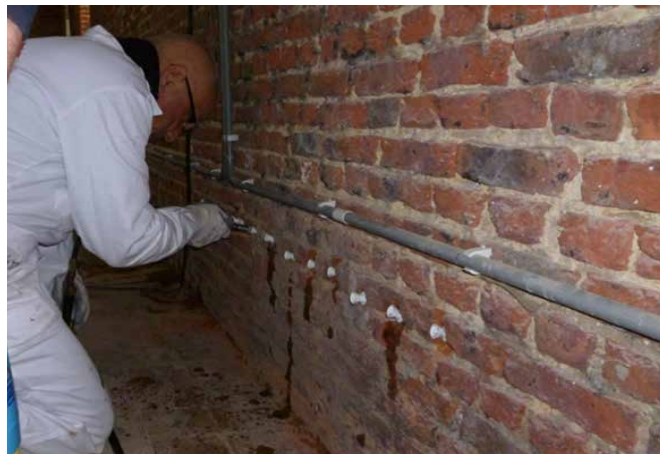
FIG. 3.5 Injection of a liquid product by means of pressure / Photo: B. Lubelli

- *Chemical interruption:* chemical products, meant to fill the pores and/or make them water repellent, are injected (under or without pressure) in a series of holes drilled at a distance of 10-15 cm from each other along a horizontal line in the wall [FIG. 3.5]. The product should spread to form a horizontal layer through the whole section of the masonry, stopping water from rising any higher up the wall [FIG. 3.6];

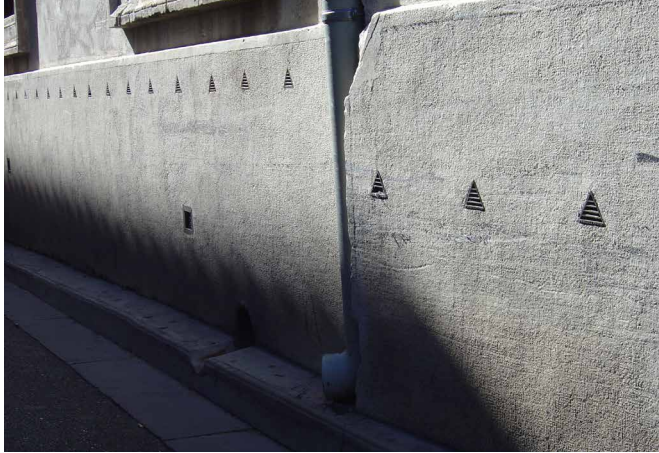
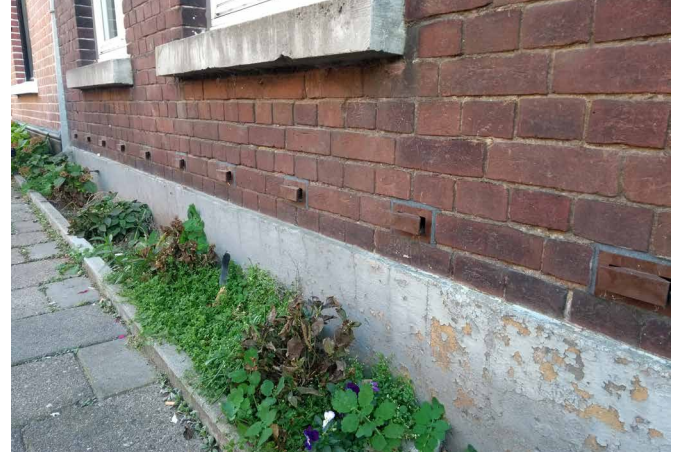
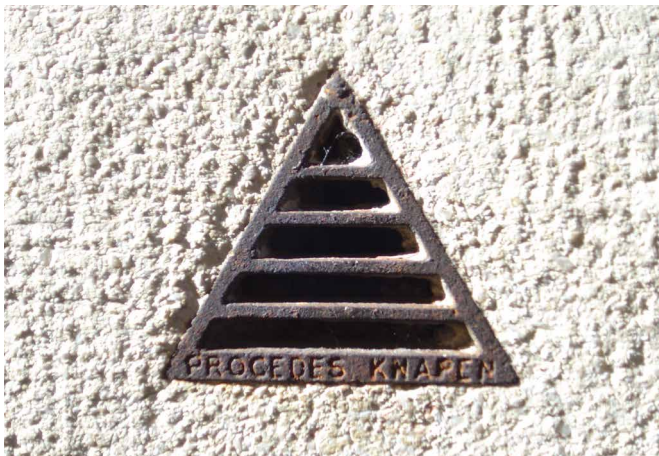
FIG. 3.7 Knapen syphons / Photos: B. Lubelli

- *Methods based on evaporation increase, including:*
  - *Knapen syphons and similar devices, such as Schrijver systeem:* holes are made in the wall and the syphons are placed in them: the hole increases the evaporation surface and it might thus enhance evaporation [FIGS. 3.7/3.8]. As pointed out by Massari in (Massari and Massari, 1985), these systems may help (if not obstructed by debris) only in situations when the wall temperature is slightly lower than, or equal to that of the outside air and when the Relative Humidity (RH) of the outside air is very low. In humid regions, such as in the Netherlands, these systems are generally ineffective. Moreover, drilling a hole in the wall would work similarly (Vos, 1971) and be much cheaper;

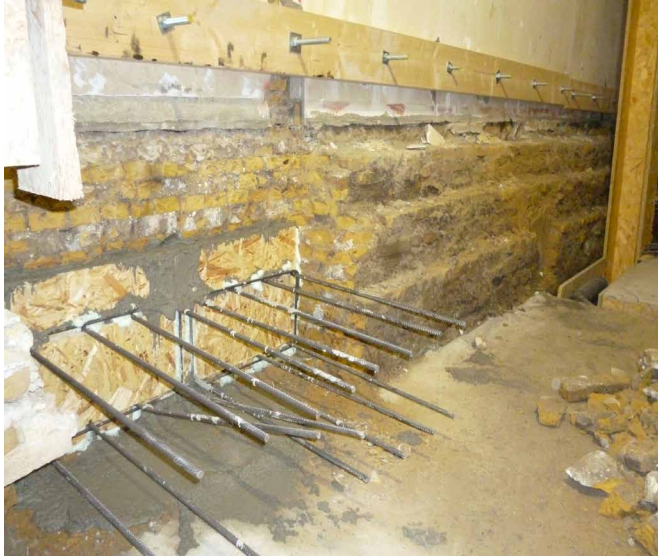
FIG. 3.10 Huis Nolet, basement: reinforcement for insertion of concrete floor (December 2016) / Photo: B. L.ubelli

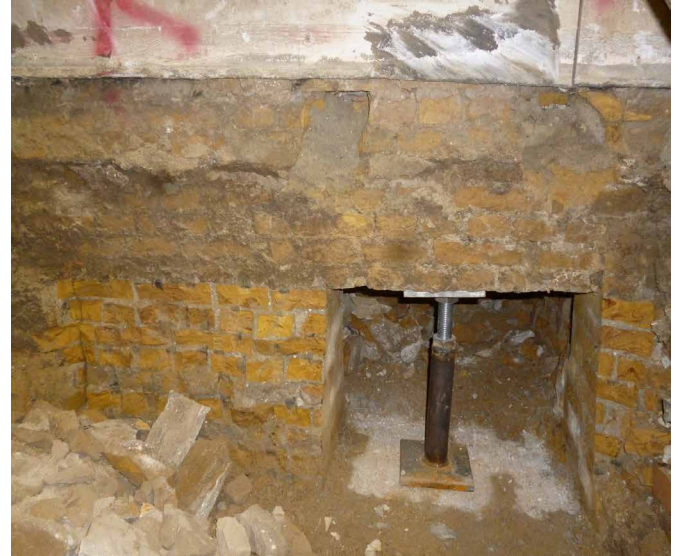
FIG. 3.11 Huis Nolet, basement: temporary support of the wall during insertion of concrete floor (December 2016) / Photo: B. L.ubelli

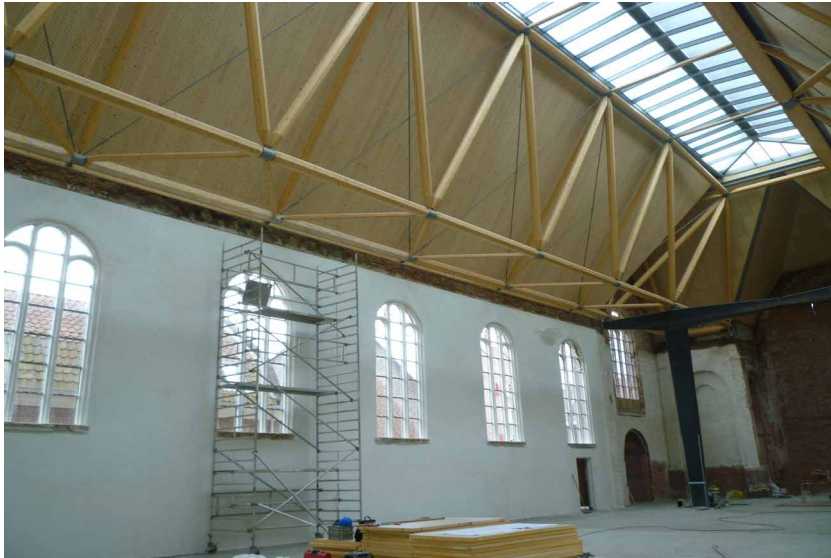
FIG. 3.12 Interior of the Elleboog church: water used to extinguish a fire had accumulated on the concrete floor and risen up in the wall, leading to a moisture content distribution similar to that observed in the presence of rising damp from groundwater / Photo: B. Lubelli

damp from groundwater [FIG. 3.12]. A further investigation of the groundwater level and of the moisture content in the soil, clarified that rising damp from groundwater was indeed present, but only up to a low height in the wall [FIG. 3.13]. The high moisture content (MC) measured in the wall in the interior of the church was not due to rising damp from groundwater, but to the capillary rise of water used to extinguish the fire, which had accumulated on the concrete floor of the church. No intervention against rising damp was thus necessary; after 6 months the walls were dry enough to be safely plastered.

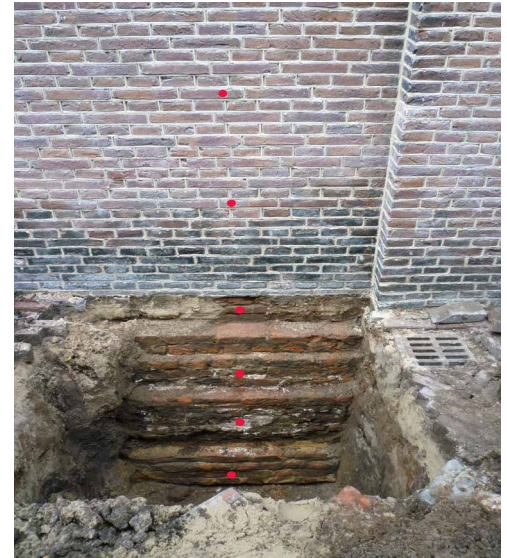
FIG. 3.13 Excavation of the ground around the foundation of the church and sampling, at different depths and heights in the wall along a vertical profile, for the measurement of the moisture content and distribution / Photo: B. Lubelli

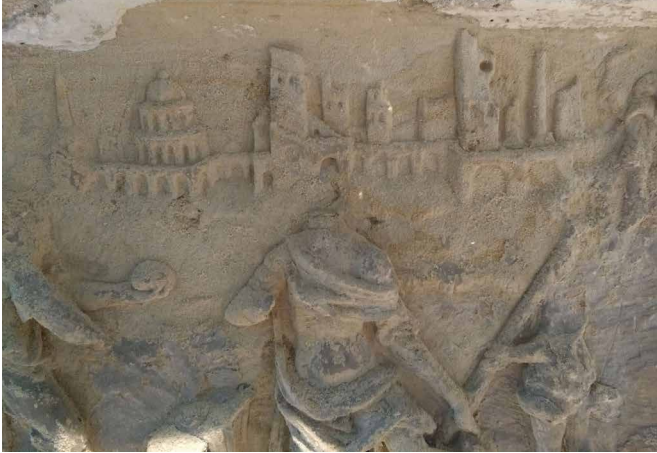
FIG. 4.4 Powdering of the stone: a consolidation treatment may be effective in this case / Photo: B. Lubelli

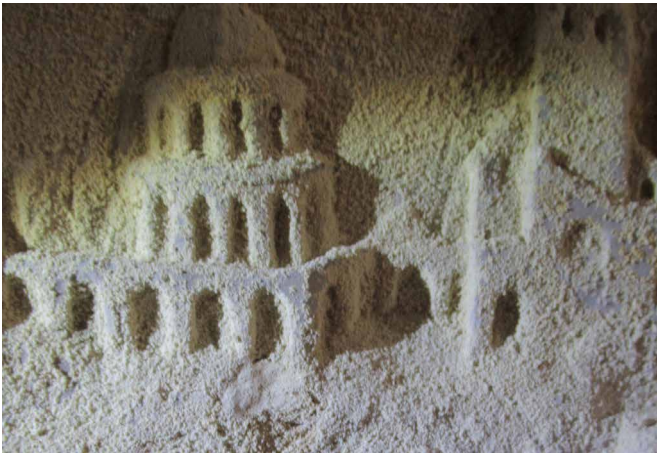
FIG. 4.5 Powdering of the stone: a consolidation treatment may be effective in this case / Photo: B. Lubelli

The main aim of a consolidation treatment is to improve the cohesion of the decayed part of the material and its adhesion to the sound material beneath. It is important to mention that consolidation treatments can be effective when the loss of cohesion occurs in the form of powdering or sanding [FIGS. 4.4/4.5]. A consolidant treatment is not effective in the presence of delamination and can even be harmful.

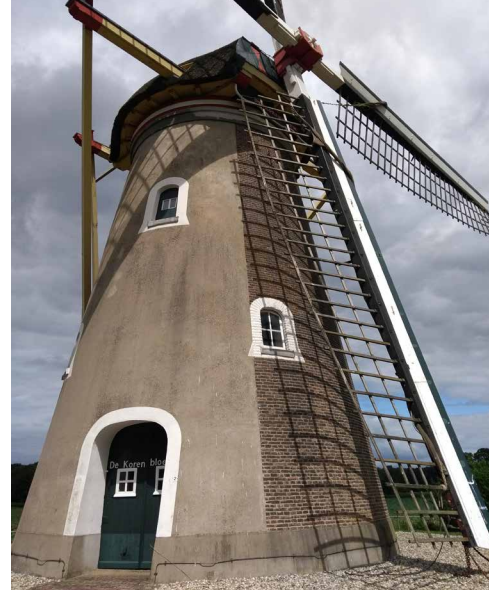
FIG. 4.10 A plaster layer for protection can be an alternative for a waterrepellent treatment / Photo M. van Hunen

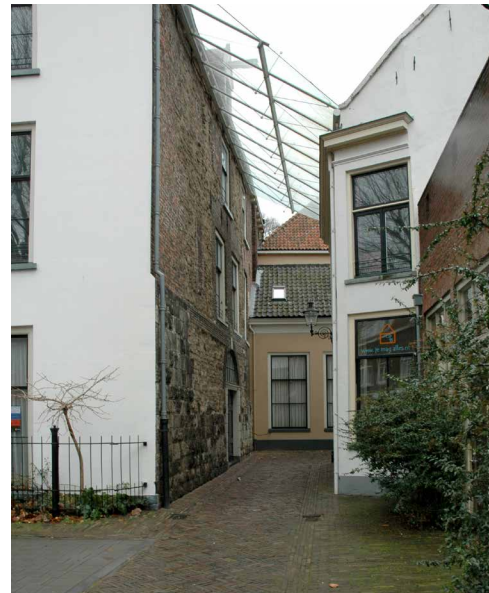
FIG. 4.11 A roof protection can be an alternative for a waterrepellent treatment / Photo W.J. Quist

When deciding on the application of a surface treatment, this choice should consider the specific situation thoroughly. A water repellent treatment might be possibly a solution for stopping rain water penetration. Differently, using a water repellent only for reducing soiling, might be ineffective in the long term and risky. In fact, the beading effect, which reduces the sticking of soiling to the treated surface, disappears after few years, while all the risks related to the application of a water repellent still remain. As surface treatments are generally irreversible, alternative solutions having a higher degree of reversibility should be considered first (Hees et al., 2014) [FIGS. 4.10/4.11].

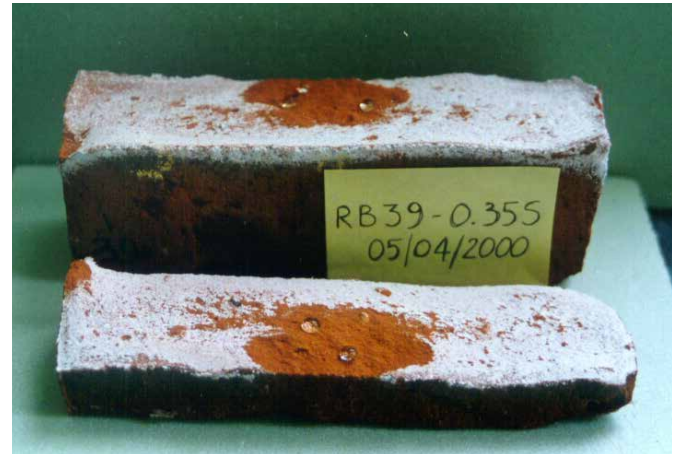
FIGS. 4.12/4.13 Salt accumulation beneath the layer treated with a water repellent (left) and subsequent spalling of the treated part (right) during a laboratory test /  
Photos: B. Lubelli

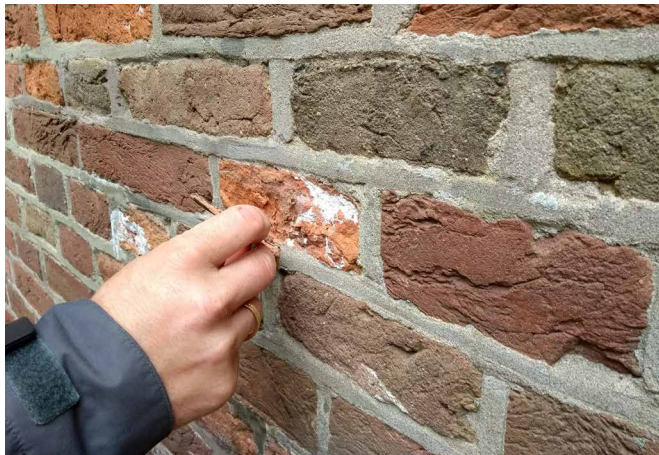
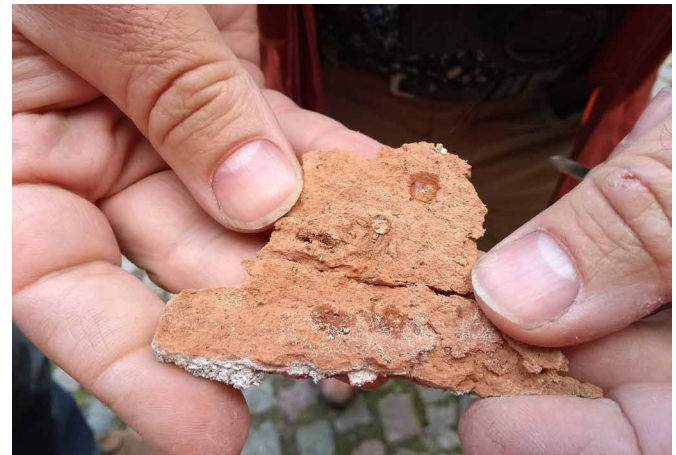
FIGS. 4.14/4.15 Spalling due to salt accumulation beneath the treated layer; the water repellent is still effective several years after the application /  
Photos: M. van Hunen

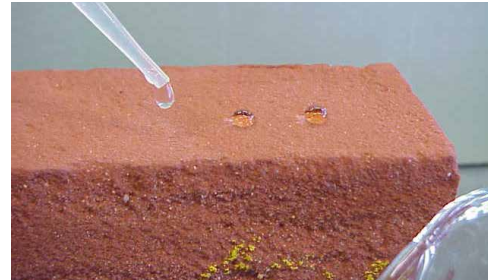
FIG. 4.19 Method for the assessment of effectiveness of water repellent treatment: beading effect / Photo: B. Lubelli

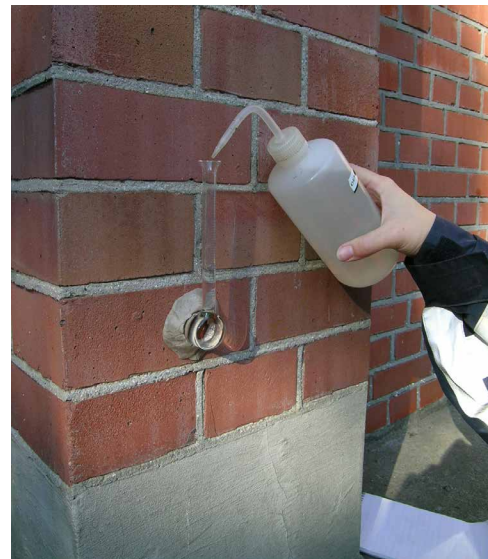
FIG. 4.20 Karsten Tube test / Photo: R. van Hees

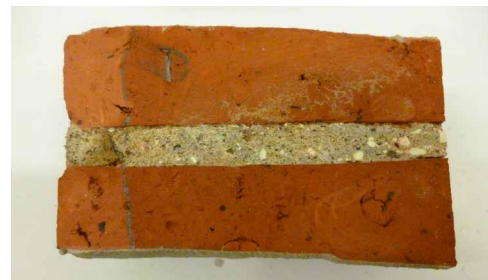
FIG. 4.21 Measurement of the impregnation depth / Photo: B. Lubelli

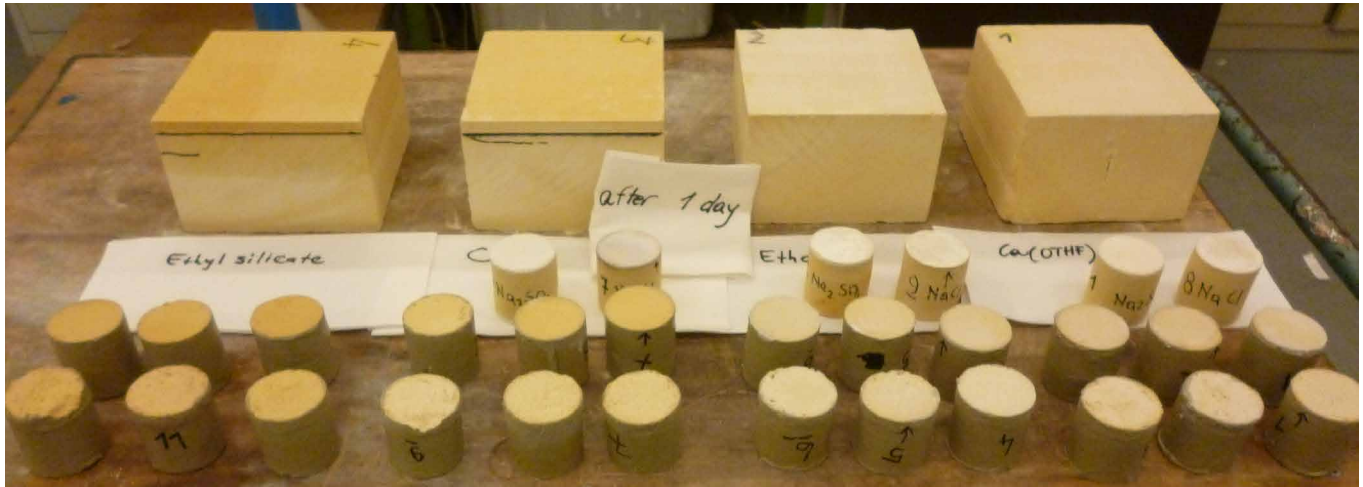
FIG. 4.23 Maastricht limestone 1 day after the application of different consolidation products: product 2 and to a lesser degree product 1, have caused whitening of the surface / Photo: B. Lubelli

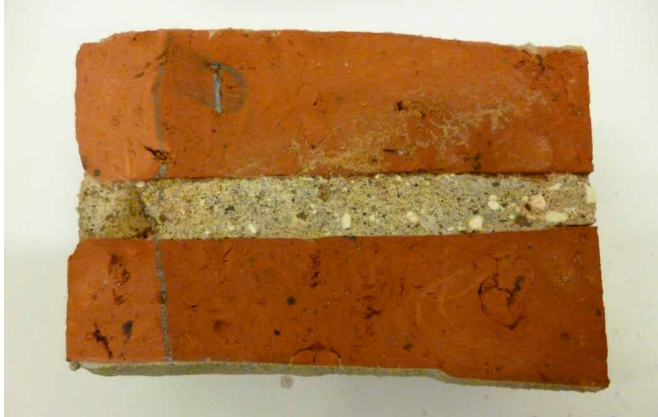
FIG. 4.26 The penetration depth of a water repellent treatment has been assessed by wetting a cross section of the sample with water: the light part corresponds with the treated layer / Photo: B. Lubelli

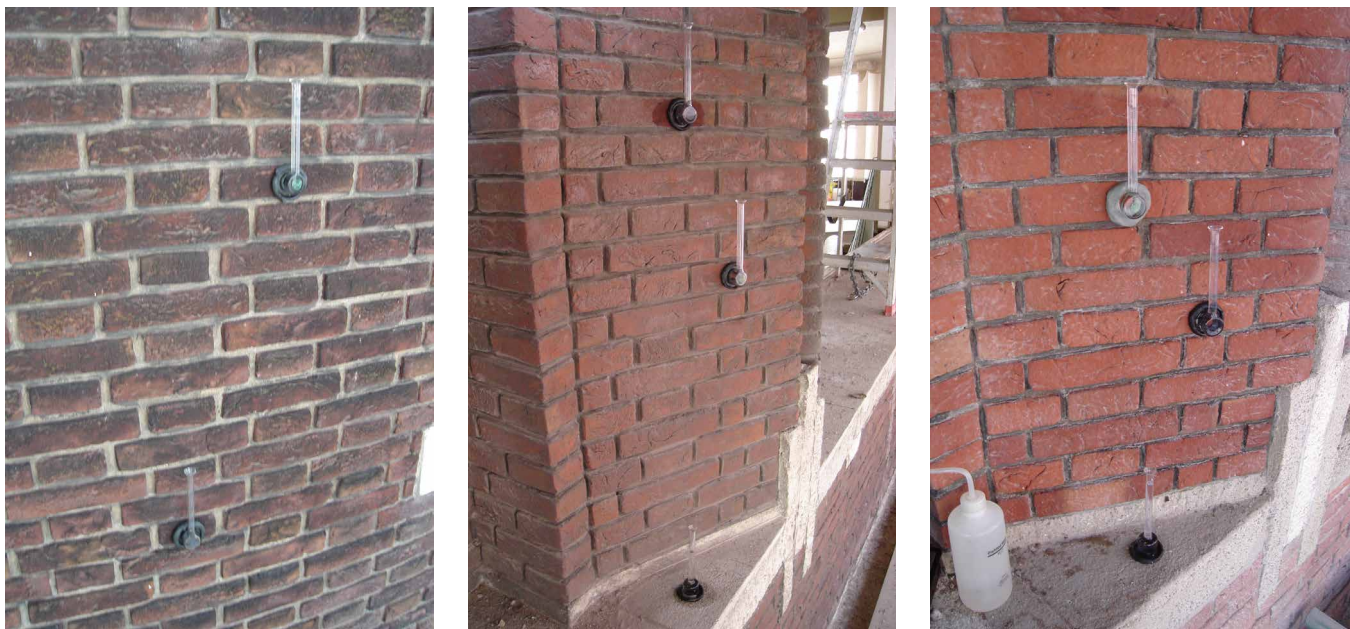
FIG. 4.27 Execution of the Karsten Tube tests on the masonry not cleaned (left), cleaned (middle) and cleaned and treated with a water repellent (right) / Photos: B. Lubelli

The results of the Karsten Tube tests [TABLE 4.2] show that the masonry before cleaning had a very low absorption. Cleaning significantly increased the water absorption; the subsequent treatment with a water repellent was able to reduce the water absorption to nihil. However, the results of the salt analyses showed the presence of a high salt content in the masonry. Based on these results it was advised to reconsider the need for cleaning the masonry.

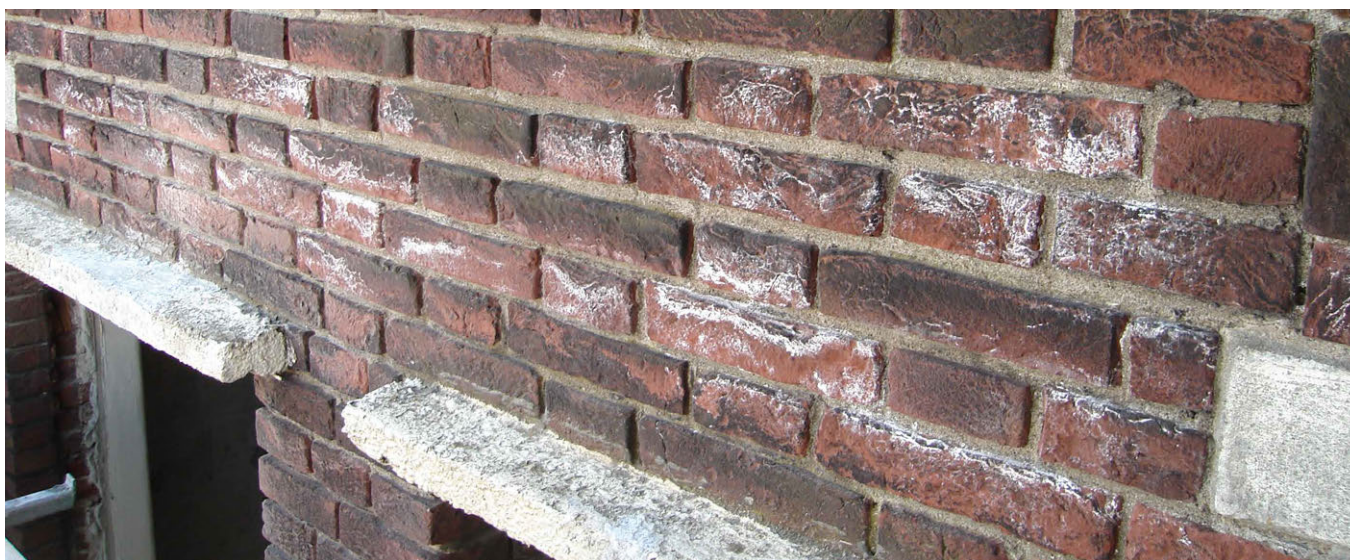
FIG. 4.28 Salt efflorescence, evidence of the presence of salts in the masonry, further confirmed by chemical analyses / Photo: B. Lubelli

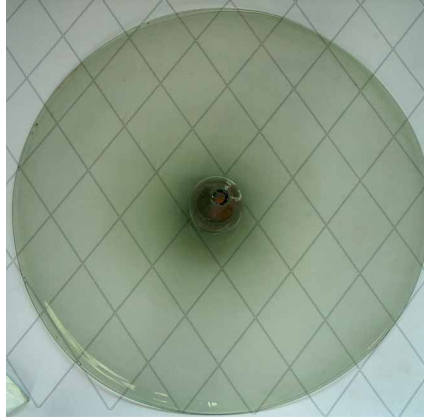
FIG. 5.3 The term 'bull's eye' refers to the thicker centre area of crown glass around the pontil mark / Photo: RCE

*Crown Glass (400 CE onwards):* to make crown glass, a bubble of glass is transferred from the blowpipe to a pontil iron and after perforating the glass balloon, is spun at high speed so that the centrifugal force causes it to flatten into a round 'crown'. The central piece, the 'bull's eye' was often used for cheaper (domestic) windows. Crown glass was one of the most common processes for making window glass in Europe until the 19<sup>th</sup> century [FIGS. 5.2/5.3/5.4].

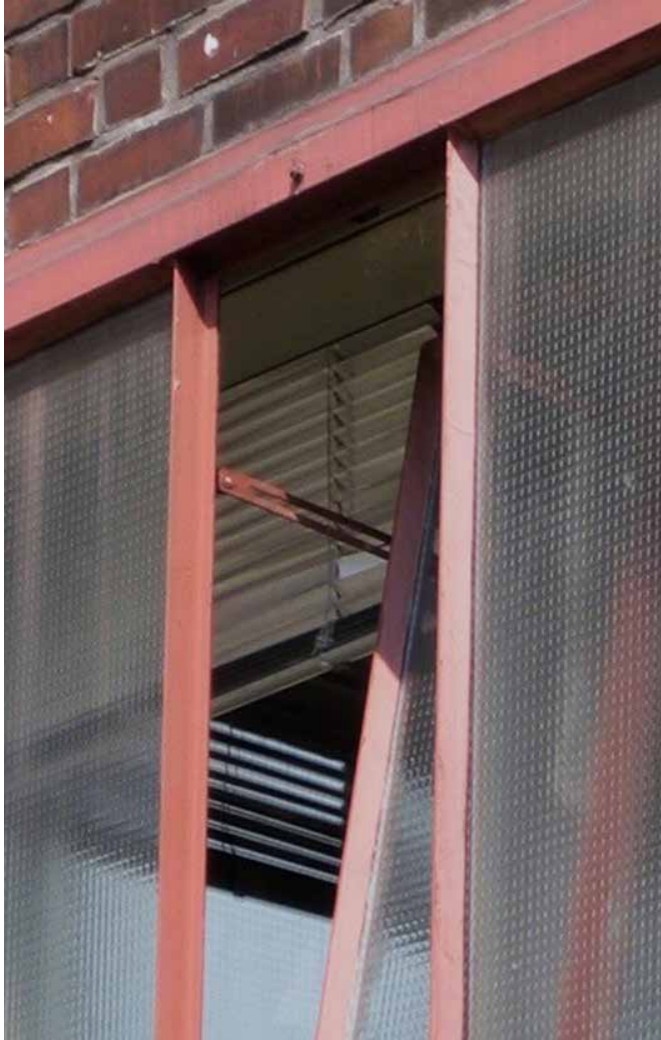
FIG. 5.21 Metal framed windows were used in industrial architecture since 18<sup>th</sup> century, and became standard in 20<sup>th</sup> century with mostly patterned or wired glass, Zollverein Coalmine, 1932 / Photo: U. Pottgiesser

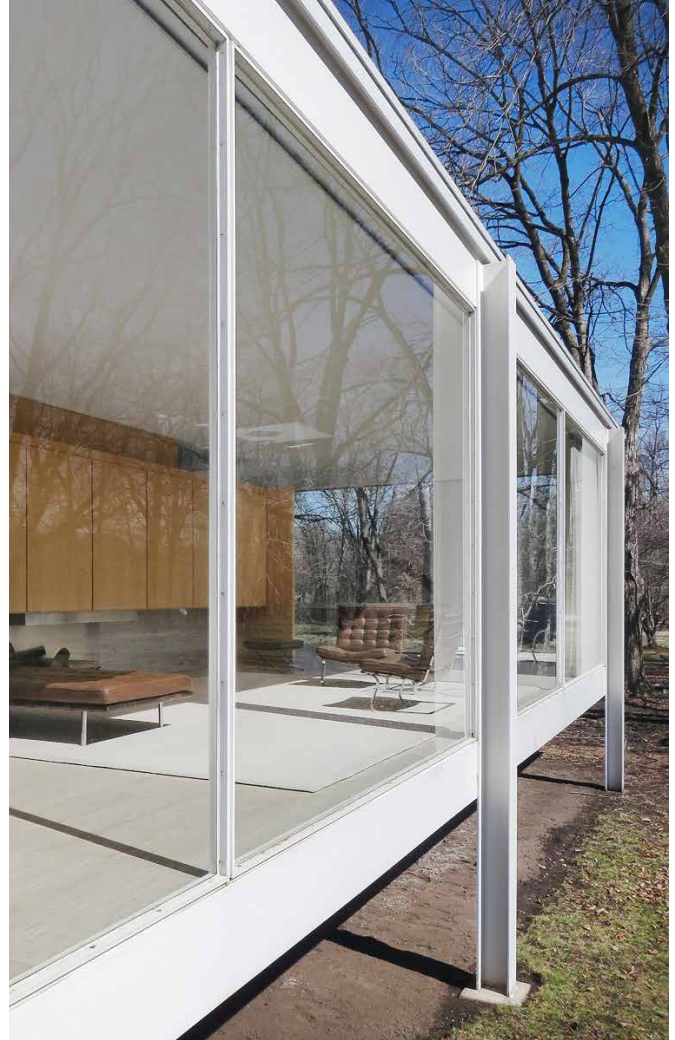
FIG. 5.22 Large metal framed windows were introduced to residential architecture in early 20<sup>th</sup> century, and became famous with buildings like the Farnsworth House, 1951 / Photo: A. Ayón
