**Laser Scanning of Damaged Historical Icons  
Surveying Technology is Heading for Maturity**

GIM International: the worldwide magazine for geomatics

# Laser Scanning of Damaged Historical Icons

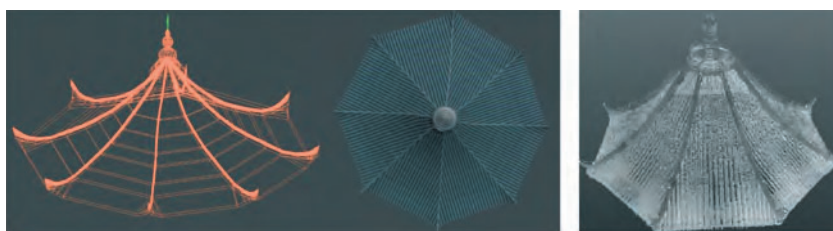
▲ Figure 2: Two views of the 3D models of the roof of the Liuhe Pagoda (left) derived from a laser scanning point cloud.

The Liuhe Pagoda (Six Harmonies Pagoda), located at the mouth of the Qiantang river in Hangzhou, Zhejiang province, China, has been demolished and rebuilt several times since originally being constructed in AD 970. Today it is a major tourist attraction (Figure 1). In addition to suffering human devastation, forces of nature have caused the monument to decay. Combined with the size of the pagoda, which is 13 storeys tall, this makes it a challenging restoration project. In 2013, its fourth major repair and renovation project began. The interior and exterior were scanned over a period of six months to support restoration. After scanning, which took three minutes per scan position, the building was modelled to find the missing parts, which required two to three hours per scan (Figure 2). Next the missing parts were designed, crafted by hand and assembled. For quality assurance and control inspections and detailed 3D documentation, the building was scanned using a compact 3D laser scanner resulting in 23 billion 3D points.

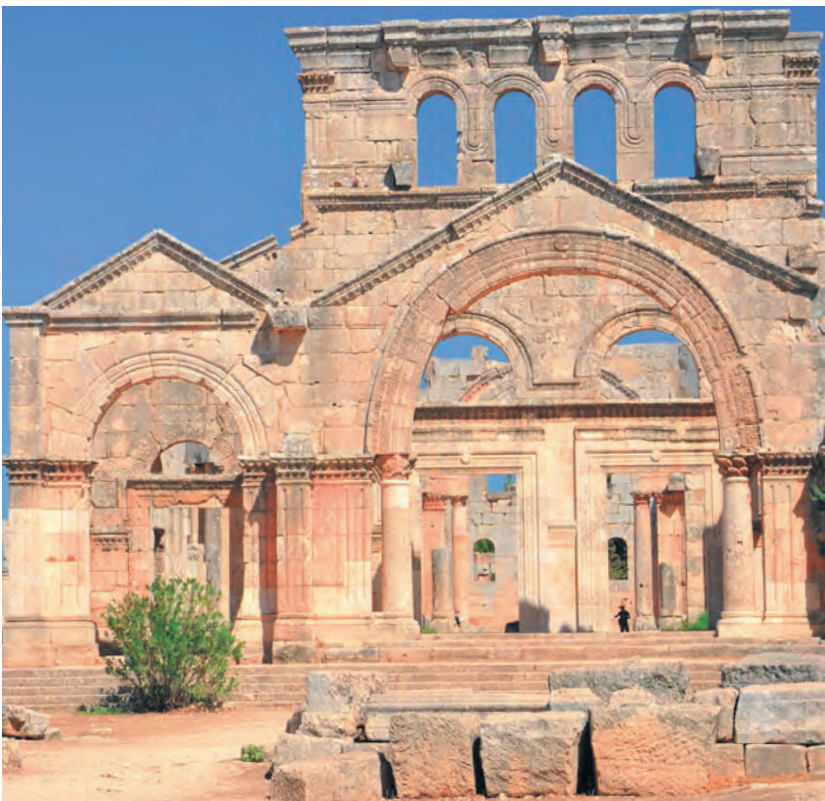
▲ Figure 7: South facade of the Church of Saint Simeon Stylites before the 2016 attack.

partly destroyed by a Russian rocket attack in 2016. Since 2003, the site had been regularly surveyed by crews from France, including by using laser scanning (Kurdy et al., 2011). One of the surveys was conducted with TLS equipment from the Ecole Nationale des Sciences Géographiques (ENSG) in 2004. The cruciform church (Figure 7) was captured from 36 positions using a Trimble TLS device with a horizontal field of view of 360° and a vertical field of view of 60°. In the overlaps of the scans, spheres were mounted for registration purposes. After manual removal of unnecessary points, the 250 million remaining points were processed to create 3D representations of relevant parts of the building. The resulting 3D documentation forms a historical record of the building and is very valuable in preparing and conducting the restoration work.
